RE: *Flow Way CDD v. Taylor Morrison of Florida, Inc., et al.*
NOTICE OF CLAIM, PURSUANT TO FLA. STAT. § 558.004

Thus, pursuant to Chapter 558 of the Florida Statutes, **YOU ARE HEREBY NOTIFIED of the construction defects existing within the CDD Boundaries, each of which are set forth in more detail in the enclosed Forge Engineering Report, dated June 2, 2021, and the CGA Report.**

FLOW WAY CDD PERIMETER FENCING INVESTIGATION MAP

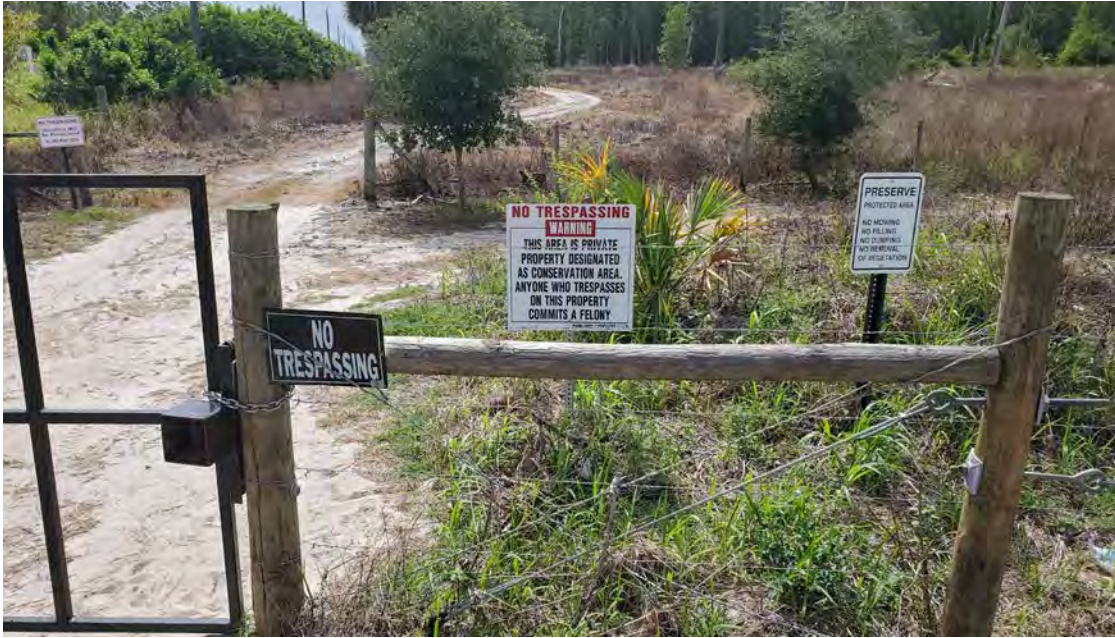
Northern Area - Access was obtained to northern area via Parklands Preserve's ingress/egress metal gate immediately adjacent to Logan Boulevard. The Flow Way CDD access point was unobstructed, and no metal gate was found to prohibit trespassers. Following an existing path along the northern property boundary line (within CDD preserve limits), various types of fences (chain link fence and barbed wire cattle fencing) were observed, which seemed to be newly installed by adjacent residential developments. Little to no security fencing exists along the entire northern property limits as adjacent neighborhoods to the north seem to have discouraged access by the placement of proposed lakes or fencing. While fencing is missing in these portions, this area is considered 'low-risk' for trespassers. It should be noted that a trailer was parked/abandoned, located outside of the preserves area along the northern property line, and might have been used to transport recreational vehicles into the CDD property, however no recreational vehicles were observed during on-site inspection.

#1 - NW Logan Access – Parkland Preserve Gate & Flow Way CDD Missing Gate

- Northern Area – One (1) 12-ft metal access gate w/ pad lock
- Collier Boulevard Access and Eastern Private Property Areas – Two (2) 12-ft metal access gates w/ pad locks; wooden post and barbed wire fence repair and/or re-installation
- Western Property Limits - Two (2) 12-ft metal access gates w/ pad locks; wooden post and barbed wire fence repair and/or re-installation procedures
- Southern Entrance and Outparcel Areas – No security improvements are recommended.

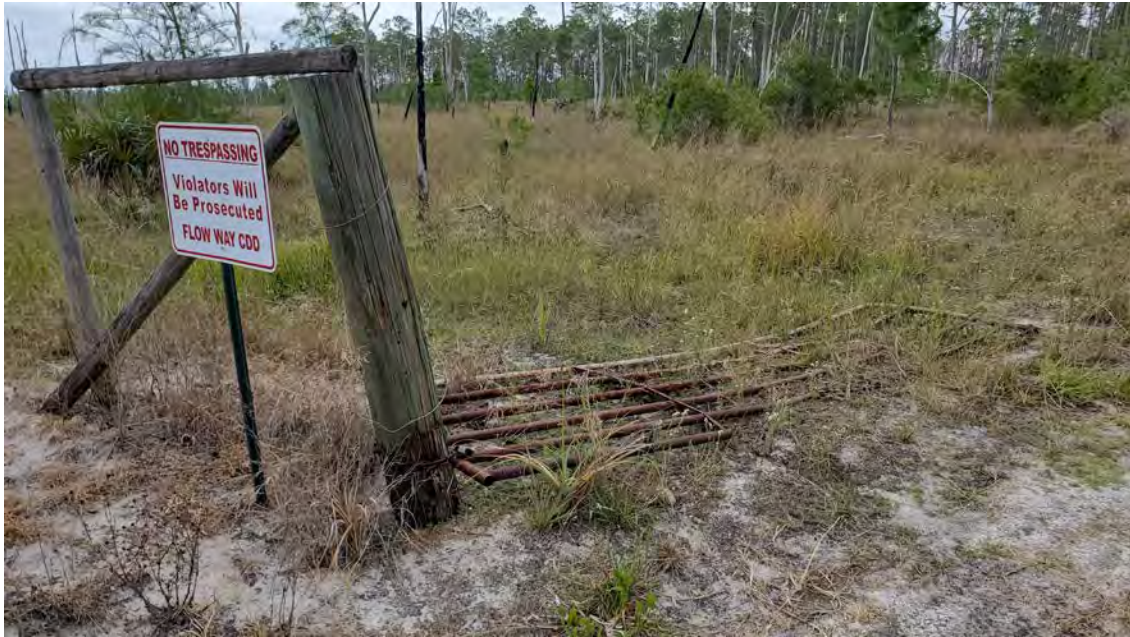
- 3) Western Property Limits – Central preserve entry gates broken – Gate broken and unhinged on ground to restrict access, however off-site Parklands gate prohibits egress from right-of-way.
- 4) Southern Entrance and Outparcel Areas – No improvements are recommended.

#46 - Flow Way CDD Gate 1 – Broken

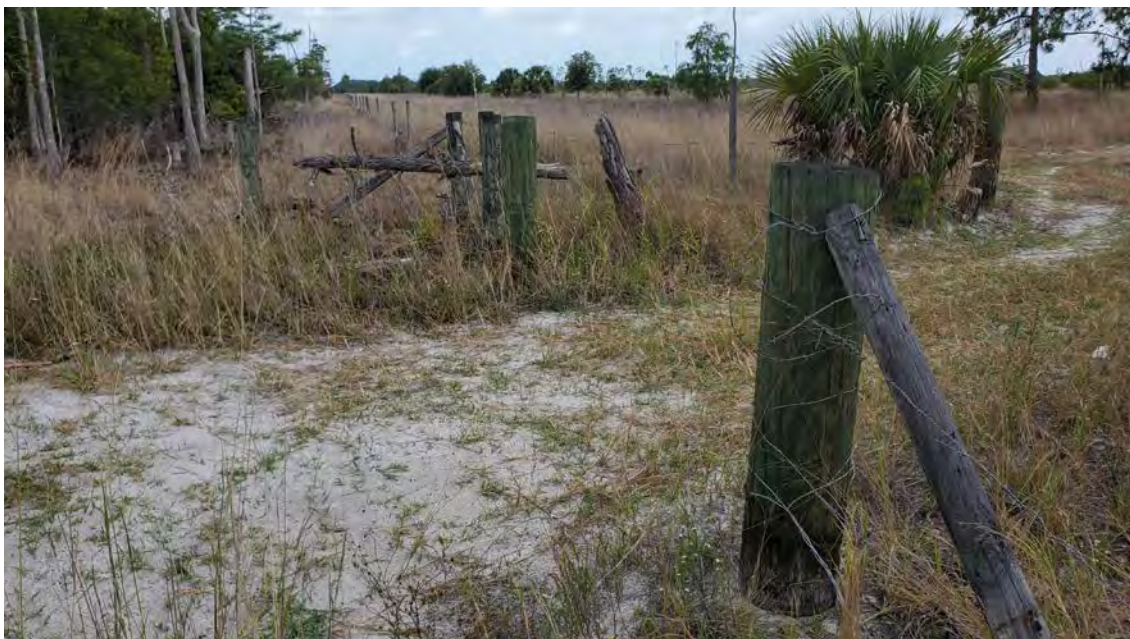
#51 - Flow Way CDD Gate 2 – Broken

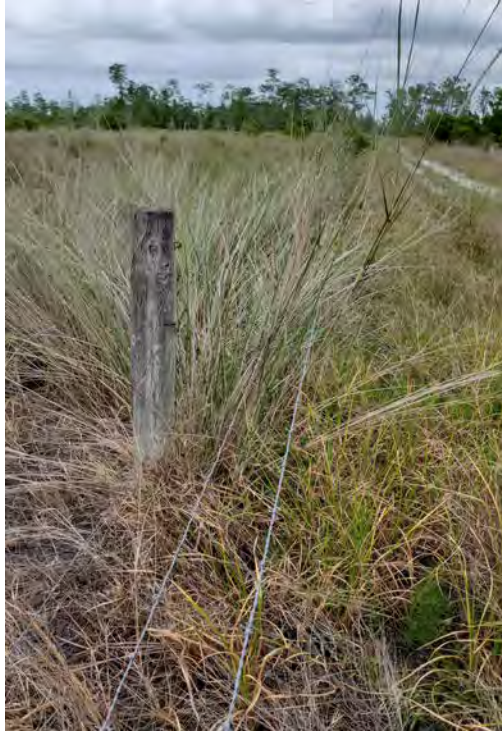
Generally, wooden post & barb wire fence needs restoration or replacement (generally located throughout external preserves). See attached Exhibit 3 – Preserve Perimeter Investigations Report.

#62 - Wooden Post & Barbed Wire Repair

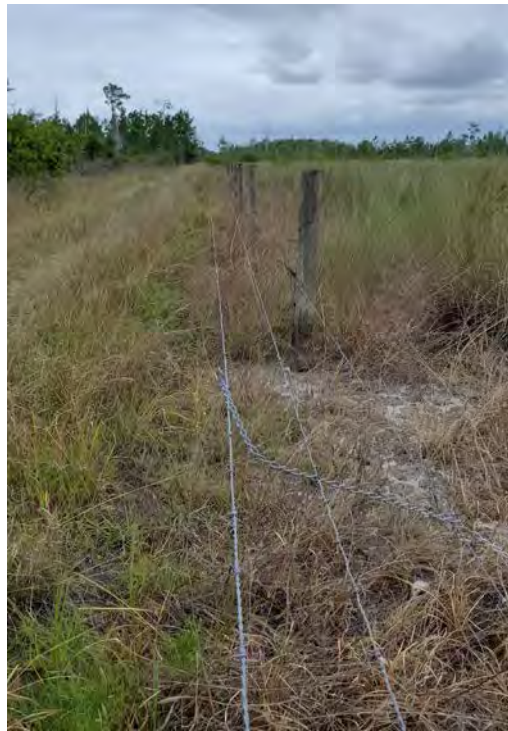
#63 - Wooden Post & Barbed Wire Repair

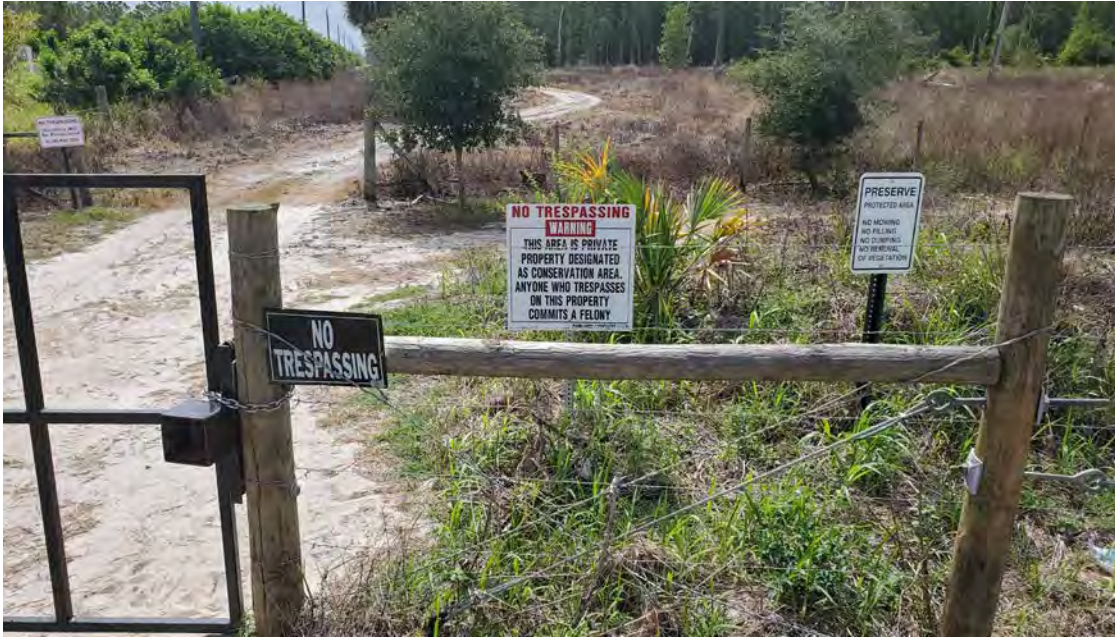
NW Logan Access – Parkland Preserve Gate & Flow Way CDD Missing Gate

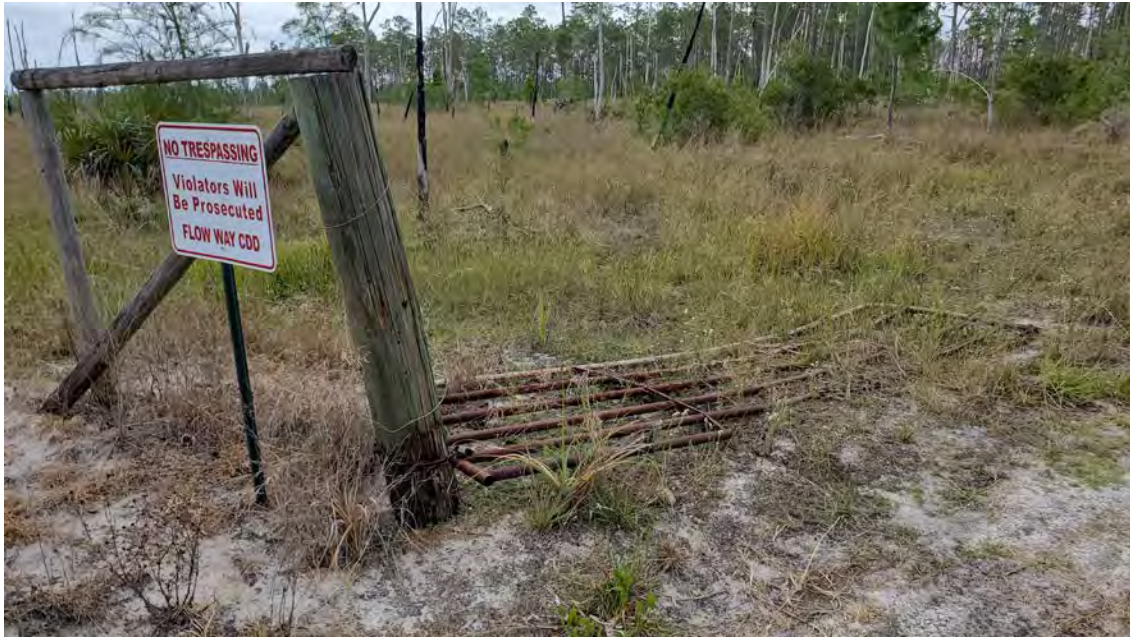
Flow Way CDD Gate 1 – Broken

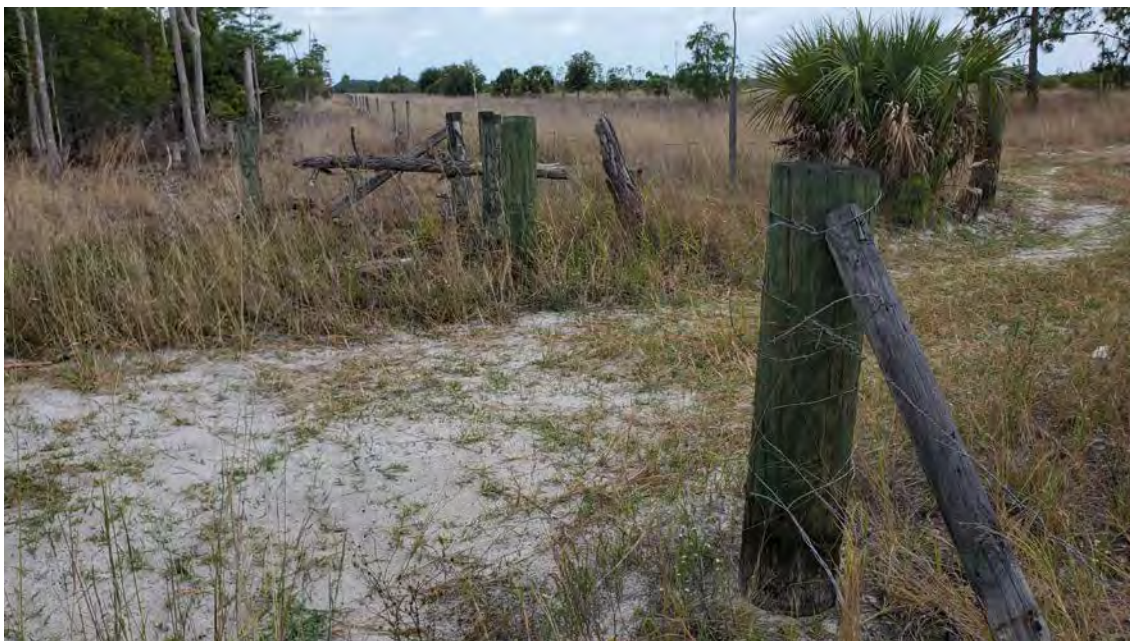
Flow Way CDD Gate 2 – Broken

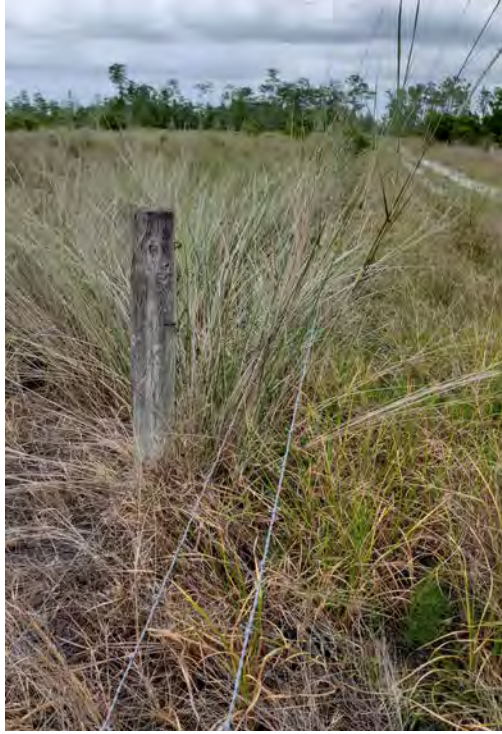
Wooden Post & Barbed Wire Repair

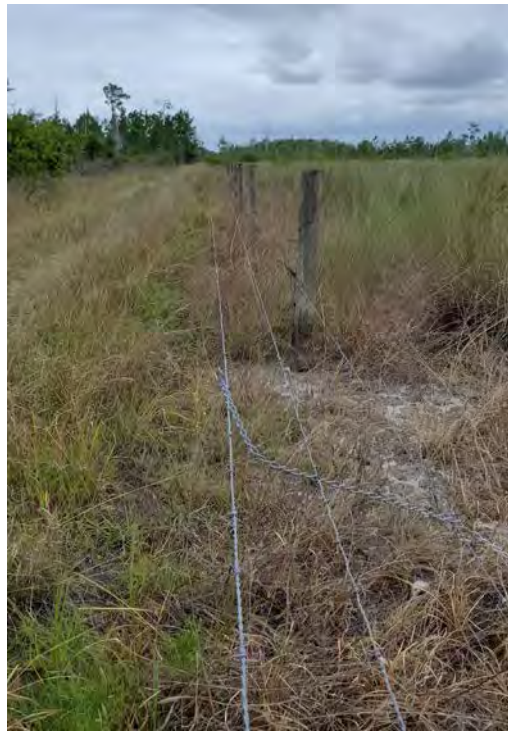
Wooden Post & Barbed Wire Repair

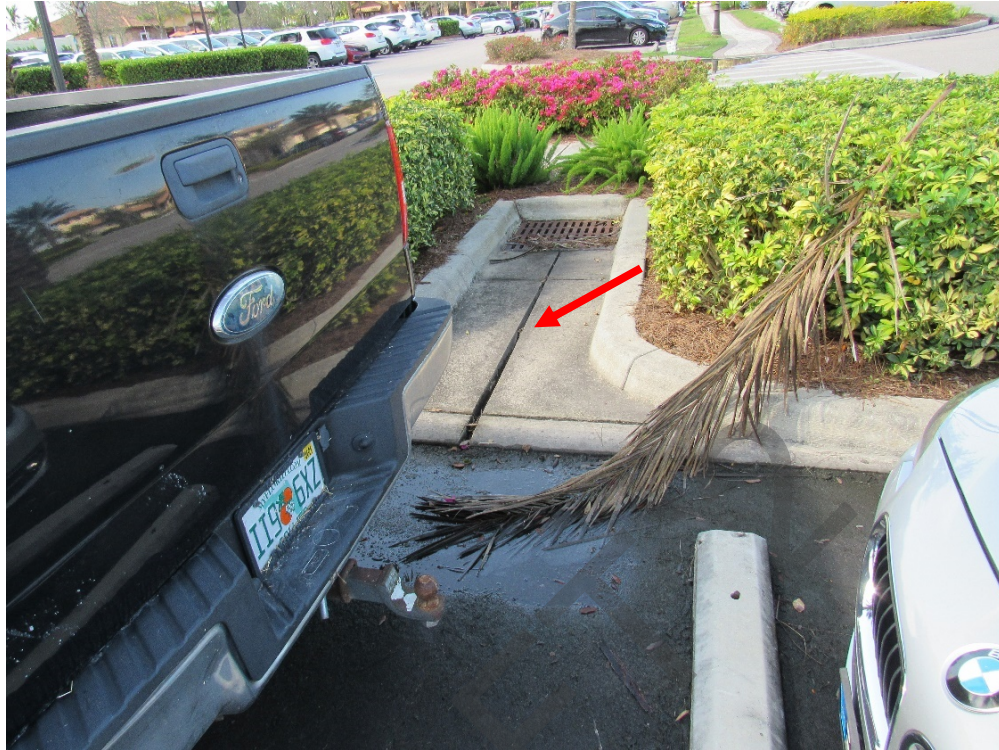
View of groove cut into concrete catch basin – Amenity Center Parking Lot.

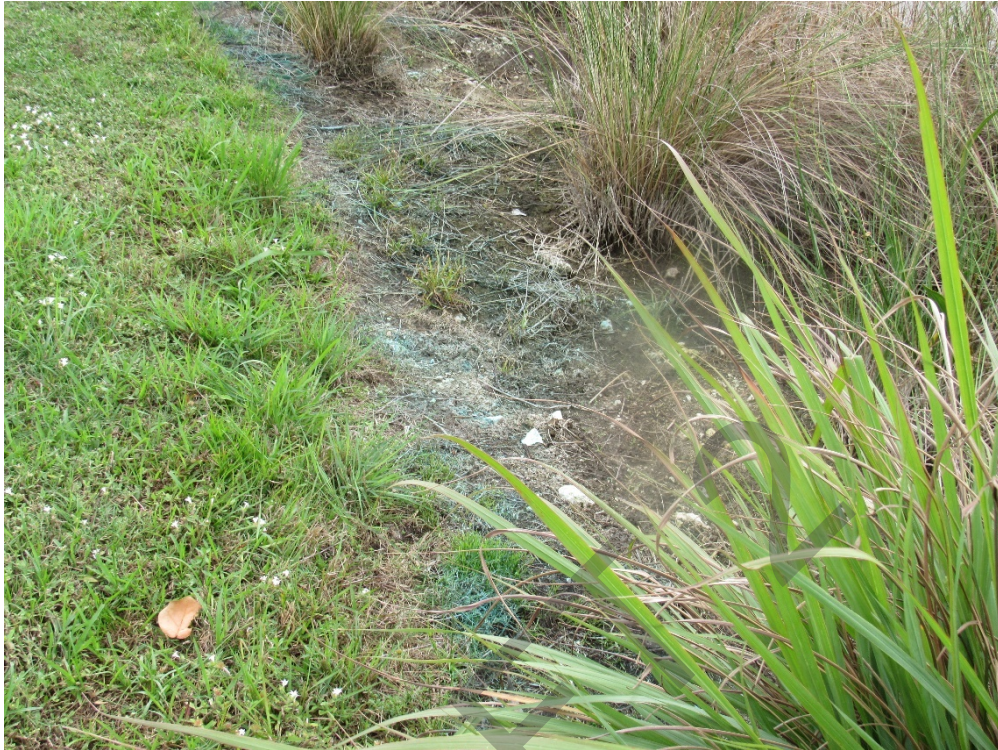
View of herbicide spray, not permitted in littoral areas - Lake 5A.

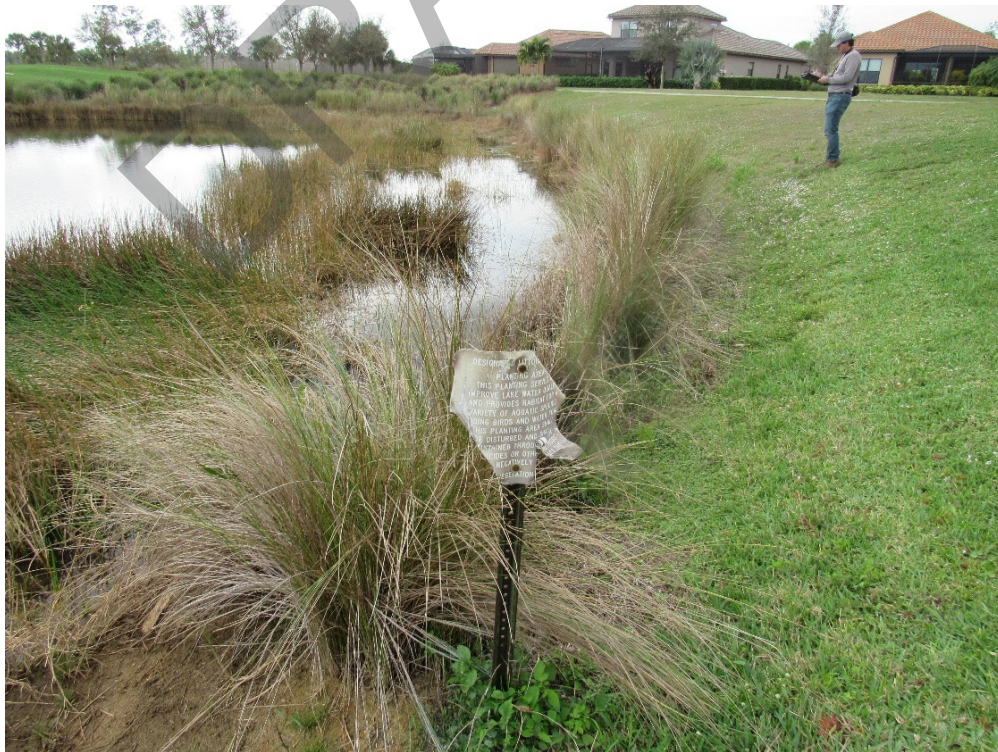
View of damaged Littoral sign - Lake 5B.

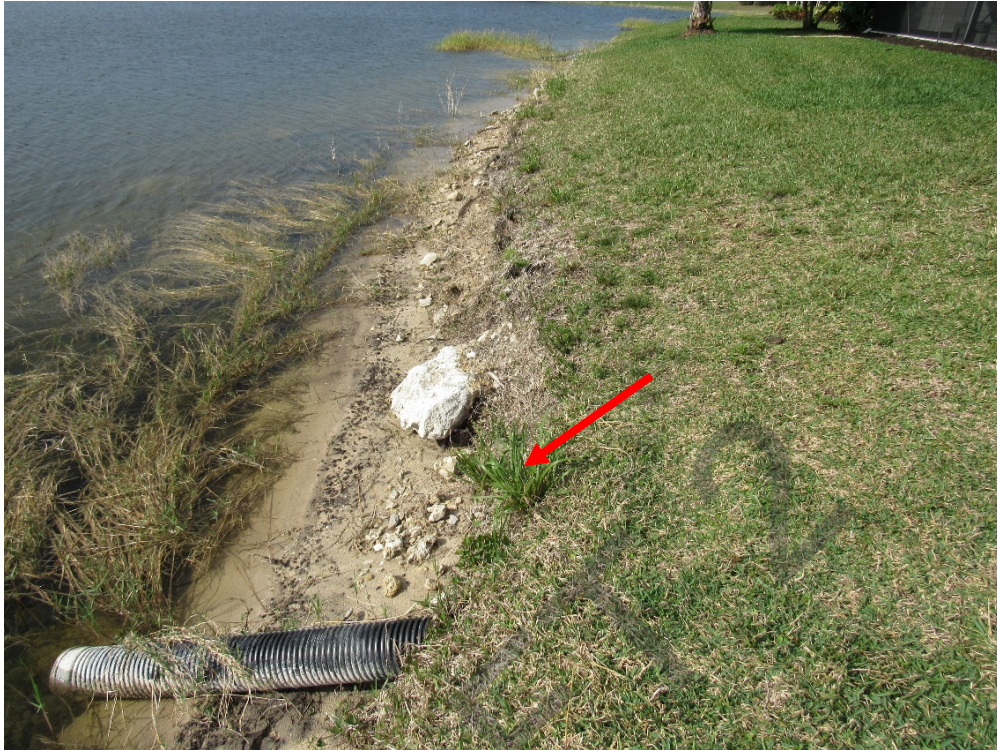
View of erosion at lake embankment - Lake 7.

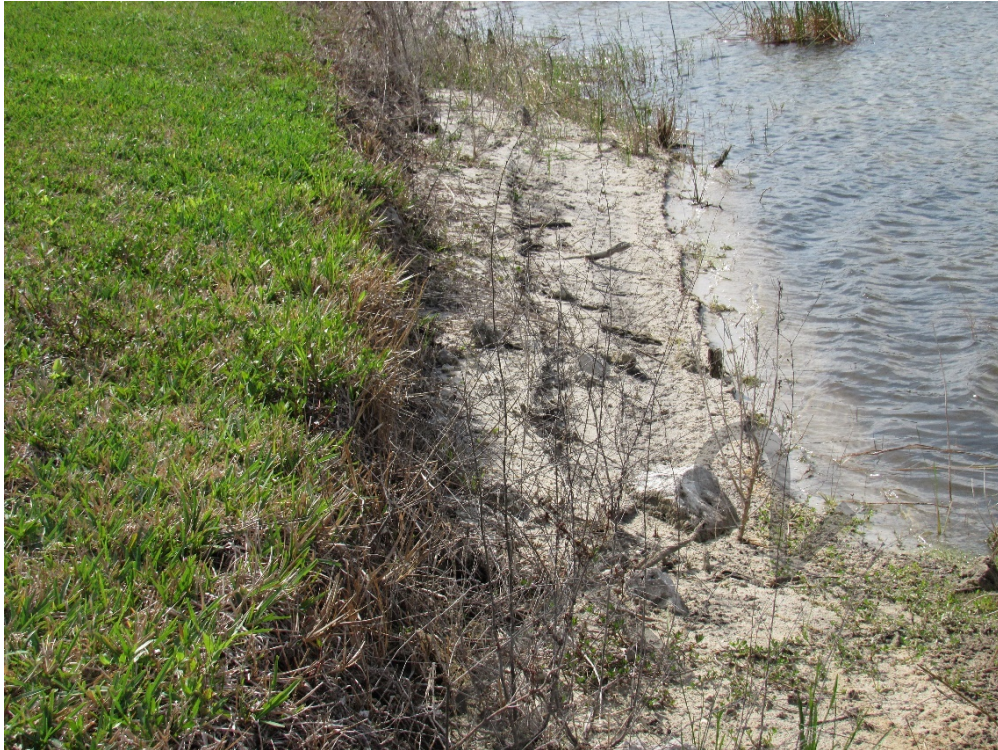
View of erosion at lake embankment - Lake 23.

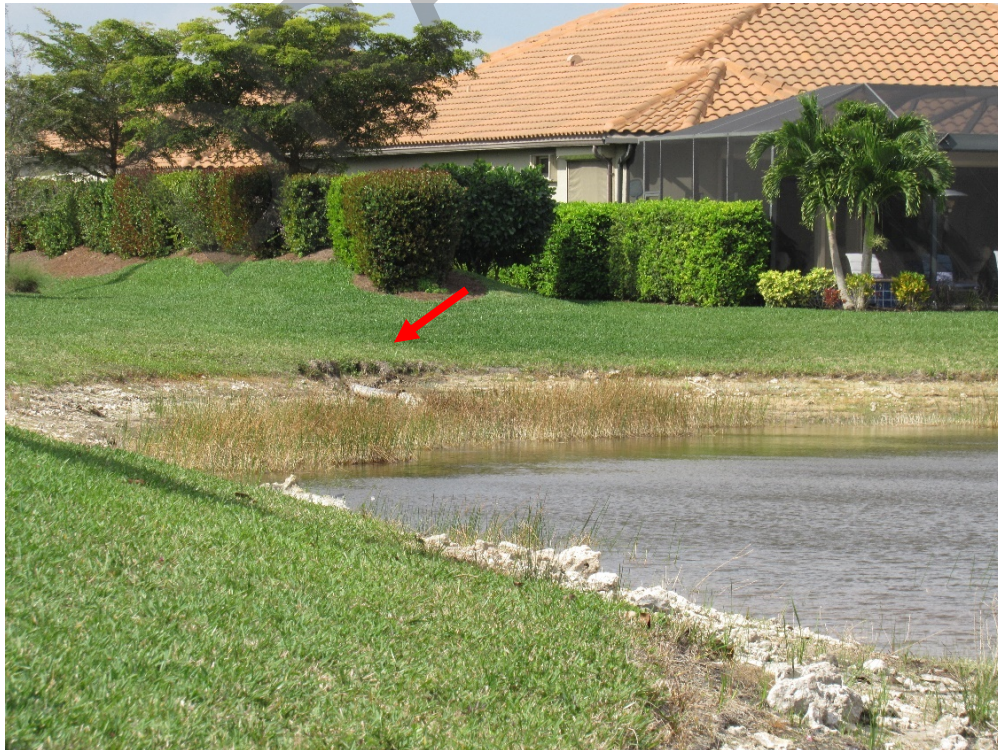
View of erosion at lake embankment - Lake 15A.

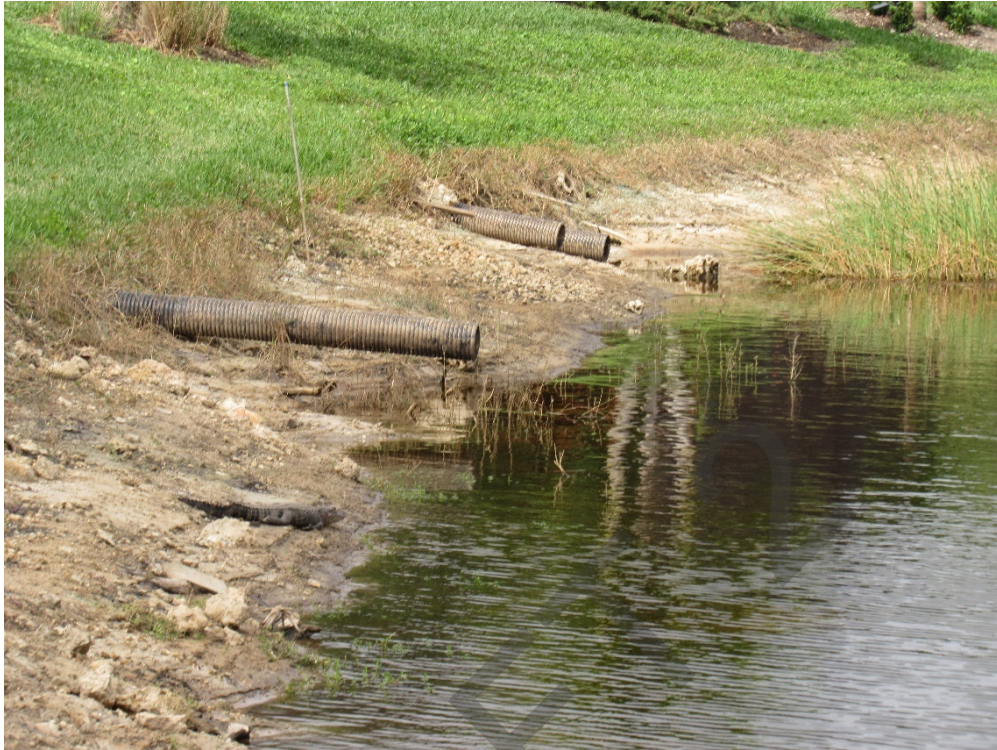
View of erosion at lake embankment and direct discharge lines - Lake 16.

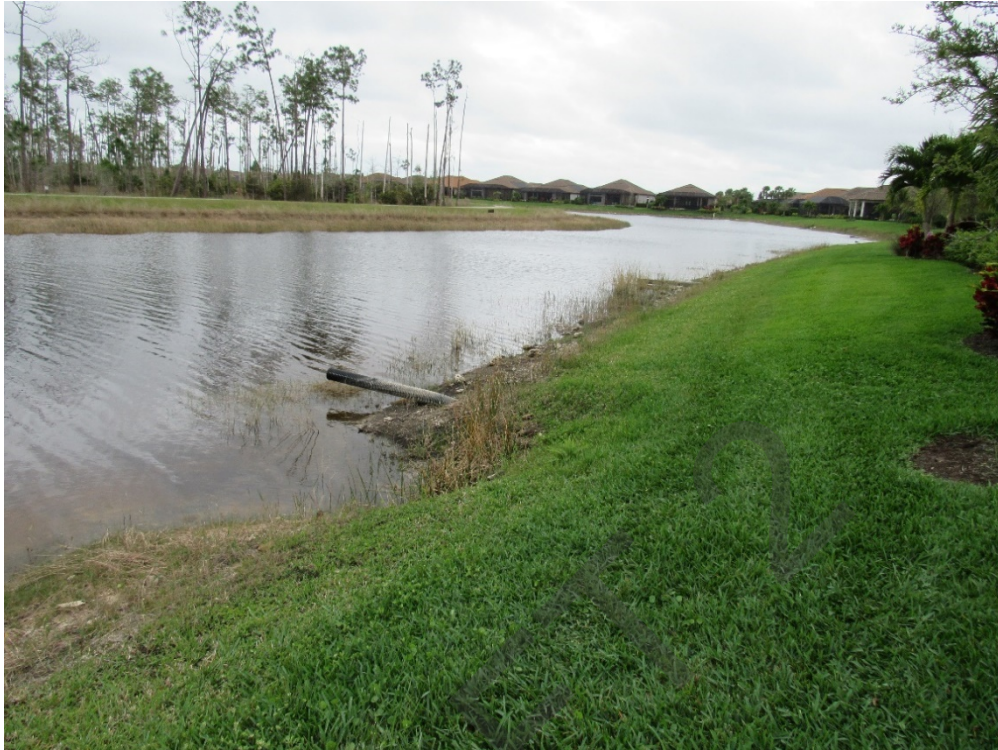
View of erosion at lake embankment - Lake 18.

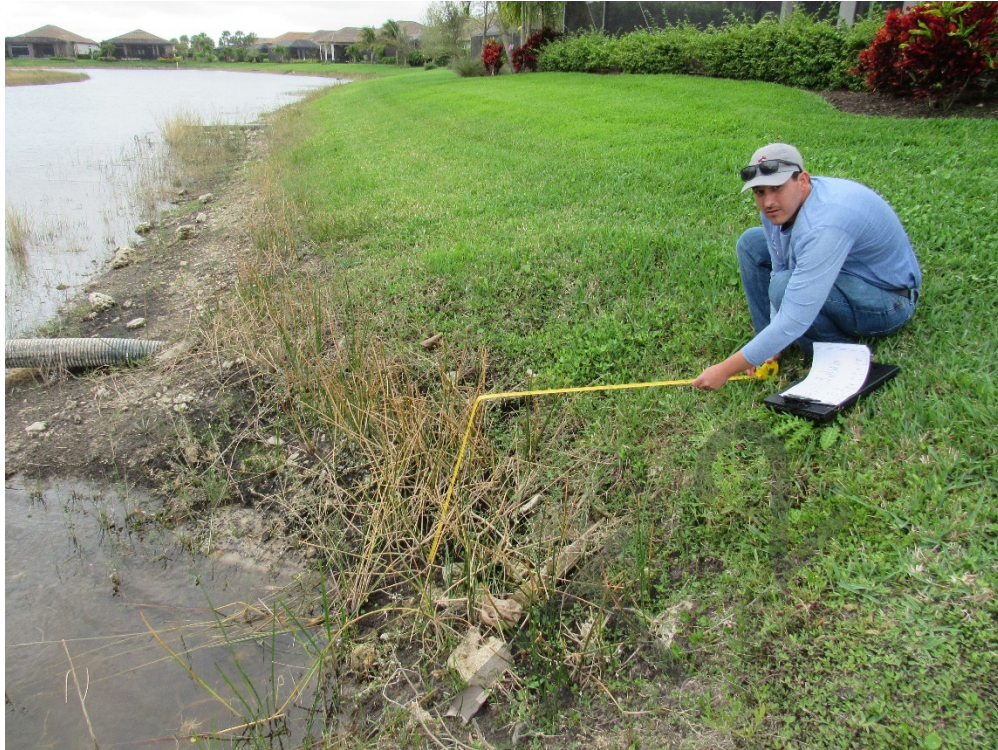
View of erosion at lake embankment - Lake 18.

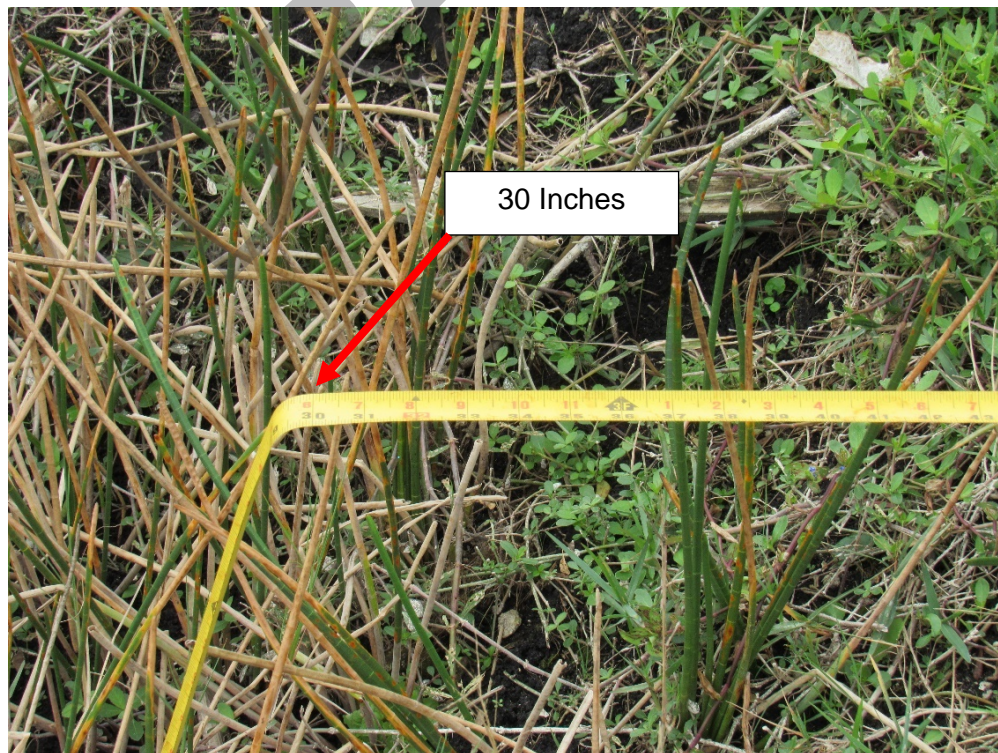
View of the depth of erosion at lake embankment - Lake 18.

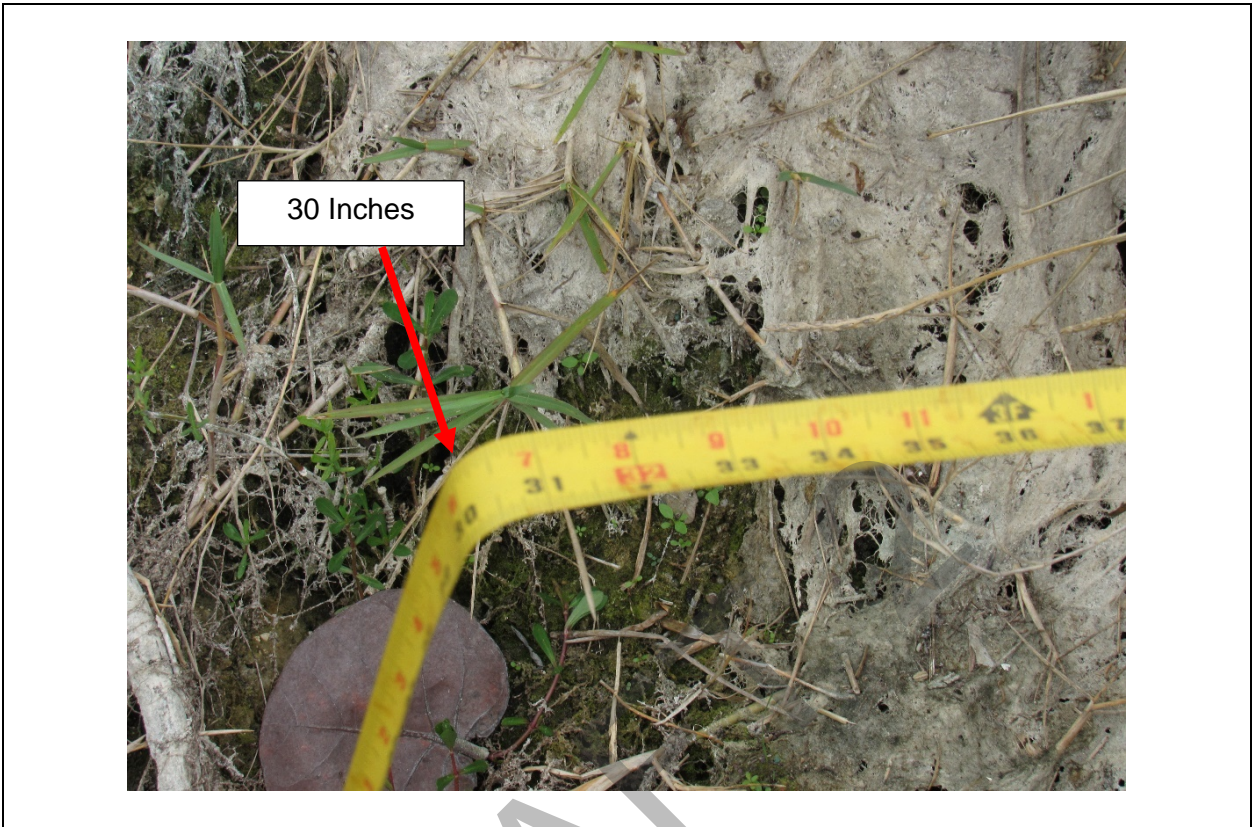
View of the depth of erosion at lake embankment - Lake 20.

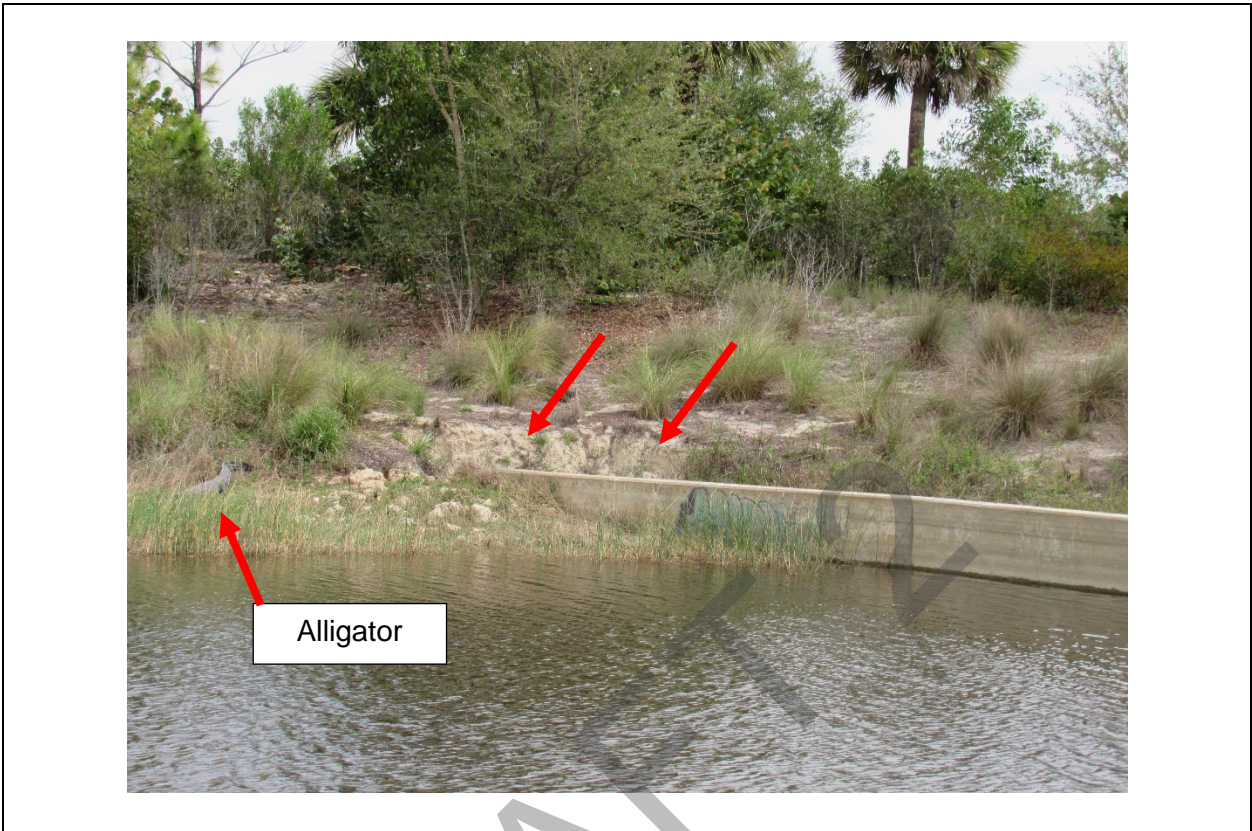
- Phase 1 – Board Crested Weir (South) Erosion on both ends (Forge cost estimate of **\$8,000**) – Immediate action is recommended.
- Phase 2 – Sediment & Debris Removal (structures with 25% or more blockage) in Storm Structures and Pipe (MRI Cost Estimate of **\$84,000**) – Immediate action is recommended.
- Phase 3A – Lake Embankment Restoration, 1st group of Lakes (Forge, \$264,000) & Rip Rap erosion at Lake 12 AB (Forge, \$12,000) (Phase Total **\$276,000**)
- Phase 3B – Littoral Shelf Aquatic Plant Restoration and exotics removal, Lake littoral shelves on Phase 3A lakes (Forge **\$80,000**)
- Phase 4A – Lake Embankment Restoration, 2nd group of Lakes (Forge, **\$264,000**)
- Phase 4B – Littoral Shelf Aquatic Plant Restoration and exotics removal, Lake littoral shelves on Phase 3B (Forge **\$80,000**)

View of erosion - South Broad Crested Weir.

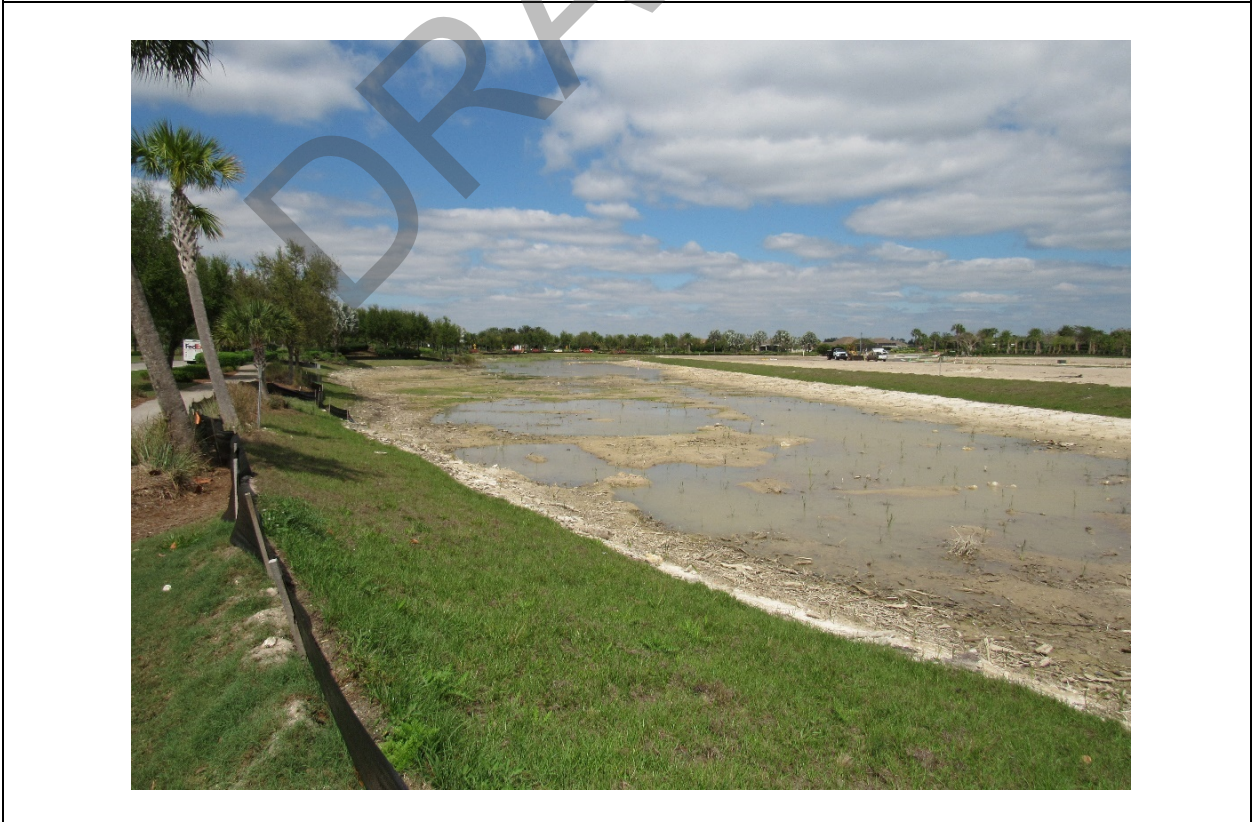
Upon further investigation, it has also been learned that TM submitted erroneous information to the South Florida Water Management District as it relates to the lakes. Specifically, with regard to Lake 11, the floor of the lake is at least one foot higher than it should have been constructed. This is evident from the as-built survey being compared to Waldrop Engineering’s submitted survey, both of which are enclosed herein. Lake 11 was also constructed in such a manner that the pipes leading into it are improperly covered and fail to drain correctly.

View of lake under construction - Lake 11.

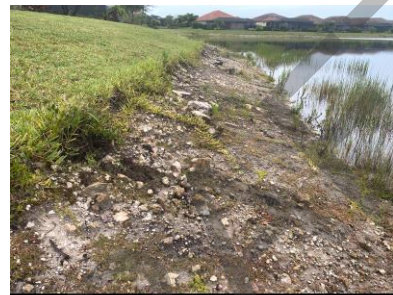
Washout found during inspection

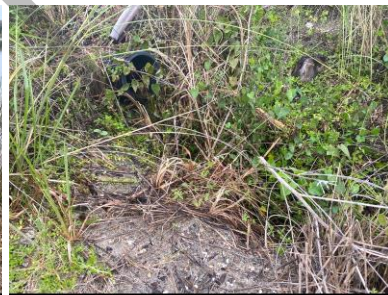
Drainage pipe causing washout

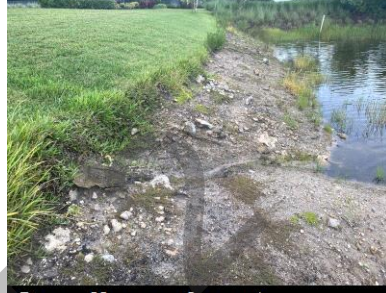
Small washout starting no plants

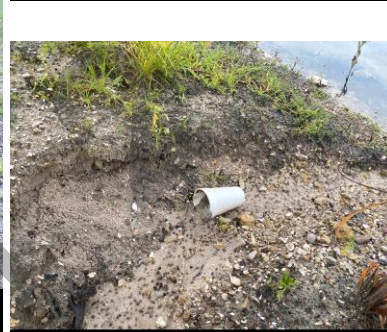
trash found in washout
