Esplanade Lake Club CDD Waterway Inspection Report

Reason for Inspection: Normal growth observed

Inspection Date: 2022-09-26

Esplanade Lake Club CDD
11621 Venetian Lagoon Dr.
Fort Myers, FL 33913

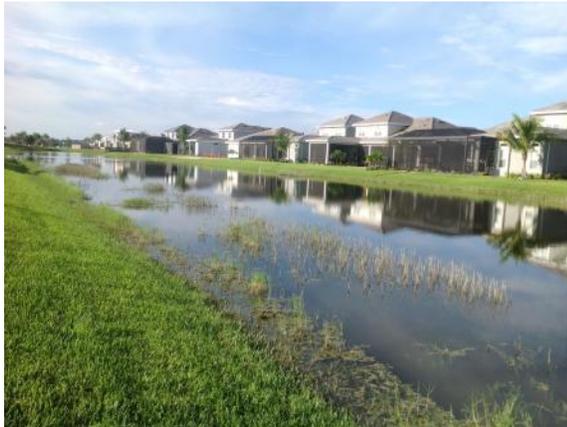
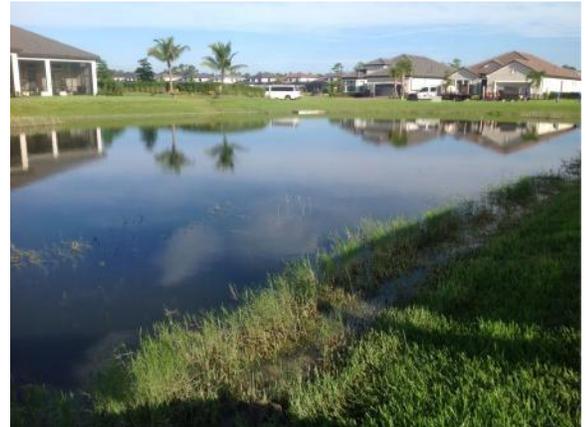
1

Treatment in progress

Shoreline is well maintained, some torpedograss noted, appears recently treated. Algae and aquatic weeds are at controlled levels.

Routine maintenance next visit

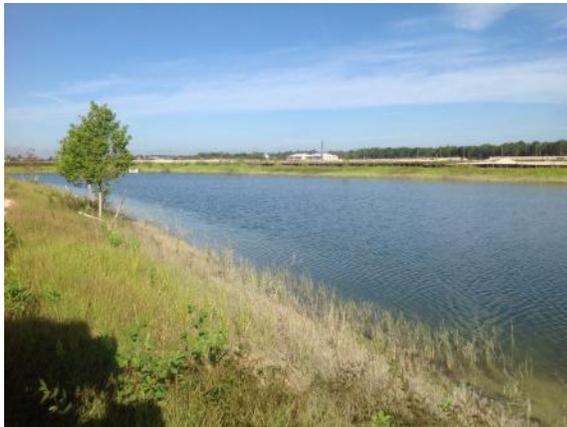
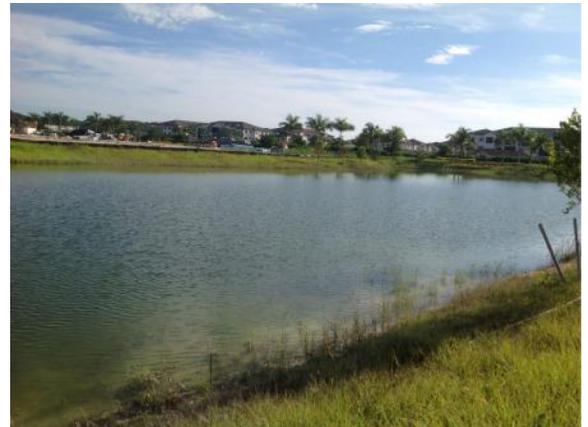
2

Normal growth observed

Shoreline is well maintained, spot treat torpedograss in east cove. Algae and aquatic weeds are at controlled levels. Monitor and treat as needed for chara.

Routine maintenance next visit

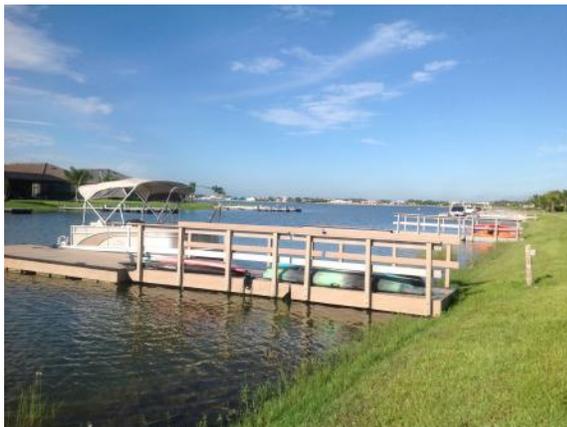
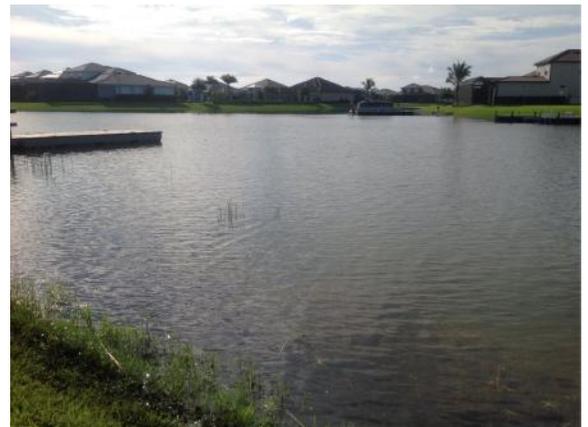
5/6N 1

Normal growth observed

Shoreline grasses and brush are well maintained. Algae and aquatic weeds are at controlled levels.

Routine maintenance next visit

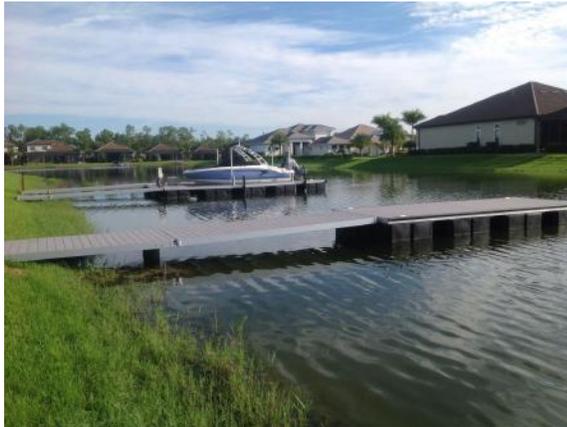
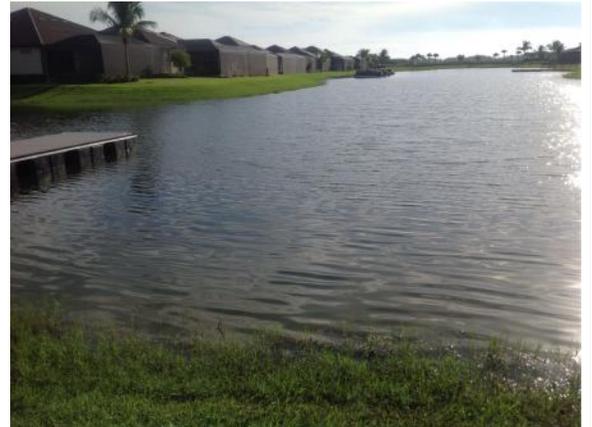
5/6N 2

Site looks good

Shoreline grasses and brush are well maintained. Some turf is flooded creating a weed band. Algae and aquatic weeds are at controlled levels.

Routine maintenance next visit

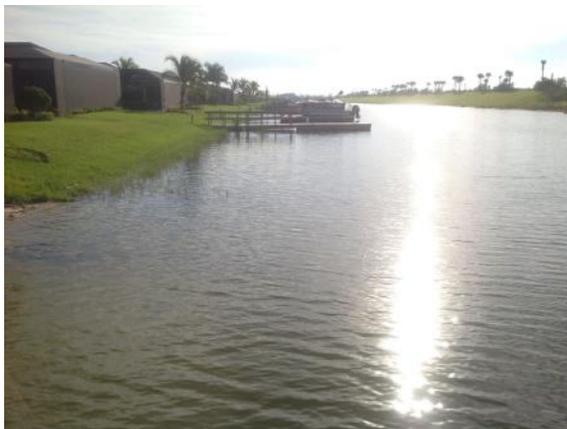
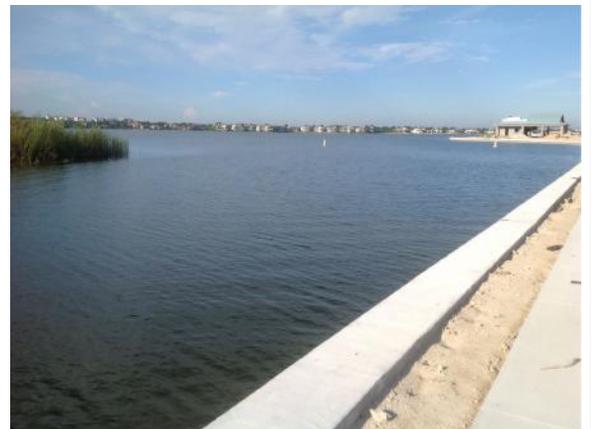
5/6N 3

Normal growth observed

Minimal grasses noted. Algae and aquatic weeds are at controlled levels.

Routine maintenance next visit

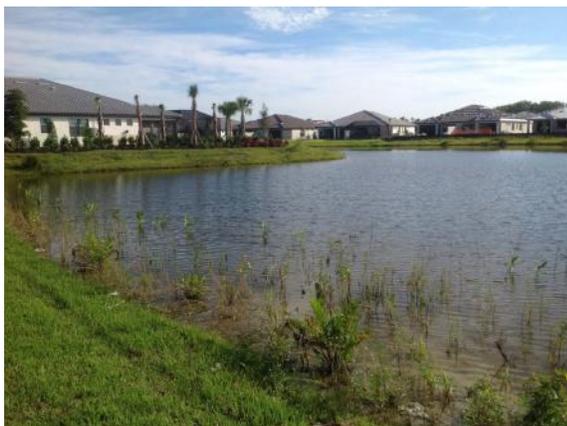
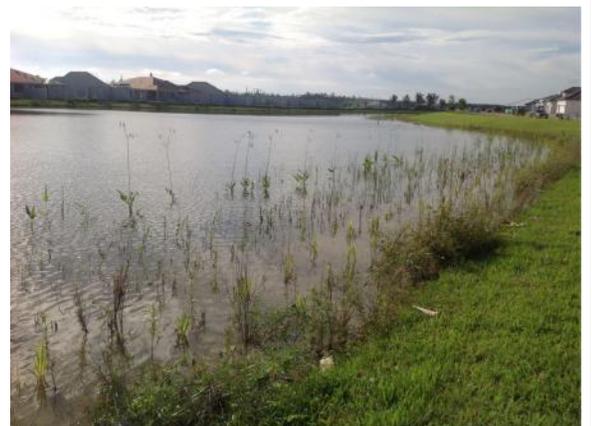
5/6N 4

Requires attention

Spot treat for torpedograss. Algae and aquatic weeds are at controlled levels.

Littoral planting is responding well at this time.

- Site 5/6N-4: Recent planting is responding well, technician will continue to spot treat as the native littoral plants get taller. This allows the technician to maximize spot treatments and minimize littoral damage.

Routine maintenance next visit

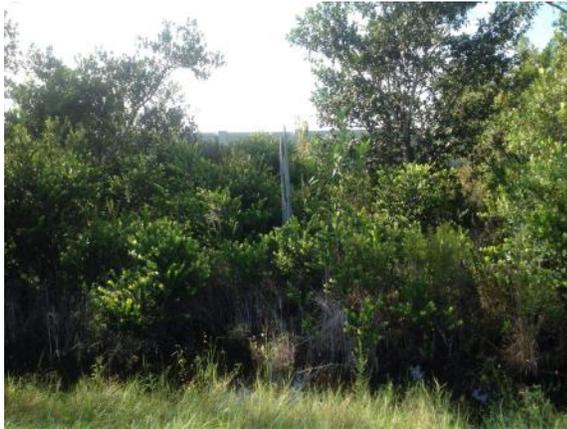
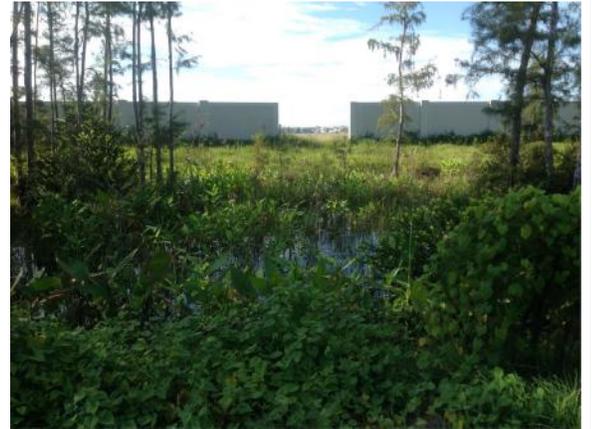
Site: CA1

Site looks good

Conservation area is well maintained for category I and II nuisance and invasive species. Some grape vine noted around parts of the perimeter. Coverage is below 5%.

Routine maintenance next visit

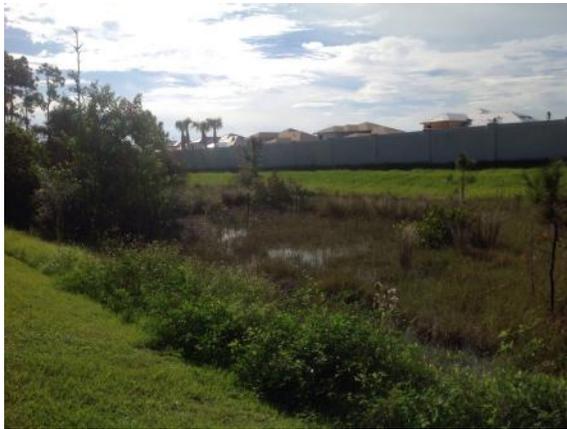
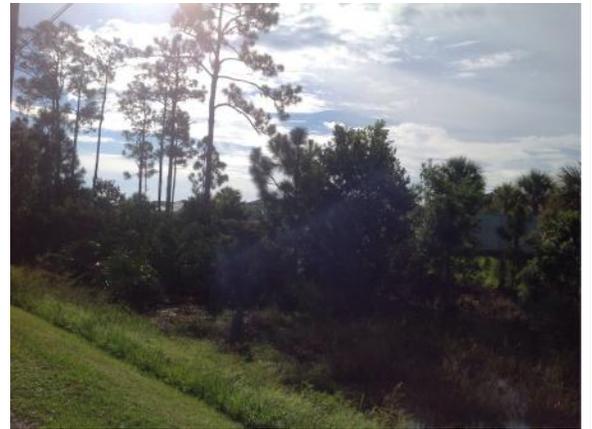
Site: CA2

Site looks good

Conservation area is well maintained for category I and II nuisance and invasive species. Coverage is below 5%. Minimal grape vine noted in canopy.

Routine maintenance next visit

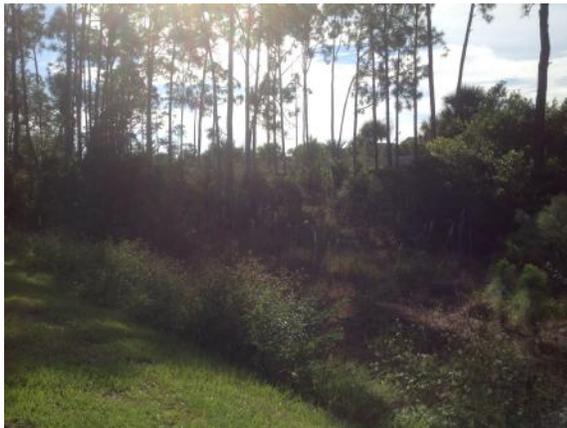
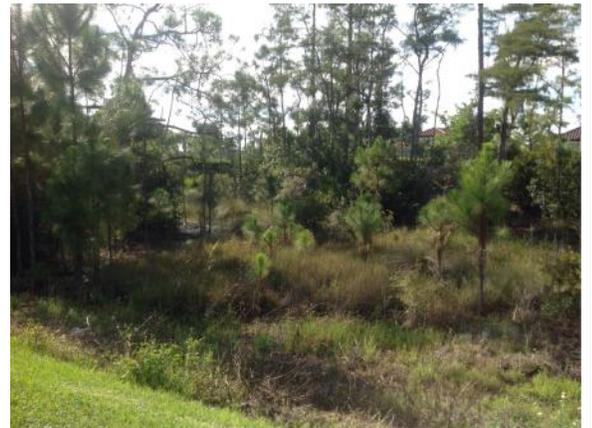
Site: CA3

Normal growth observed

Conservation area is well maintained for category I and II nuisance and invasive species. Coverage is below 5%.

Routine maintenance next visit

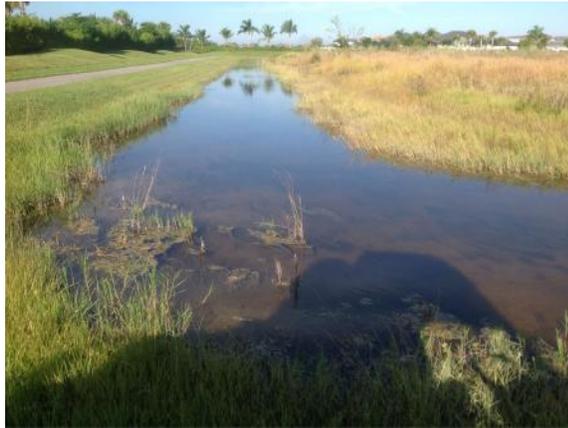
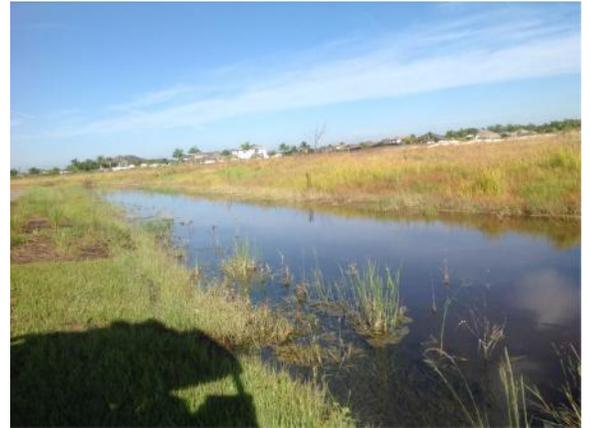
Site: Ditch

Site looks good
Site well maintained for shoreline
grasses and brush

Routine maintenance next visit
