Esplanade Lake Club CDD Waterway Inspection Report

Inspection Date: 2022-04-07

Esplanade Lake Club CDD
11621 Venetian Lagoon Dr.
Fort Myers, FL 33913

Christina Kennedy, Aquatic Biologist

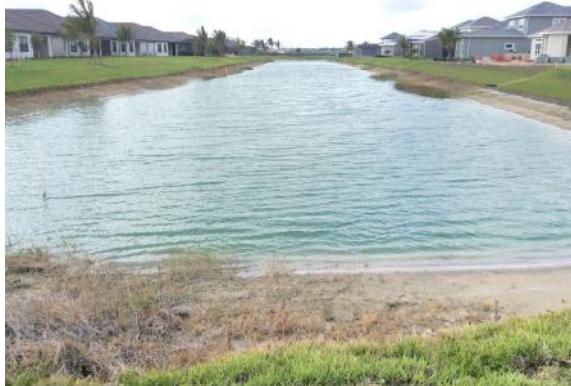
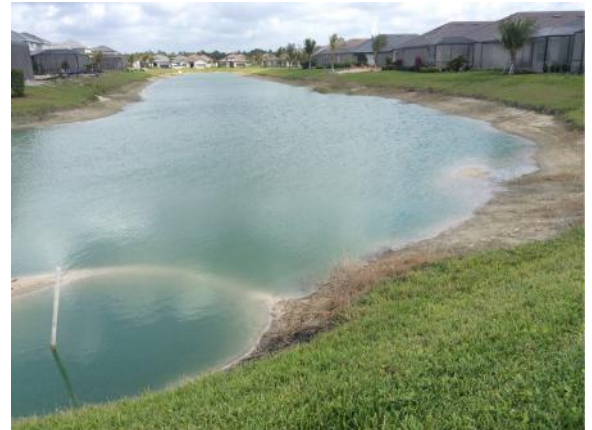
1

Site looks good
Shoreline is well maintained.
Algae and aquatic weeds are at controlled levels.

Routine maintenance next visit

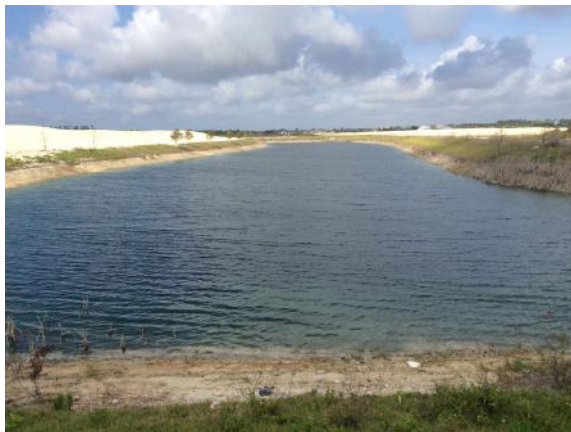
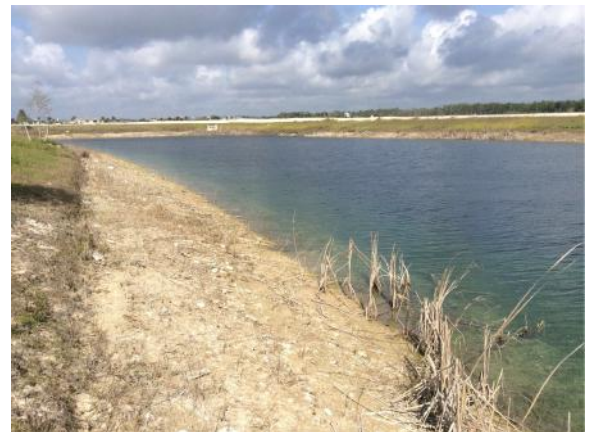
2

Normal growth observed
Shoreline is well maintained.
Algae and aquatic weeds are at controlled levels. Monitor and treat as needed for chara.

Routine maintenance next visit

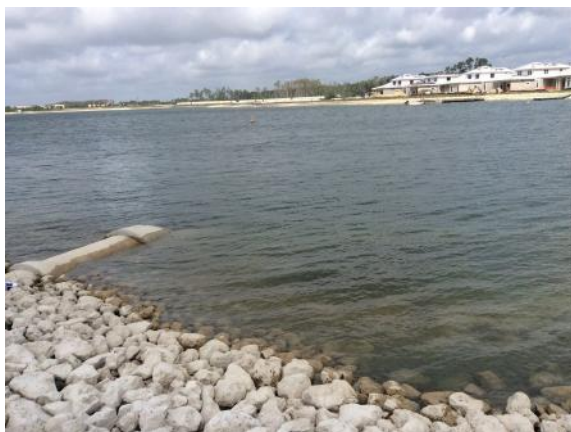
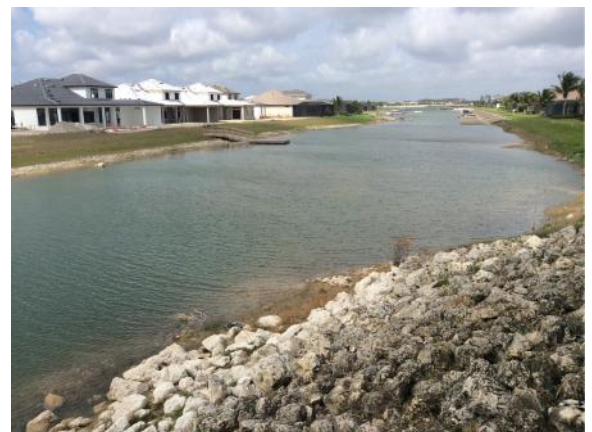
5/6N 1

Normal growth observed
Shoreline grasses and brush are well maintained. Algae and aquatic weeds are at controlled levels. Monitor and treat as needed for chara and naiad.

Routine maintenance next visit

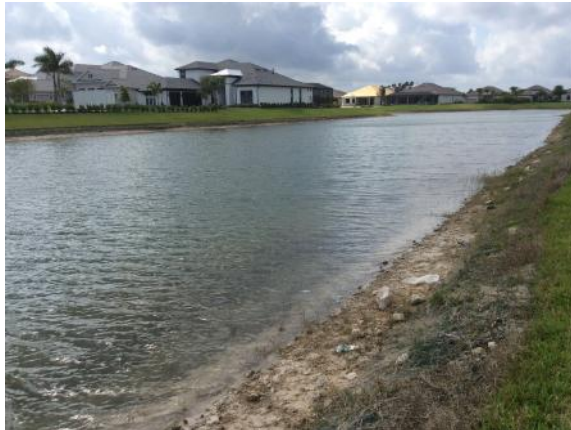
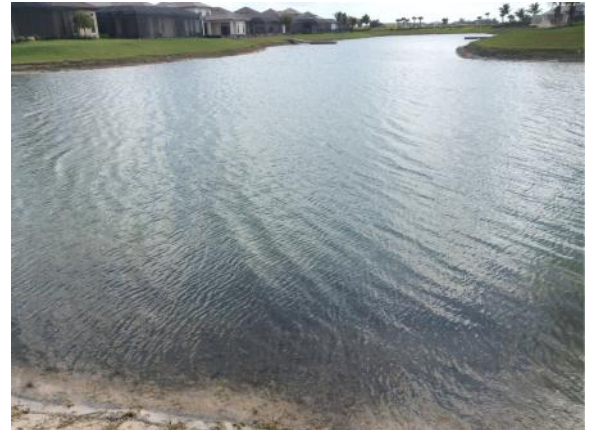
5/6N 2

Normal growth observed
Shoreline grasses and brush are well maintained, minimal regrowth noted. Algae and aquatic weeds are at controlled levels. Monitor and treat as needed for chara

Routine maintenance next visit

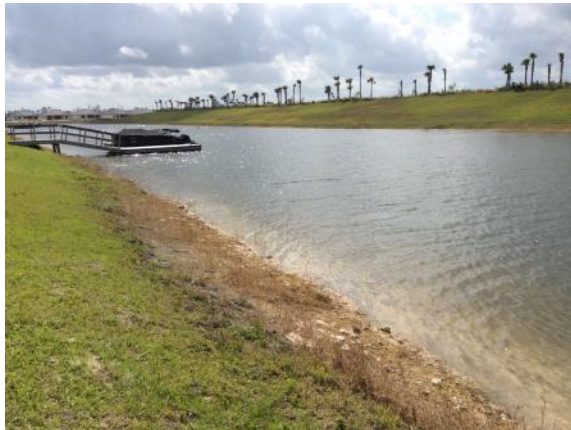
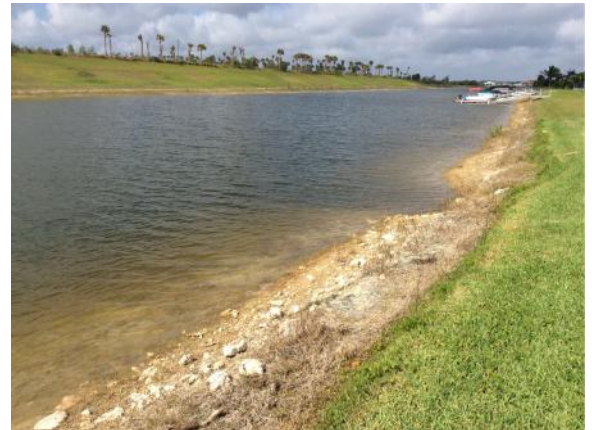
5/6N 3

Requires attention
Treat for torpedograss on south bank. Algae and aquatic weeds are at controlled levels. Monitor and treat as needed for chara, and naiad.

- The perimeter of 5/6N was mostly clean with the exception of the perimeter in the south which corresponds to photo point 3, and 4, mostly on the southern bank. The area of the large lake near the main entrance to the east of the bridge where the cattails were present have been treated successfully.
- 5/6N-1 corresponds to photo point 1.
- 5/6N-2 corresponds to photo point 2.
- 5/6N-3 corresponds to photo point 3.
- 5/6N-4 corresponds to photo point 4.
- Debris seems to be a on-going issue even with routine removal. The debris reaccumulates faster than it can be removed. This will likely remain the case as long as the site is under construction.
- No major issues with submersed weeds were found. Monitor chara and southern naiad growth at all sites.
- Conservation areas 1-3: no issues to report.
- The next quality control report will be due July 2022.

Routine maintenance next visit

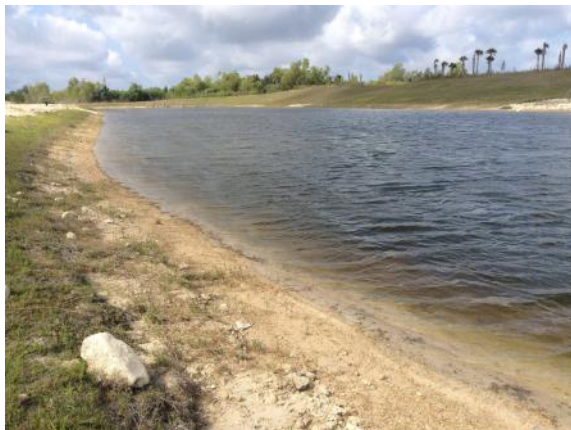
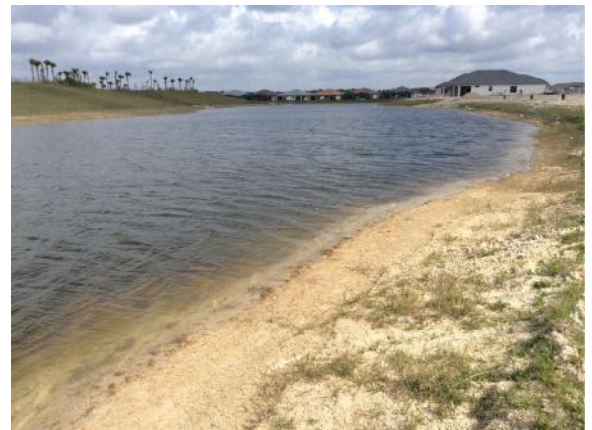
5/6N 4

Requires attention
Treat for torpedograss. Algae and aquatic weeds are at controlled levels. Monitor and treat as needed for chara.

Routine maintenance next visit

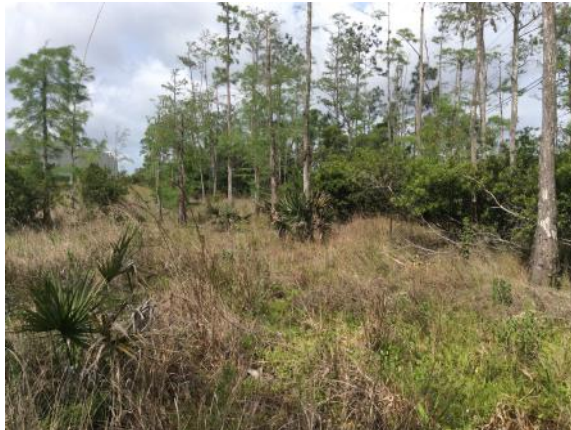
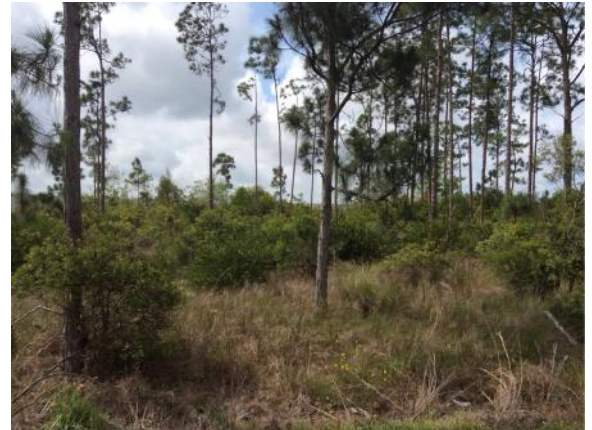
Site: CA1

Site looks good
Conservation area is well maintained for category I and II nuisance and invasive species. Coverage is below 5%.

Routine maintenance next visit

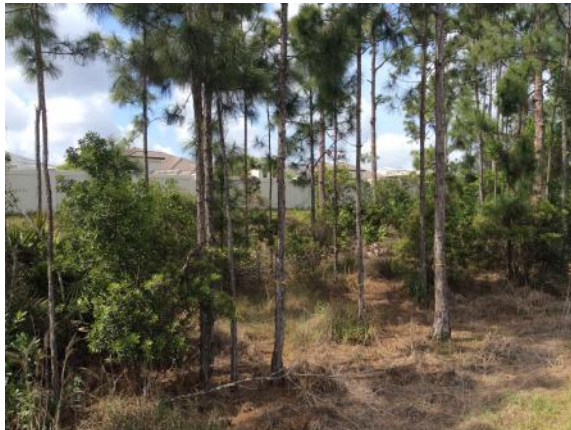
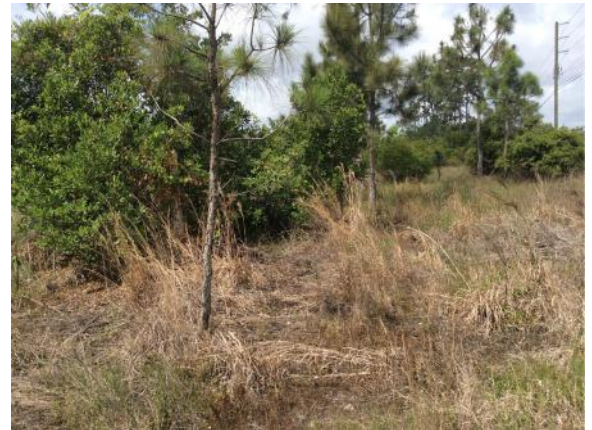
Site: CA2

Site looks good
Conservation area is well maintained for category I and II nuisance and invasive species. Coverage is below 5%.

Routine maintenance next visit

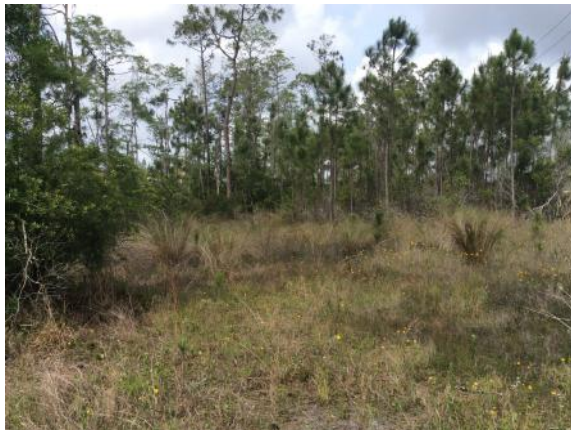
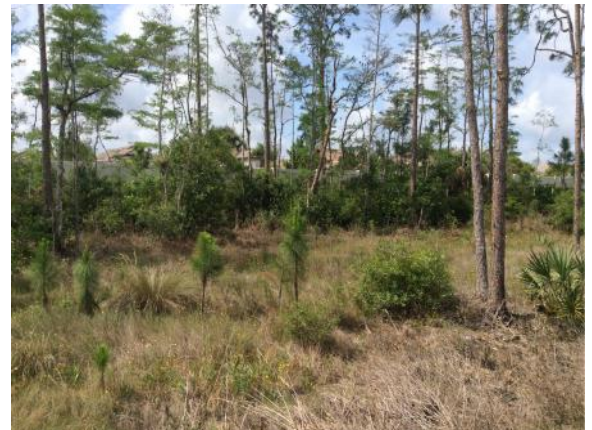
Site: CA3

Site looks good
Conservation area is well maintained for category I and II nuisance and invasive species. Coverage is below 5%.

Routine maintenance next visit

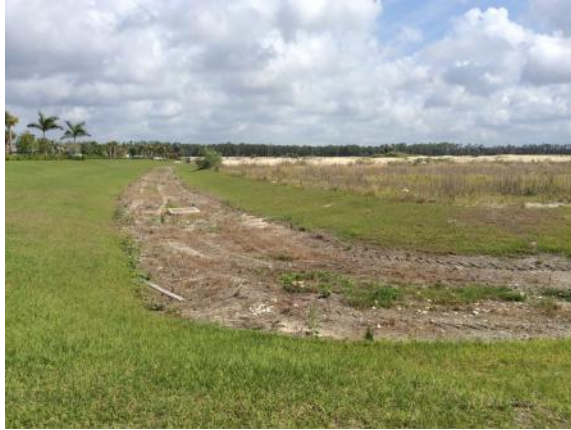
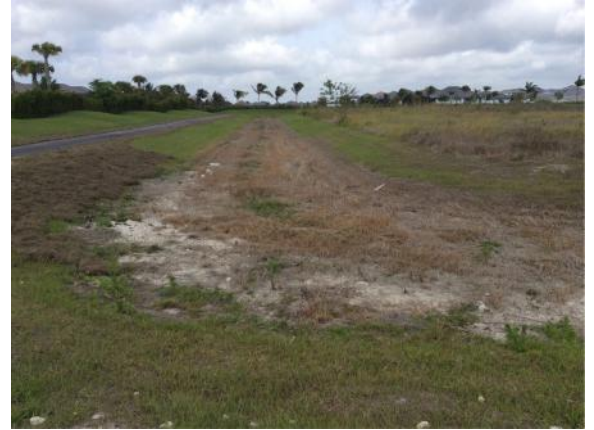
Site: Ditch

Site looks good
Site well maintained for shoreline
grasses and brush

Routine maintenance next visit
