Esplanade Lake Club CDD Waterway Inspection Report

Reason for Inspection: Scheduled-recurring

Inspection Date: 2022-07-19

Esplanade Lake Club CDD
11621 Venetian Lagoon Dr.
Fort Myers, FL 33913

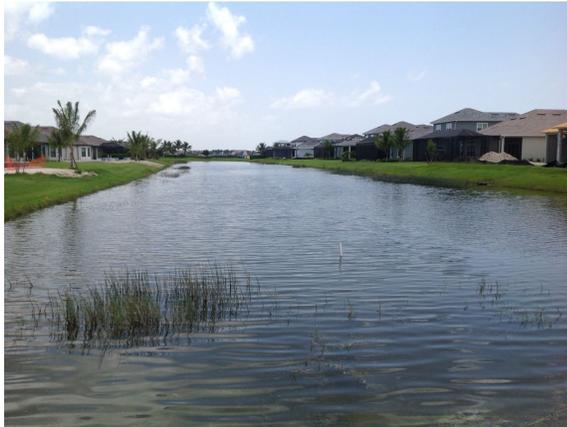
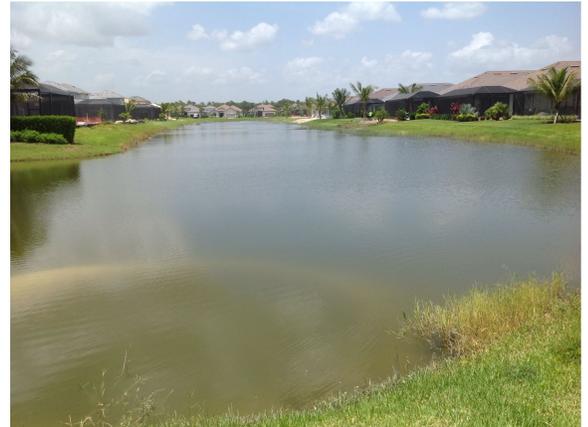
1

Treatment in progress
Shoreline is well maintained, some torpedograss noted, appears recently treated. Algae and aquatic weeds are at controlled levels.

Routine maintenance next visit

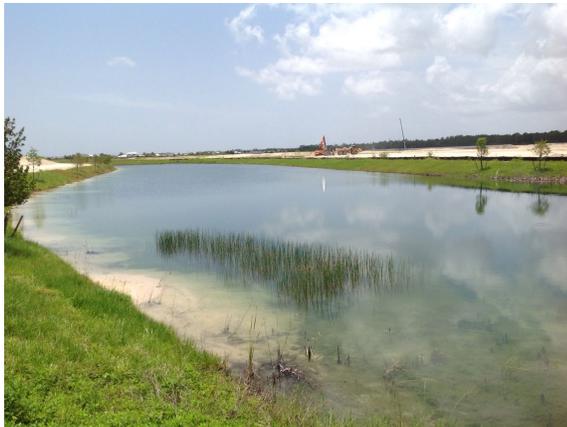
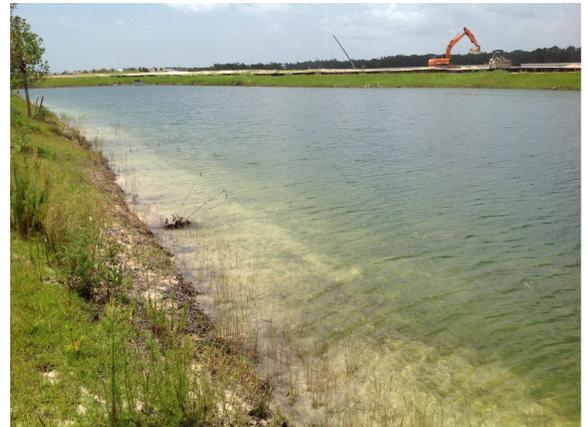
2

Normal growth observed
Shoreline is well maintained, spot treat torpedograss in east cove. Algae and aquatic weeds are at controlled levels. Monitor and treat as needed for chara.

Routine maintenance next visit

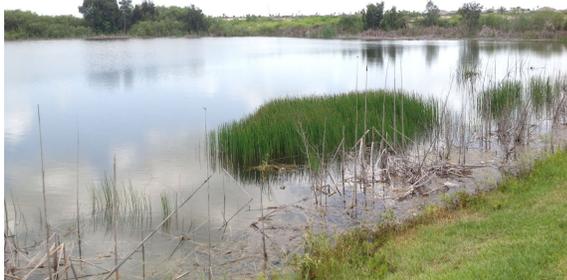
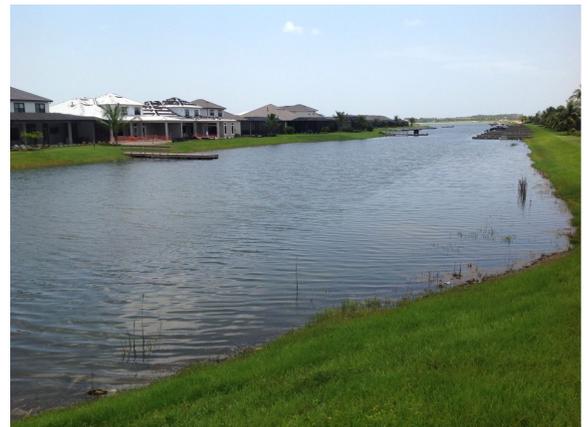
5/6N 1

Requires attention
Shoreline grasses and brush are well maintained, spot treat cattail regrowth the in E. cove. Algae and aquatic weeds are at controlled levels.

Routine maintenance next visit

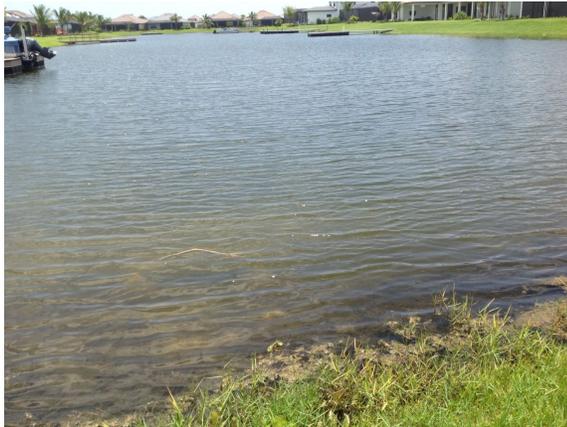
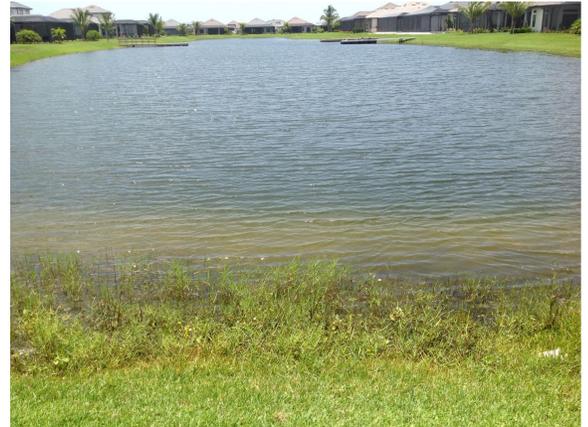
5/6N 2

Site looks good
Shoreline grasses and brush are well maintained. Some turf is flooded creating a weed band. Algae and aquatic weeds are at controlled levels.

Routine maintenance next visit

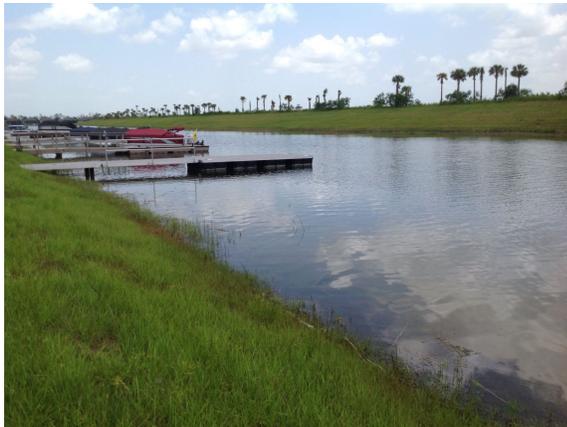
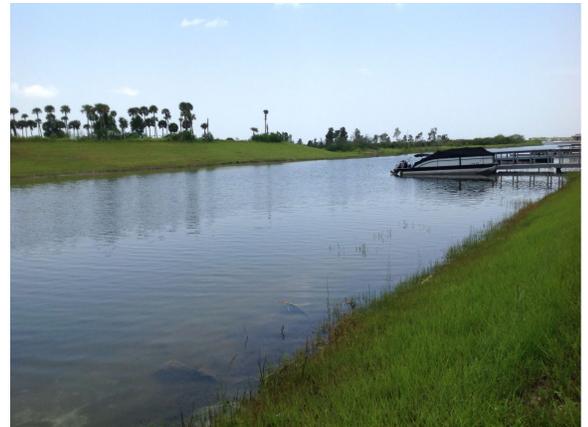
5/6N 3

Normal growth observed
Minimal grasses noted. Algae and aquatic weeds are at controlled levels.

Routine maintenance next visit

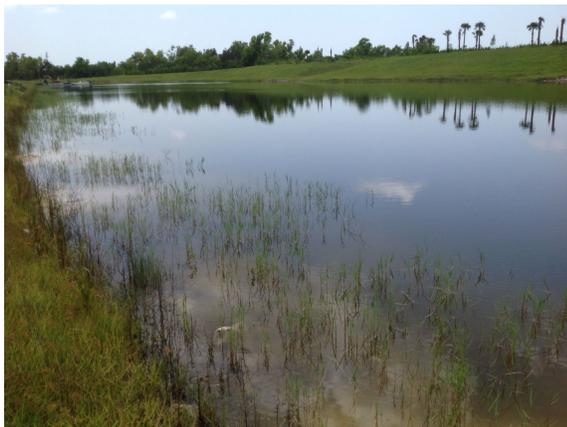
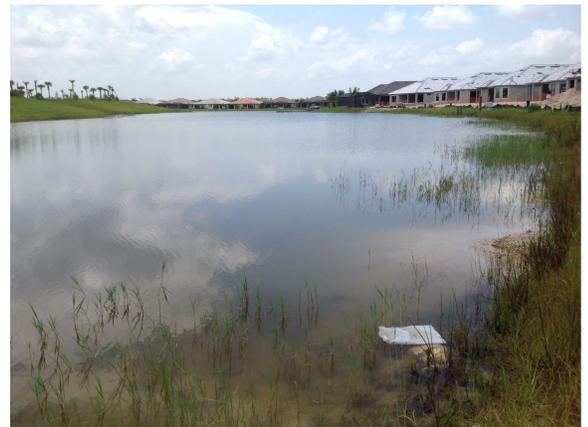
5/6N 4

Requires attention
Treat for torpedograss. Algae and aquatic weeds are at controlled levels.

Routine maintenance next visit

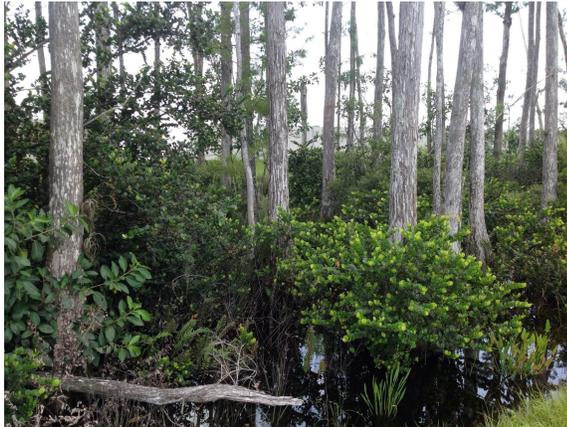
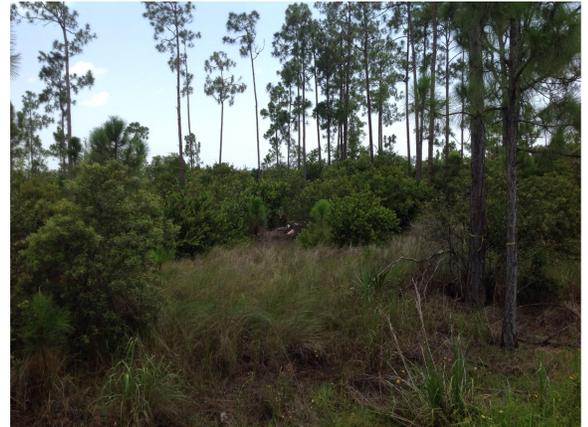
Site: CA1

Site looks good
Conservation area is well maintained for category I and II nuisance and invasive species. Coverage is below 5%.

Routine maintenance next visit

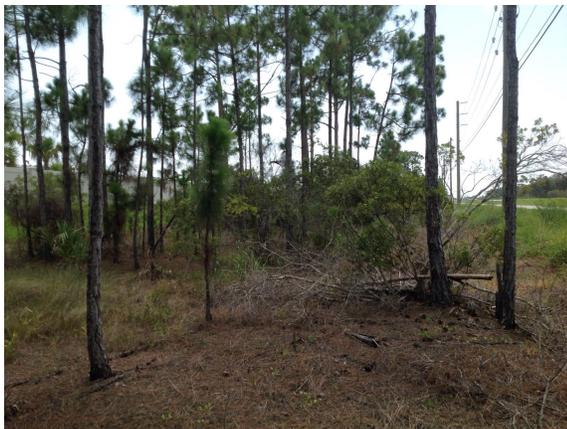
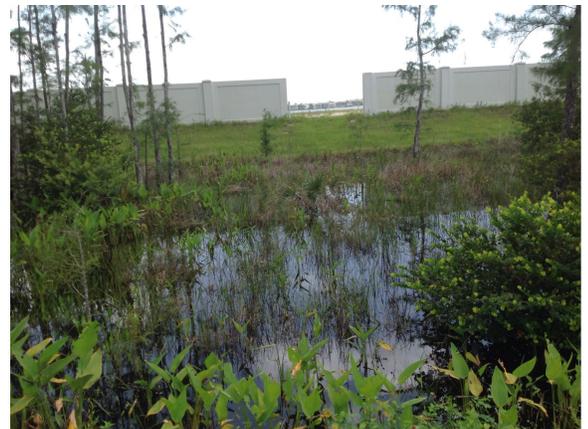
Site: CA2

Site looks good
Conservation area is well maintained for category I and II nuisance and invasive species. Coverage is below 5%. Minimal grape vine noted in canopy.

Routine maintenance next visit

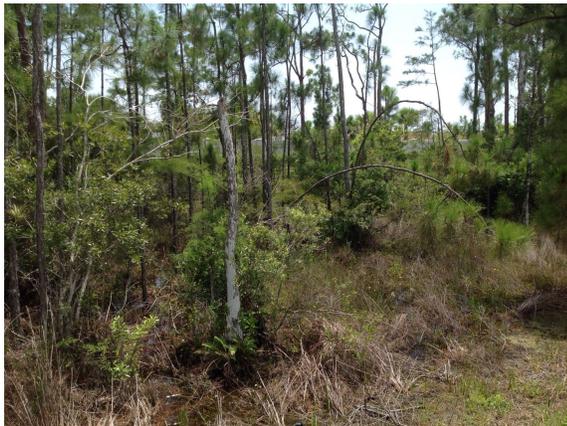
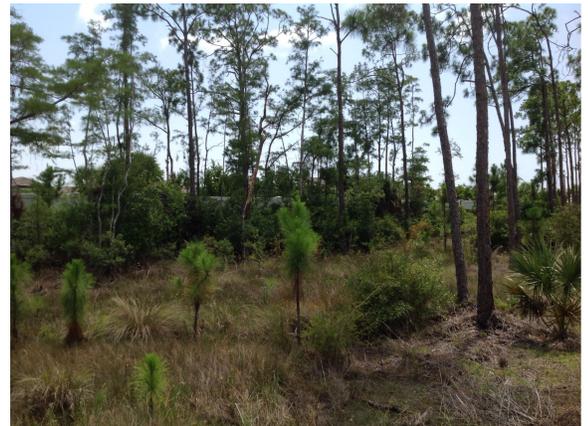
Site: CA3

Site looks good
Conservation area is well maintained for category I and II nuisance and invasive species. Coverage is below 5%.

Routine maintenance next visit

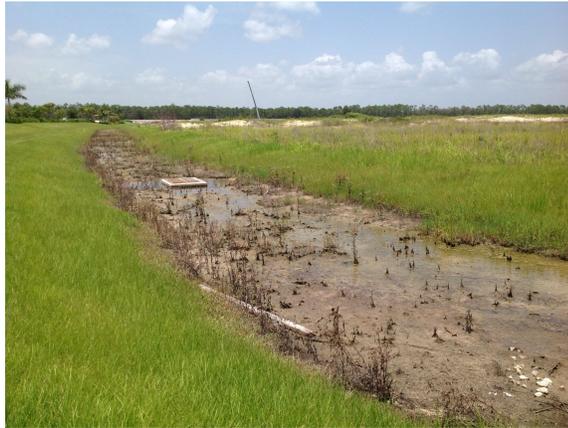
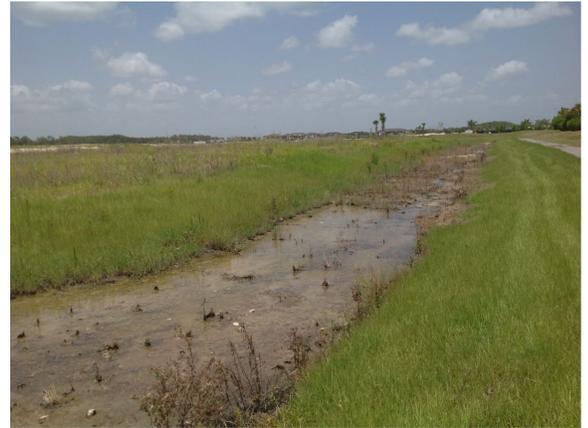
Site: Ditch

Site looks good
Site well maintained for shoreline
grasses and brush

Routine maintenance next visit
