**Report of Water Management System Study**

**FLOW WAY  
COMMUNITY DEVELOPMENT DISTRICT  
(FLOW WAY CDD)**

**Forge Engineering Project Number 5911-001.01**

**June 2021**

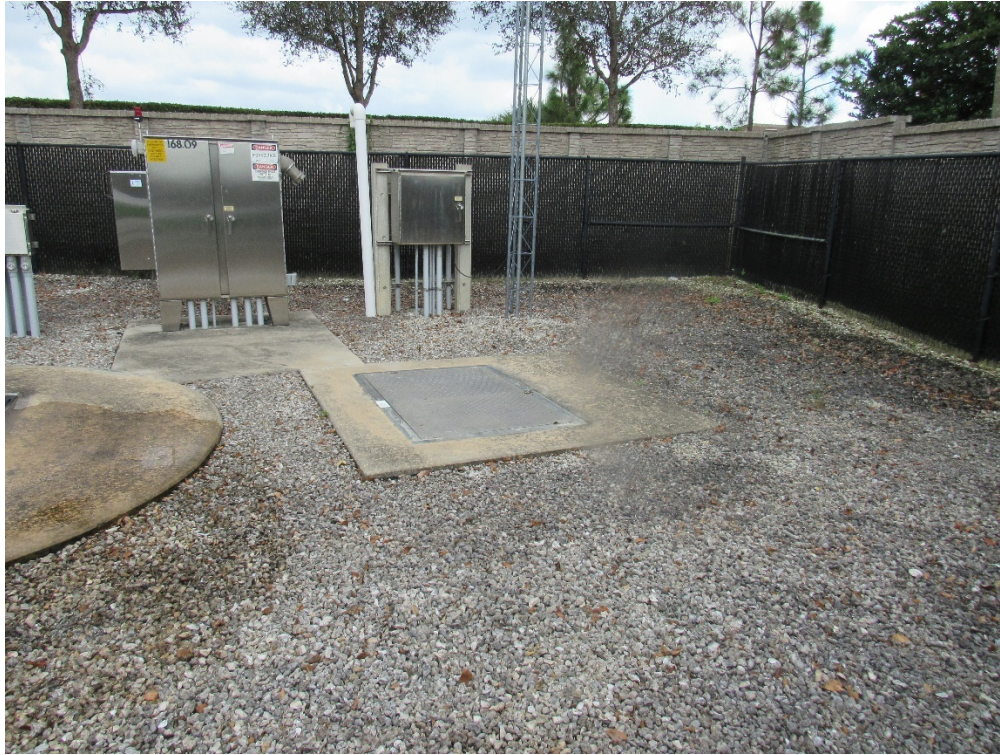
- We noted a foul odor at lift station 168.09, even though there is an odor control device installed at this location.
  - Further investigation with the Collier County Wastewater Division indicated that the odor control apparatus is a two-stage treatment process which requires regular maintenance and upkeep of the treatment media on a roughly quarterly basis.
  - The subject unit is at the end of the wastewater stream within the development and is therefore experiencing periodic surging of flows from upstream.
  - The Collier County Wastewater Department should be contacted when odors are detected.

View of lift station 168.09.

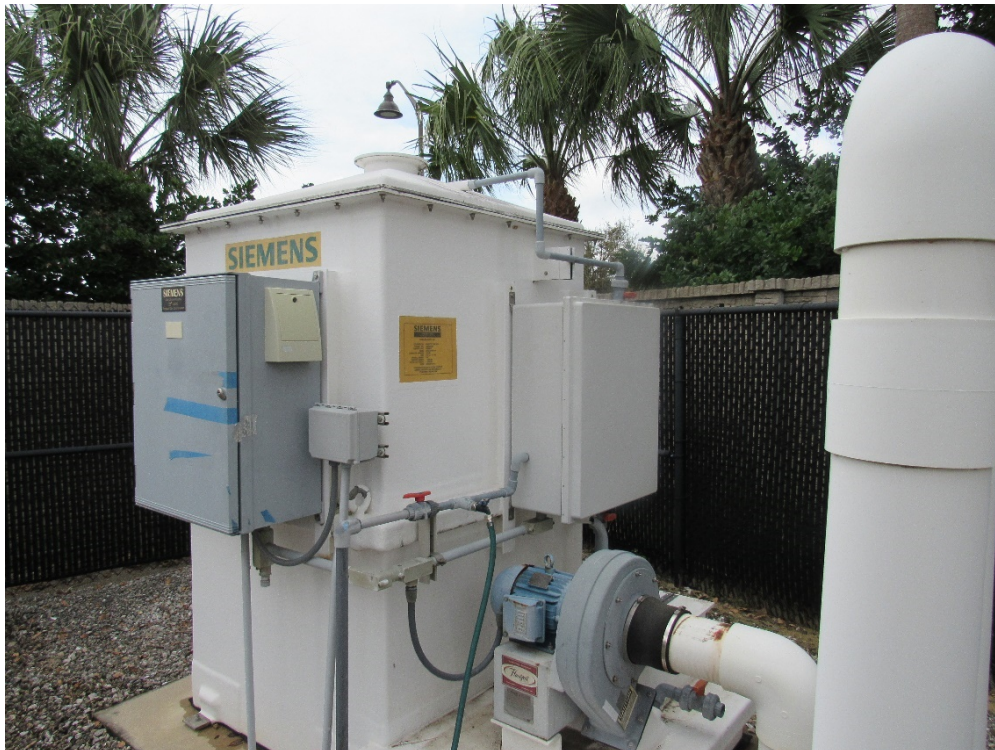
View of odor control system at 168.09.

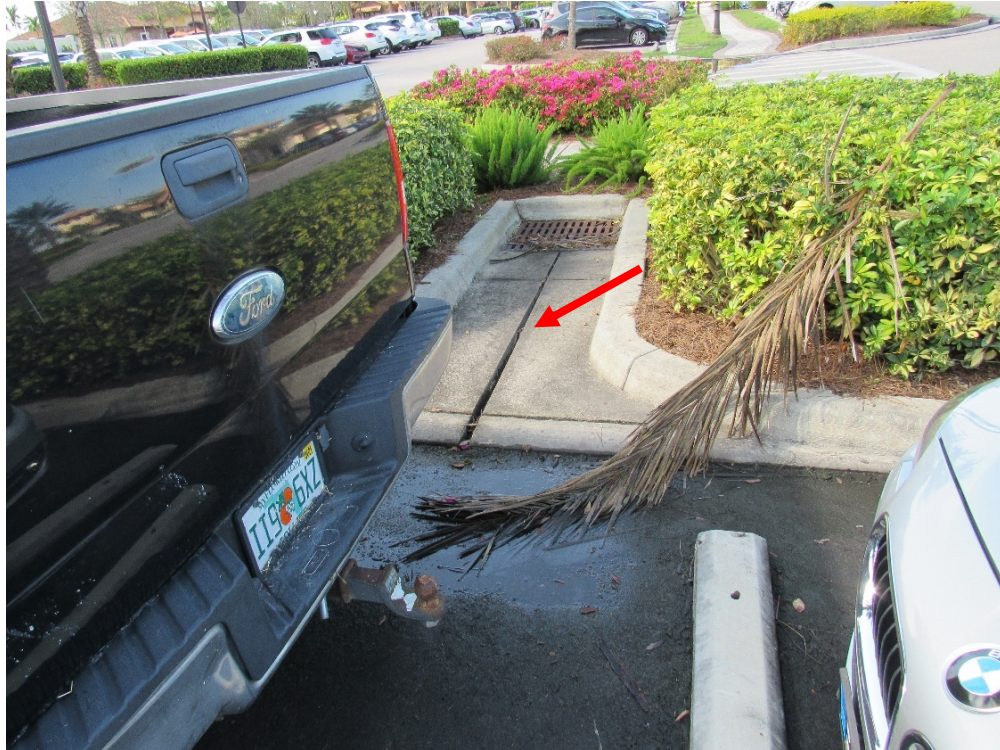
View of groove cut into concrete catch basin – Amenity Center Parking Lot.

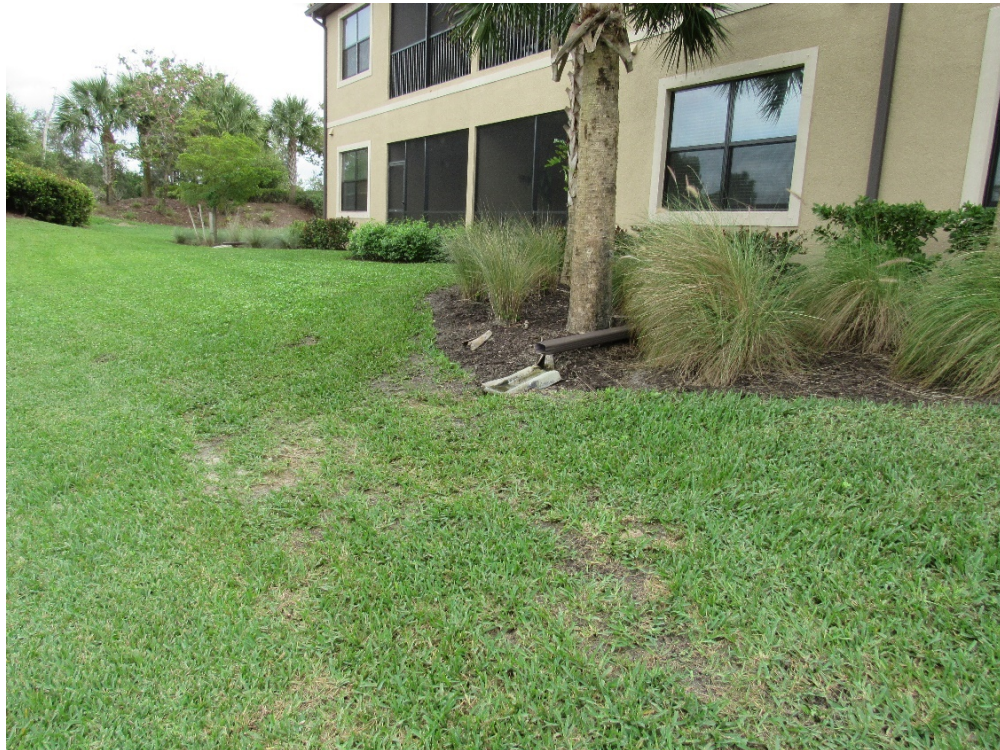
- We observed direct discharge of building downspout drains into the following lakes: Numbers 5B, 6, 7, 9, 13, 14, 15A, 15B, 16, 17, 18, 19, 20, 21, 22, 23, 25, 26 and 27.

View of gutter downspout from a building - Lake 17/Benvenuto Court.

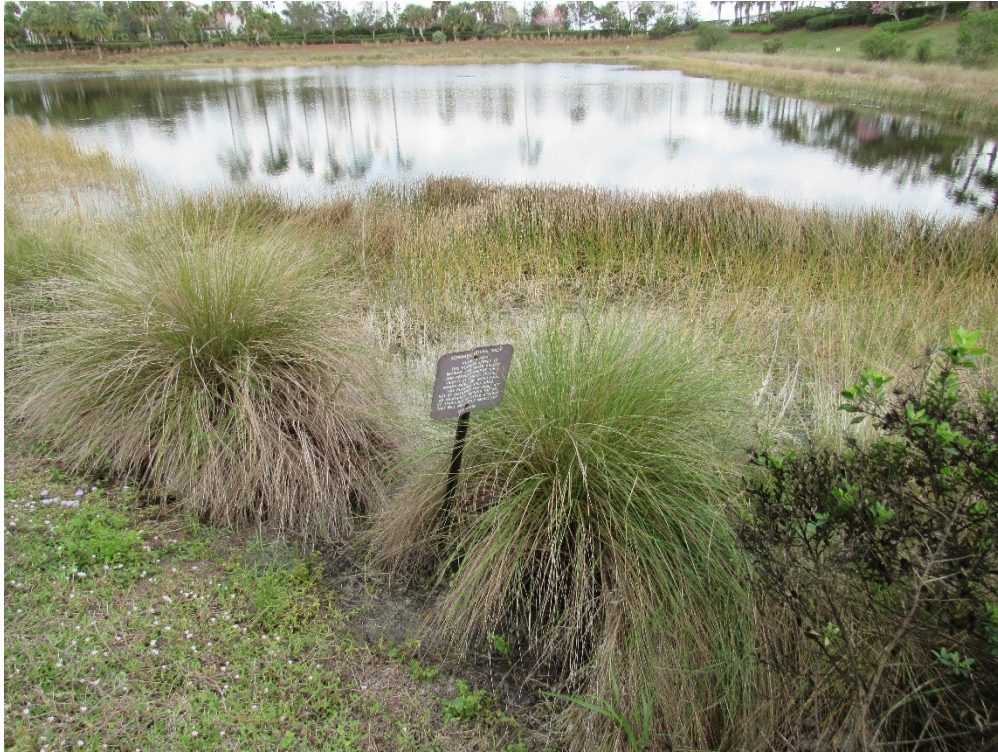
Typical view of Lake 1, note sign condition

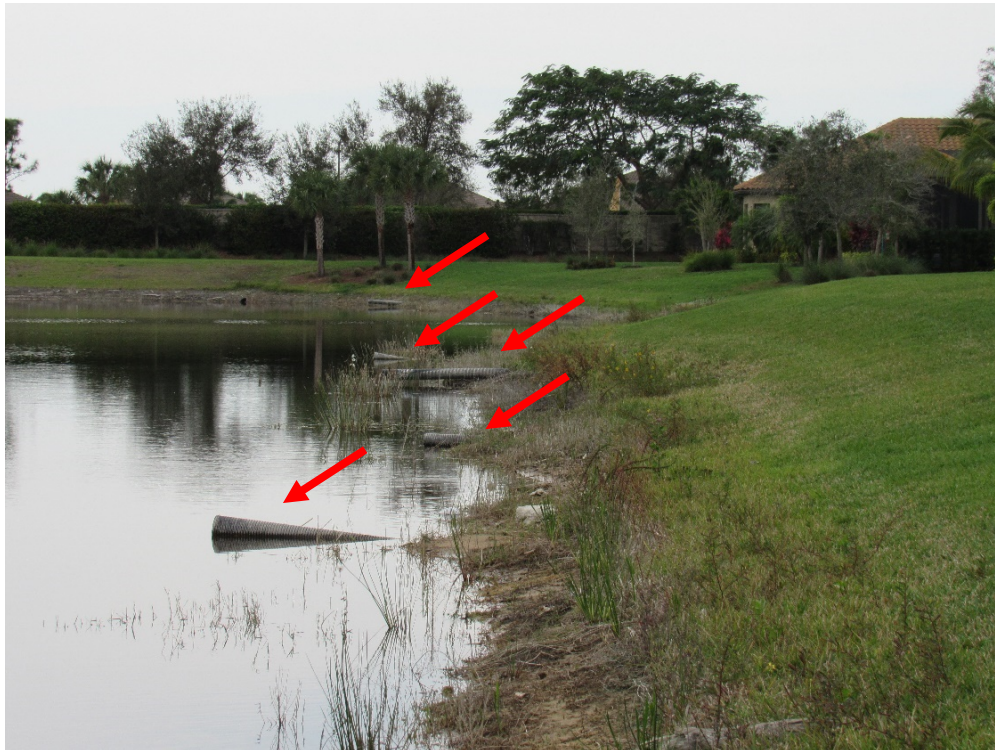
View of direct discharge lines - Lake 27.

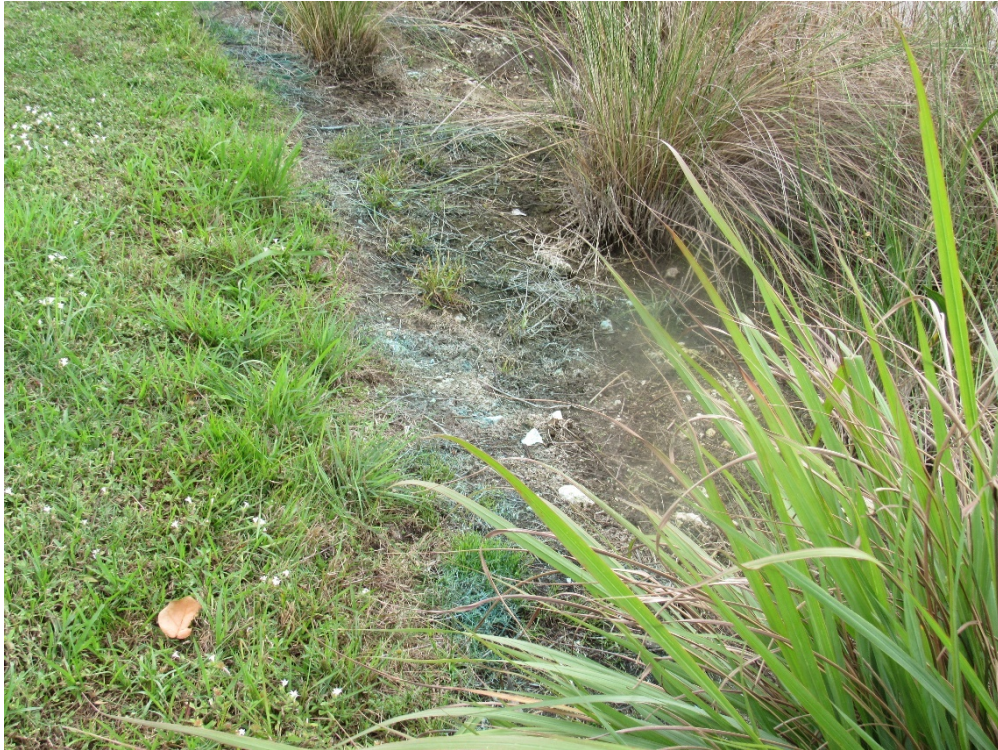
View of herbicide spray, not permitted in littoral areas - Lake 5A.

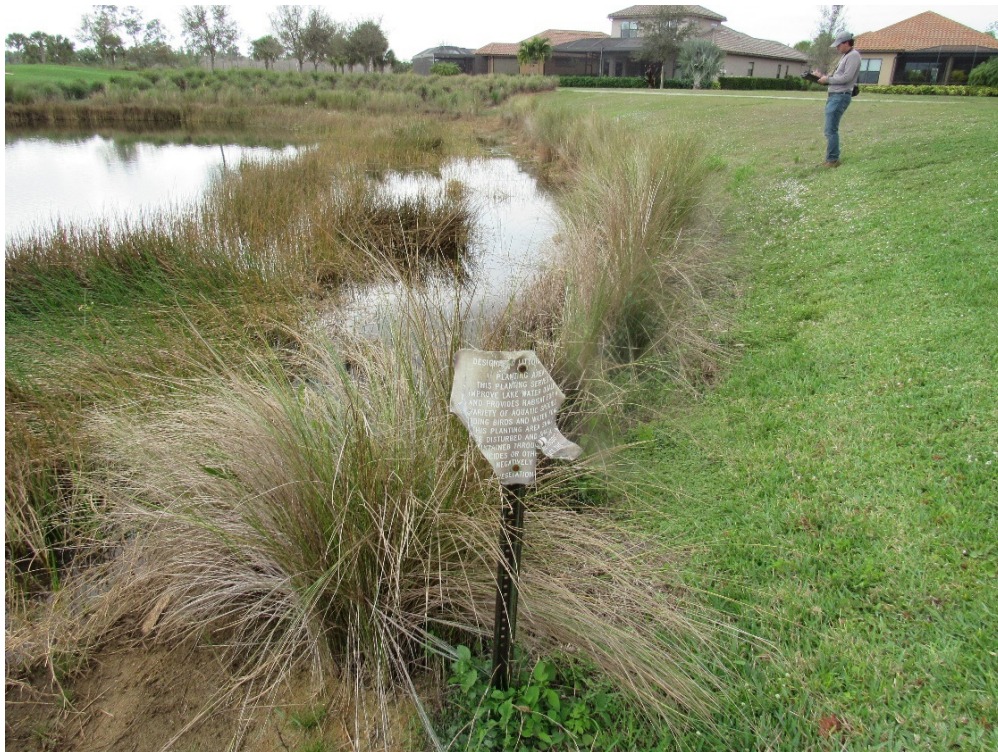
View of damaged Littoral sign - Lake 5B.

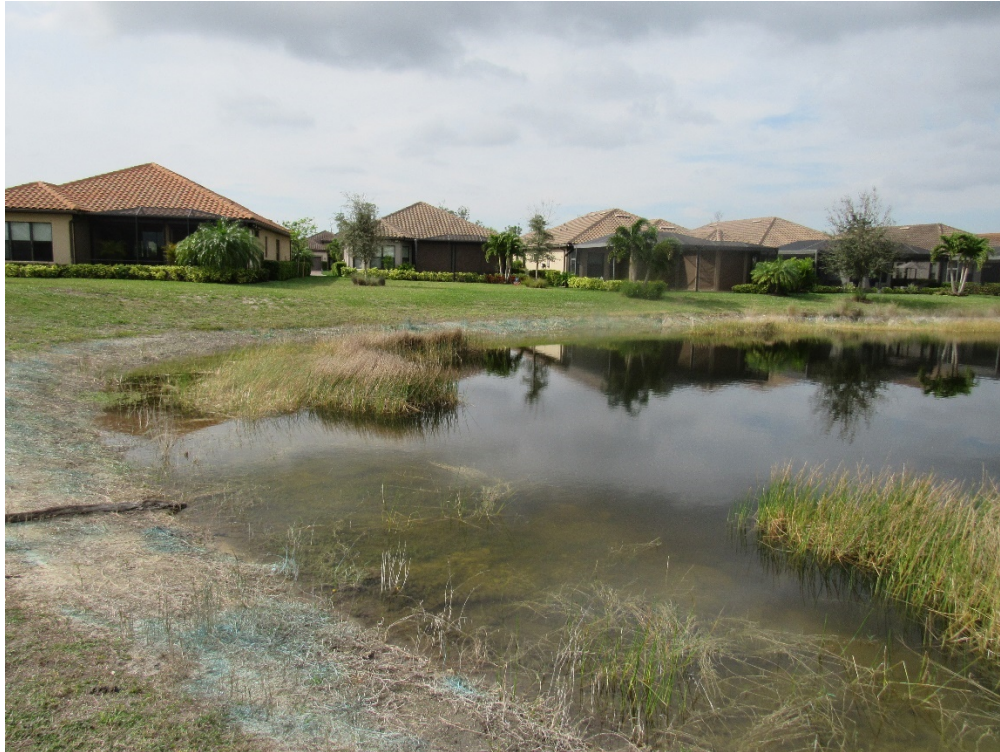
Typical view of littoral - Lake 9.

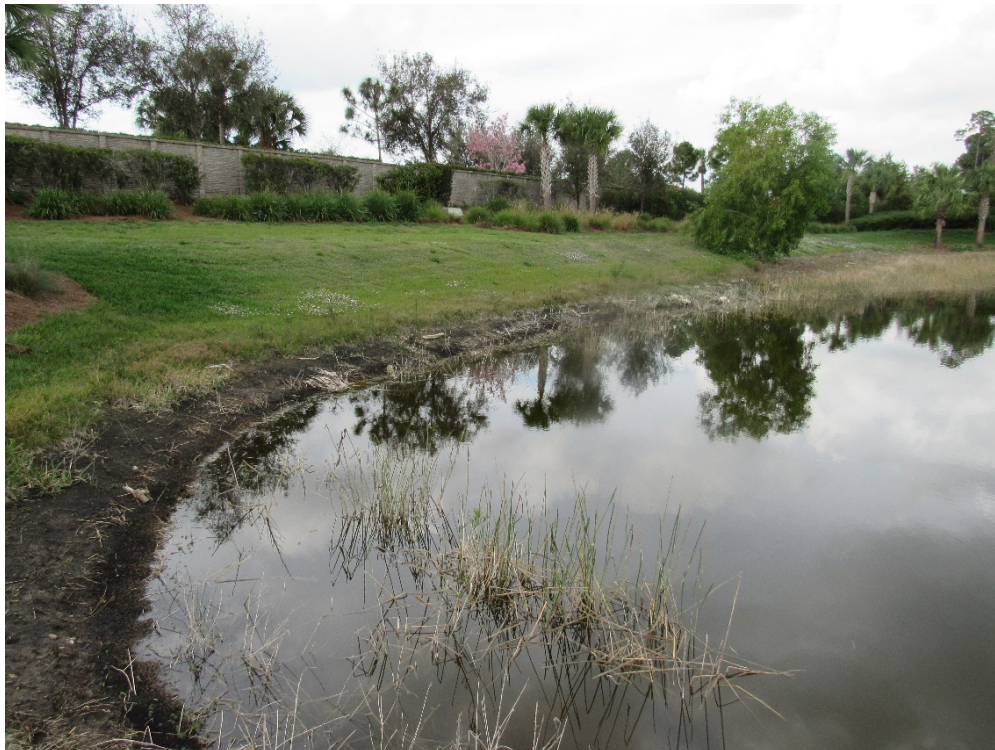
Typical view of littoral - Lake 26.

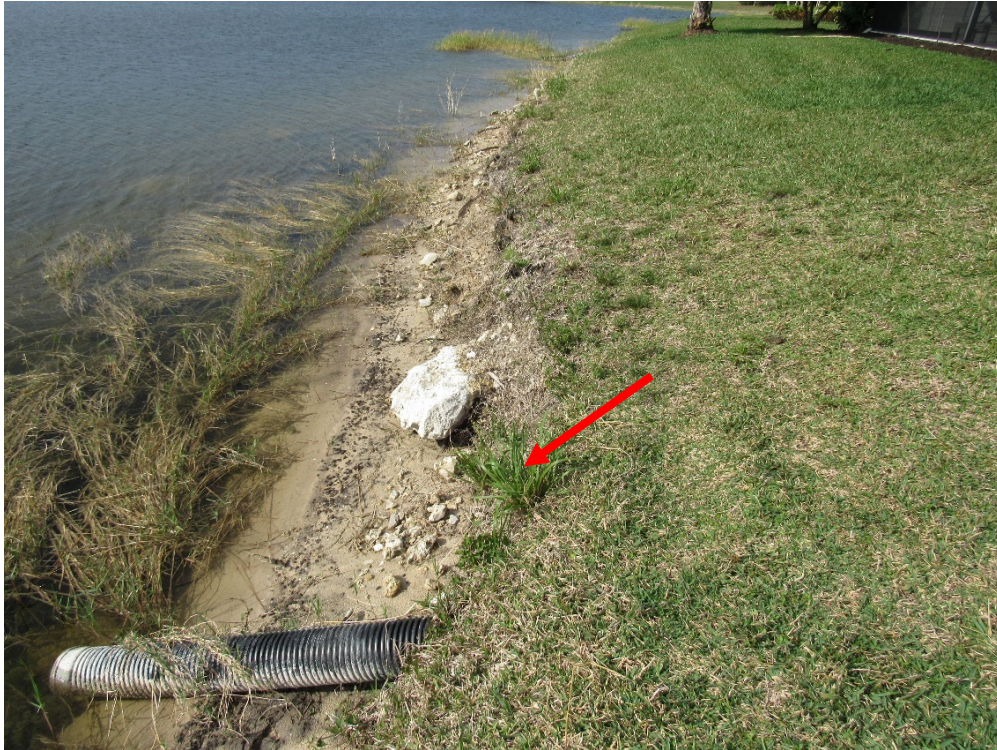
View of erosion at lake embankment - Lake 7.

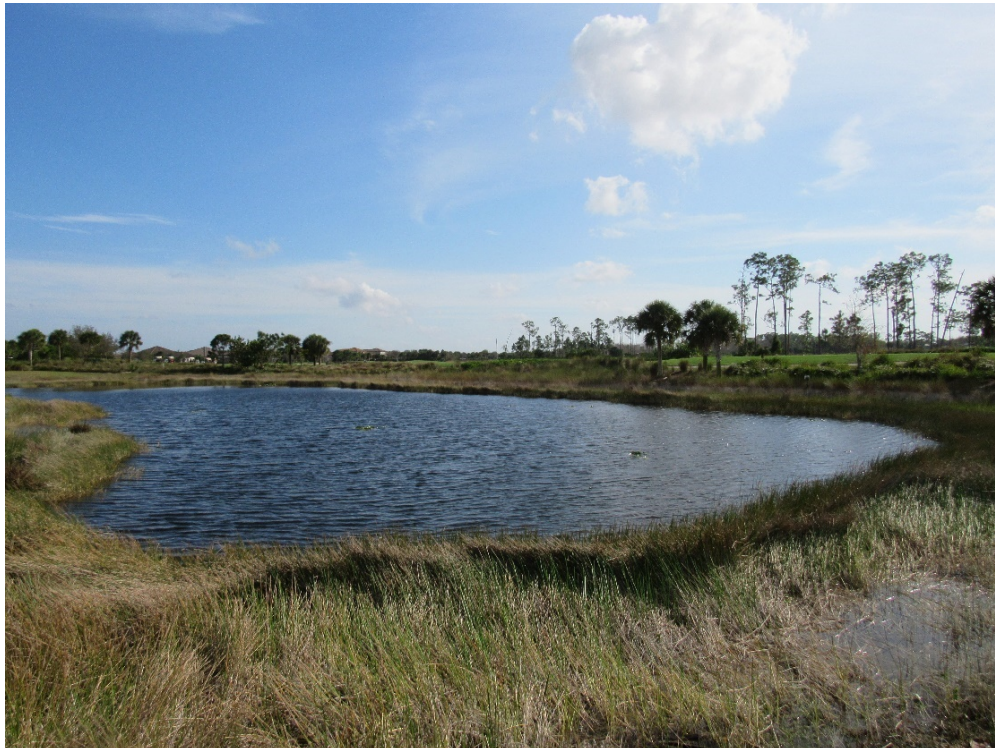
Typical view of Lake 6.

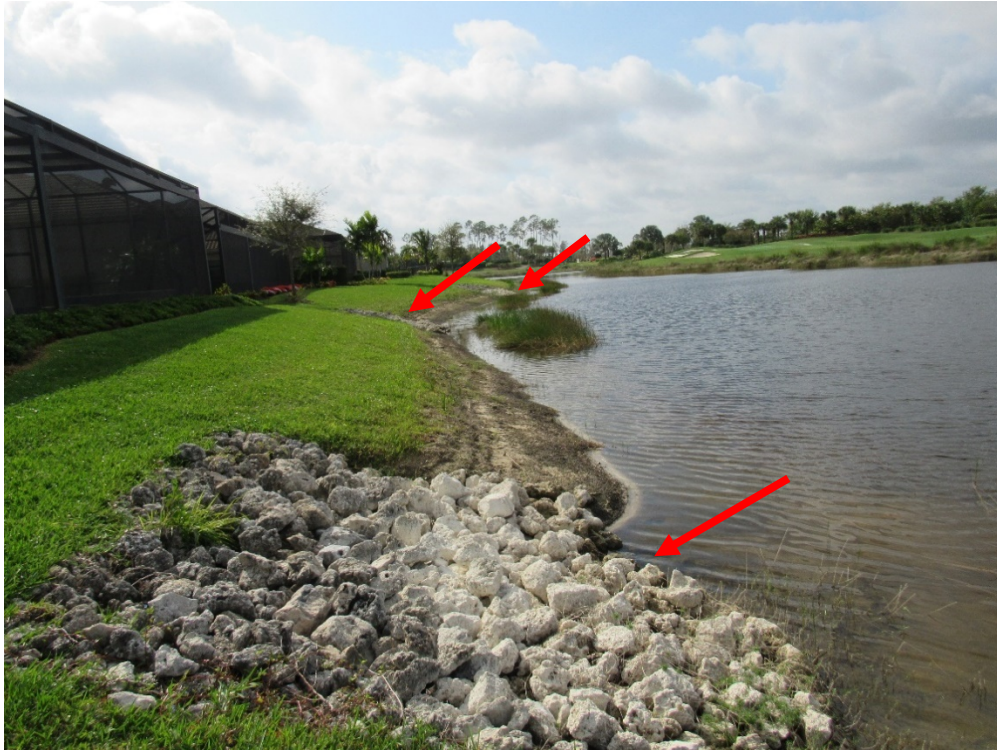
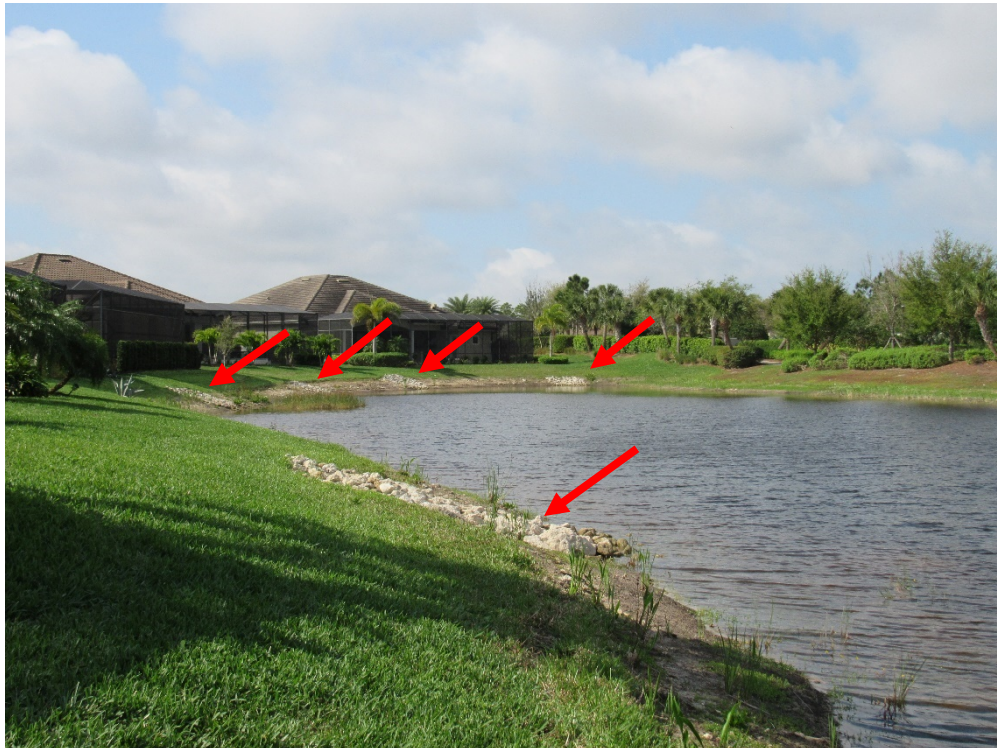
- We observed areas of rip rap at various locations of embankment erosion at lake 12AB.
- We observed dead littoral plants at the following lakes: Numbers 5A, 6, 9, 10, 20, 25, 26 and 27. (Refer to Mettauer Environmental report located within Appendix F, Inspection Reference: 08202020 for detailed information.)

View of rip rap at areas of erosion - Lake 12.

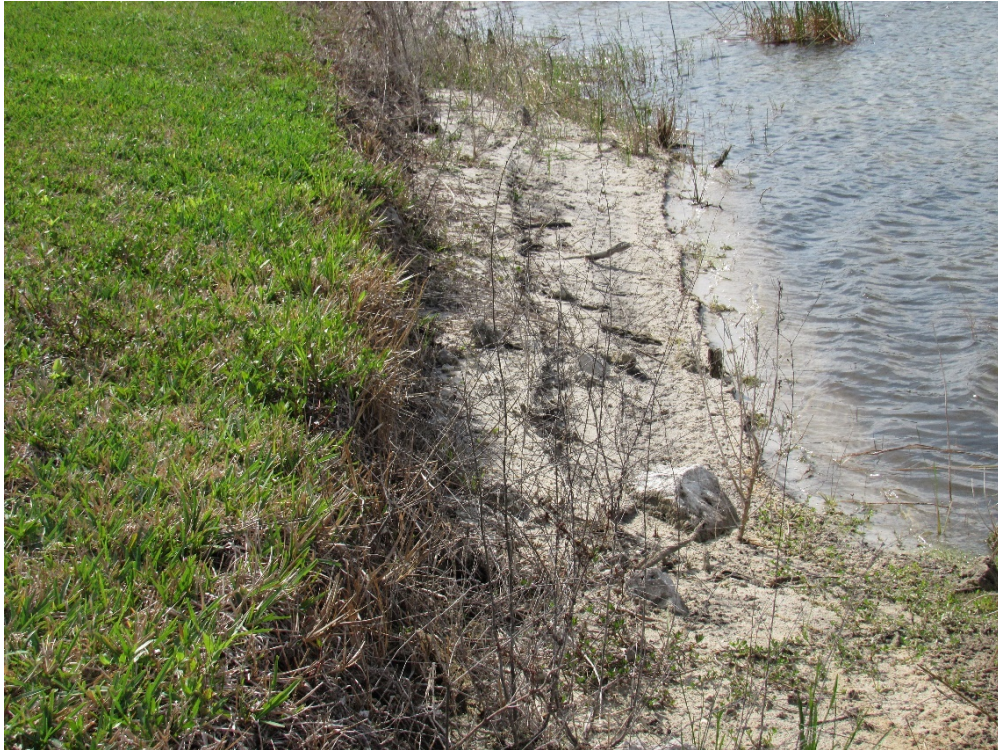
View of erosion at lake embankment - Lake 23.

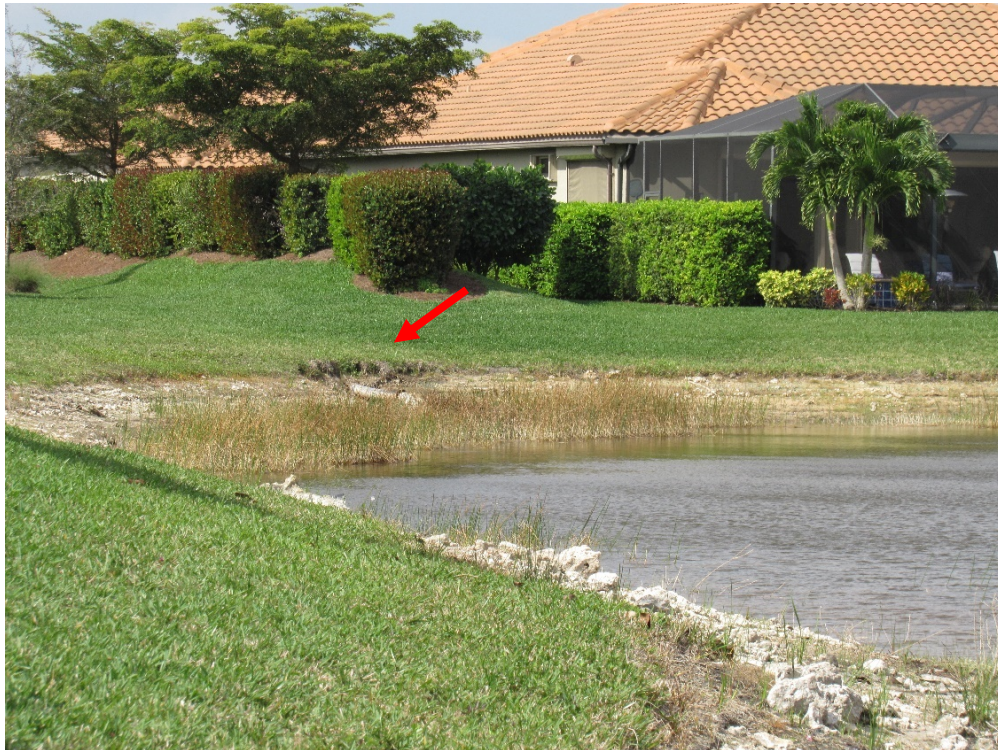
View of erosion at lake embankment - Lake 15A.

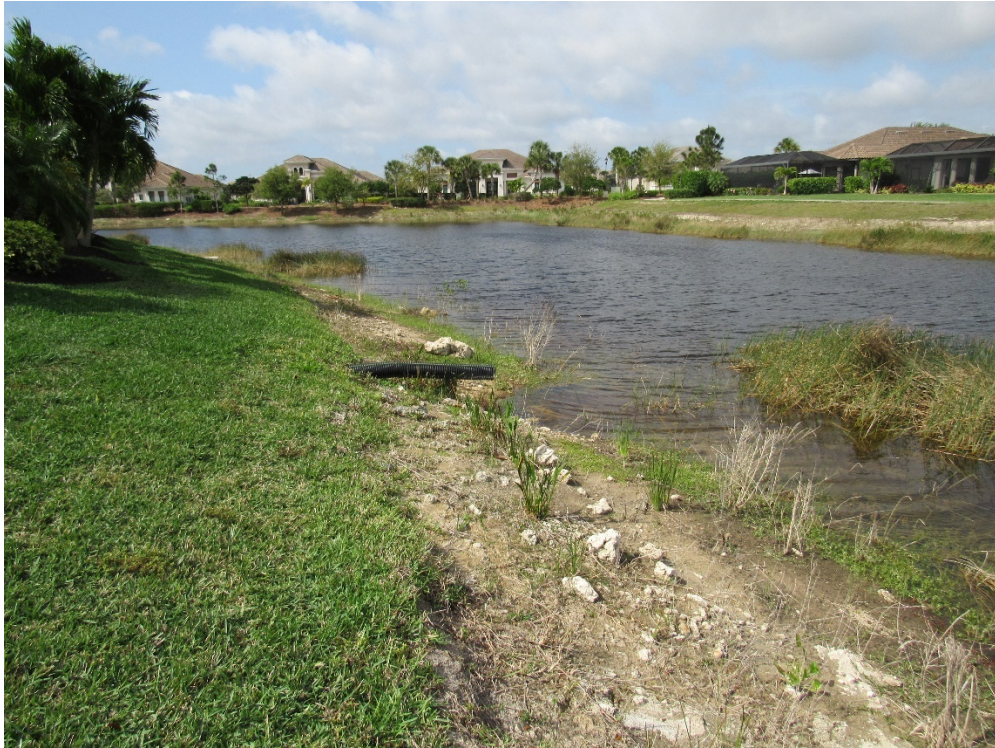
View of erosion at discharge line - Lake 14.

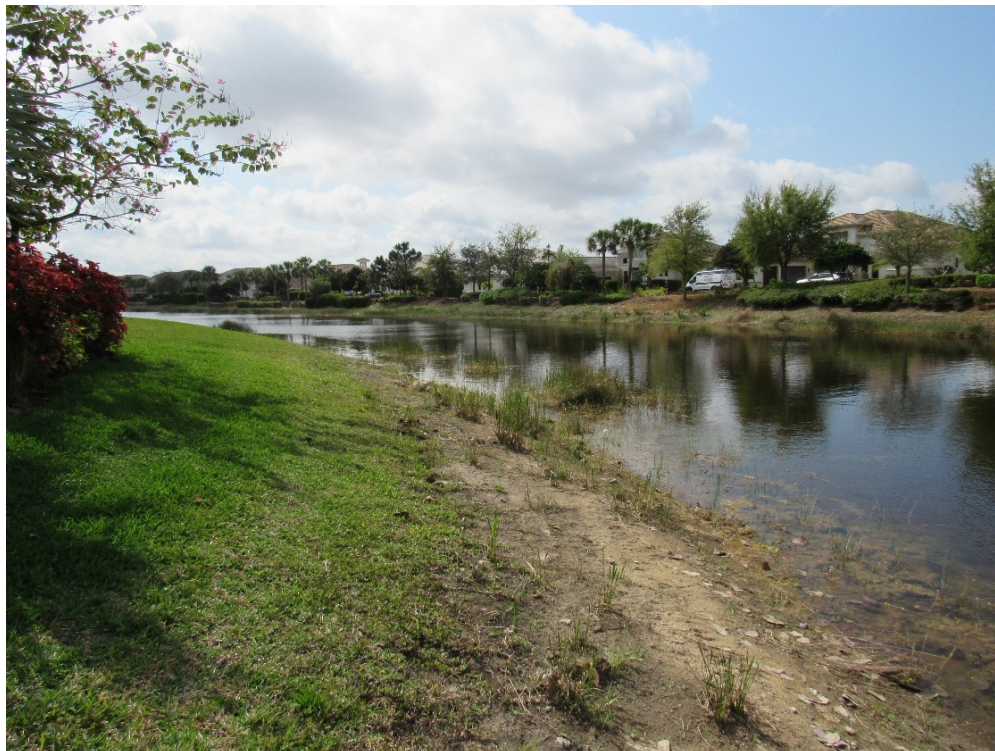
Typical view of Lake 14.

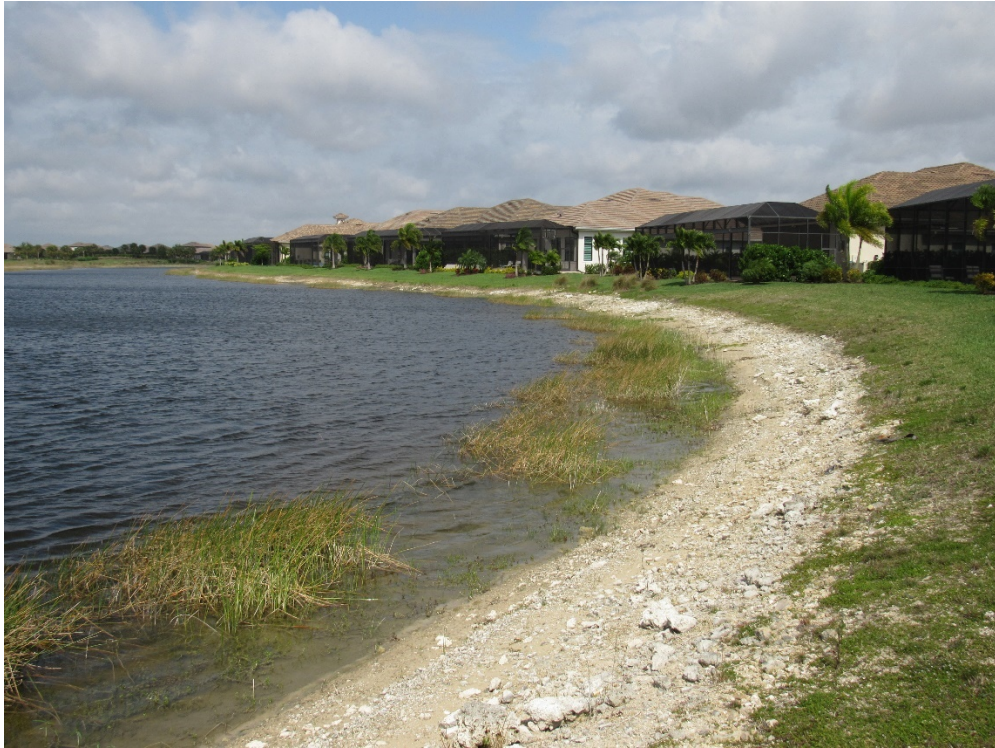
Typical view of Lake 13.

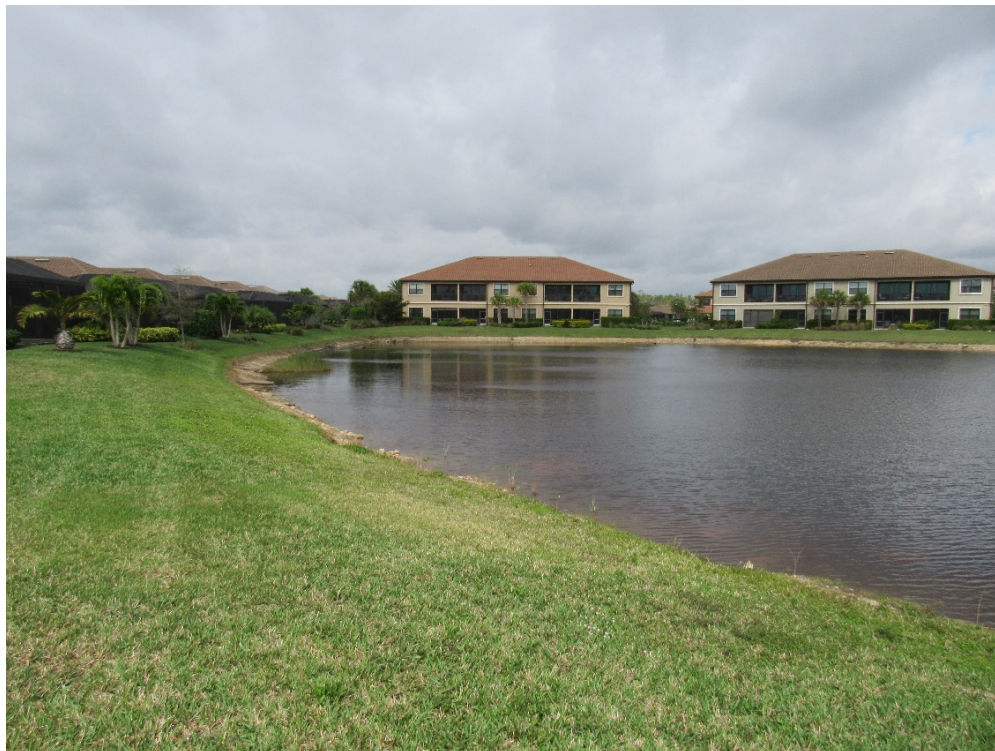
View of limited littoral plants - Lake 16.

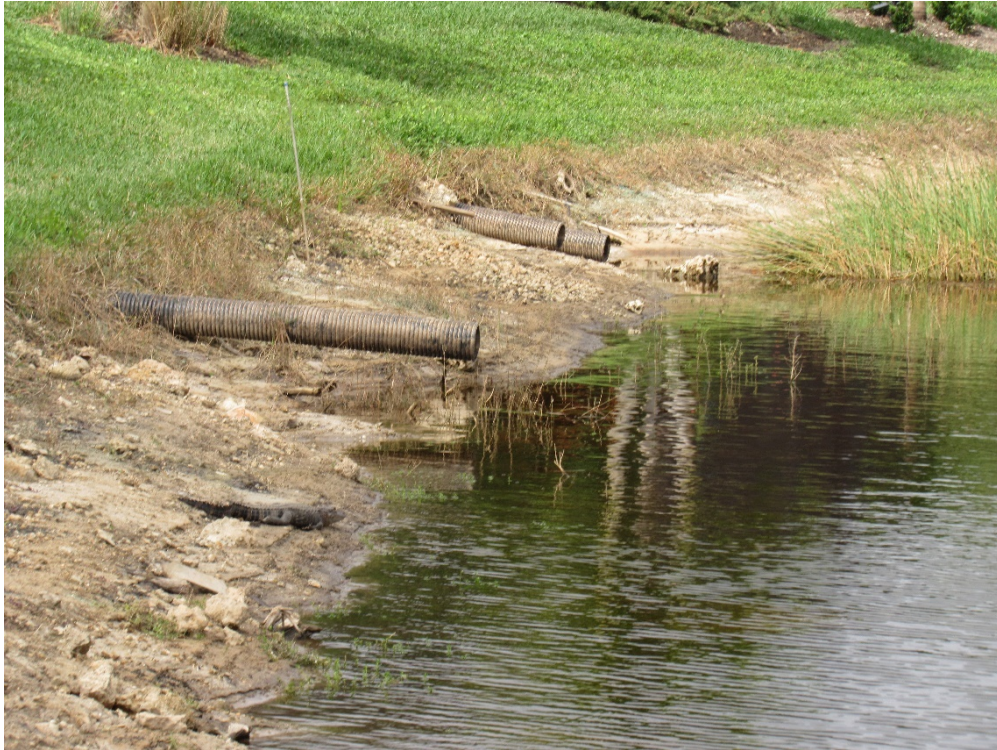
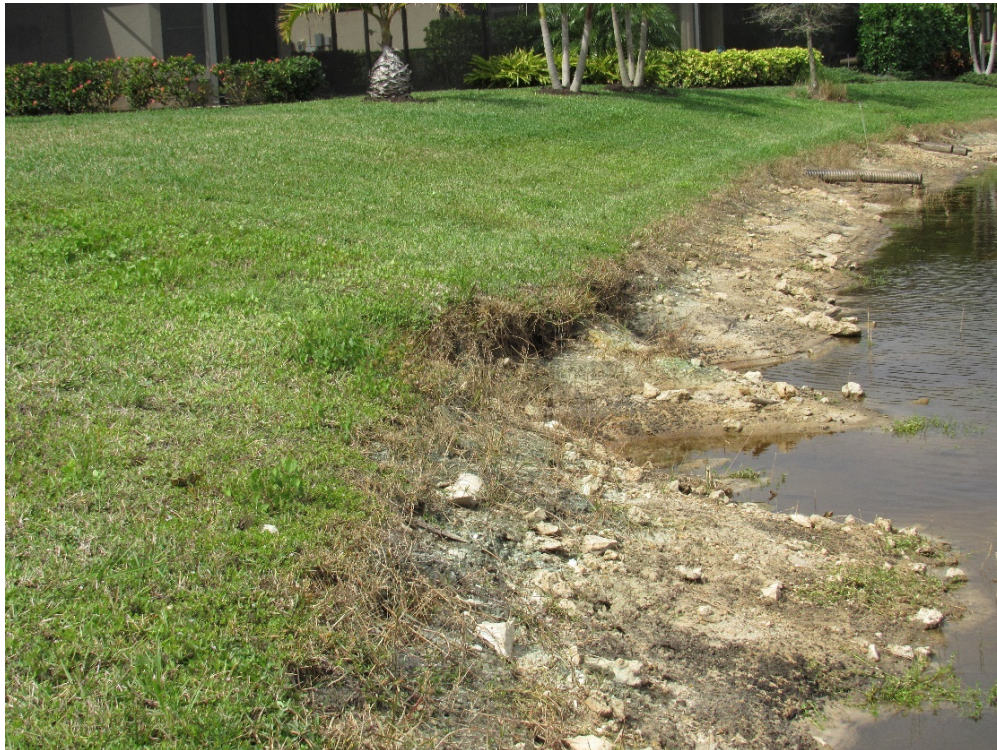
View of erosion at lake embankment and direct discharge lines - Lake 16.

View of erosion at lake embankment and direct discharge lines - Lake 16

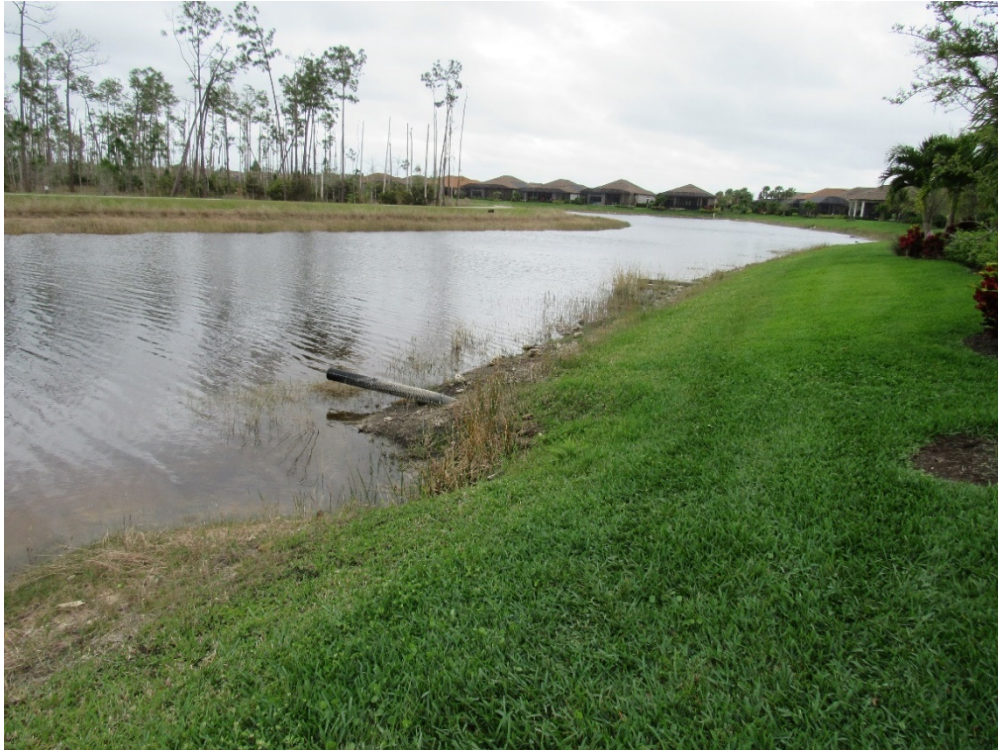
View of erosion at lake embankment - Lake 18.

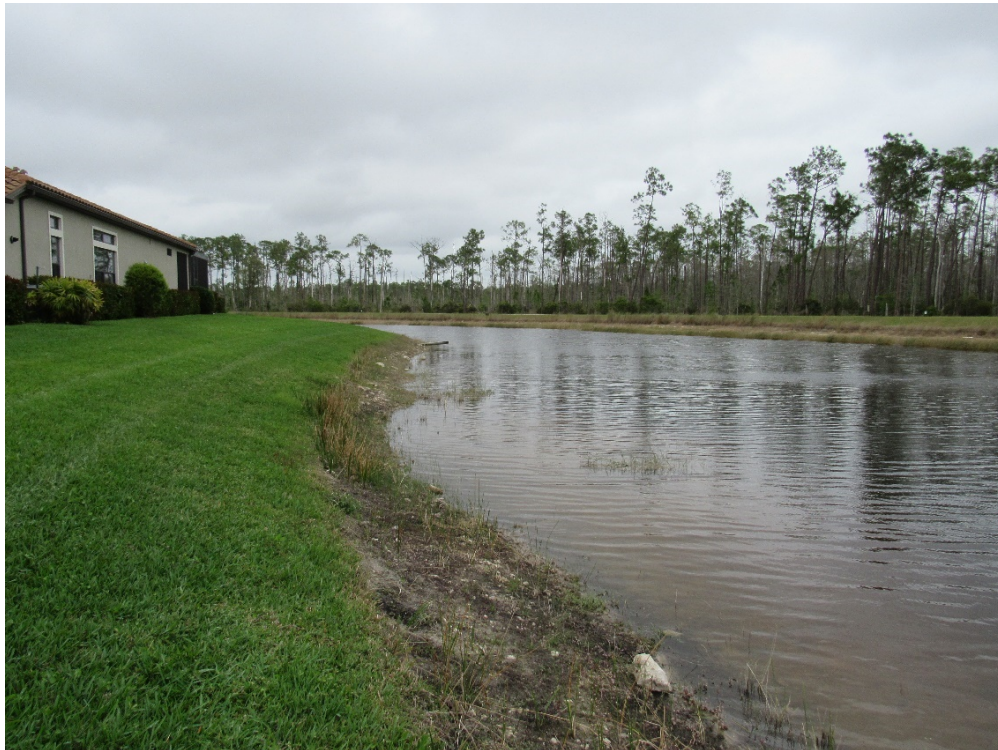
Typical view of limited littoral plants - Lake 18.

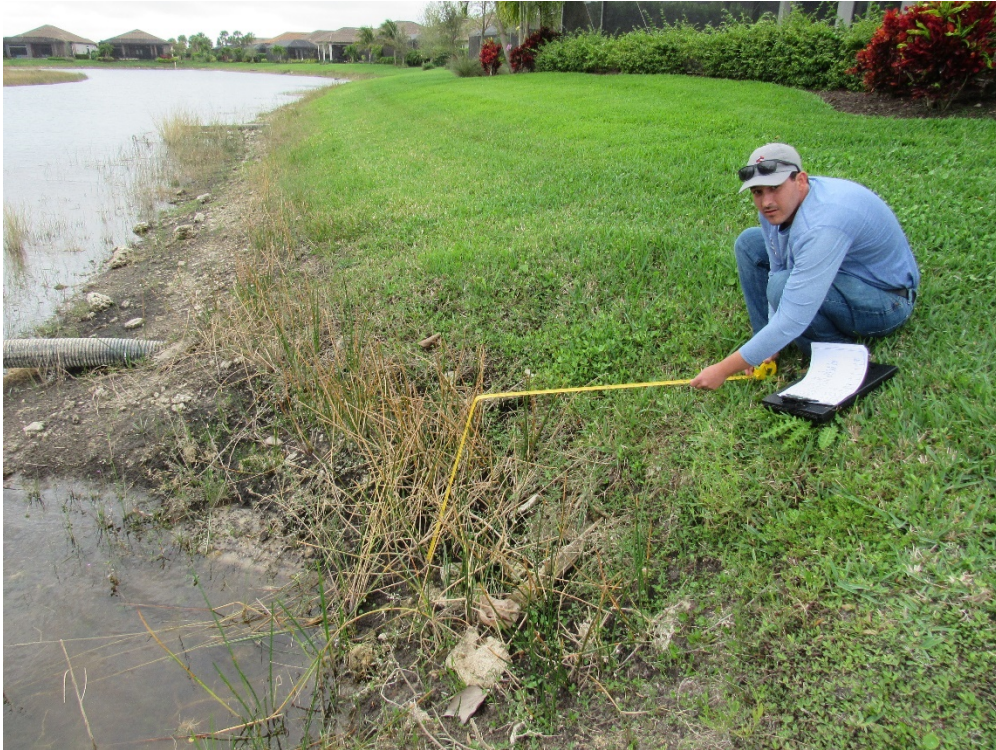
View of erosion at lake embankment - Lake 18.

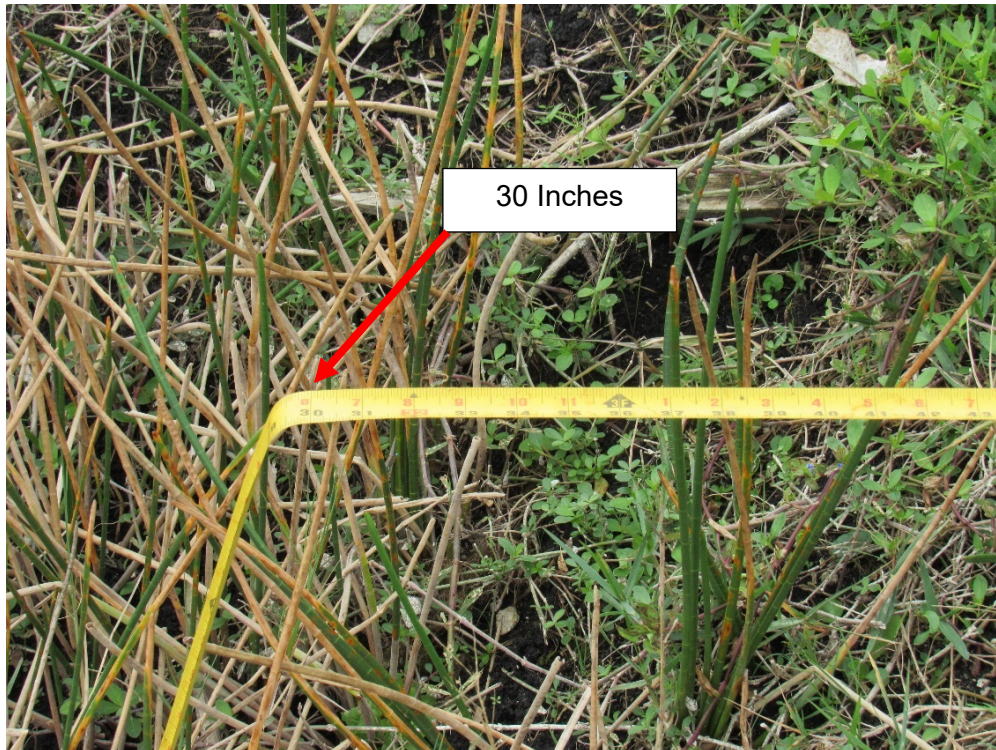
View of the depth of erosion at lake embankment - Lake 18.

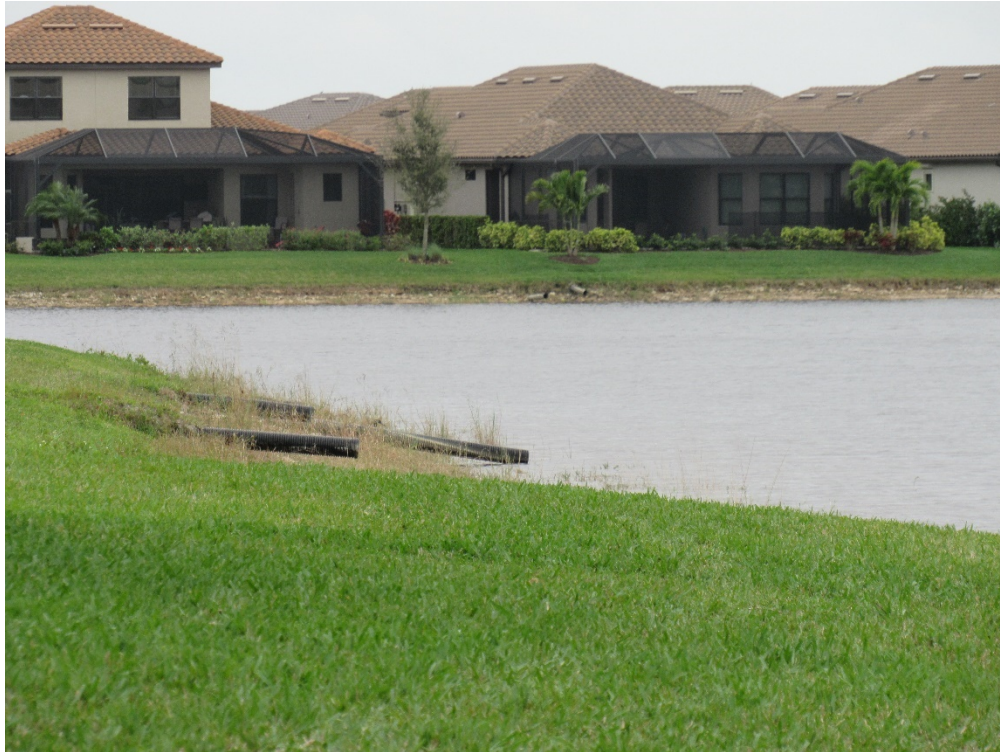
Typical view of limited littoral plants and direct discharge lines - Lake 18.

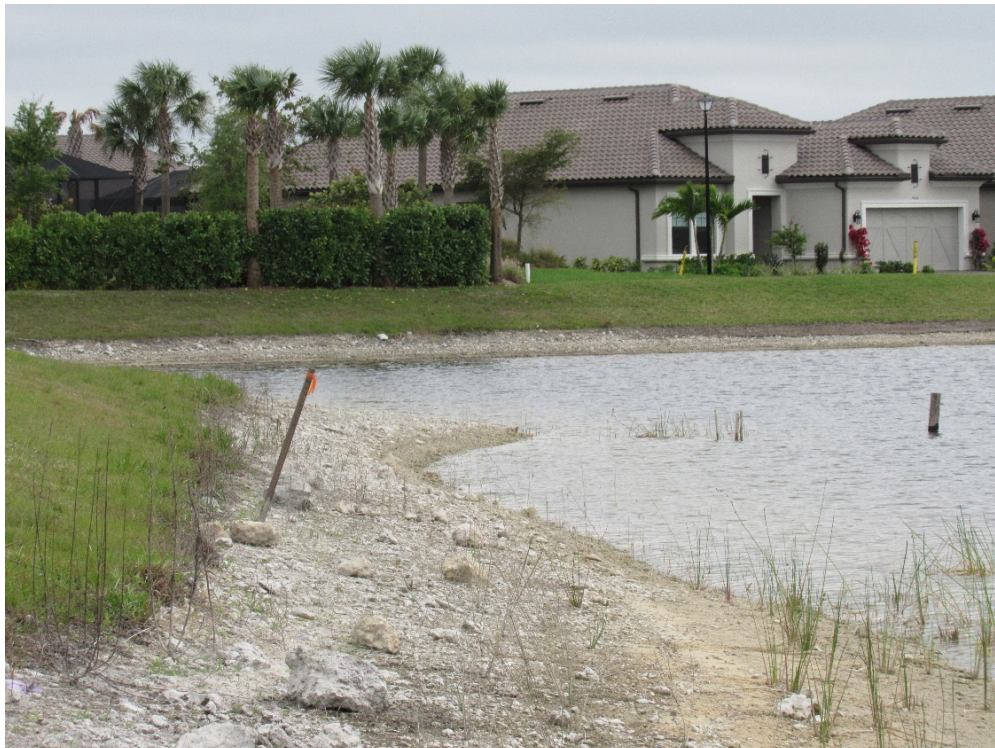
Typical view of limited littoral plants - Lake 25.

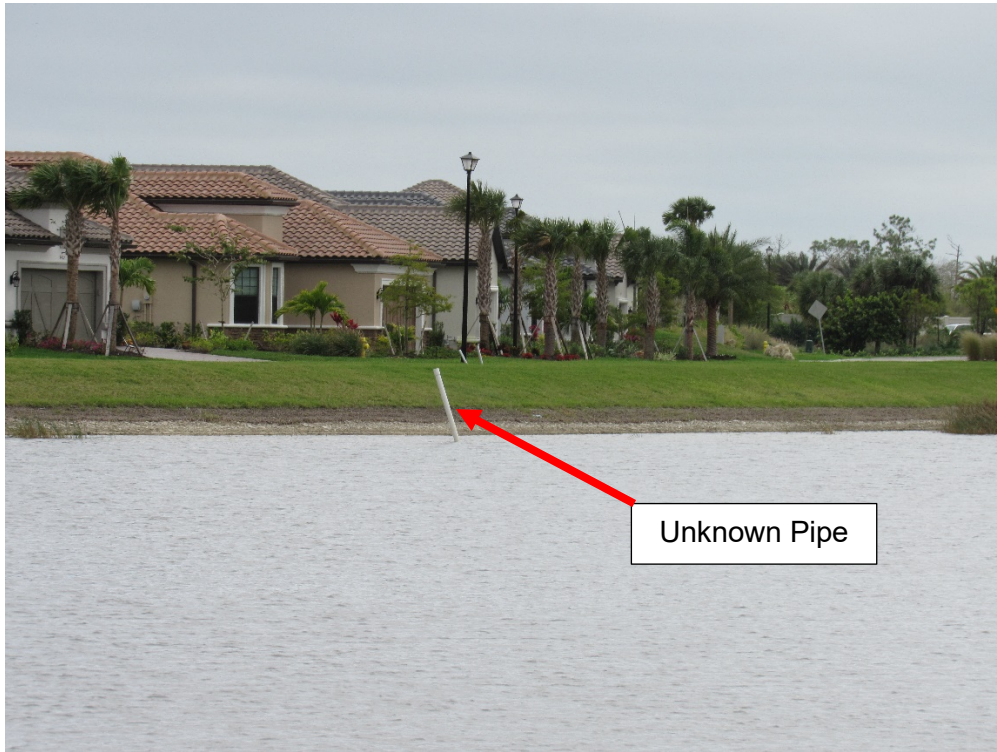
Typical view of limited littoral plants - Lake 25.

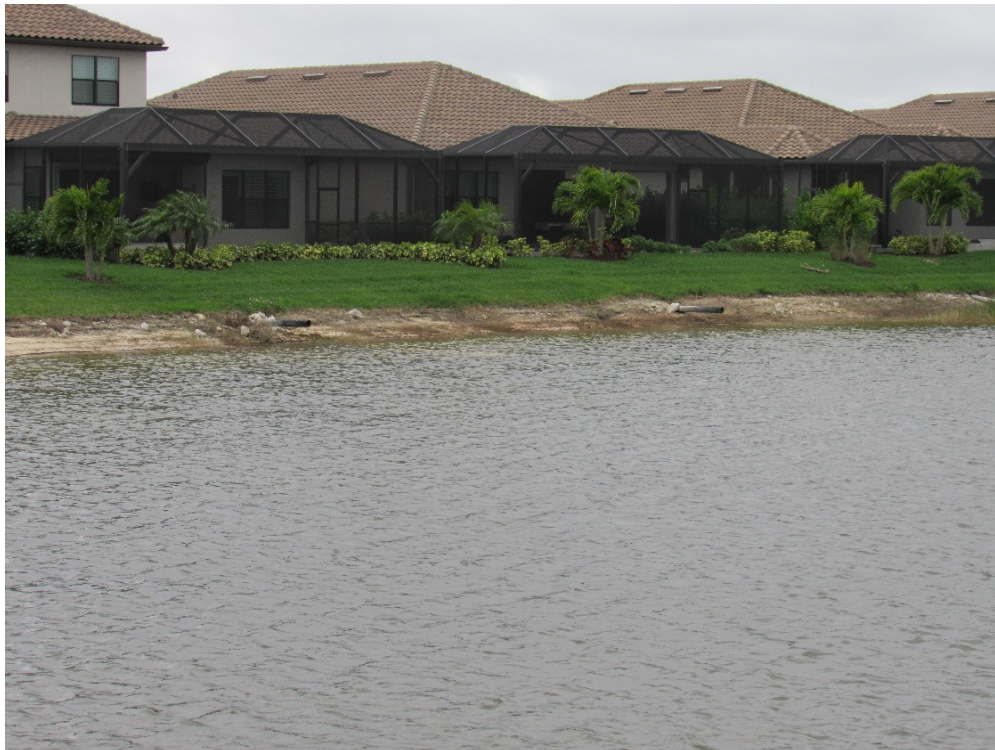
Typical view of limited littoral plants and direct discharge lines - Lake 20.
