**Report of Water Management System Study**

**FLOW WAY  
COMMUNITY DEVELOPMENT DISTRICT  
(FLOW WAY CDD)**

**Forge Engineering Project Number 5911-001.01**

**June 2021**

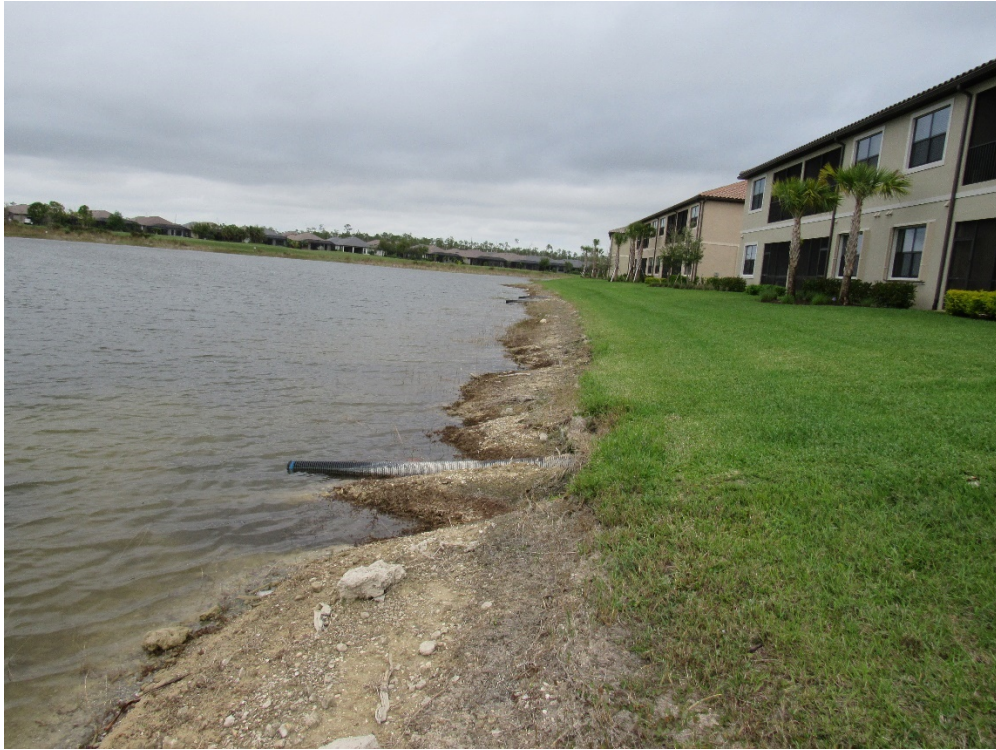
View of limited littoral plants and erosion at lake embankment - Lake 20.

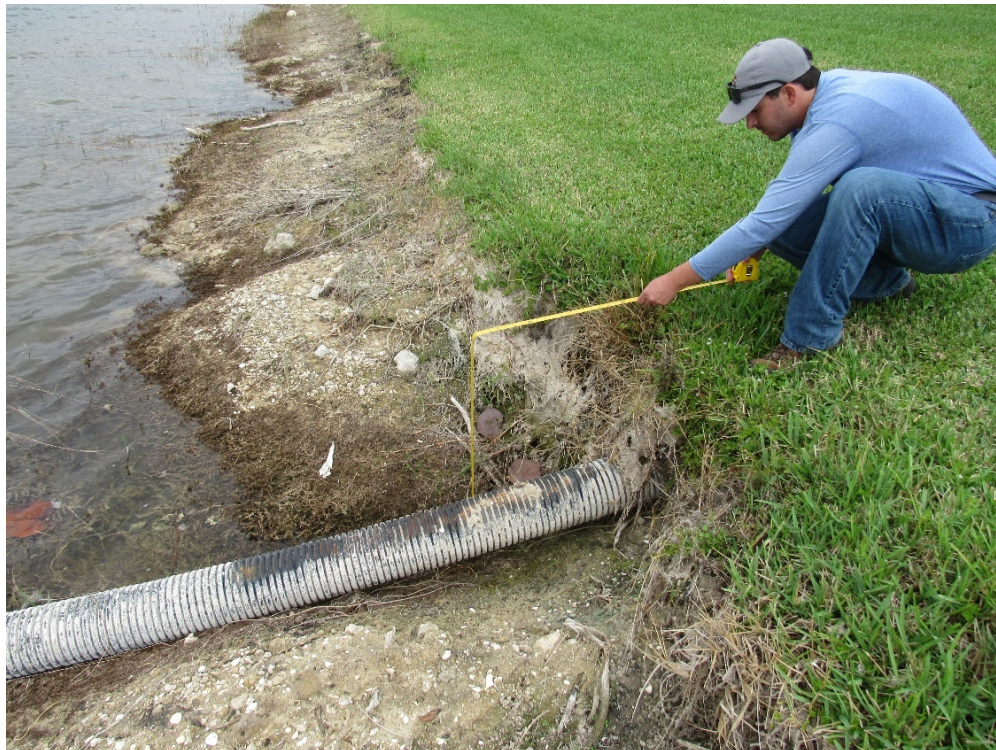
View of the depth of erosion at lake embankment - Lake 20.

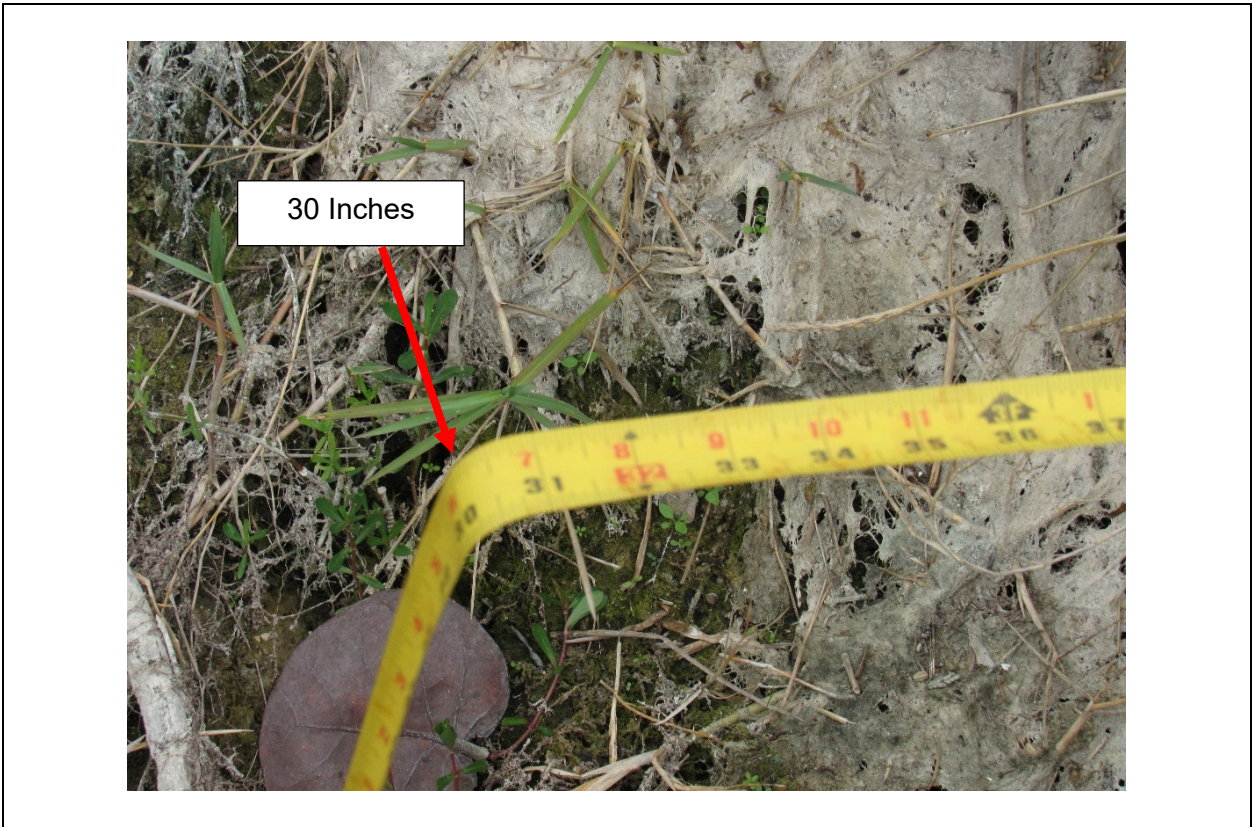
View of the depth of erosion at lake embankment - Lake 20.

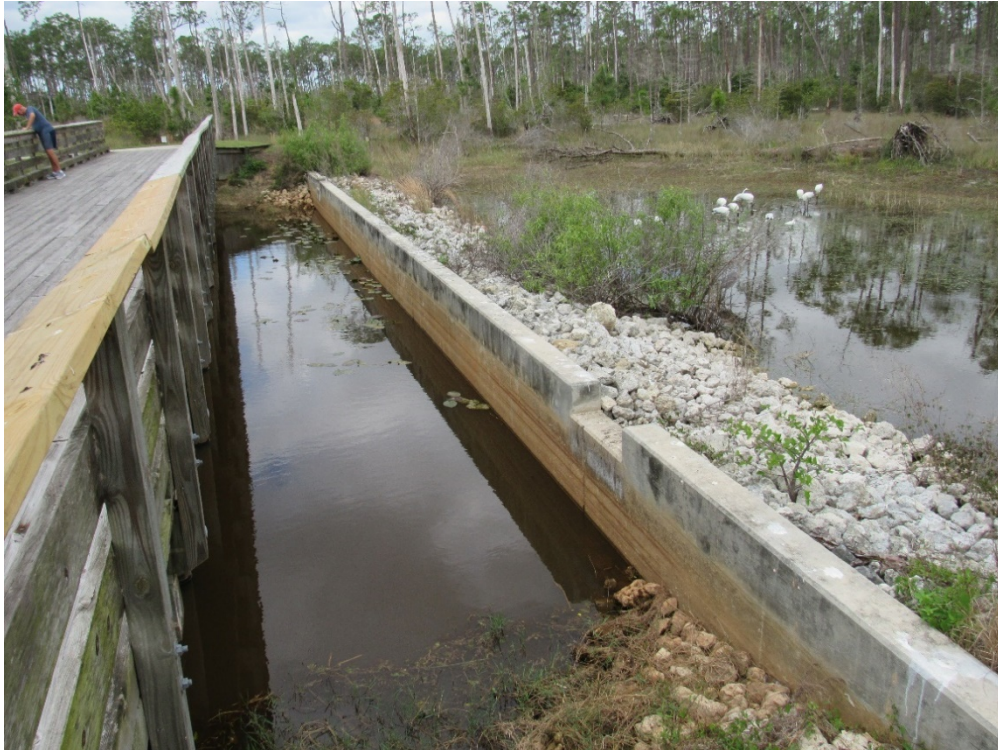
View of North Broad Crested Weir.

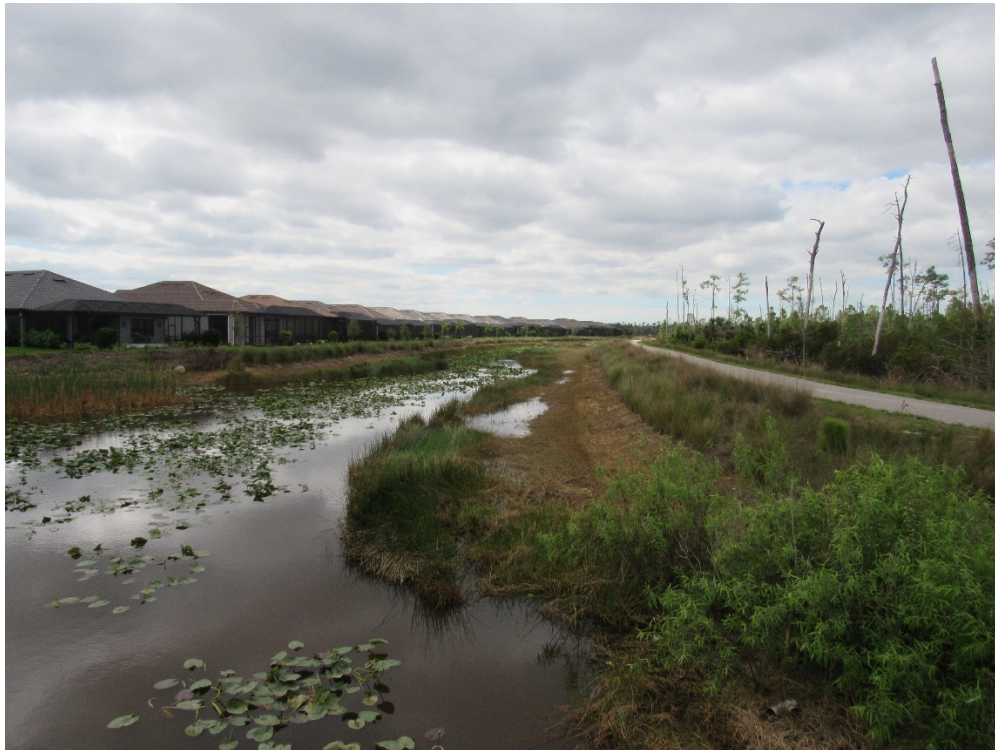
Typical view of Flow Way.

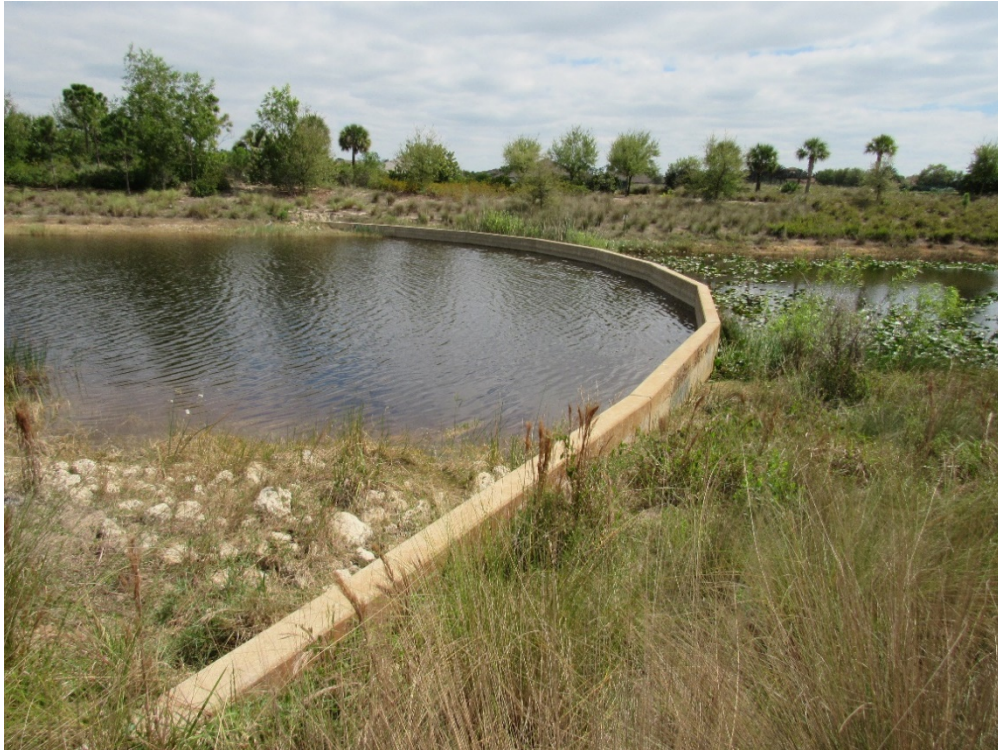
View of South Broad Crested Weir.

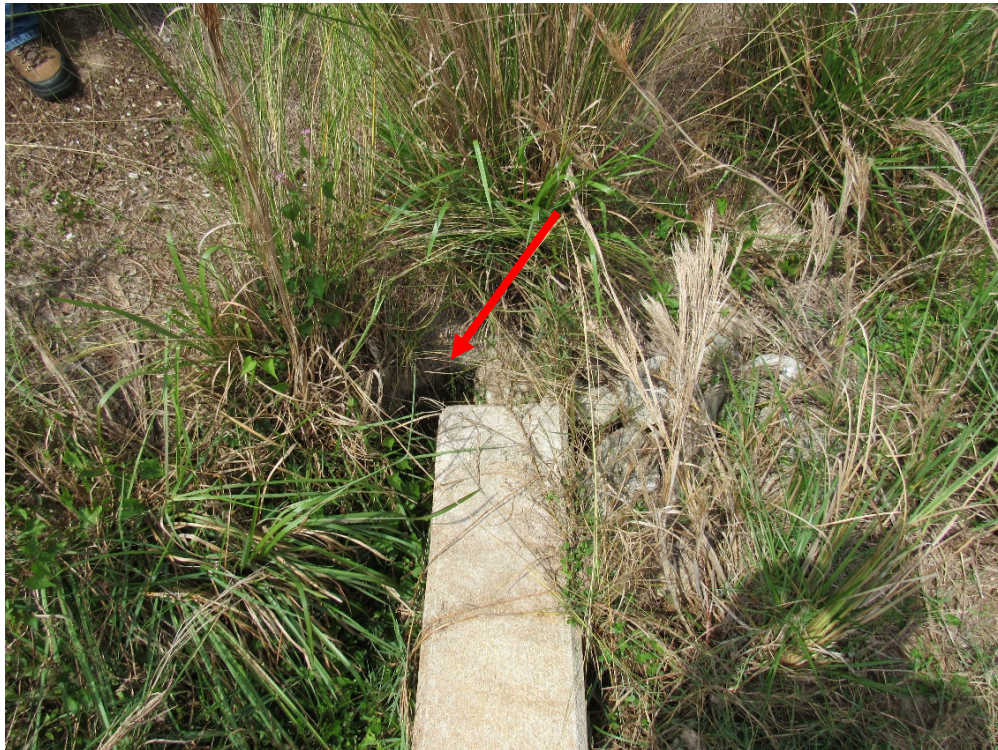
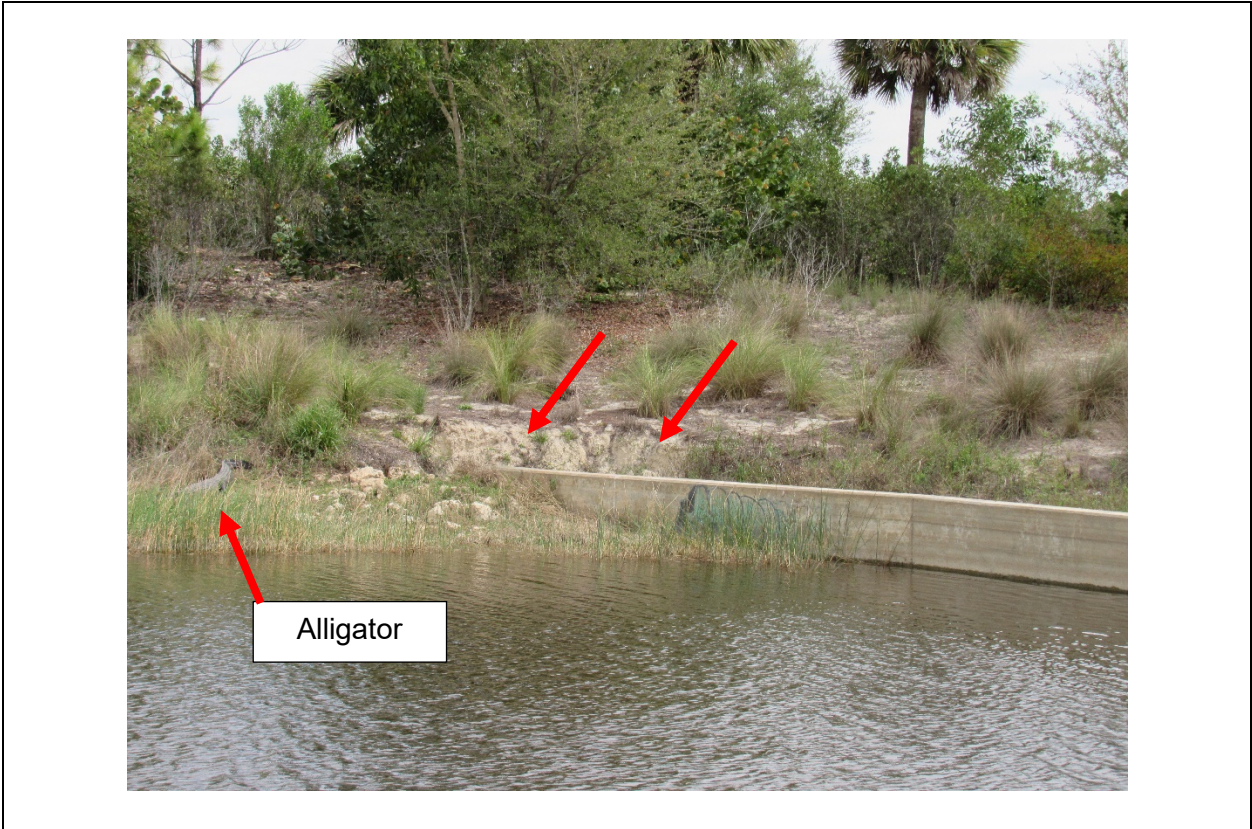
- We observed an area of dead littoral plants along the flow way.
- While both broad crested weir structures were in good condition, we observed soil erosion at both ends of the south, broad crested weir of the Flow Way and recommend repair of these areas in advance of the next wet season.

View of erosion - South Broad Crested Weir.

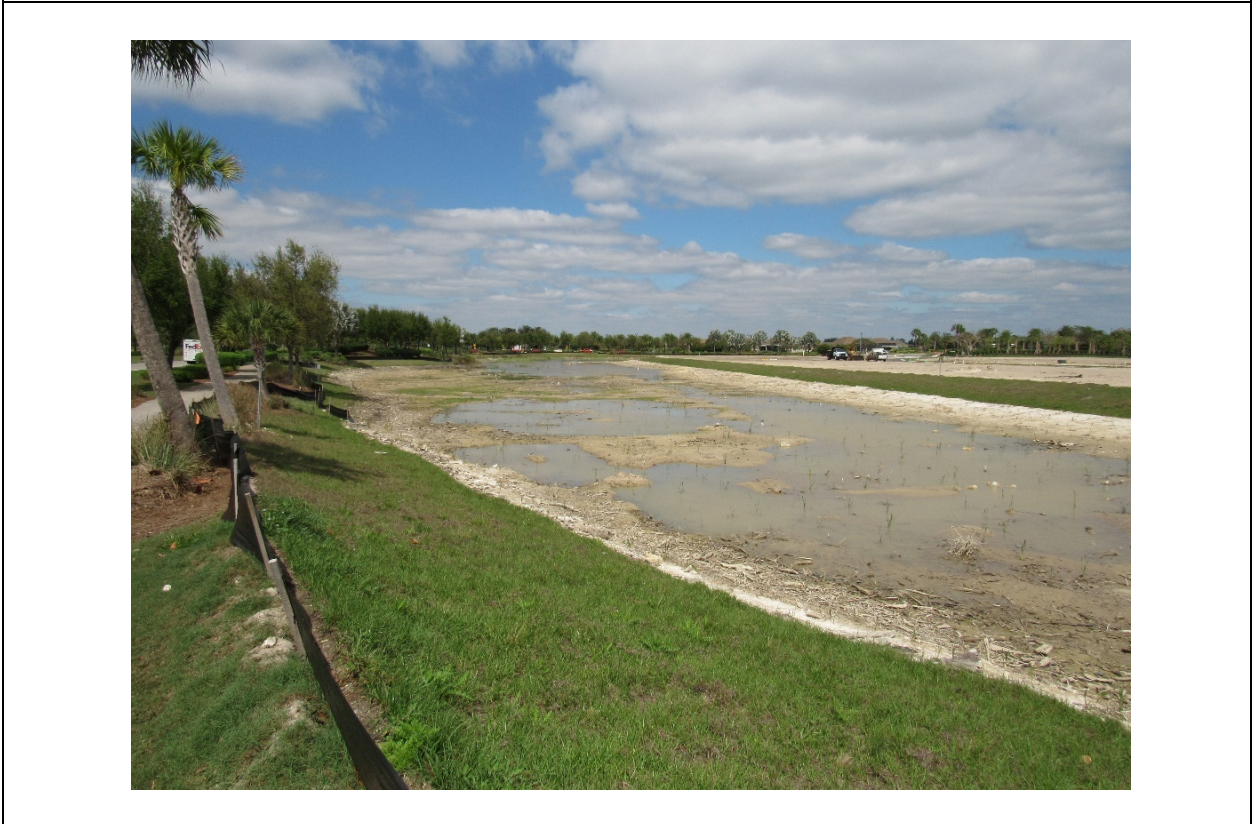
View of lake under construction - Lake 11.

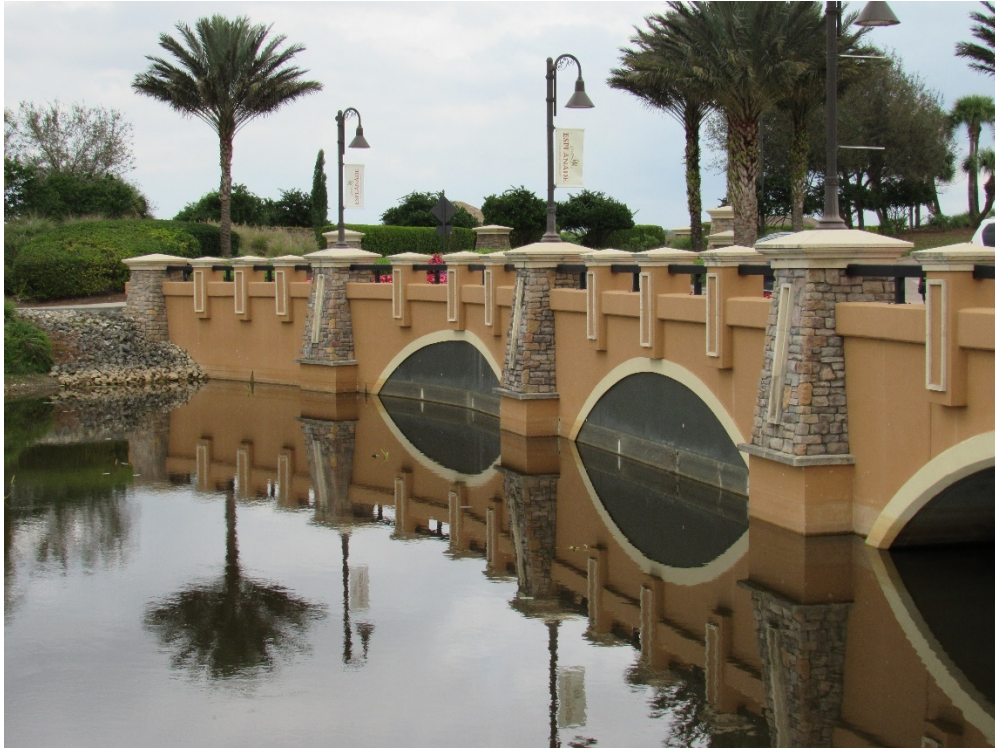
View of Entry Bridge

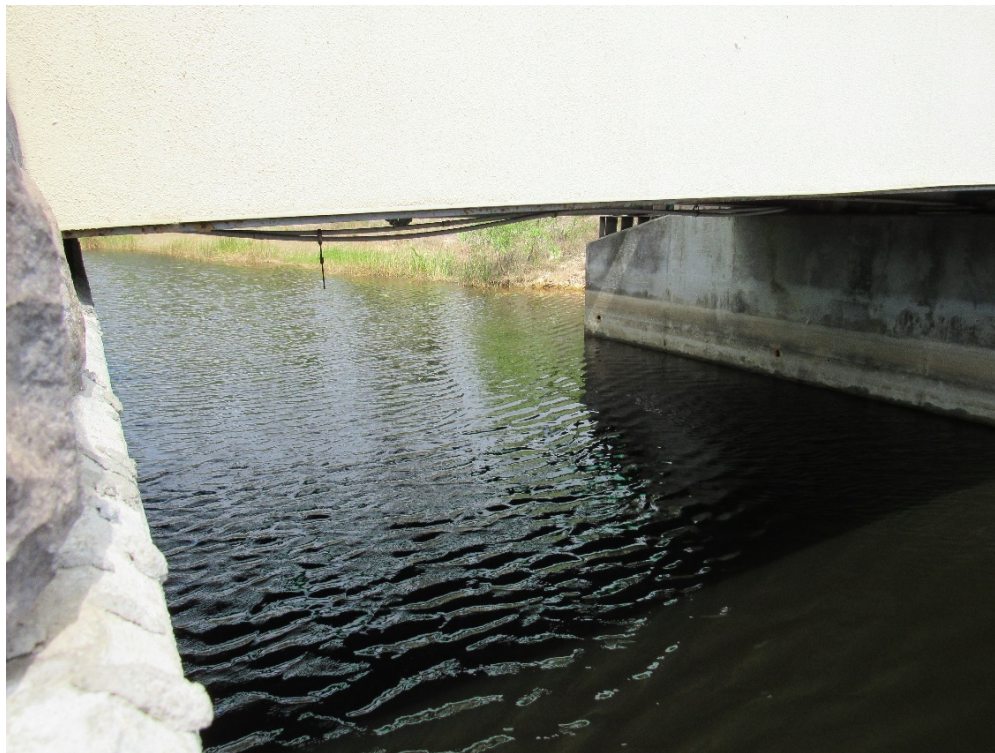
View of Flow Way at intersection with Immokalee Road Canal.

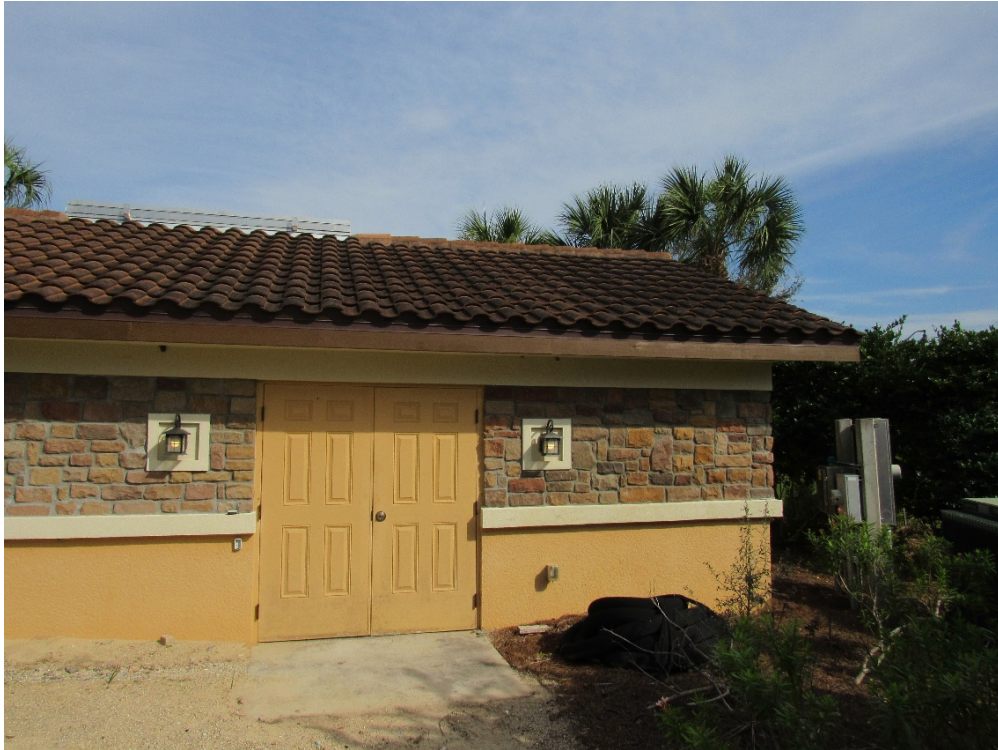
Exterior view of Community Irrigation Pump House.

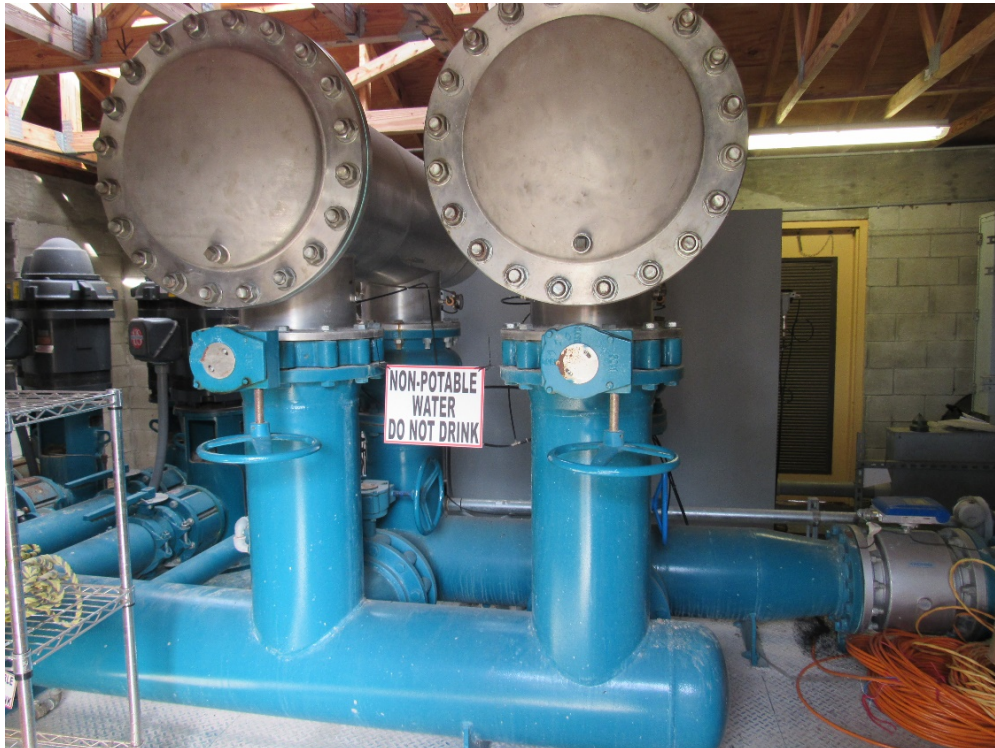
Interior view of Community Irrigation Pump House.

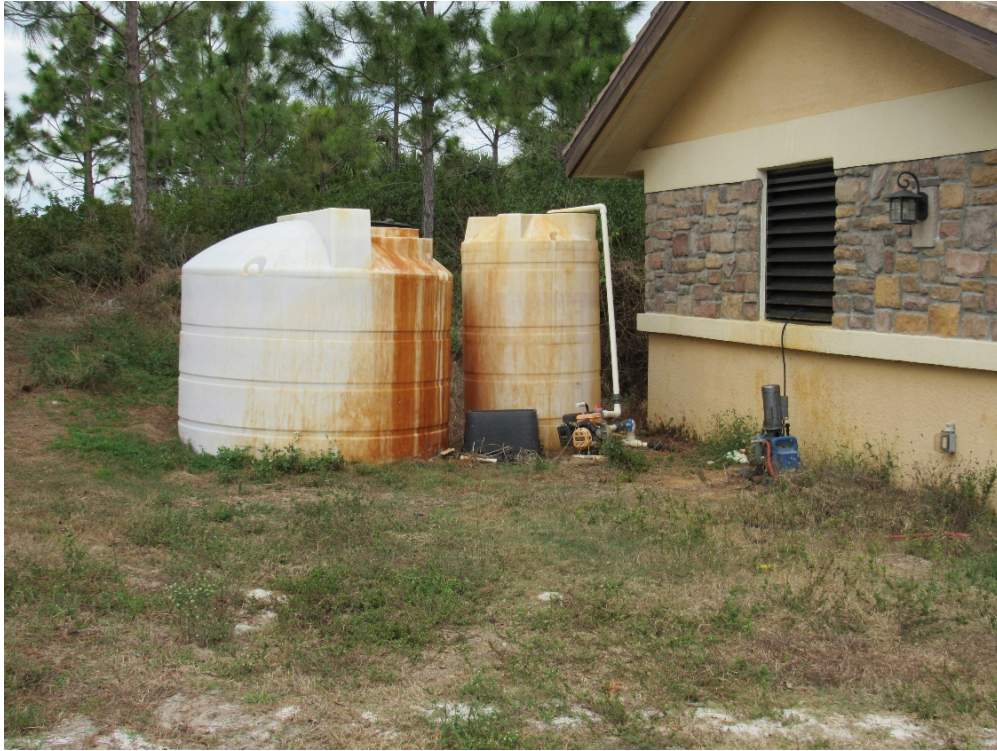
- We observed two unknown tanks at the exterior of the golf course pump house.

View of unknown tanks - Golf Course Irrigation Pump House.

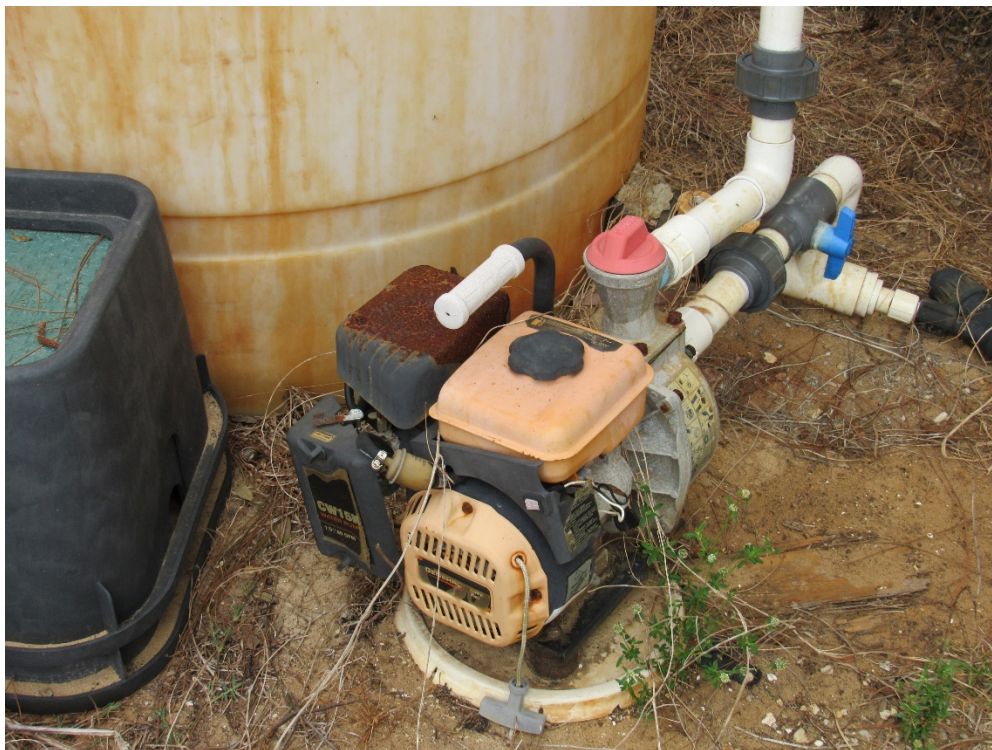
View of exterior gas pump - Golf Course Irrigation Pump House.

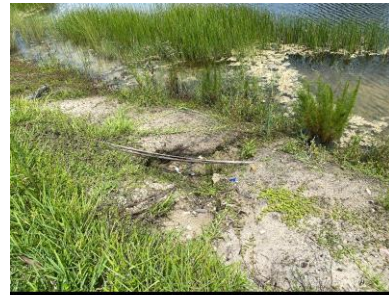
There is new erosion present at the time of inspection.

**Washout found**

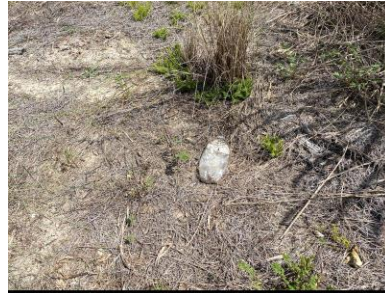
**Trash found along shoreline**

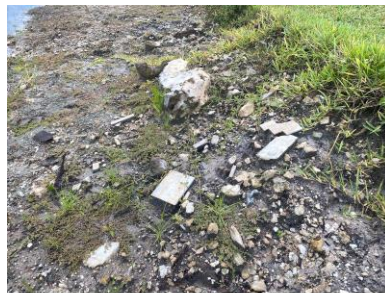
**Trash and tiles found along shoreline**

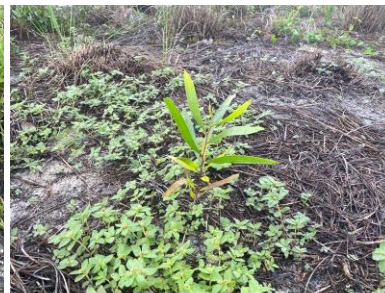
**Sappling Earleaf within littorial zone**

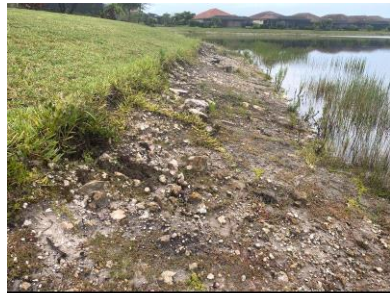
**Washout found during inspection**

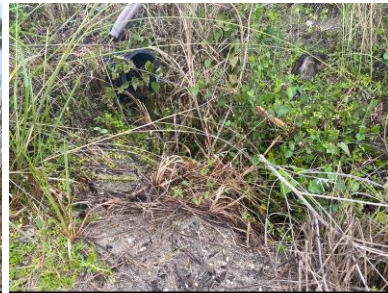
**Drainage pipe causing washout**

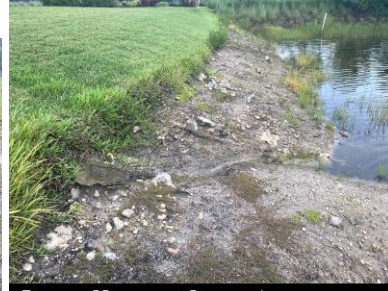
**Samll washout starting no plants**

Repair should be considered at this time.  
There is no aeration present on the lake.  
There is no fountain present.

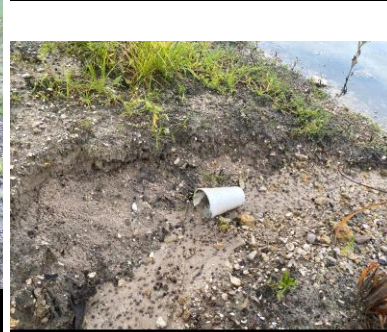
**trash found in washout**

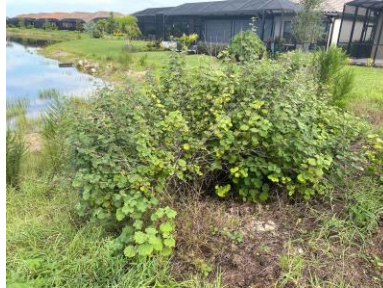
**Very large ceaserweed found in zone**

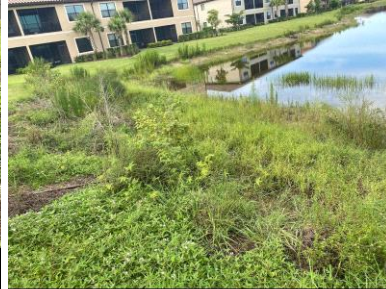
**More ceaserweed and primrose**
