Flow Way CDD at Esplanade Golf and Country Club Waterway Inspection Report

Reason for Inspection: Quality Control

Inspection Date: 2023-01-10

**Flow Way CDD at Esplanade Golf and Country Club
8910 Torre Vista Lane
Naples, FL 34119**

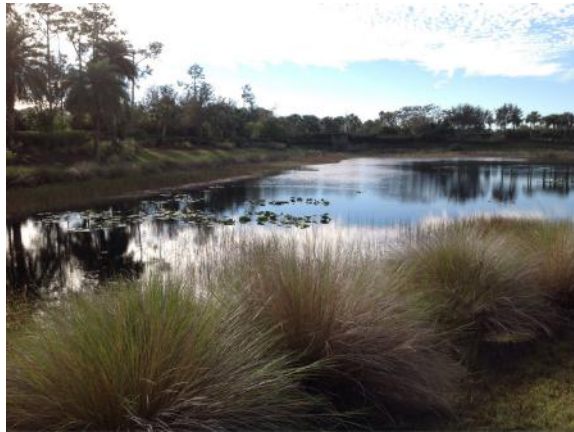
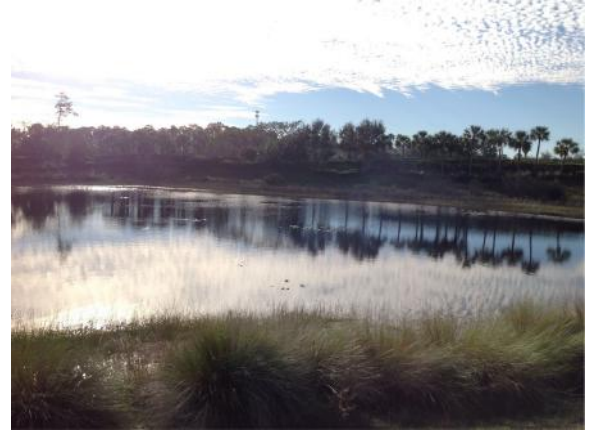
Site: 1

Requires attention
 Shoreline is well maintained.
 Treat for spatterdock.

Routine maintenance next visit

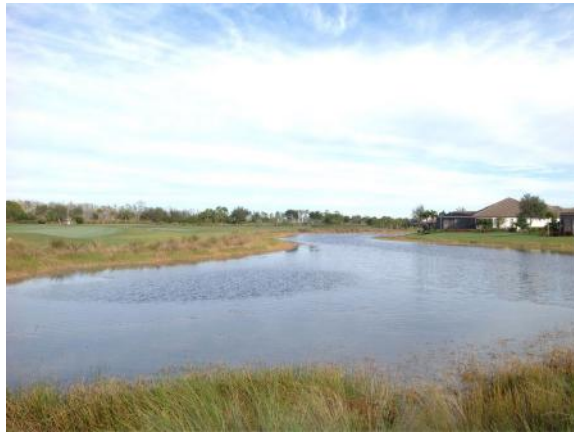
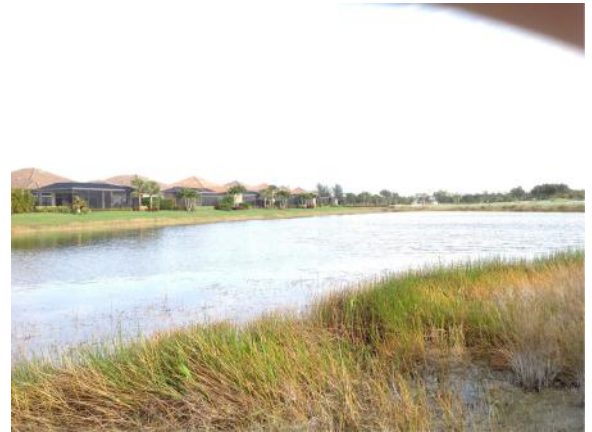
Site: 2

Requires attention
 Treat torpedograss within the littorals. Treat for Illinois pondweed and spatterdock. Algae at controlled levels.

Routine maintenance next visit

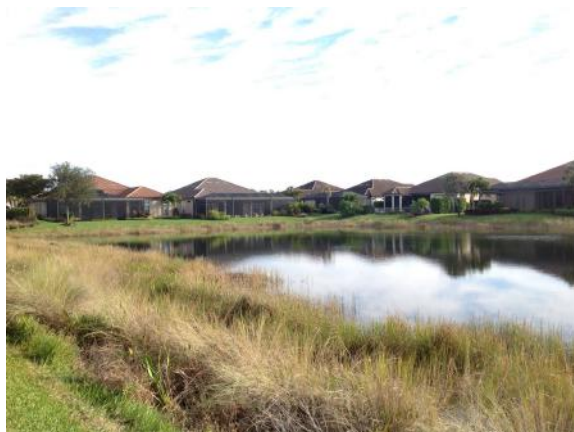
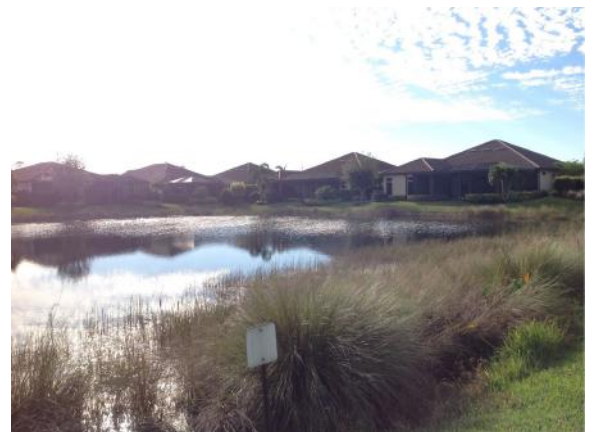
Site: 3

Normal growth observed
 Shoreline is well-maintained.
 Treat for spatterdock. Algae and aquatic weeds are at controlled levels

Routine maintenance next visit

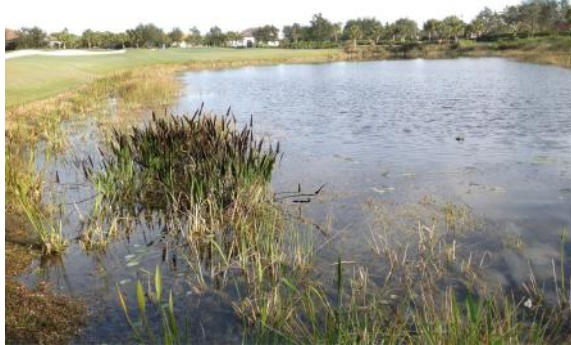
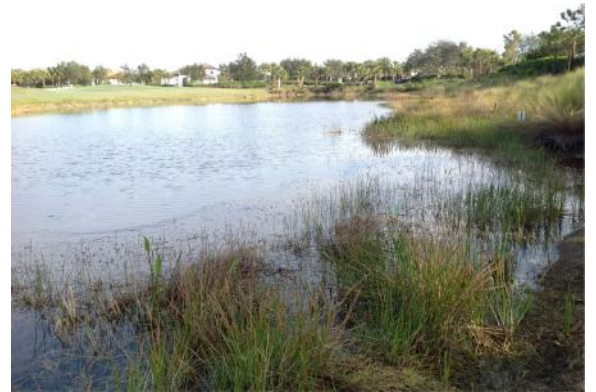
Site: 4

Requires attention

Shoreline looks good. Spot treat minimal torpedo grass. Treat for spatterdock, Illinois pondweed, chara and red ludwigia.

Routine maintenance next visit

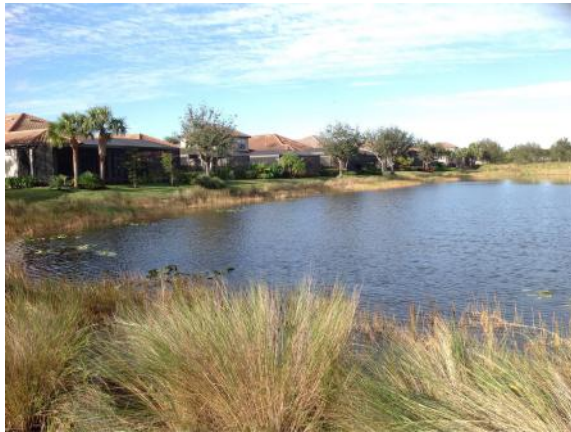
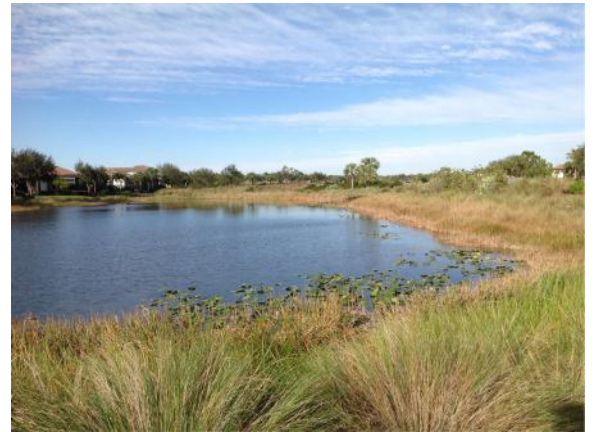
Site: 5A

Requires attention

Shoreline is well-maintained, minimal vines noted. Algae at controlled levels. Treat for spatterdock.

Routine maintenance next visit

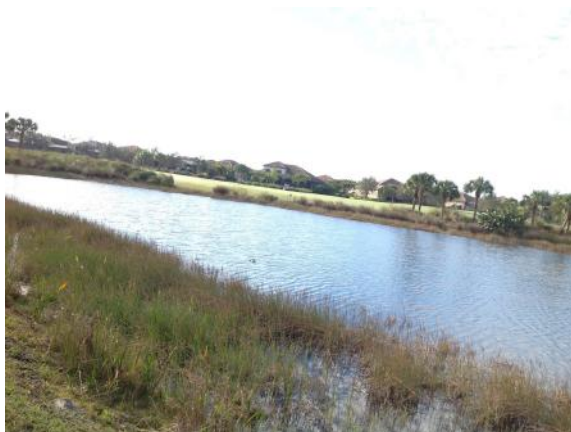
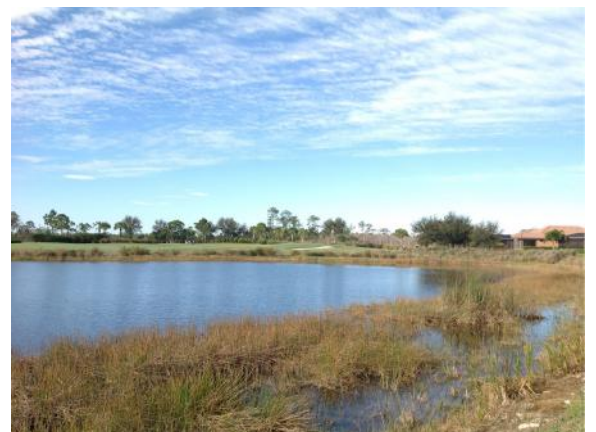
Site: 5B

Requires attention

Spot treat cattails observed within the littorals. Algae is at controlled levels. Treat for spatterdock.

Routine maintenance next visit

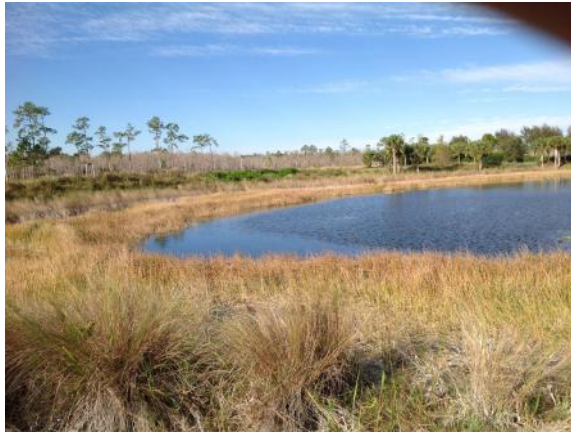
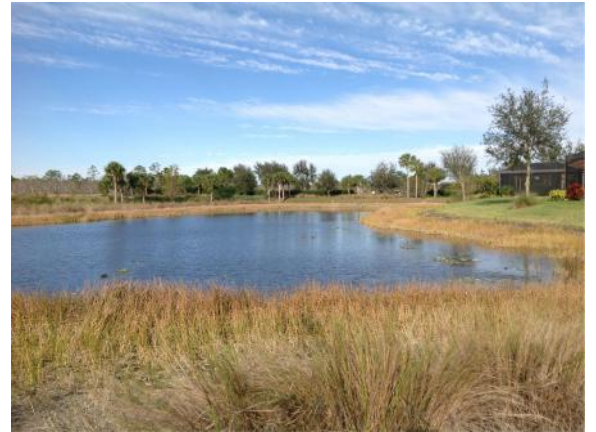
Site: 6

Requires attention

Shoreline is well maintained.
Submersed vegetations is at controlled levels. Monitor and treat filamentous algae as needed.
Treat for spatterdock.

Routine maintenance next visit

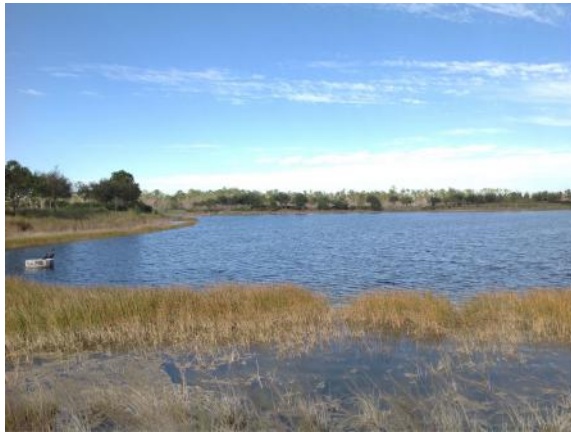
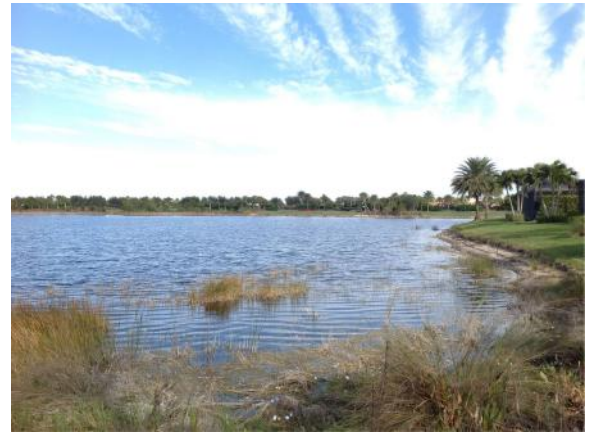
Site: 7

Normal growth observed

Shoreline is well maintained.
Submersed vegetation is at controlled levels. Monitor and treat filamentous algae as needed.

Routine maintenance next visit

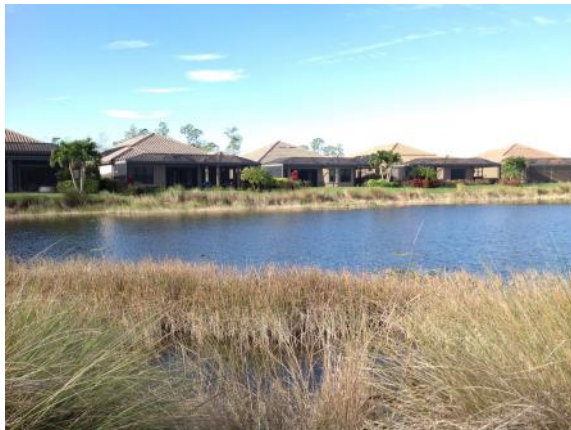
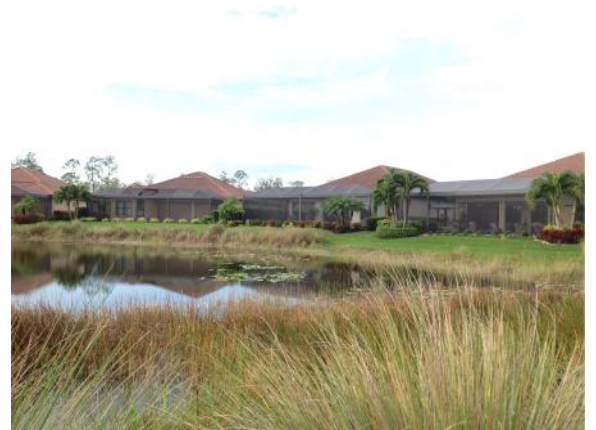
Site: 8

Requires attention

Shoreline is well maintained.
Algae is at controlled levels.
Treat for spatterdock.

Routine maintenance next visit

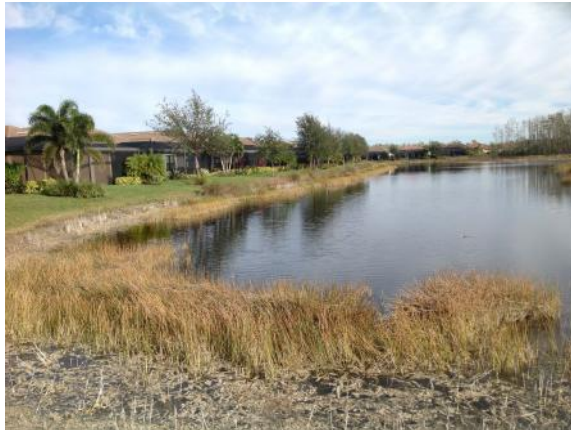
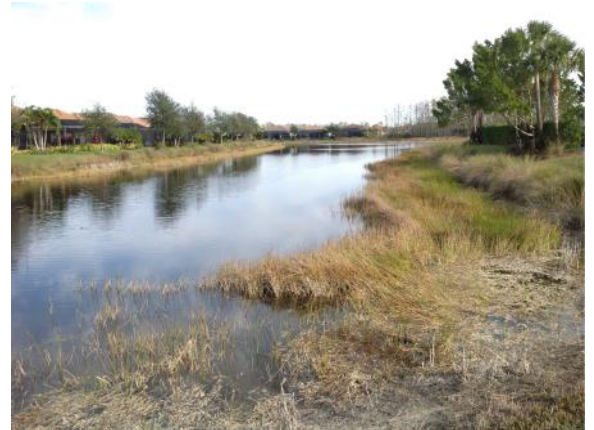
Site: 9

Normal growth observed
 Shoreline is well maintained.
 Submersed vegetation is at controlled levels. Monitor and treat surface algae as needed.
 Treat for spadderdock.

Routine maintenance next visit

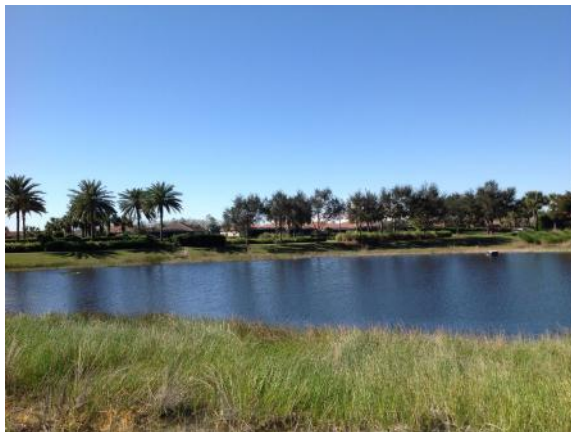
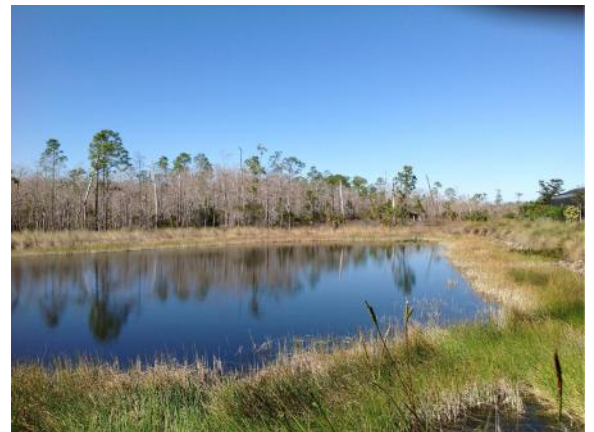
Site: 10

Normal growth observed
 Shoreline is well maintained.
 Algae and submersed vegetation are at controlled levels. Treat for spatterdock.

Routine maintenance next visit

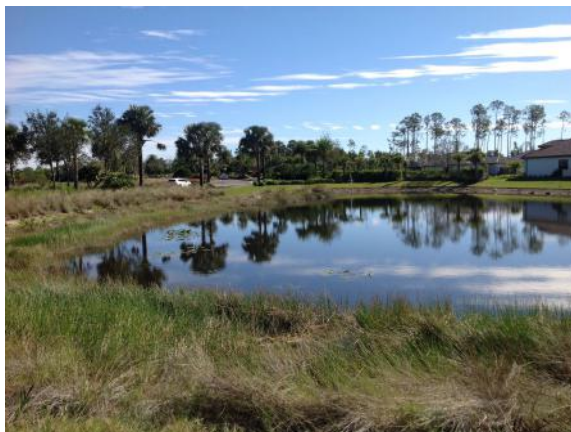
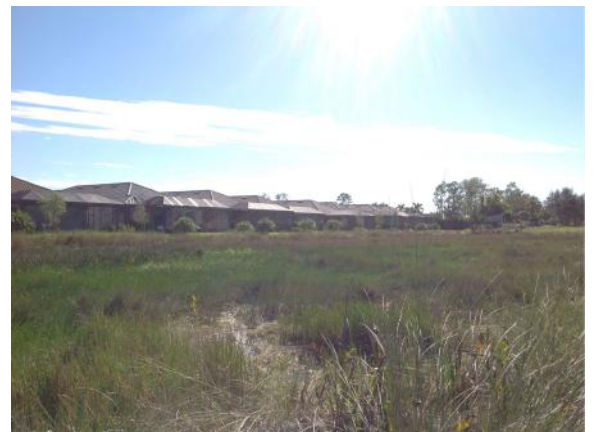
Site: 11

Requires attention
 Spot treat for vines and torpedograss within the littorals.
 Treat for spatterdock and bladderwort.

Routine maintenance next visit

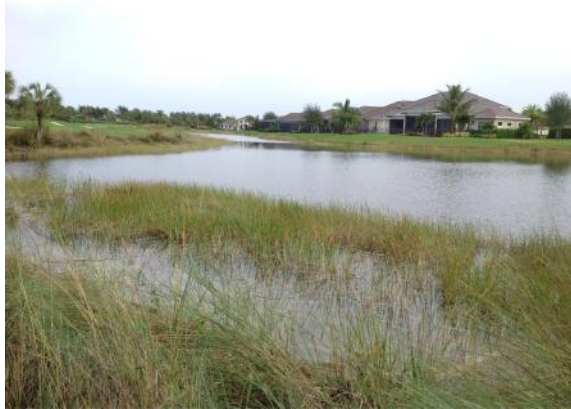
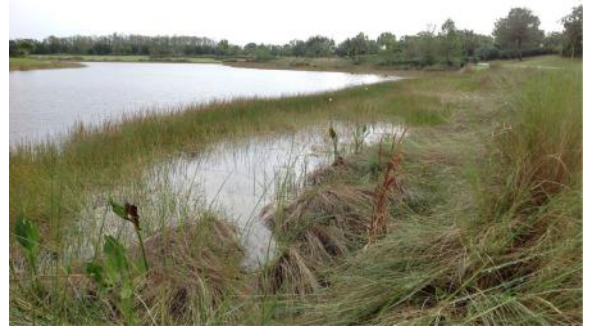
Site: 12

Requires attention

Shoreline is well maintained. Algae and submersed weeds are at controlled levels. Treat for spatterdock.

Routine maintenance next visit

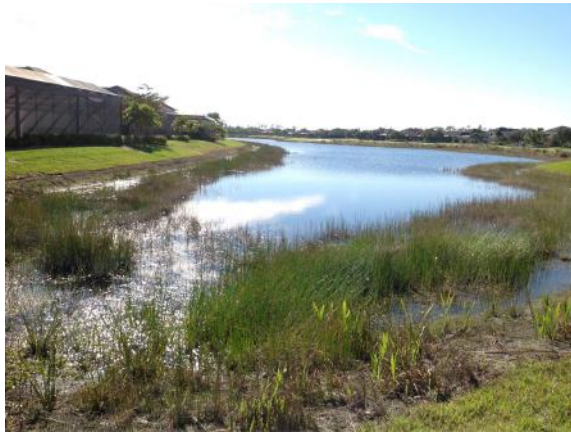
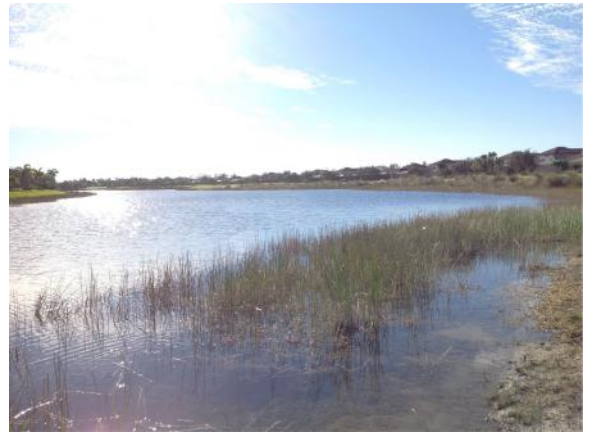
Site: 13

Requires attention

Shoreline is well maintained. Algae is at controlled levels. Treat Illinois pondweed and Vallisneria. Erosion noted along lot lines.

- The majority of ponds that require attention were for floating weeds/lilies or submersed aquatic vegetation.
- Many of the lakes do not have good coverage of littorals high on the lake banks and this may be exacerbating the erosion issues noted during this inspection. Some lakes also had substantial washouts, lakes 17 and 19 being a good examples. Most of the erosion was found between homes where downspouts are located, the sheet flow from the concentrated runoff often causes this erosion. Some of the washouts were also likely from pool drains though this seemed much less common.

Routine maintenance next visit

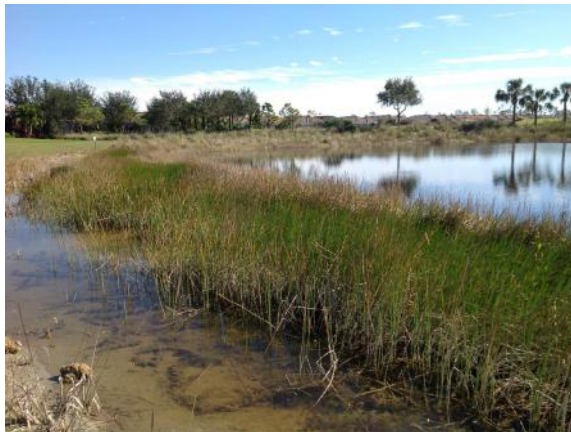
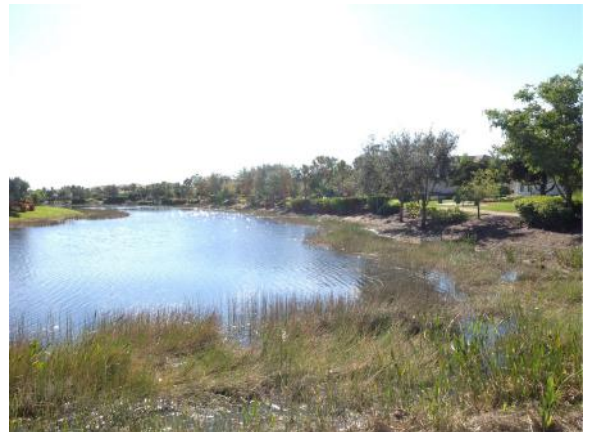
Site: 14

Requires attention

Shoreline is well maintained. Treat for bladderwort, Vallisneria and chara. Lot line erosion noted, with larger washouts in N branch of lake.

Routine maintenance next visit

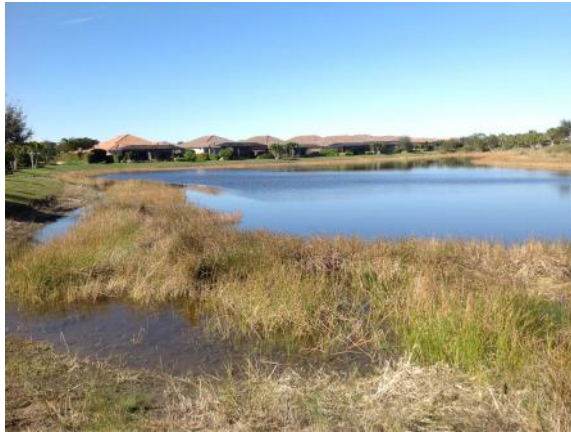
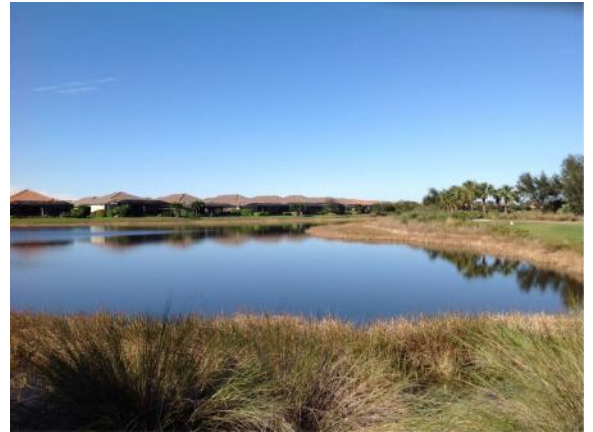
Site: 15A

Requires attention

Shoreline is well maintained, minimal growth noted. Algae is at controlled levels. Treat as needed for Illinois pondweed and bacopa. Lot line erosion occurring.

Routine maintenance next visit

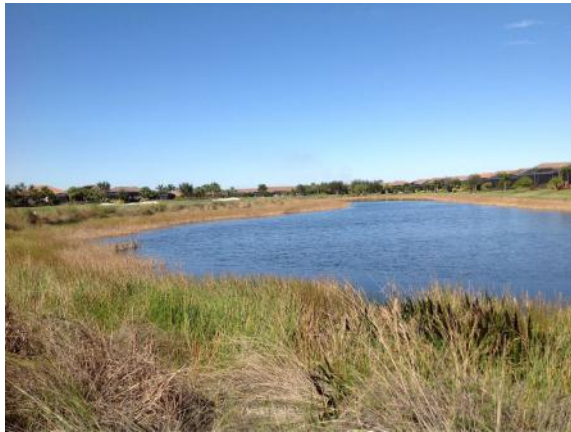
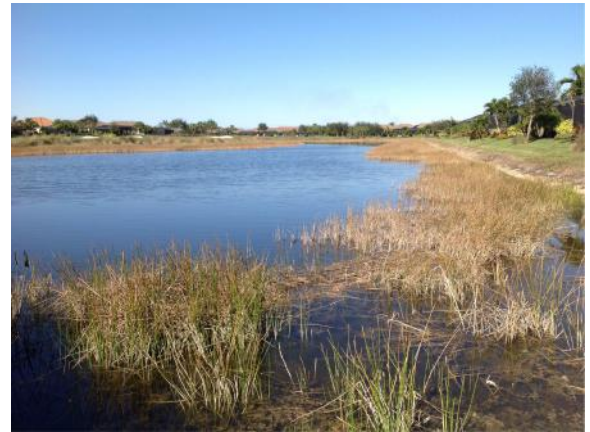
Site: 15B

Requires attention

Shoreline is well-maintained minimal growth noted. Bladderwort, hydrilla and red ludwigia were observed. Treat as needed. Lot line erosion present.

Routine maintenance next visit

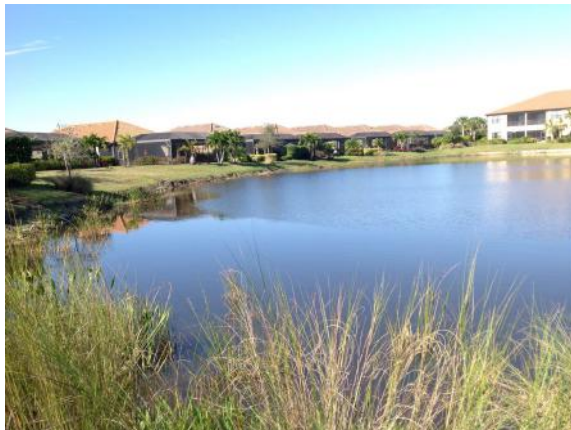
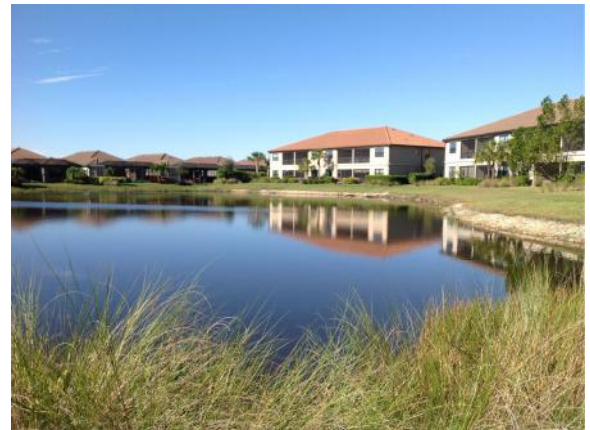
Site: 16

Normal growth observed

Shoreline is well maintained. Submersed and algae are at controlled levels. Treat for bacopa as needed. Lot line erosion and some washout areas noted.

Routine maintenance next visit

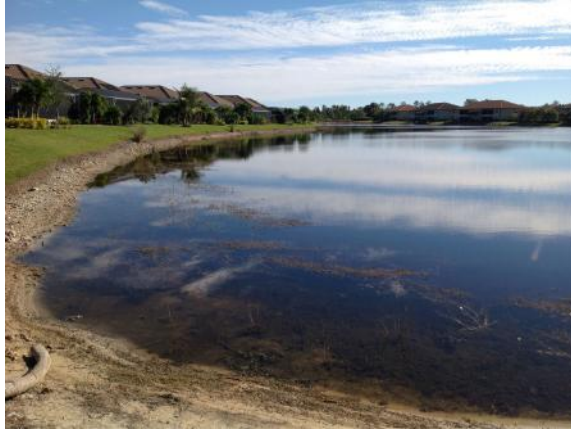
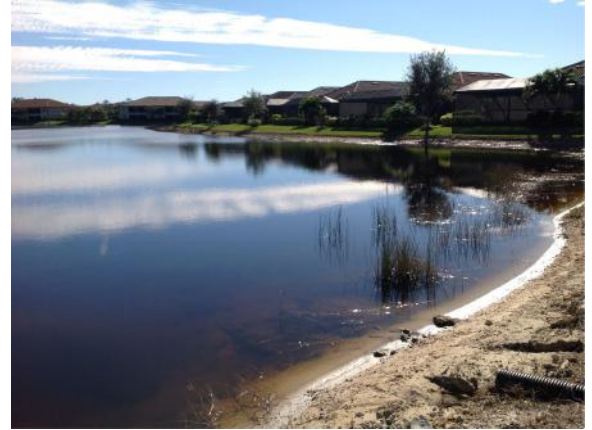
Site: 17

Normal growth observed

Spot treat minimal torpedograss. Algae and submersed vegetation are at controlled levels. Some severe washouts and widespread lot line erosion were observed.

Routine maintenance next visit

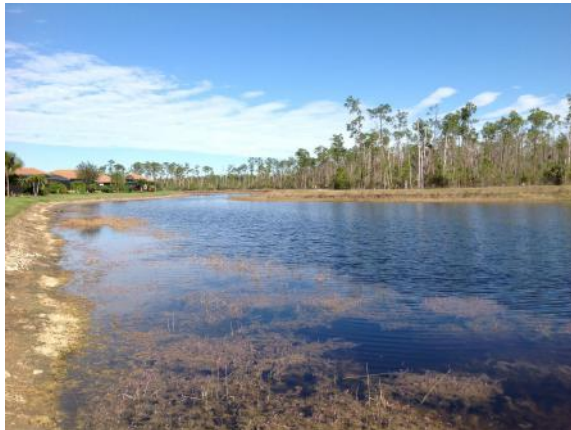
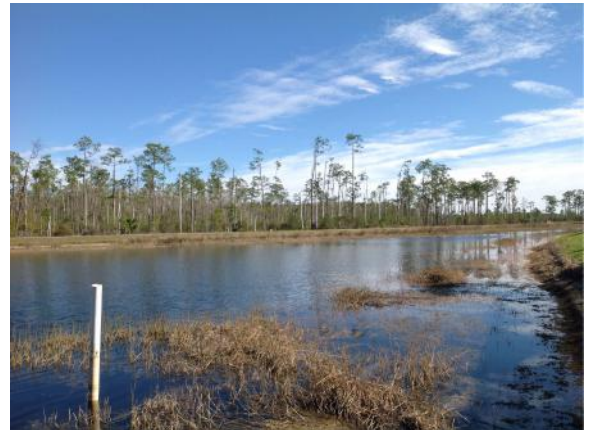
Site: 18

Requires attention

Shoreline is well maintained. Treat for purple bladderwort, chara and spatterdock.

Routine maintenance next visit

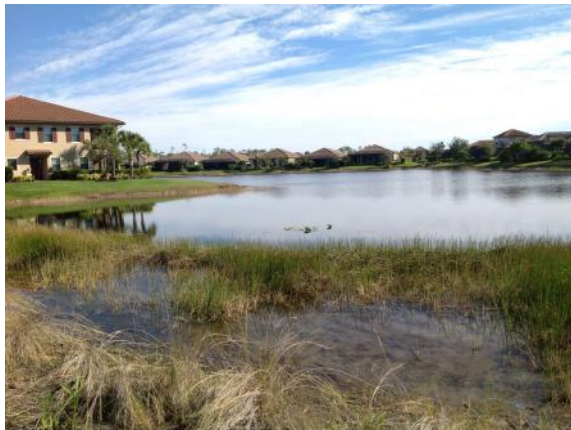
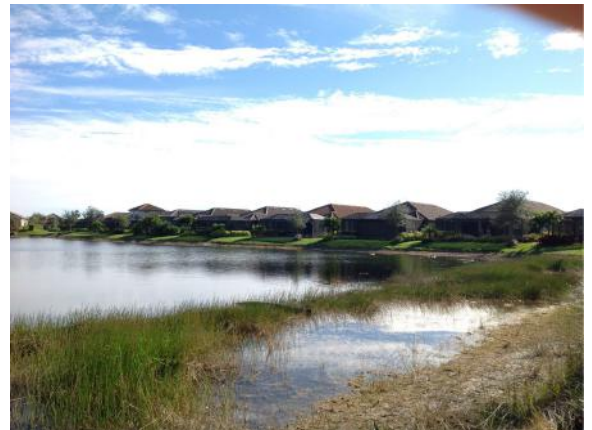
Site: 19

Requires attention

Shoreline is well maintained. Treat for purple bladderwort and spatterdock. Some algae was observed. Erosion along lot lines and washouts noted.

Routine maintenance next visit

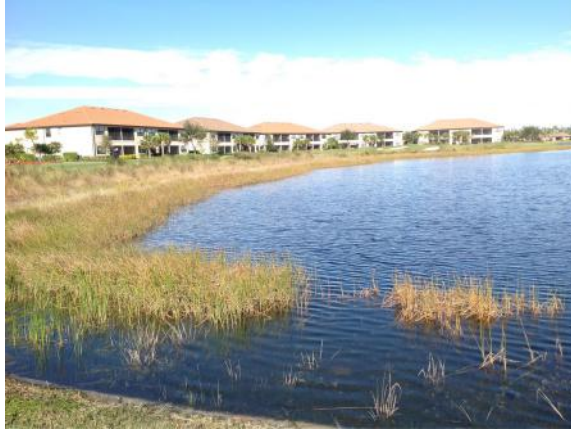
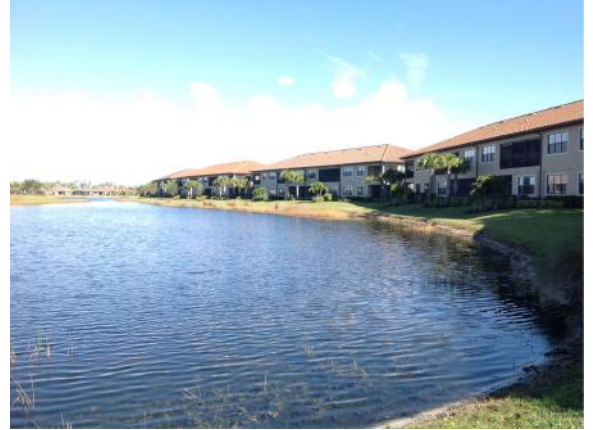
Site: 20

Normal growth observed

Shoreline is well maintained. Some algae observed. Submersed vegetation is at controlled levels.

Routine maintenance next visit

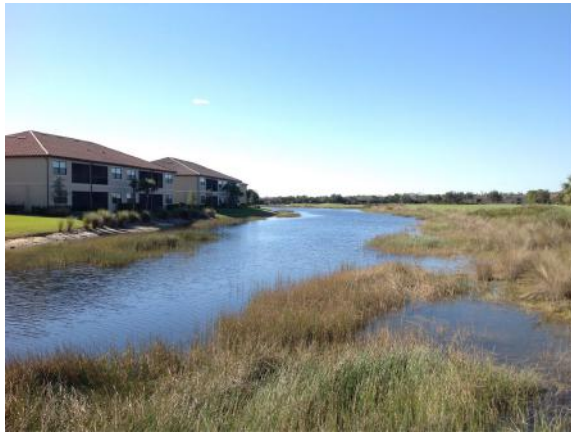
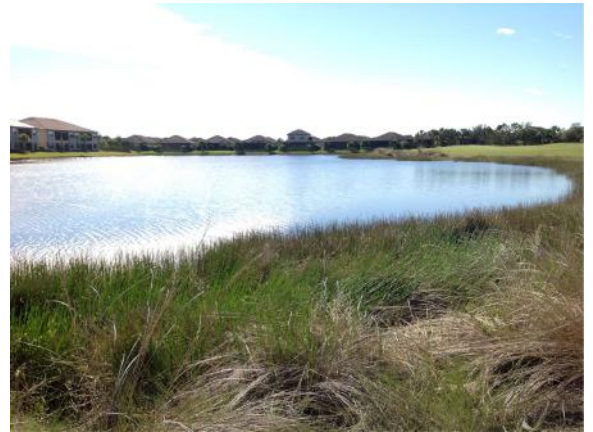
Site: 21

Normal growth observed

Shoreline is well maintained. Spot treat minimal torpedograss. Algae and submersed vegetation are at controlled levels.

Routine maintenance next visit

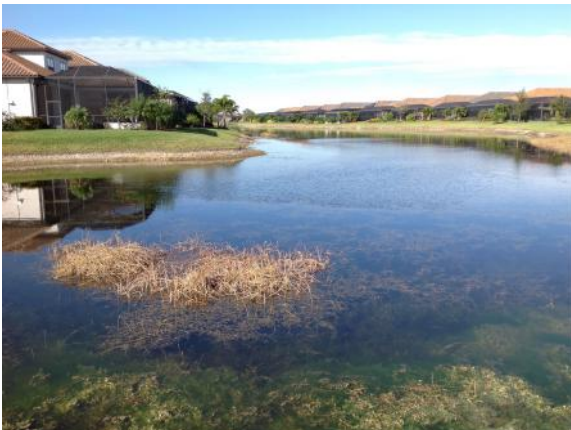
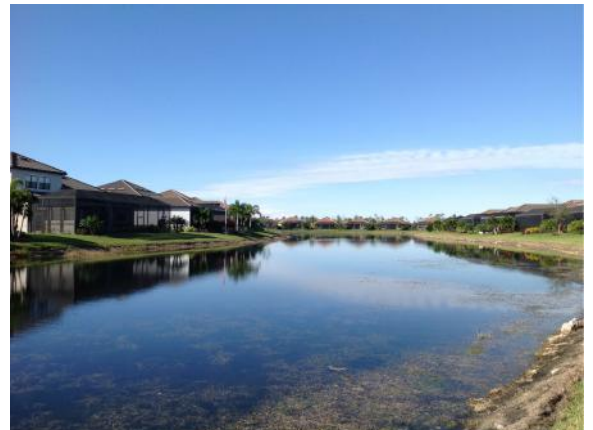
Site: 22

Requires attention

Shoreline is well maintained. Treat for Illinois pondweed and chara.

Routine maintenance next visit

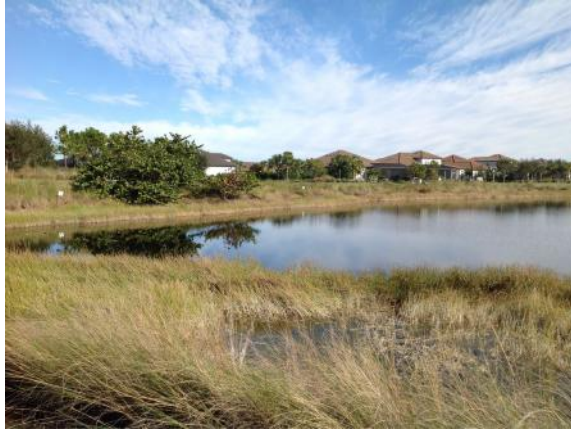
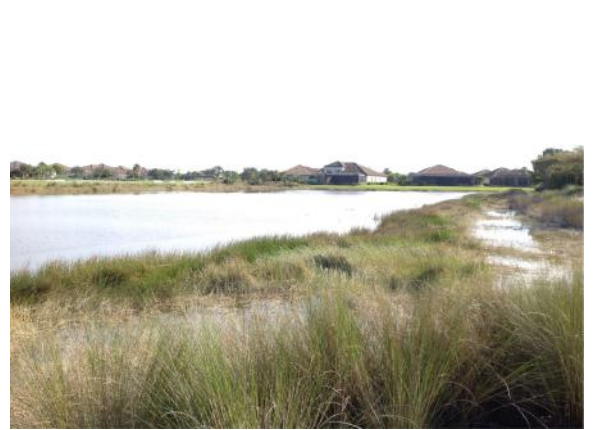
Site: 23

Normal growth observed

Shoreline is well maintained.
Treat for spatterdock. Algae and submersed vegetation are at controlled levels.

Routine maintenance next visit

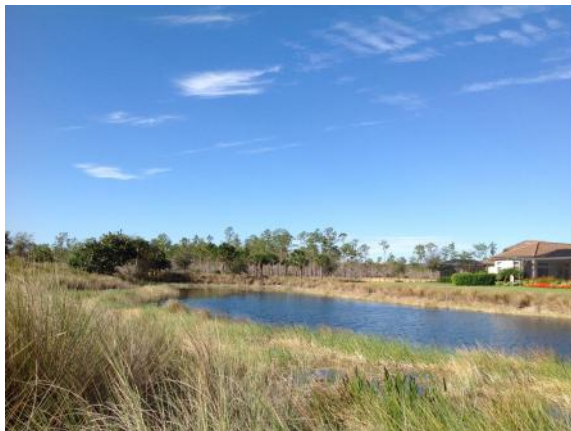
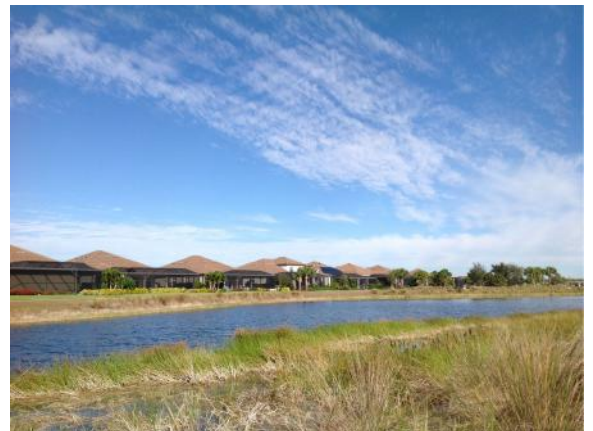
Site: 24

Site looks good

Shoreline is well maintained.
Algae and submersed vegetation are at controlled levels.

Routine maintenance next visit

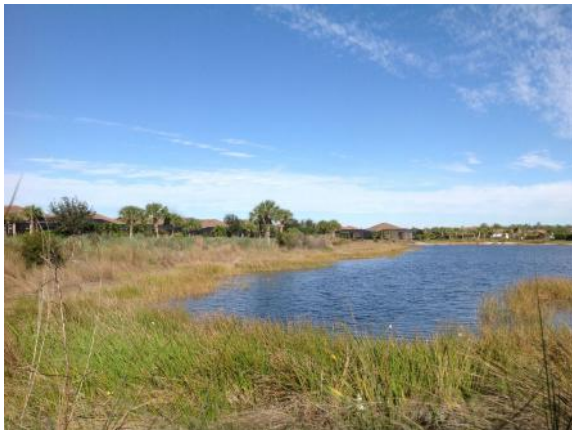
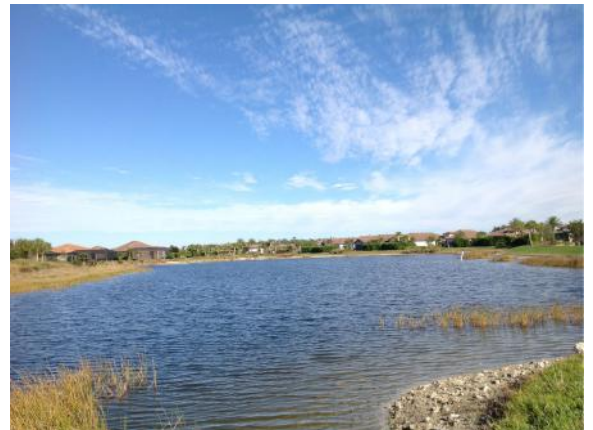
Site: 25

Normal growth observed

Shoreline is well maintained.
Spot treat minimal torpedograss.
Algae and submersed vegetation are at controlled levels. Erosion noted behind homes.

Routine maintenance next visit

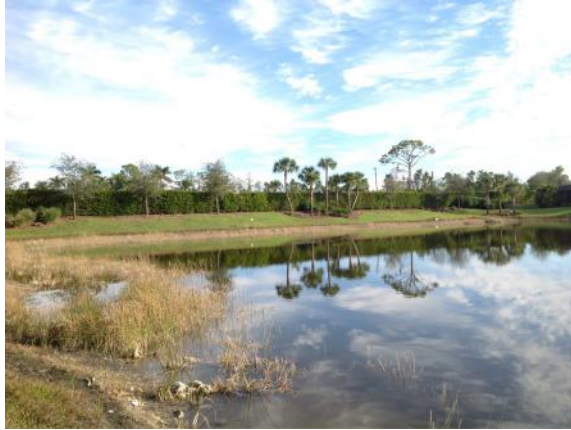
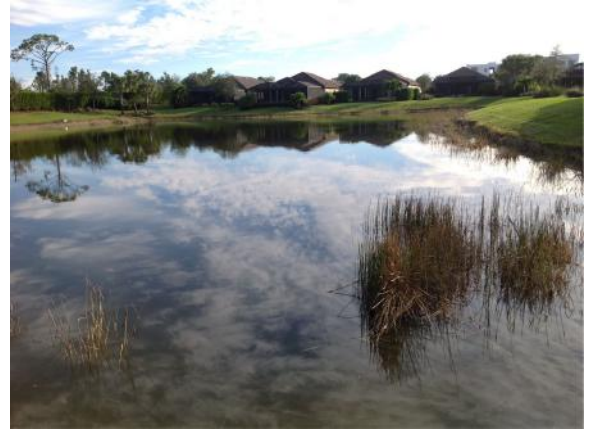
Site: 26

Site looks good

Shoreline is well maintained. Algae and submersed vegetation are at controlled levels. Lot line and pool drain erosion occurring.

Routine maintenance next visit

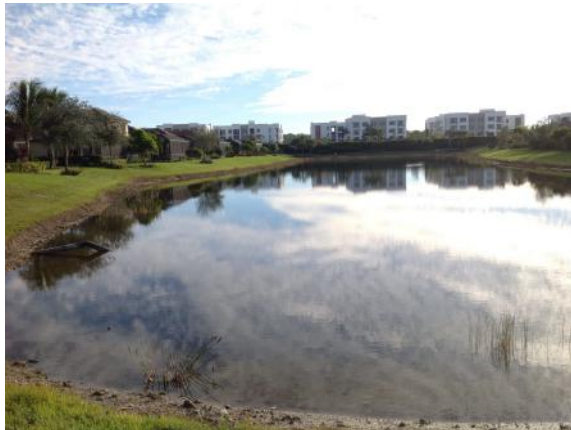
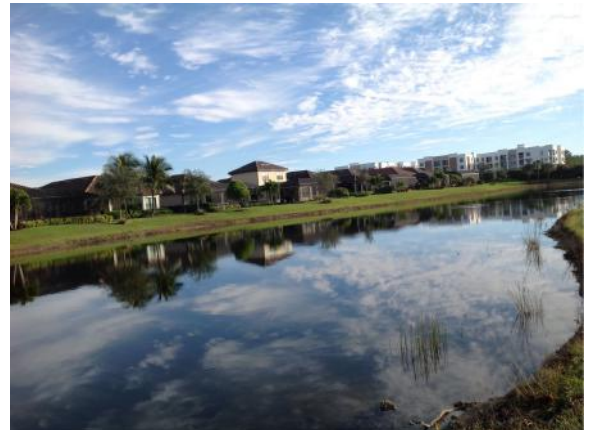
Site: 27

Site looks good

Shoreline is well maintained. Algae and submersed vegetation are at controlled levels.

Routine maintenance next visit

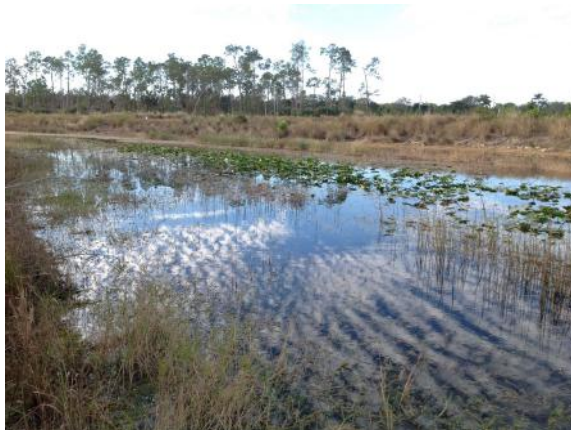
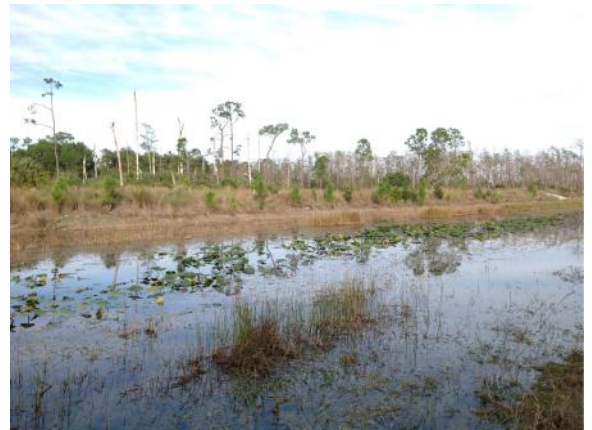
Site: FW1

Requires attention

Treat for bladderwort, spatterdock, bacopa, and Illinois pondweed. Some torpedograss observed within the littorals. Spot treat as needed.

Routine maintenance next visit

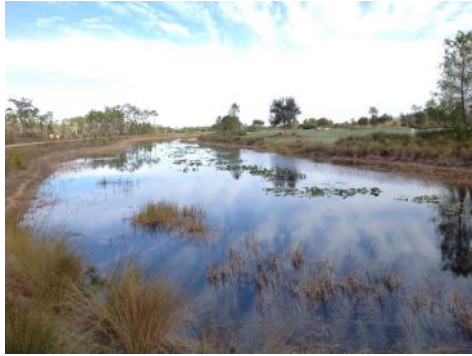
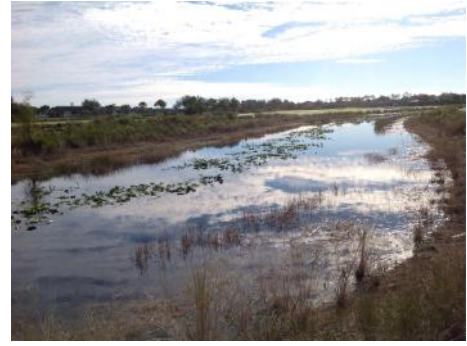
Site: FW2**Comments:**

Requires attention

Shoreline is well maintained.
Treat for bladderwort,
spatterdock, bacopa, and Illinois
pondweed

Routine maintenance next visit

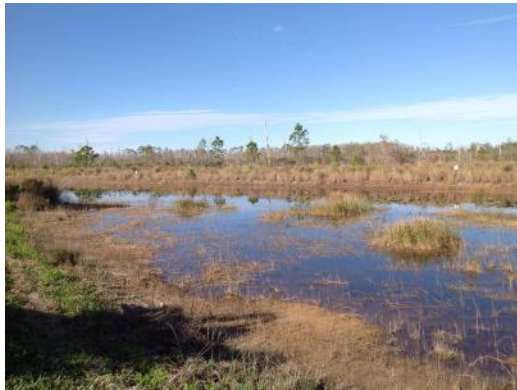
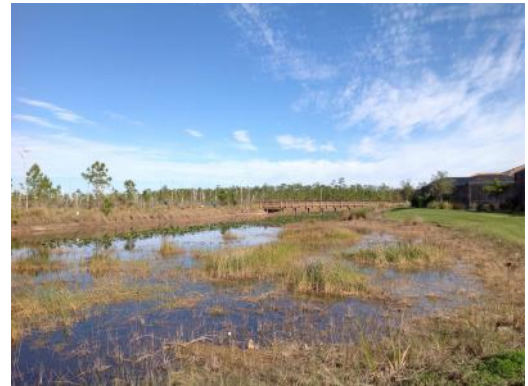
**Site:** FW3**Comments:**

Requires attention

Treat for spatterdock and
torpedograss. Algae is at
controlled levels.

Routine maintenance next visit
