Miromar Lakes CDD Waterway Inspection Report

Reason for Inspection: Routine Scheduled

Inspection Date: 2021-12-20

**Miromar Lakes CDD
10160 Miromar Lakes Blvd.
Fort Myers, Florida 33913**

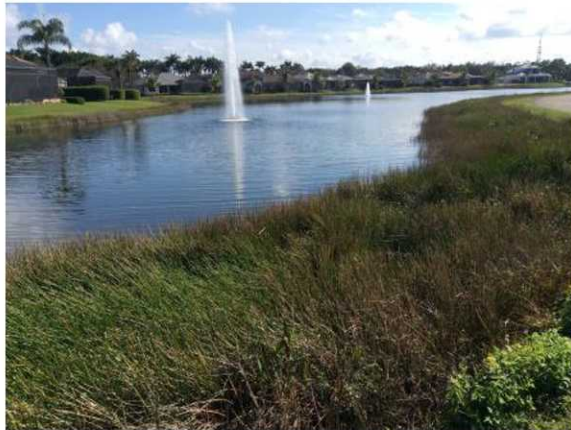
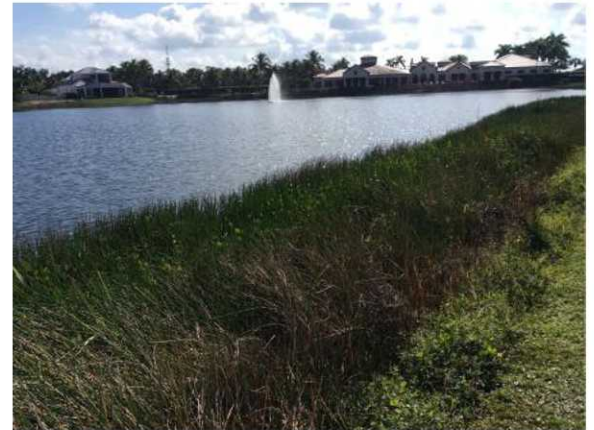
Site: 1A

Requires attention

Treat for vines, thalia noted near the middle of the fairway. Algae and aquatic weeds are at controlled levels.

Routine maintenance next visit

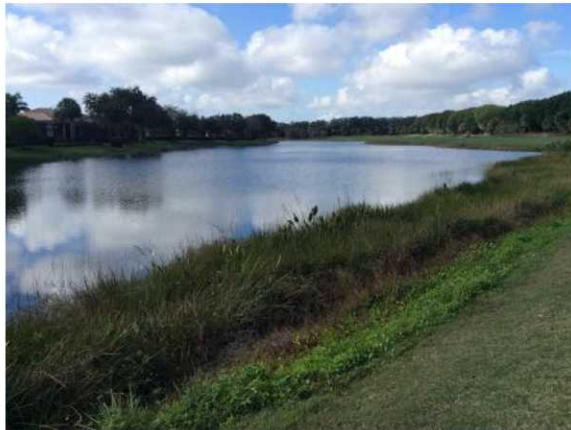
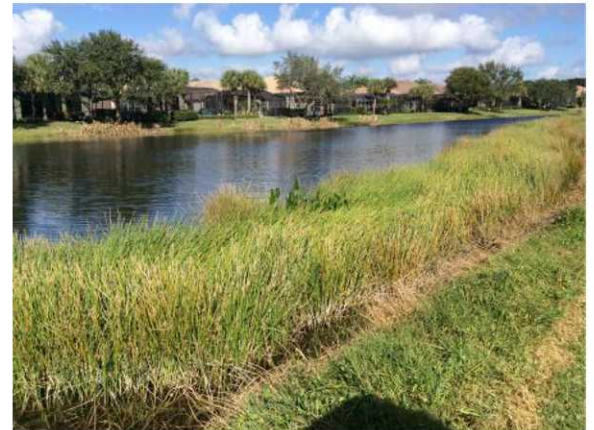
Site: 1B

Normal growth observed

Spot treat for vines, minimal alligatorweed noted as well, spot treat thalia along fairway. Algae and aquatic weeds are at controlled levels.

Routine maintenance next visit

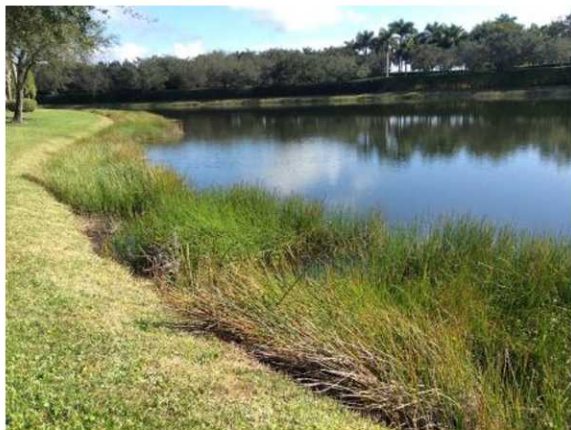
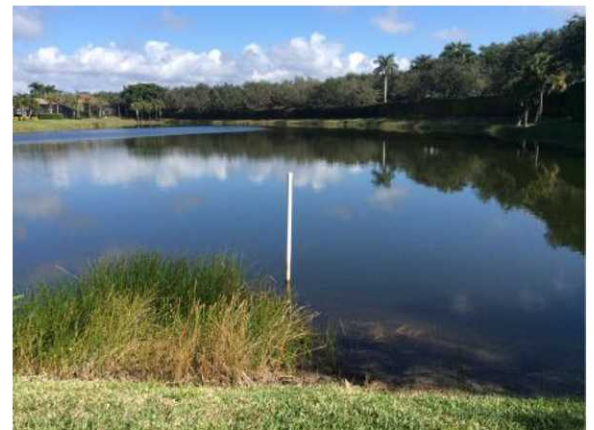
Site: 1C

Site looks good

Shoreline grasses and brush are well maintained. Algae and aquatic weeds are at controlled levels. Aeration was not running during inspection.

- Algae growth was fairly limited, spot treat maine naiad at sites 6G, 3B, and 3A.
- Aeration was off at site 1C, this system was recently worked on and needs a follow visit, this was reported to Eric Carnall the manager for aeration and fountains.

Routine maintenance next visit

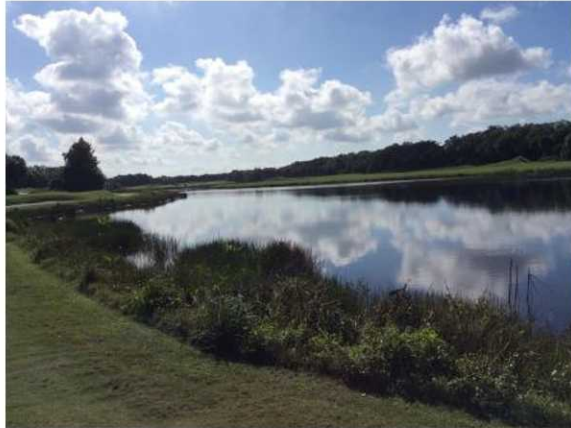
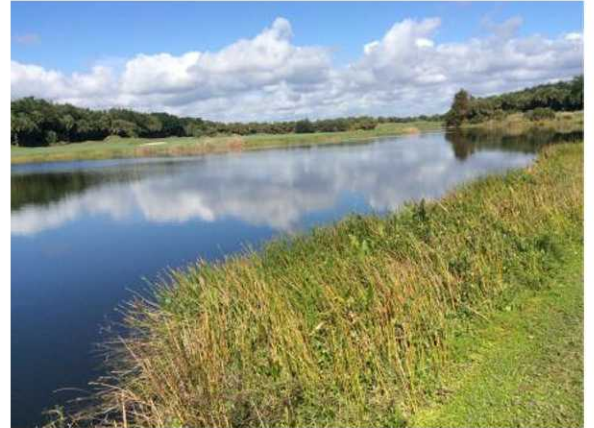
Site: 2A

Requires attention
Treat for vines spot treat thalia along fairway. Algae and aquatic weeds are at controlled levels.

Routine maintenance next visit

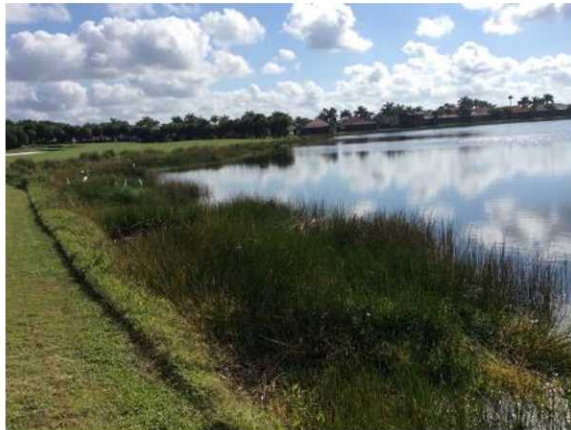
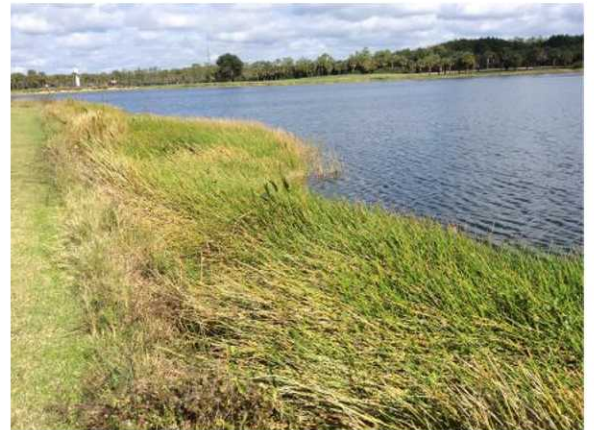
Site: 3A

Requires attention
Treat for vines and torpedograss. Minimal algae noted. Spot treat marine naiad in open areas along hole 6.

Routine maintenance next visit

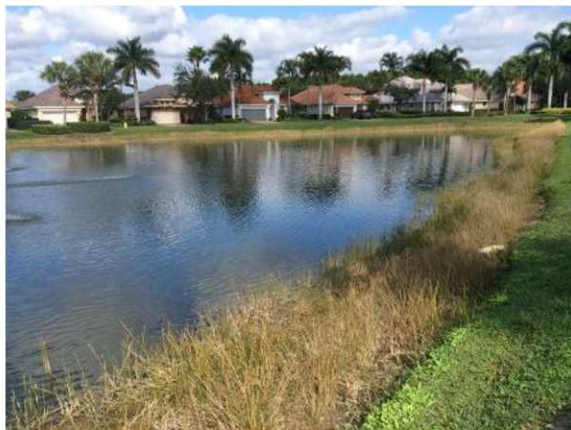
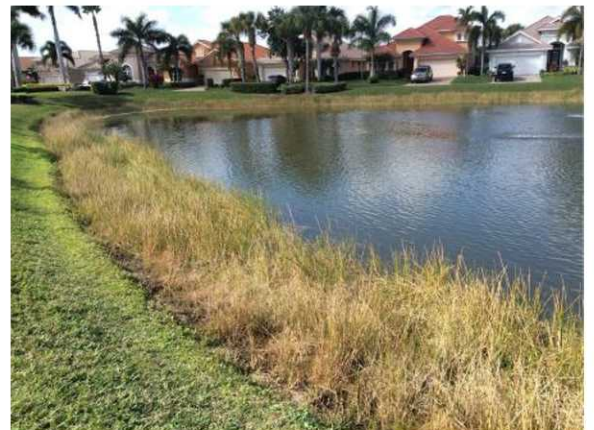
Site: 3B

Normal growth observed
Shoreline grasses and brush are well maintained. Algae and aquatic weeds are at controlled levels. Monitor and treat as needed for marine naiad.

Routine maintenance next visit

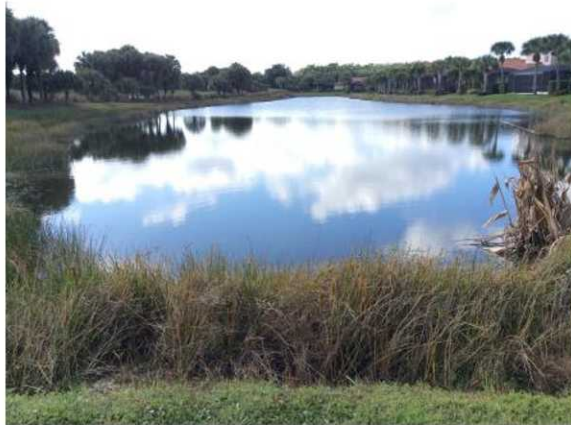
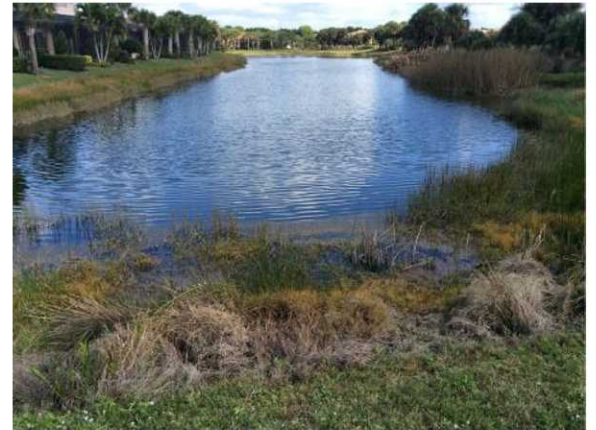
Site: 3C

Treatment in progress
Shoreline grasses and brush were recently treated monitor and treat as needed. Algae and aquatic weeds are at controlled levels.

Routine maintenance next visit

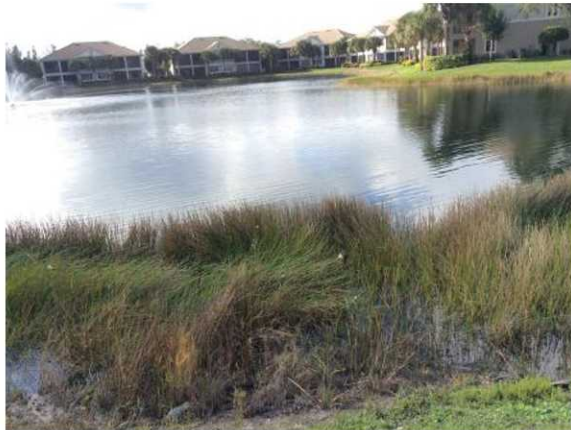
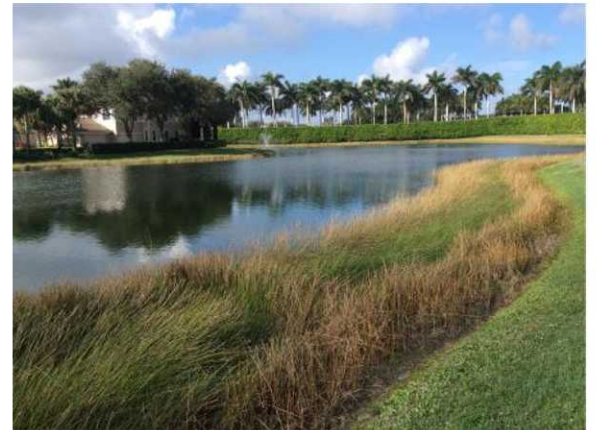
Site: 6A

Normal growth observed
Spot treat for minimal vines. Algae and aquatic weeds are at controlled levels. Large washout found in NE corner of lake.

- A large washout was located in the NE corner of lake 6A.
- The next quality control report will be due April 2022.

Routine maintenance next visit

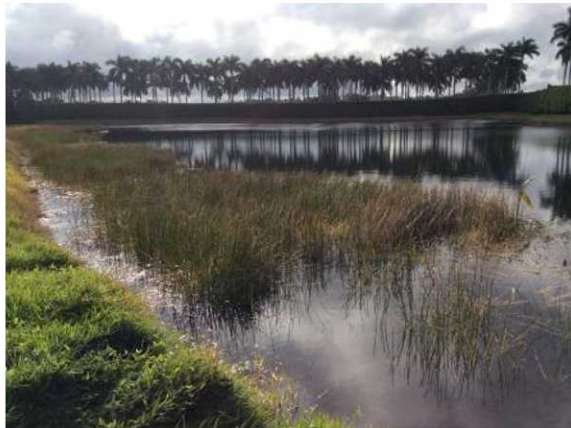
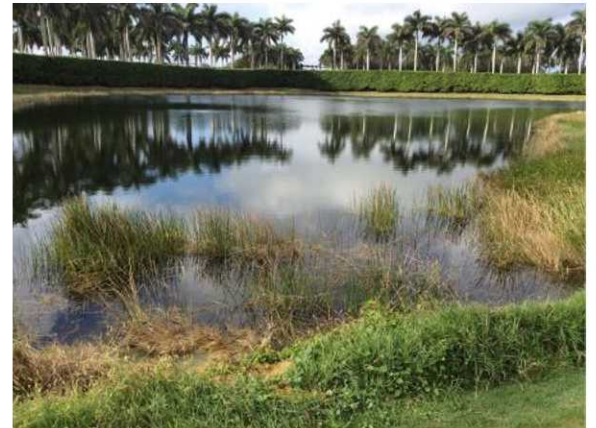
Site: 6B

Normal growth observed
Spot treat minimal vines. Algae and aquatic weeds are at controlled levels.

Routine maintenance next visit

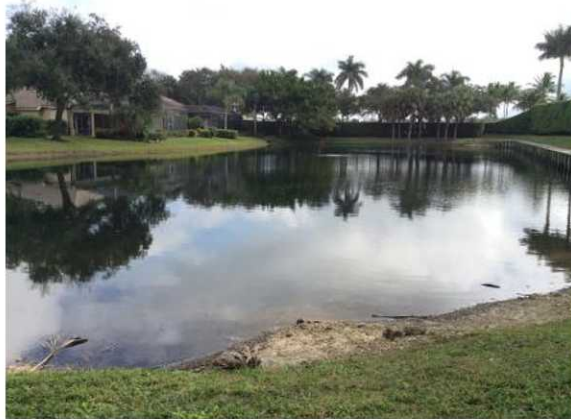
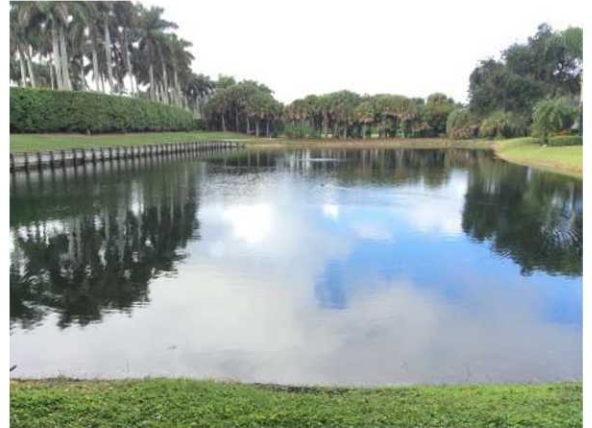
Site: 6C

Site looks good

Shoreline grasses and brush are well maintained. Algae and aquatic weeds are at controlled levels.

Routine maintenance next visit

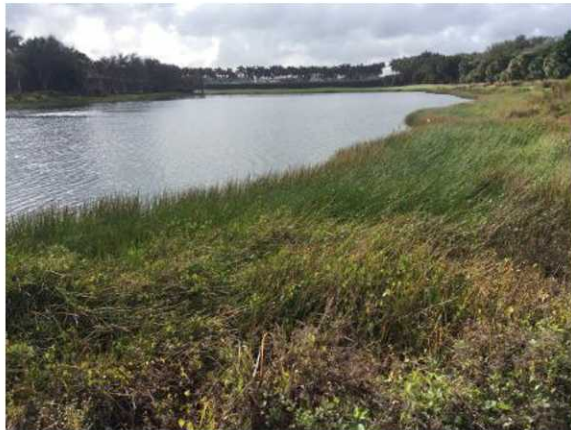
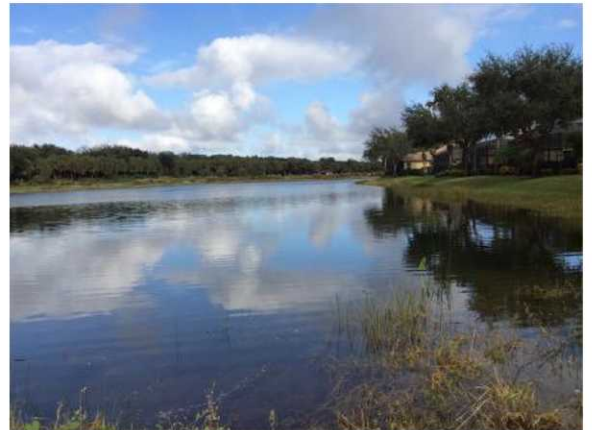
Site: 6D

Requires attention

Spot treat for vines, Thalia and bulrush noted along fairway . Algae and aquatic weeds are at controlled levels.

Routine maintenance next visit

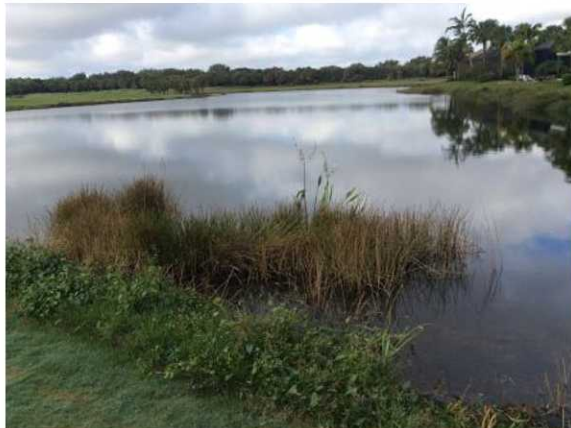
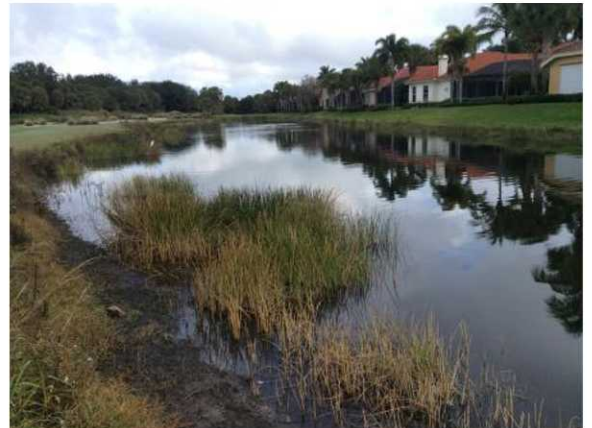
Site: 6E

Normal growth observed

Shoreline is well maintained, minimal vines noted. Algae and aquatic weeds are at controlled levels.

Routine maintenance next visit

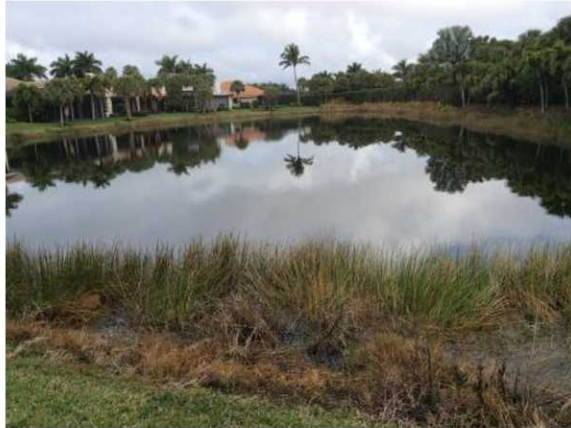
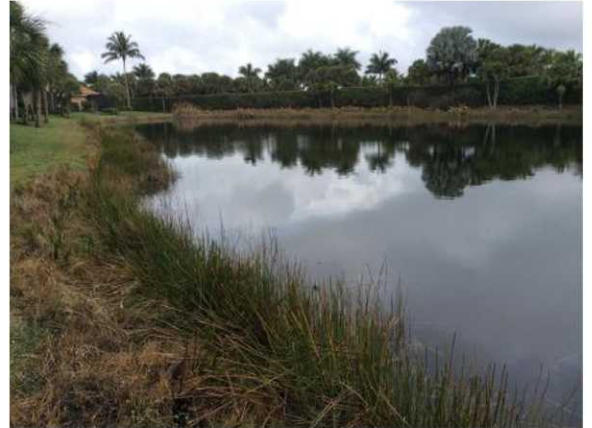
Site: 6F

Normal growth observed

Recent treatment for grasses and brush appears efficacious. Algae and aquatic weeds are at controlled levels.

Routine maintenance next visit

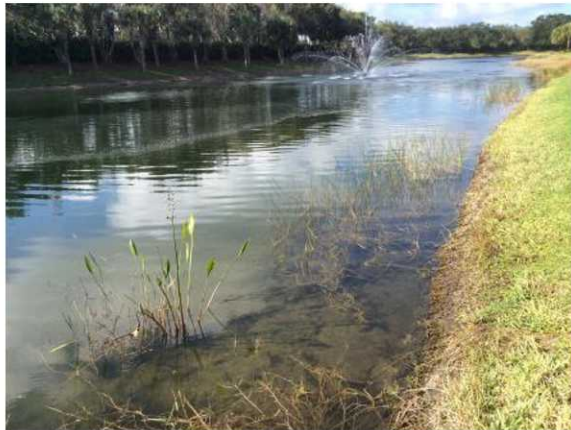
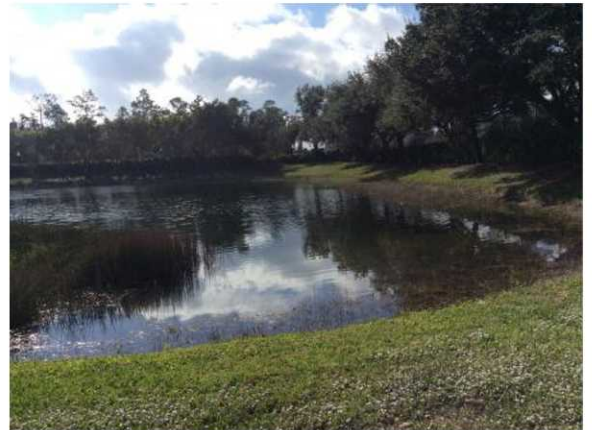
Site: 6G

Normal growth observed

Spot treat patches of vines. Algae and aquatic weeds are at controlled levels. Continue to treat marine naiad growth.

Routine maintenance next visit

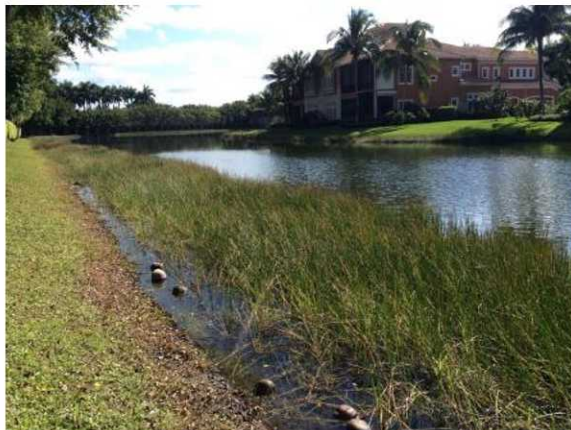
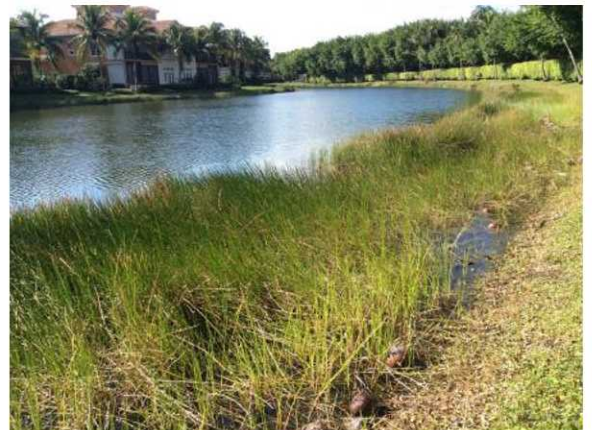
Site: 6H

Site looks good

Shoreline grasses and brush are well maintained. Lake color and clarity have both improved since last inspection.

Routine maintenance next visit

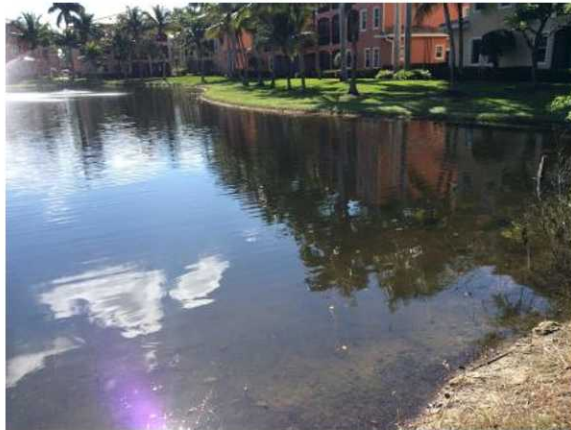
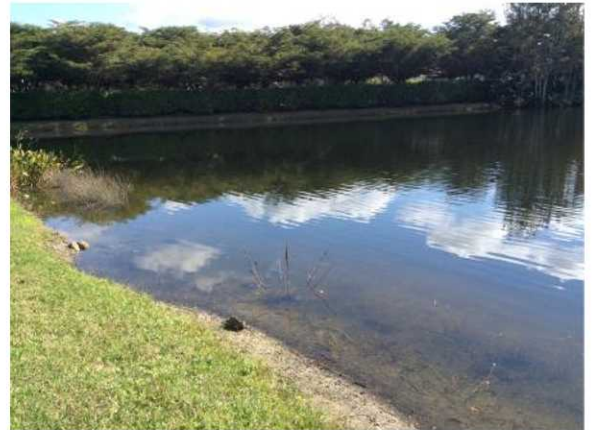
Site: 6I

Site looks good

Shoreline grasses and brush are well maintained. Algae and aquatic weeds are at controlled levels, previously observed algae bloom has cleared.

Routine maintenance next visit

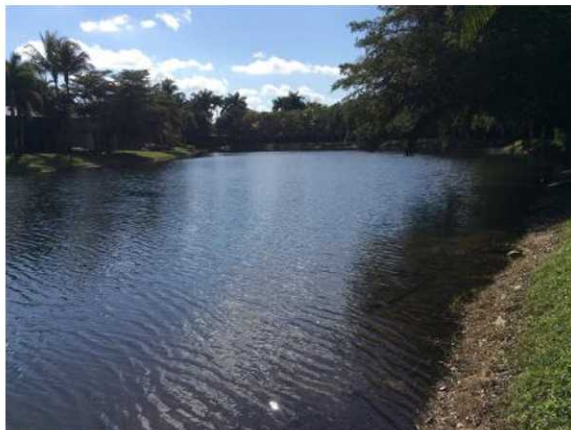
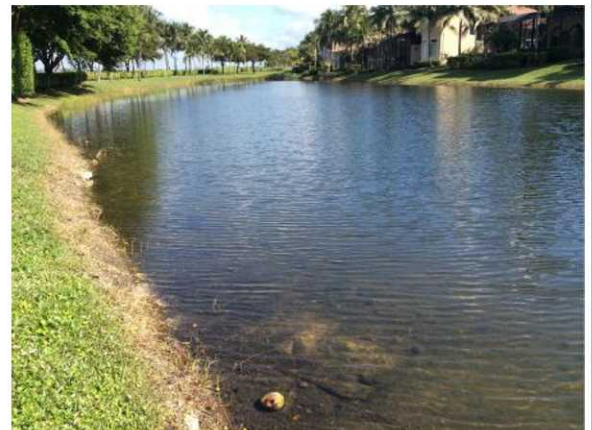
Site: 6J

Site looks good

Shoreline grasses and brush are well maintained. Algae and aquatic weeds are at controlled levels,

Routine maintenance next visit

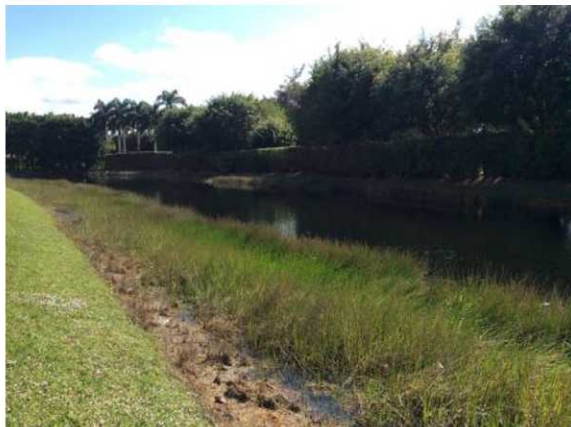
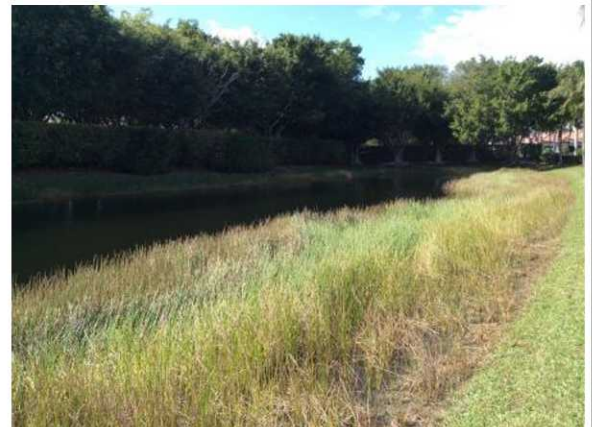
Site: 6K

Normal growth observed

Shoreline grasses and brush are well maintained, spot treat minimal vines and torpedograss. Algae and aquatic weeds are at controlled levels.

Routine maintenance next visit

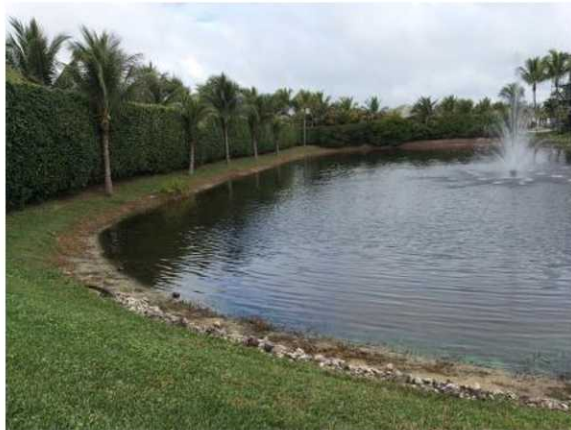
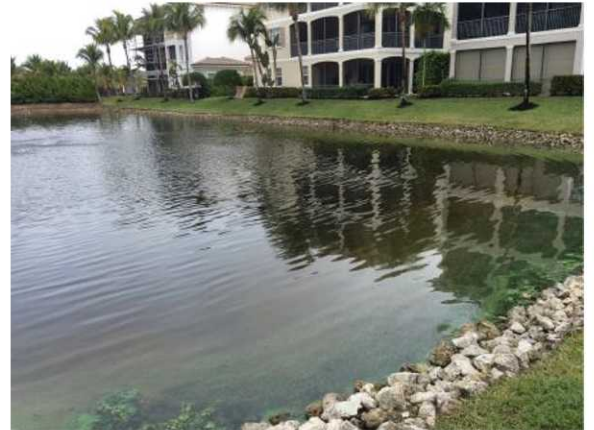
Site: 6L

Requires attention

Shoreline is well maintained. Some planktonic algae banding was noted, spot treat.

Routine maintenance next visit

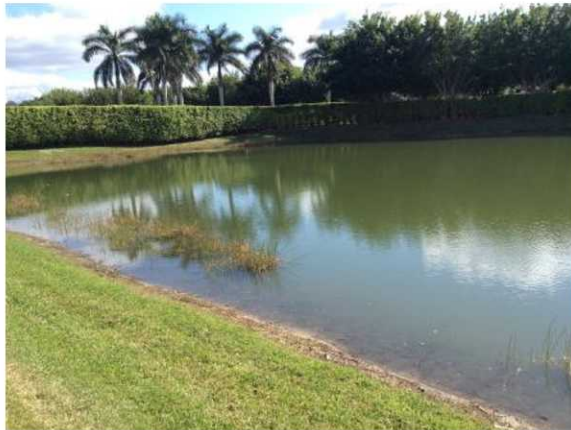
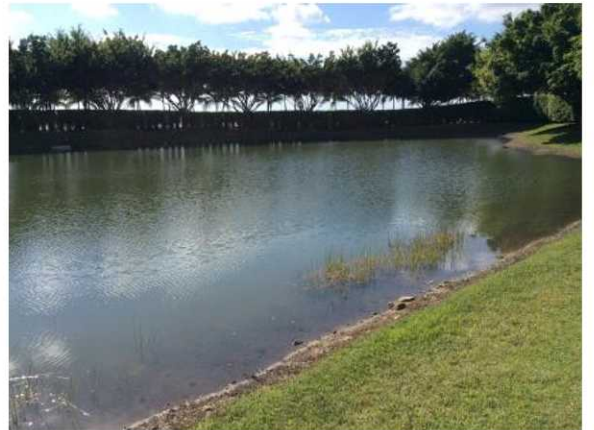
Site: 6M

Normal growth observed

Shoreline is well maintained. Algae and aquatic weeds are at controlled levels. Lake was slightly planktonic but no banding was noted.

Routine maintenance next visit

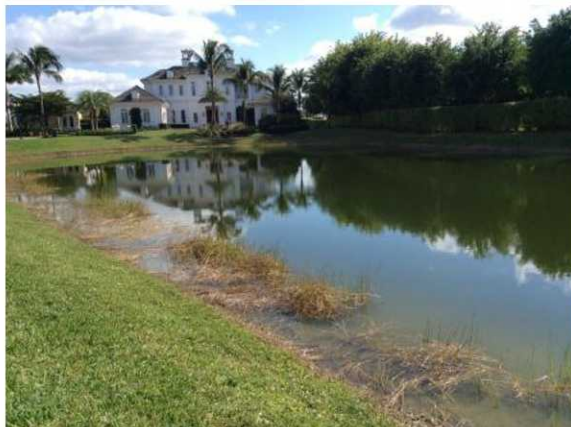
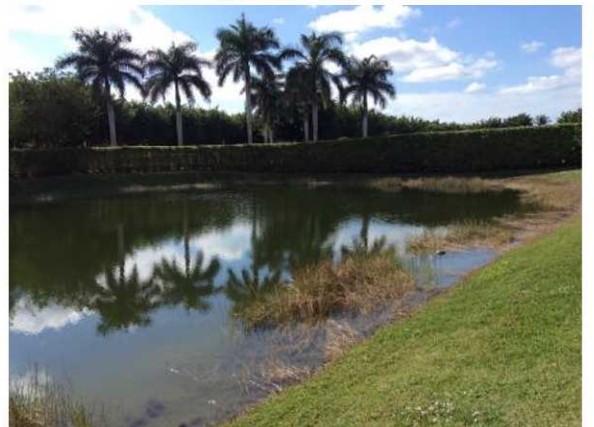
Site: 6N

Normal growth observed

Shoreline is well maintained. Algae and aquatic weeds are at controlled levels. Lake was slightly planktonic but no banding was noted.

Routine maintenance next visit

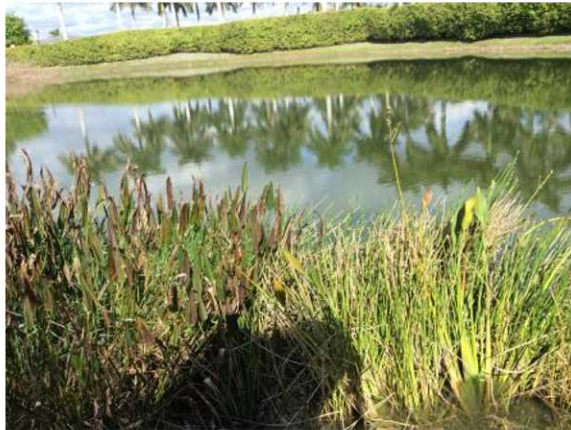
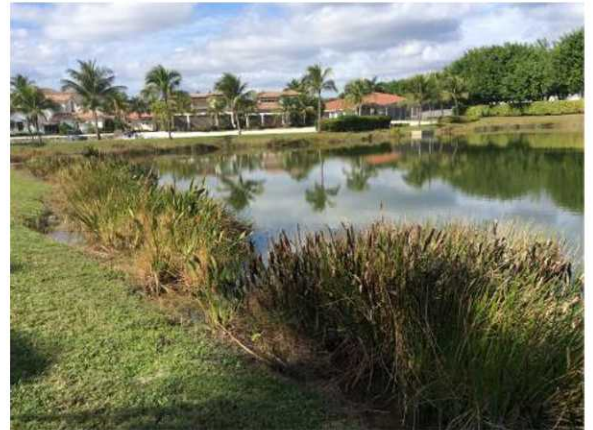
Site: 6O

Normal growth observed

Shoreline is well maintained. Algae and aquatic weeds are at controlled levels. Lake was slightly planktonic but no banding was noted.

Routine maintenance next visit

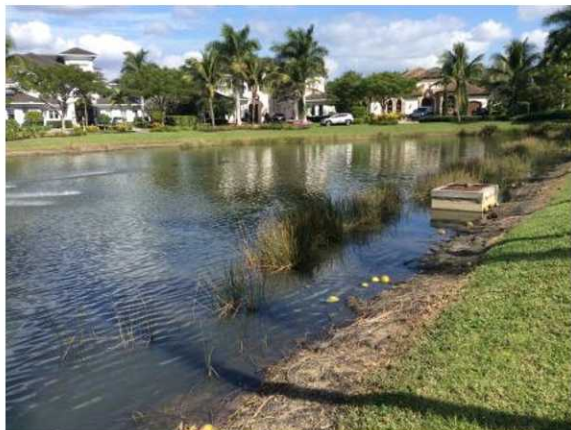
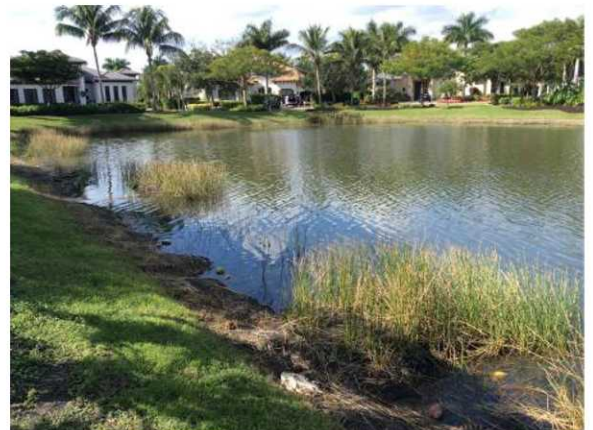
Site: 6P

Site looks good

Shoreline is well maintained. Algae and aquatic weeds are at controlled levels.

Routine maintenance next visit

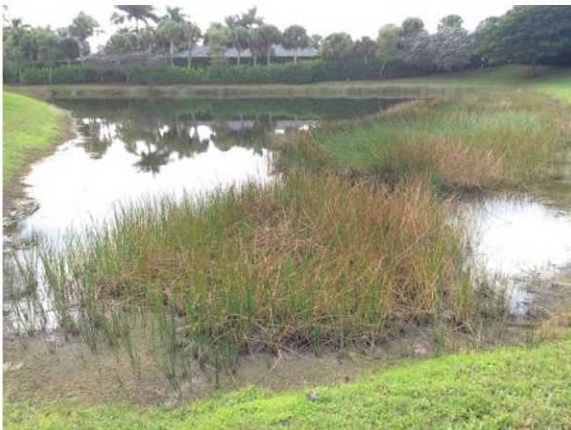
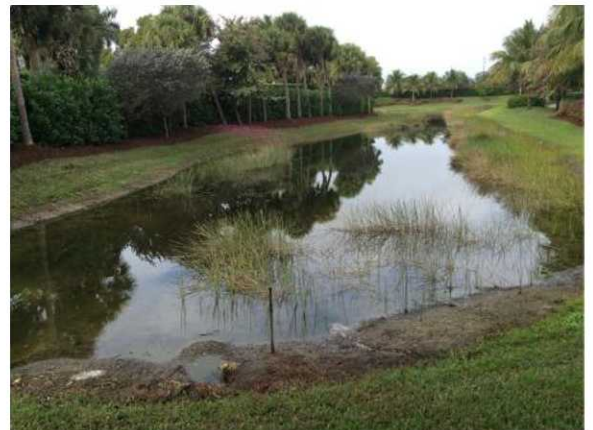
Site: 6R

Site looks good

Shoreline grasses and brush are well maintained. Algae and aquatic weeds are at controlled levels.

Routine maintenance next visit

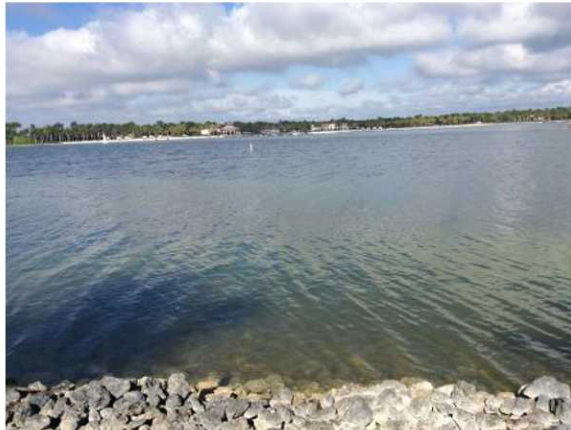
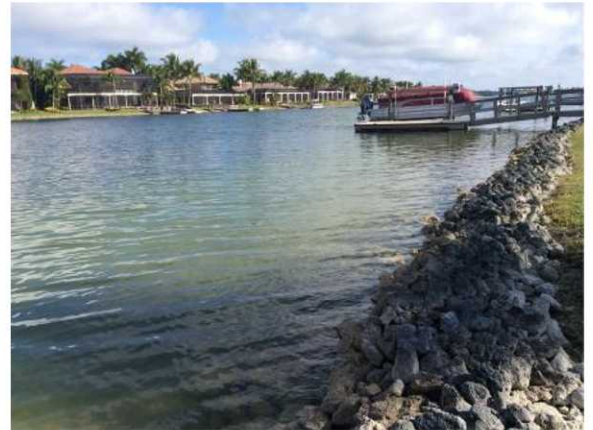
Site: 5/6-1

Site looks good

Shoreline is well maintained. Algae and aquatic weeds are at controlled levels.

Routine maintenance next visit

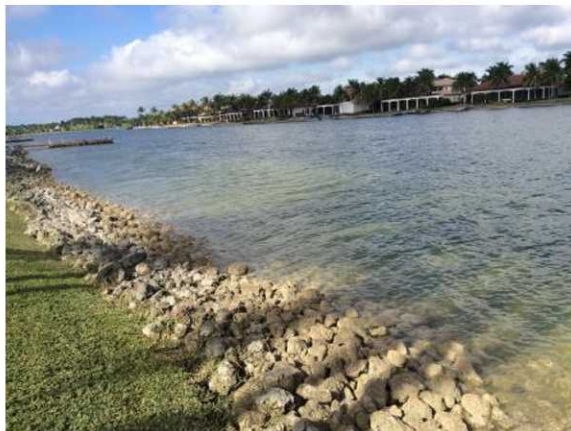
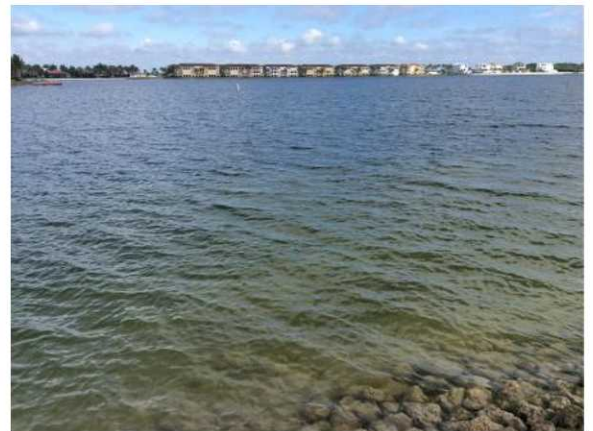
Site: 5/6-2

Site looks good

Shoreline is well maintained. Algae and aquatic weeds are at controlled levels.

Routine maintenance next visit

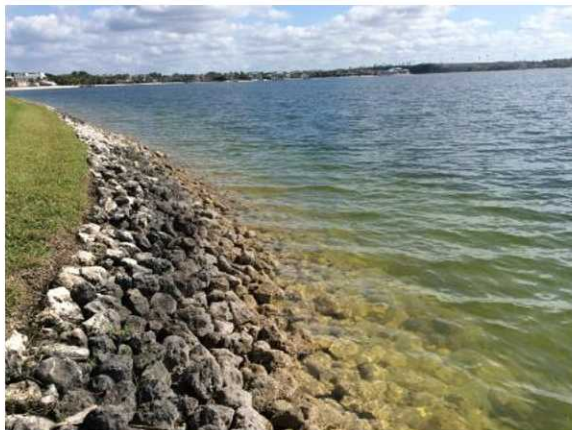
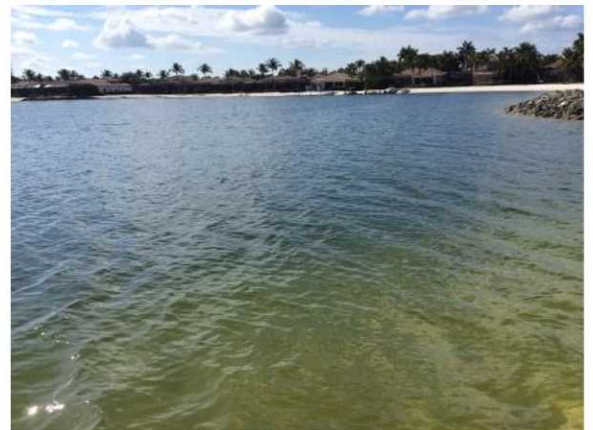
Site: 5/6-3

Normal growth observed

Shoreline grasses and brush are well maintained. Algae and aquatic weeds are at controlled levels. Vallisneria noted in Ravenna canal.

Routine maintenance next visit

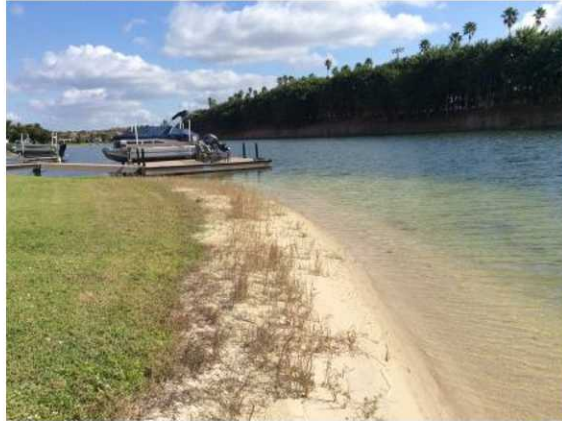
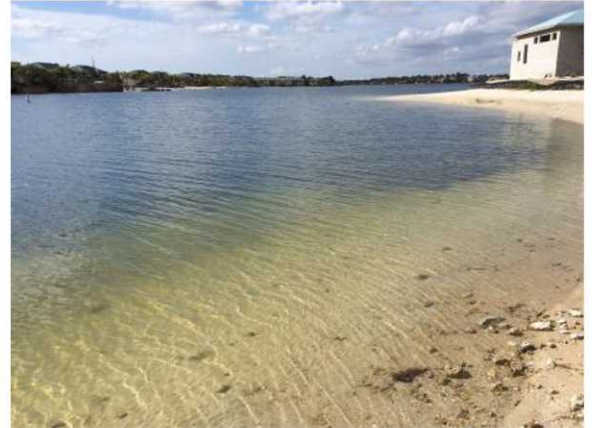
Site: 5/6-4

Site looks good

Shoreline is well maintained. Algae and aquatic weeds are at controlled levels.

Routine maintenance next vis
