Miromar Lakes CDD Waterway Inspection Report

Reason for Inspection: Routine Scheduled

Inspection Date: 2023-04-19

**Miromar Lakes CDD
10160 Miromar Lakes Blvd.
Fort Myers, Florida 33913**

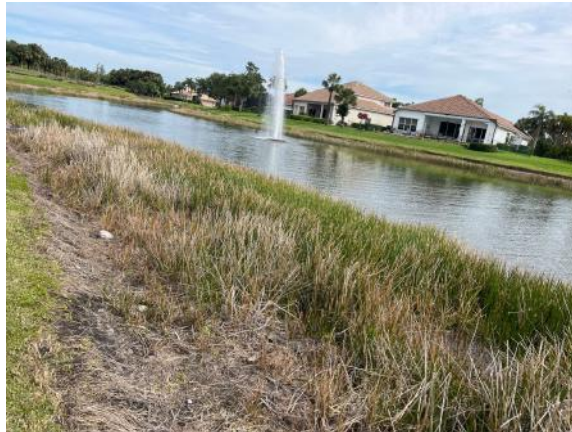
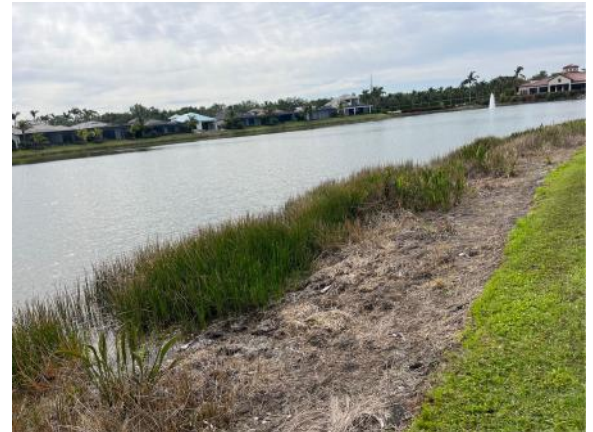
Site: 1A

Site looks good

Shoreline is well maintained. Algae and submersed vegetation are at controlled levels.

Routine maintenance next visit

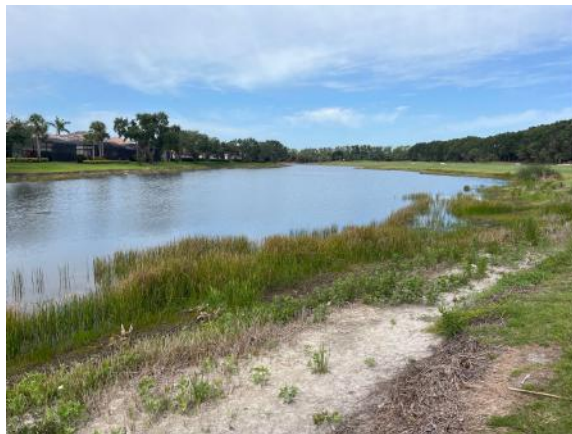
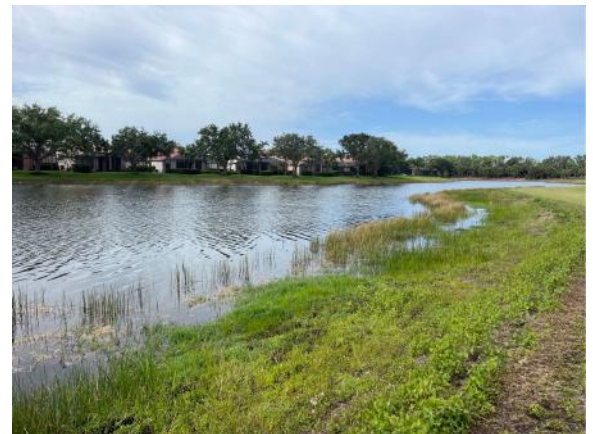
Site: 1B

Requires attention

Treat for torpedogras and annual weeds. Algae and submersed vegetation are at controlled levels.

Routine maintenance next visit

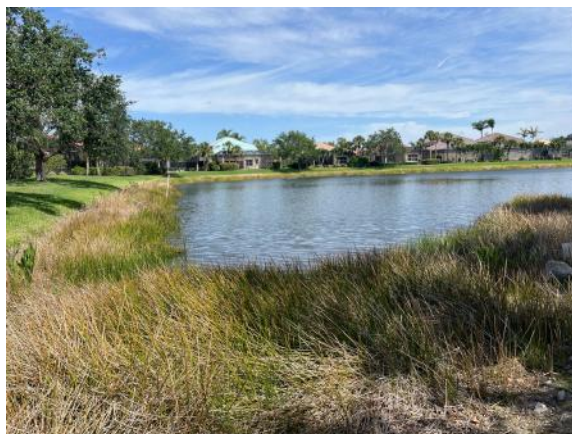
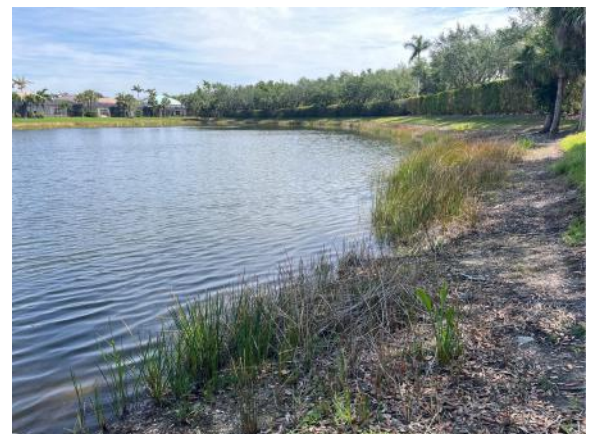
Site: 1C

Site looks good

Shoreline is well maintained. Algae and submersed vegetation are at controlled levels.

Routine maintenance next visit

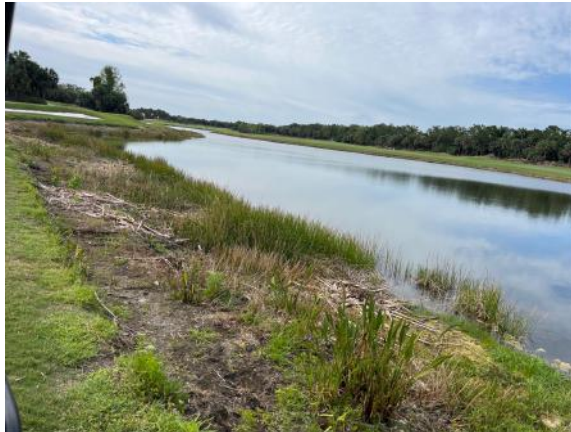
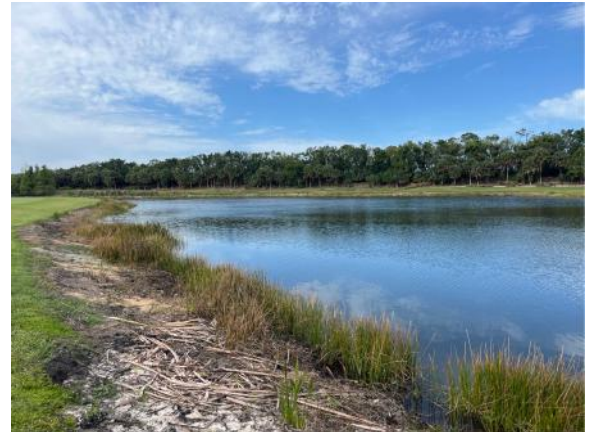
Site: 2A

Normal growth observed
Shoreline is well maintained. Spot treat minimal torpedograss. Treatment for bulrush was effective. Algae and submersed vegetation are at controlled levels.

Routine maintenance next visit

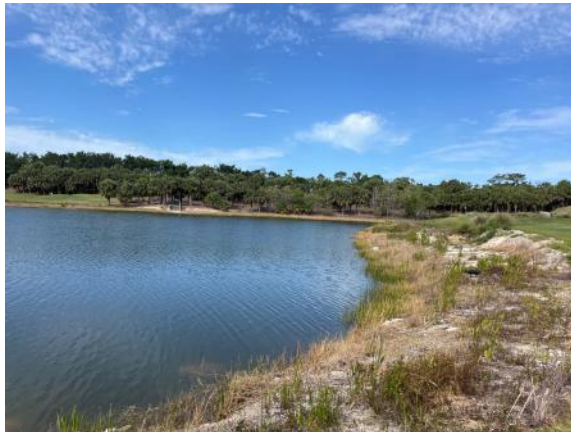
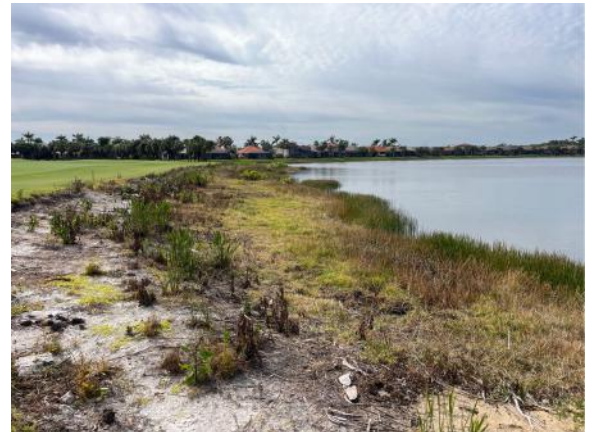
Site: 3A

Treatment in progress
Treatment for shoreline weeds is in progress. Algae and submersed vegetation are at controlled levels.

Re-inspect next visit

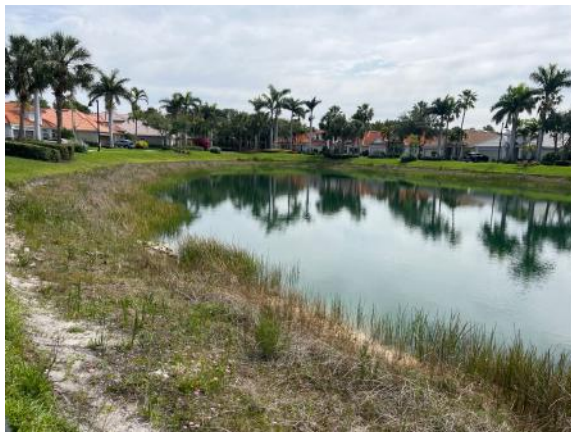
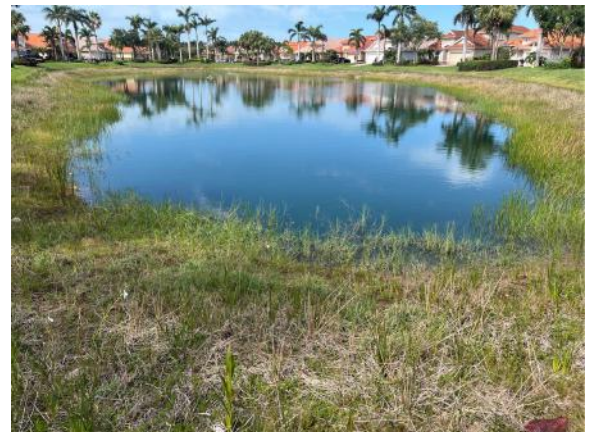
Site: 3B

Normal growth observed
Shoreline is well maintained. Spot treat torpedograss in littorals. Algae and submersed vegetation are at controlled levels.

Routine maintenance next visit

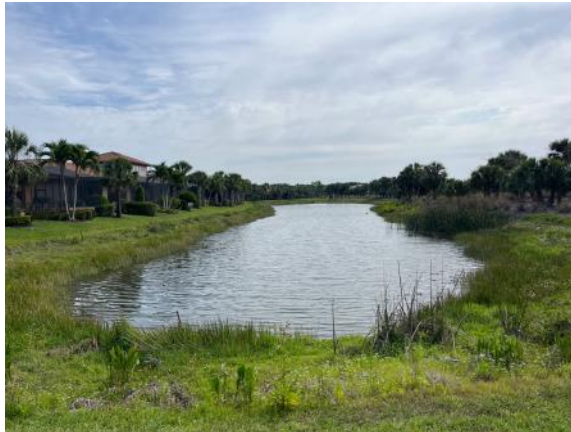
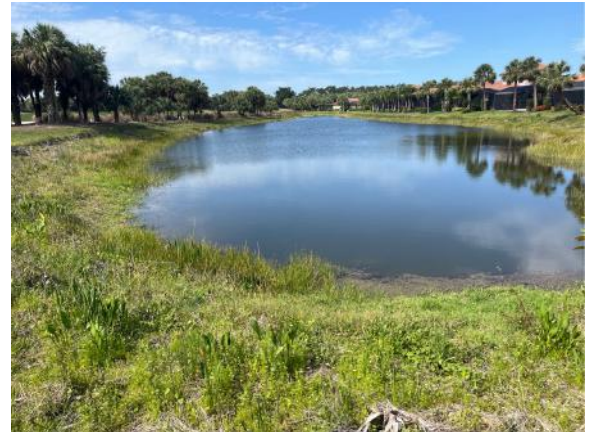
Site: 3C

Requires attention

Spot treat pennywort and torpedograss within the littorals. Algae and submersed vegetation are at controlled levels.

Routine maintenance next visit

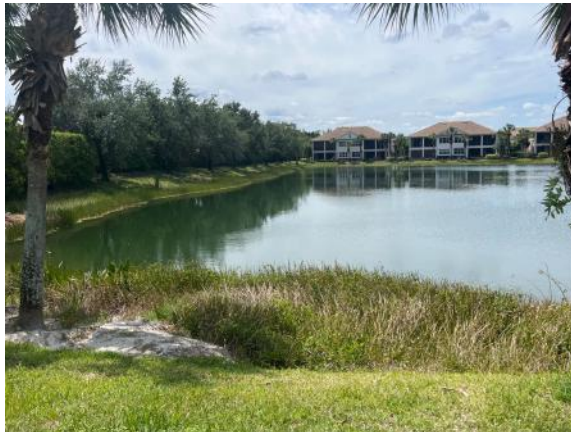
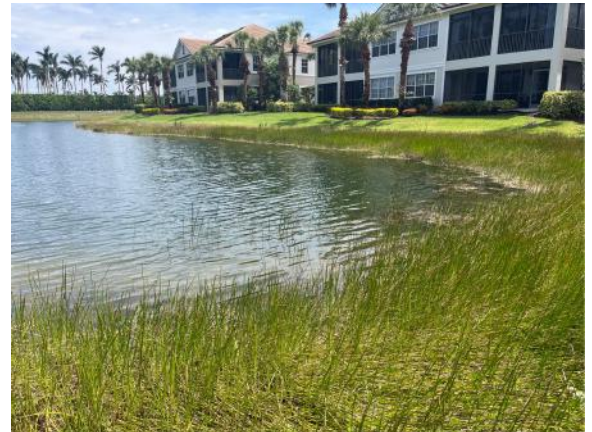
Site: 6A

Normal growth observed

Shoreline is well maintained. Spot treat for minimal vines. Algae and submersed vegetation are at controlled levels. Minimal algae noted, monitor and treat as needed.

Routine maintenance next visit

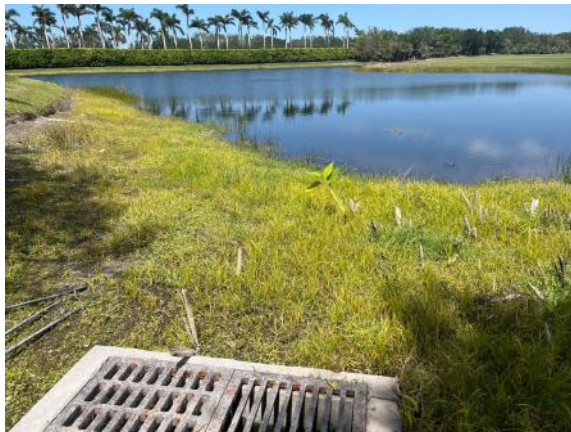
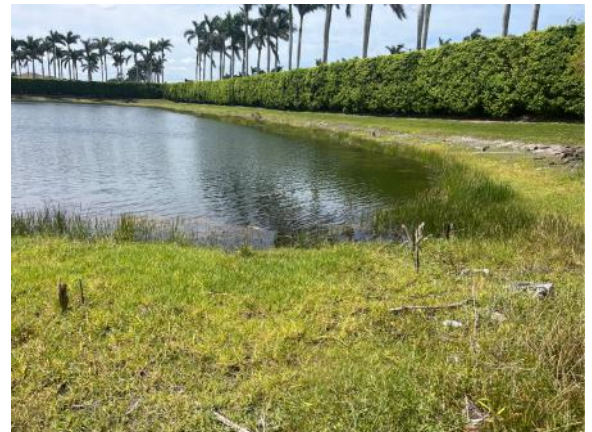
Site: 6B

Treatment in progress

Treatment for torpedograss is in progress. Continue to treat as needed. Algae and submersed vegetation are at controlled levels.

Re-inspect next visit

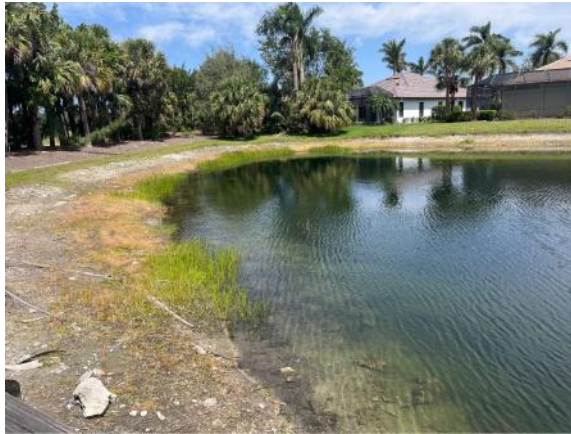
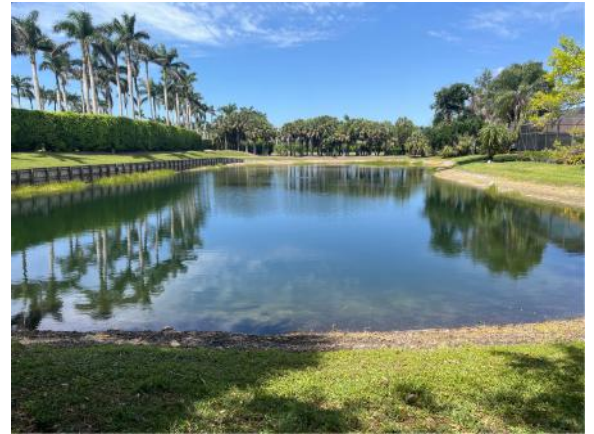
Site: 6C

Treatment in progress
Treatment for torpedogras is in progress. Continue to treat as needed. Algae and submersed vegetation are at controlled levels

Routine maintenance next visit

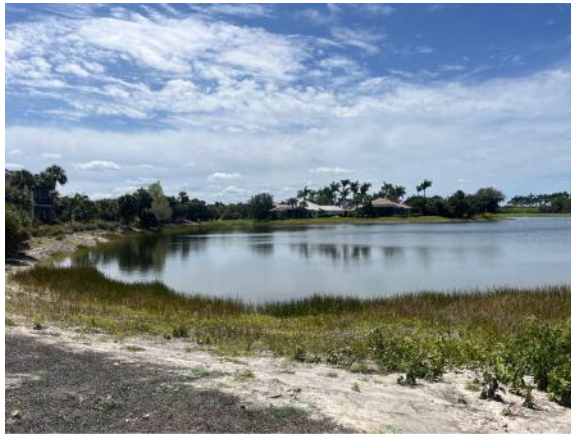
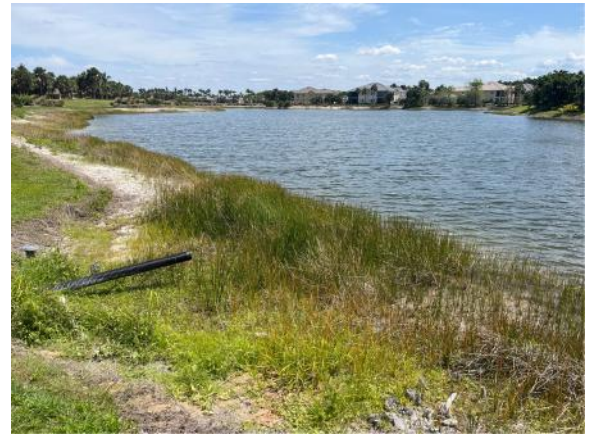
Site: 6D

Requires attention
Spot treat for torpedogras and annuals in littorals. Algae and submersed vegetation are at controlled levels.

Routine maintenance next visit

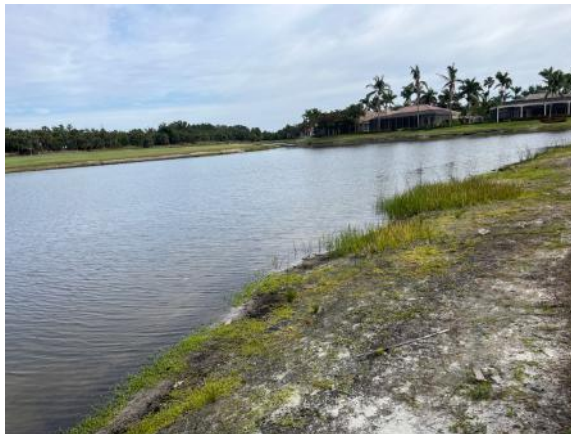
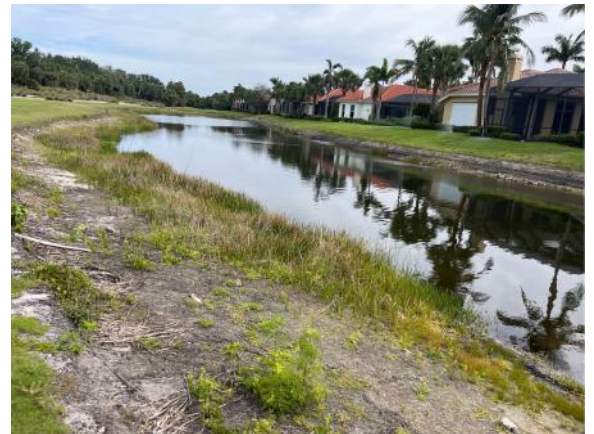
Site: 6E

Normal growth observed
Spot treat for dog fennel and annuals in littorals. Algae and submersed vegetation are at controlled levels.

Routine maintenance next visit

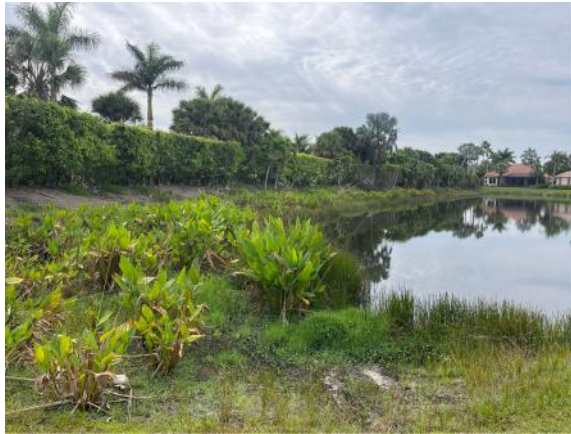
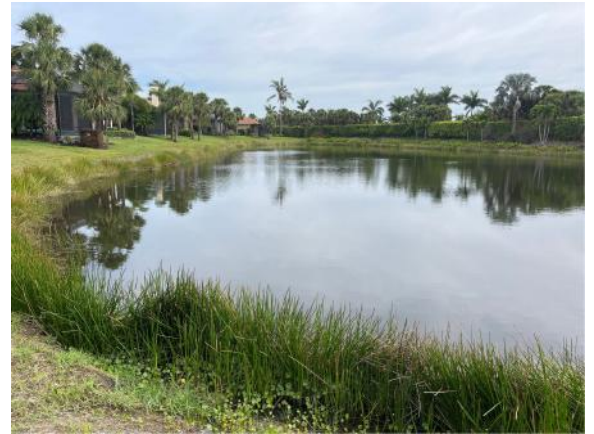
Site: 6F

Requires attention

Spot treat for pennywort and torpedograss in littorals. Algae and submersed vegetation are at controlled levels.

Routine maintenance next visit

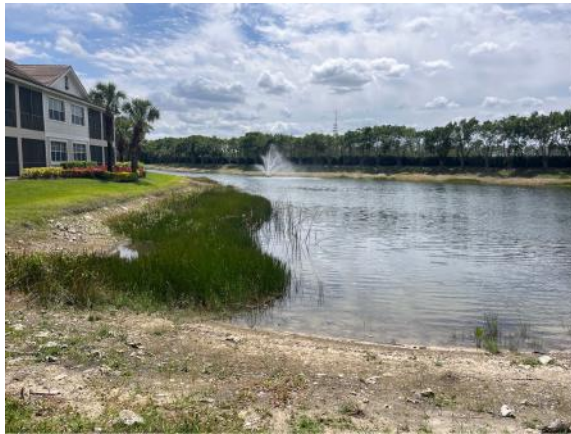
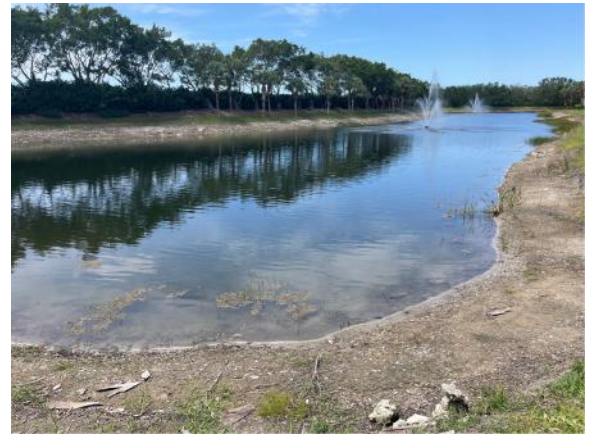
Site: 6G

Requires attention

Spot treat for vines and torpedograss in littorals. Algae and submersed vegetation are at controlled levels. Minimal algae noted, treat as needed.

Routine maintenance next visit

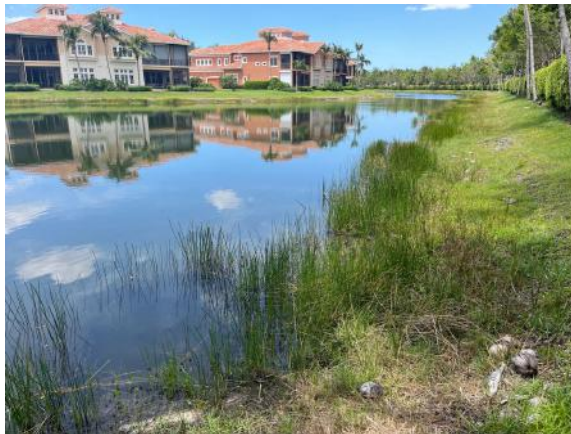
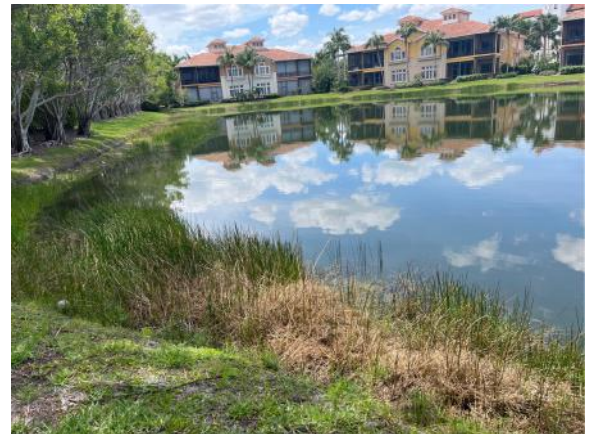
Site: 6H

Treatment in progress

Treatment for torpedograss is in progress. Continue to treat torpedograss on the north side of the lake. Algae and submersed vegetation are at controlled levels.

Routine maintenance next visit

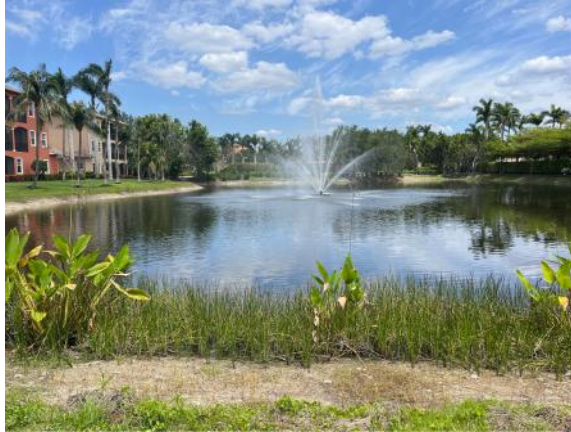
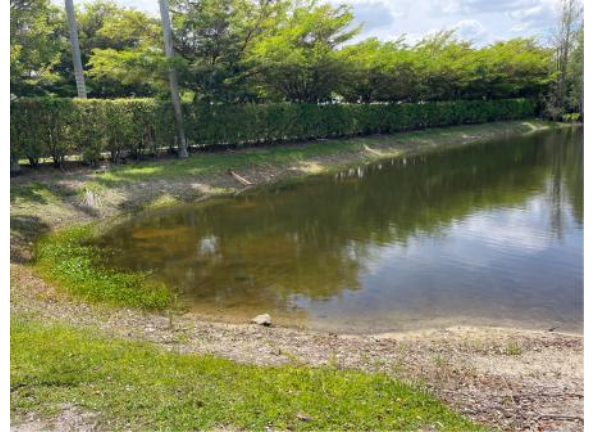
Site: 6I

Normal growth observed

Shoreline is well maintained. Spot treat for pennywort. Algae and submersed vegetation are at controlled levels.

Routine maintenance next visit

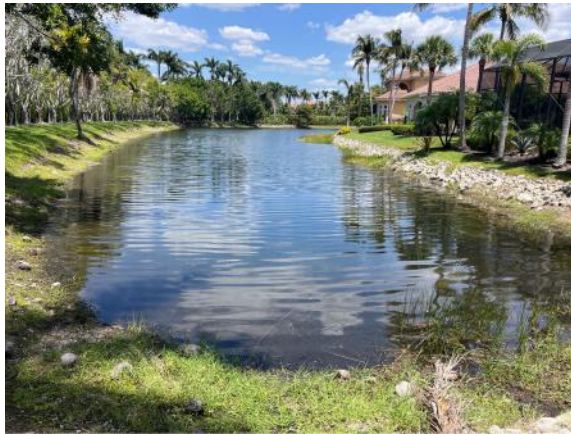
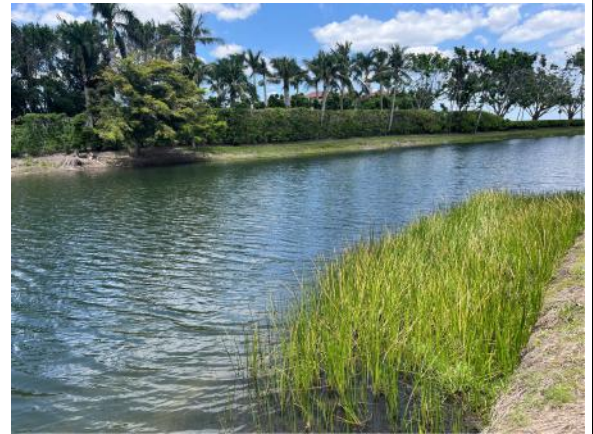
Site: 6J

Normal growth observed

Shoreline is well maintained. Spot treat minimal torpedograss. Algae and submersed vegetation are at controlled levels.

Routine maintenance next visit

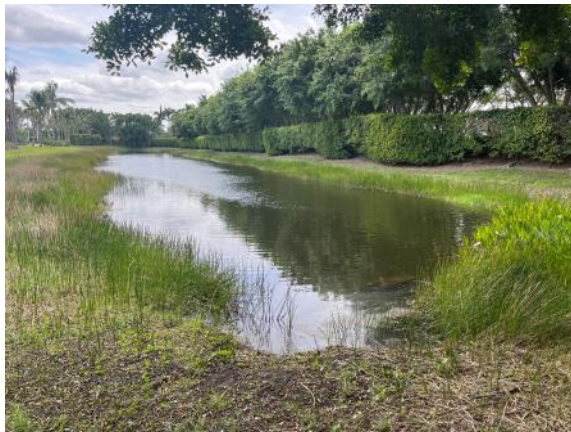
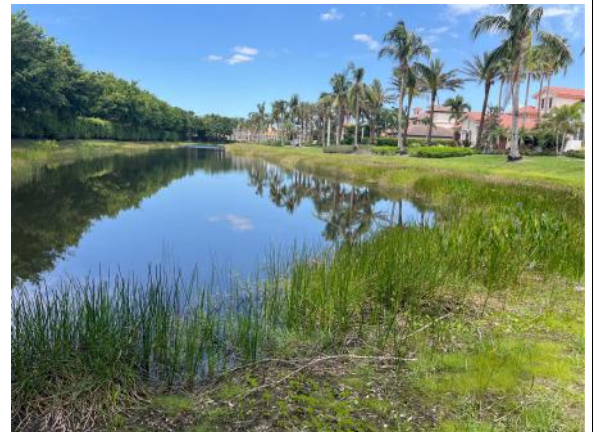
Site: 6K

Normal growth observed

Shoreline is well maintained. Spot treat minimal torpedograss. Algae and submersed vegetation are at controlled levels.

Routine maintenance next visit

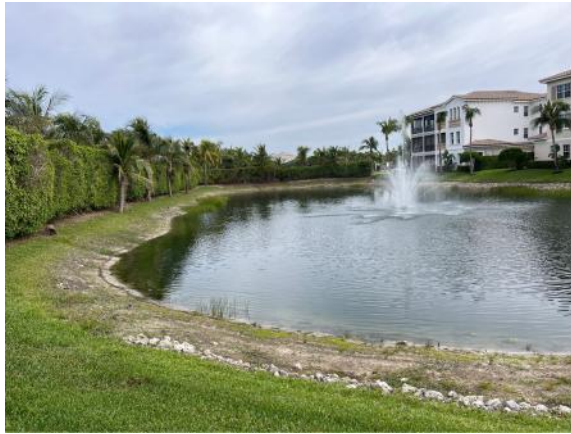
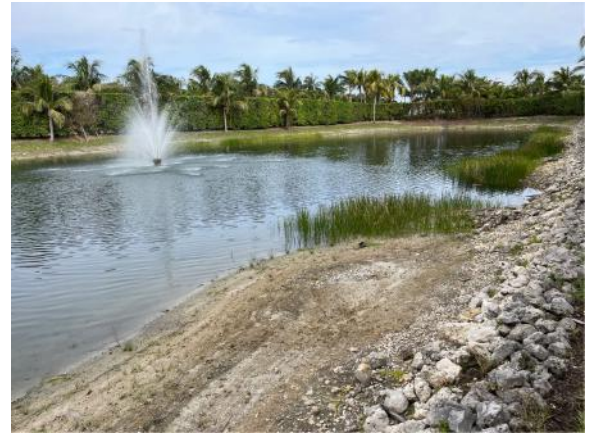
Site: 6L

Normal growth observed

Shoreline is well maintained. Spot treat minimal torpedograss on the west side. Algae and submersed vegetation are at controlled levels.

Routine maintenance next visit

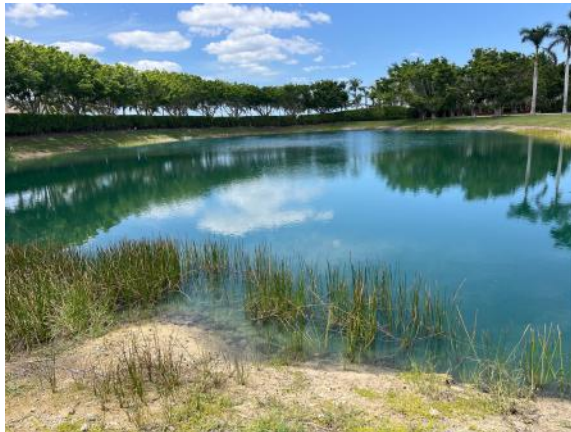
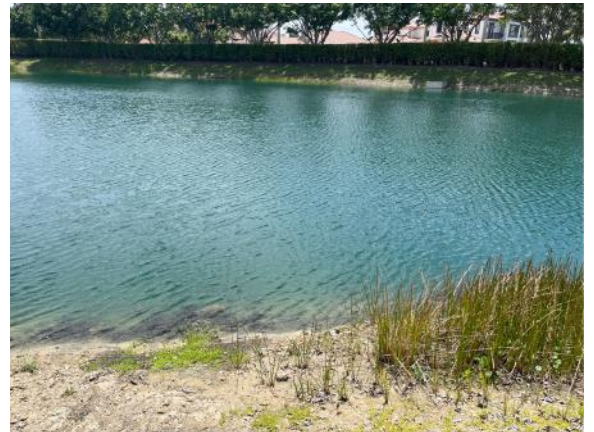
Site: 6M

Normal growth observed

Shoreline is well maintained. Algae and submersed vegetation are at controlled levels. Marine naiad appears to be dying off, monitor and treat as needed.

Routine maintenance next visit

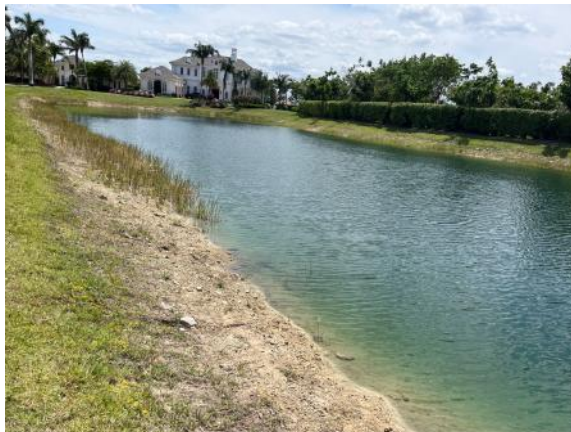
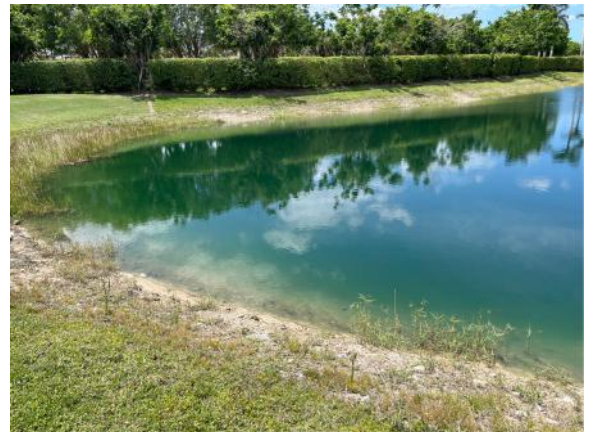
Site: 6N

Normal growth observed

Shoreline is well maintained. Spot treat minimal torpedograss. Algae and submersed vegetation are at controlled levels.

Routine maintenance next visit

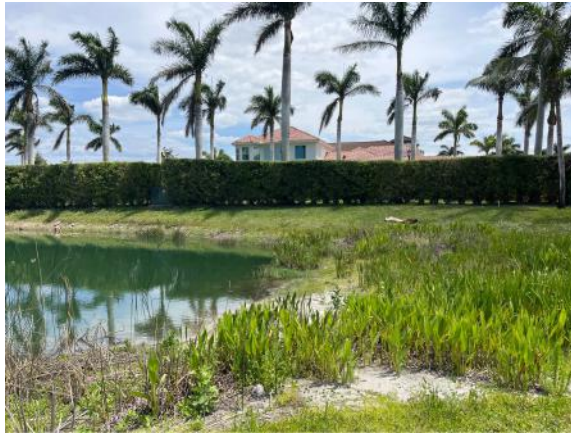
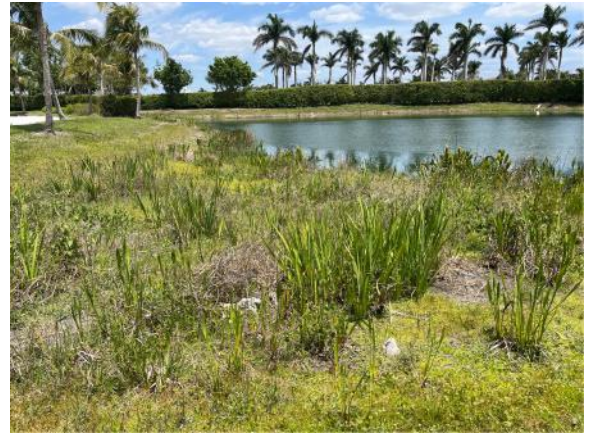
Site: 6O

Treatment in progress

Treatment in progress for torpedograss, annuals and vines. Algae and submersed vegetation are at controlled levels.

Routine maintenance next visit

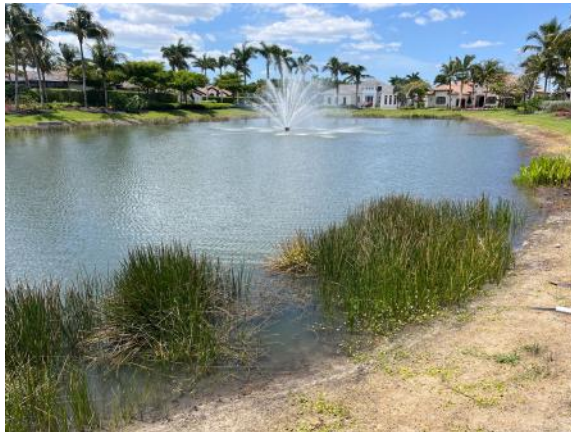
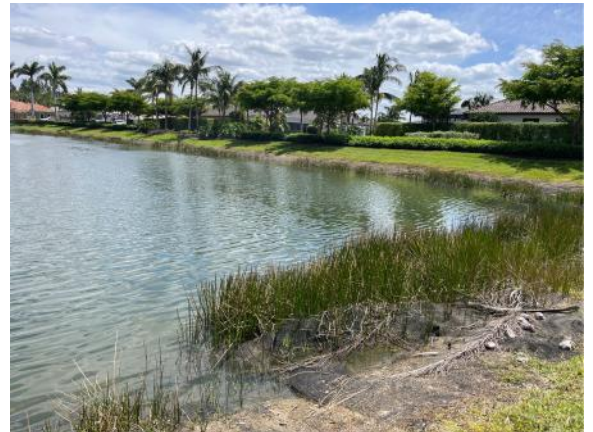
Site: 6P

Normal growth observed

Shoreline is well maintained. Spot treat minimal pennywort and alligator weed. Algae and submersed vegetation are at controlled levels.

Routine maintenance next visit

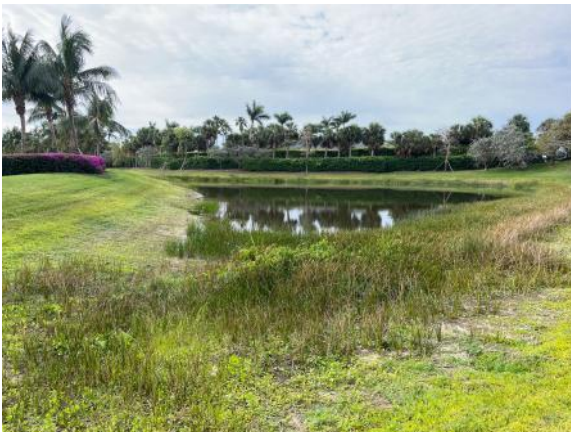
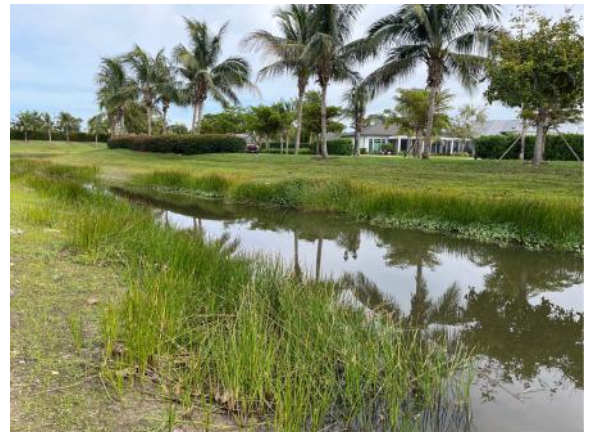
Site: 6R

Requires attention

Spot treat for pennywort, torpedograss and vines. Algae and submersed vegetation are at controlled levels.

Routine maintenance next visit

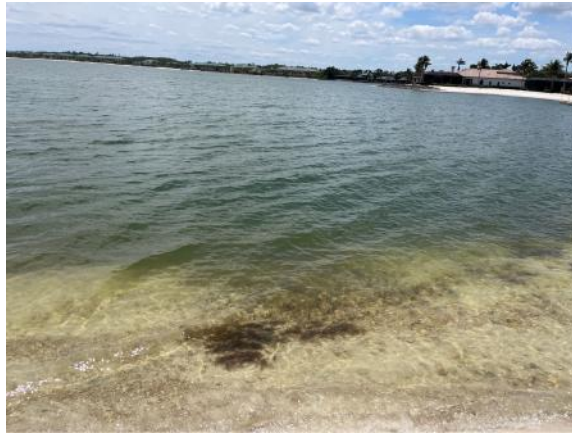
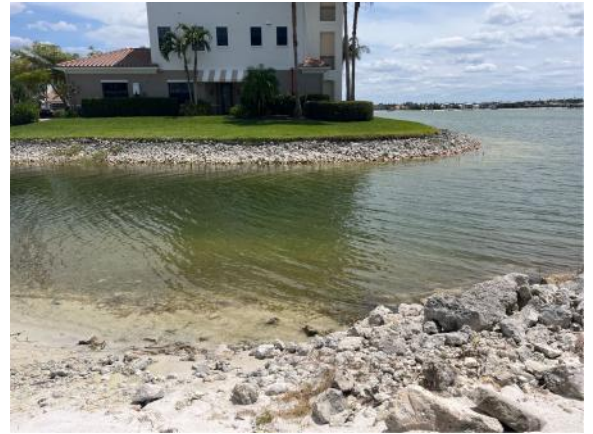
Site: 5/6-1

Normal growth observed

Shoreline is well maintained. Algae and submersed vegetation are at controlled levels. Vallisneria and southern naiad observed, monitor and treat as needed

Routine maintenance next visit

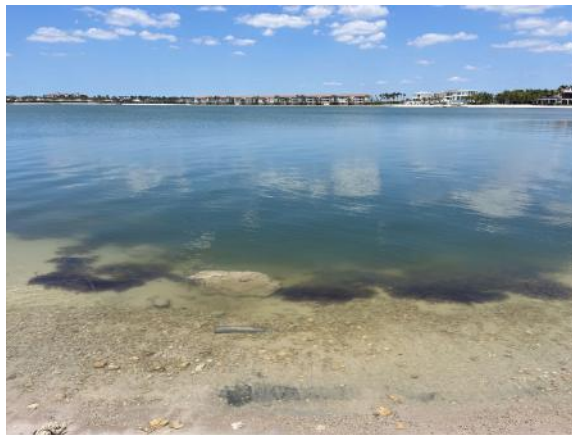
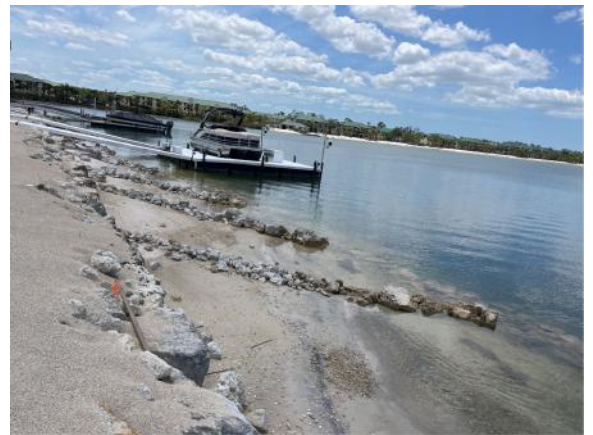
Site: 5/6-2

Normal growth observed

Shoreline is well maintained. Algae and submersed vegetation are at controlled levels. Vallisneria and southern naiad observed, monitor and treat as needed

Routine maintenance next visit

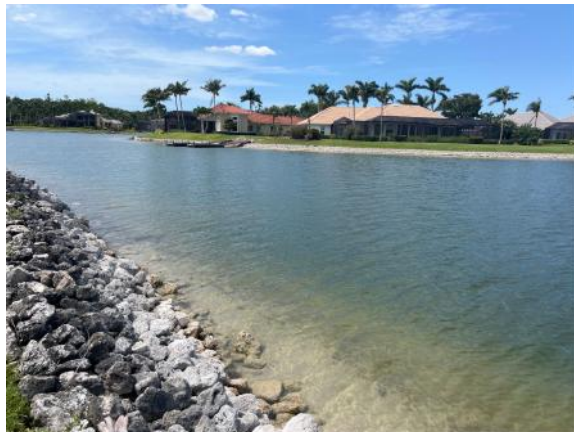
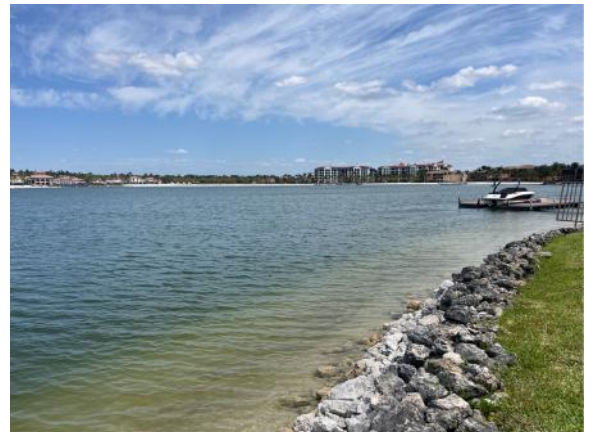
Site: 5/6-3

Normal growth observed

Shoreline is well maintained. Algae and submersed vegetation are at controlled levels. Vallisneria and southern naiad observed, monitor and treat as needed

Routine maintenance next visit

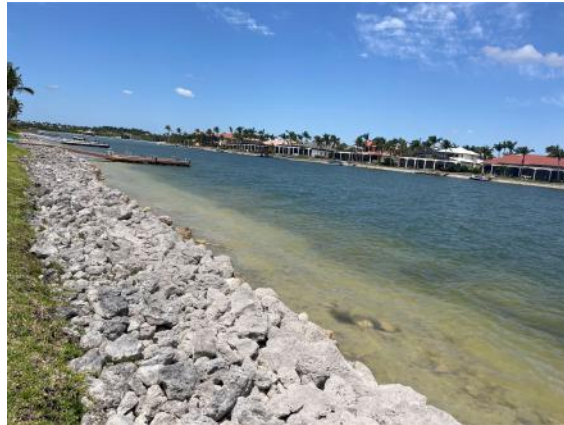
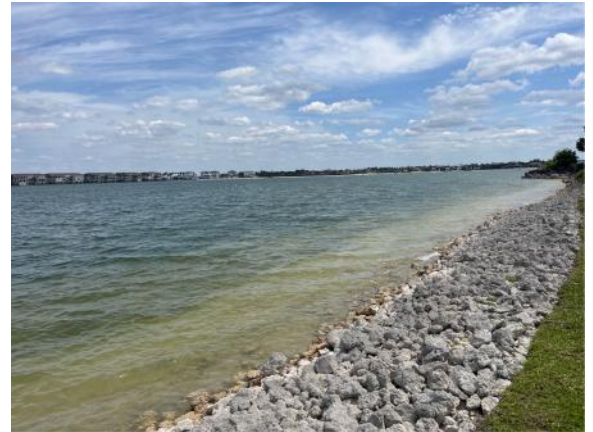
Site: 5/6-4

Normal growth observed

Shoreline is well maintained. Algae and submersed vegetation are at controlled levels. Vallisneria and southern naiad observed, monitor and treat as needed.

Routine maintenance next vis:
