Miromar Lakes CDD Waterway Inspection Report

Reason for Inspection: Routine Scheduled

Inspection Date: 2023-07-17

Bailey Hill, Aquatic Specialist

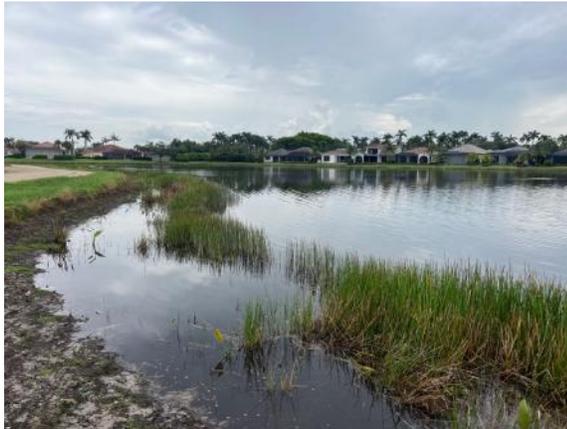
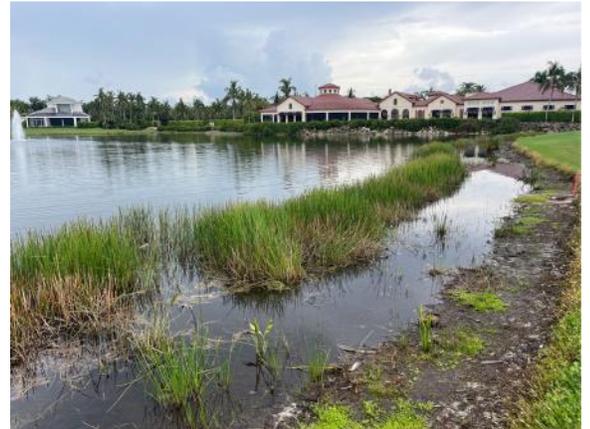
Site: 1A

Site looks good

Shoreline is well maintained.
Algae and submersed vegetation are at controlled levels.

Routine maintenance next visit

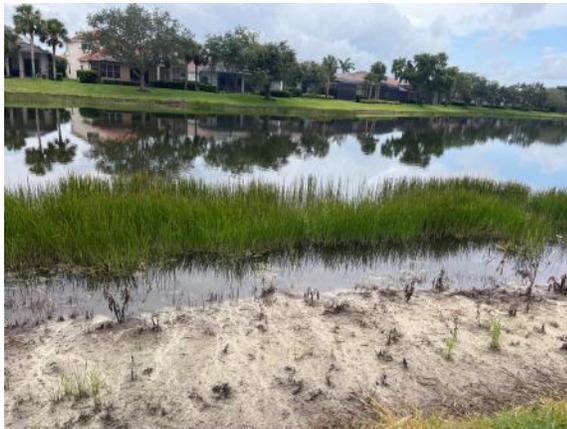
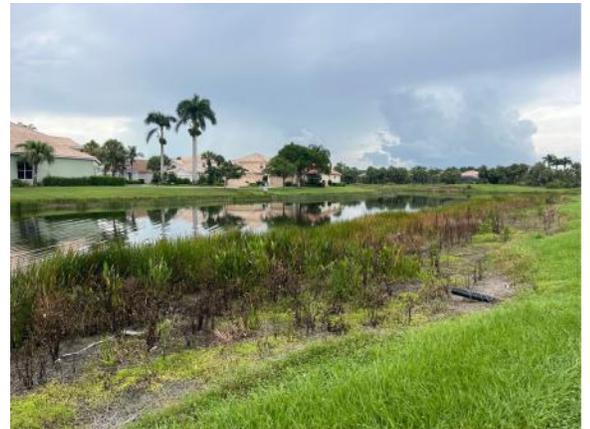
Site: 1B

Treatment in progress

Treatment for shoreline weeds was evident. Algae and submersed vegetation are at controlled levels.

Shoreline weeds

Re-inspect next visit

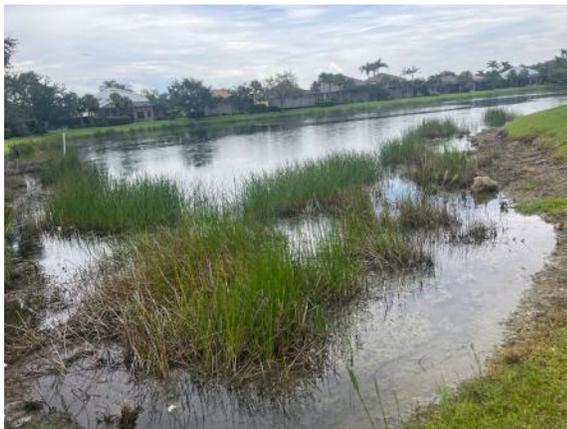
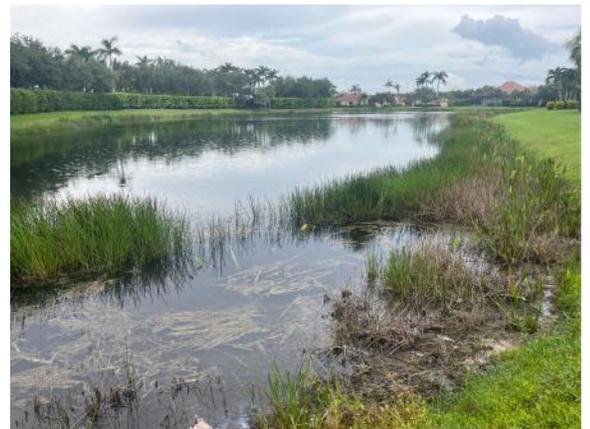
Site: 1C

Site looks good

Shoreline is well maintained.
Algae and submersed vegetation are at controlled levels.

Routine maintenance next visit

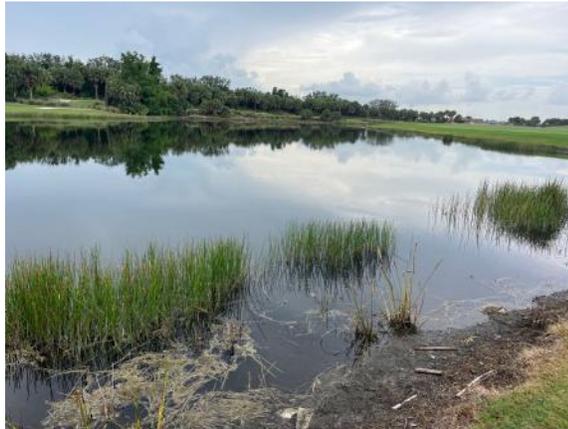
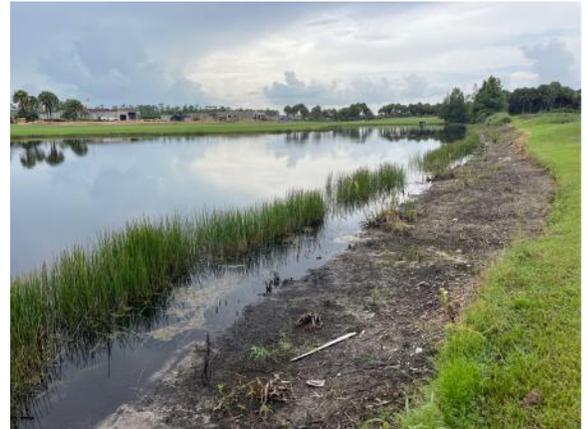
Site: 2A

Normal growth observed
Shoreline is well maintained.
Algae and submersed vegetation
are at controlled levels. Minimal
surface algae noted.

Routine maintenance next visit

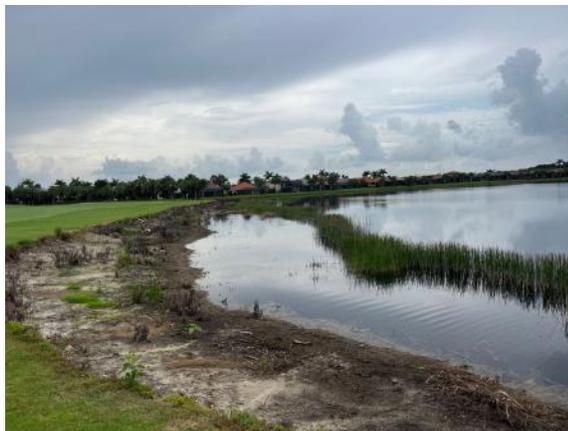
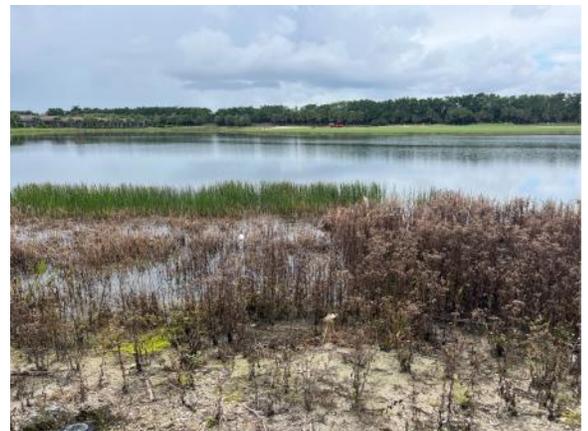
Site: 3A

Treatment in progress
Treatment for shoreline weeds is
in progress. Algae and submersed
vegetation are at controlled levels.

Re-inspect next visit

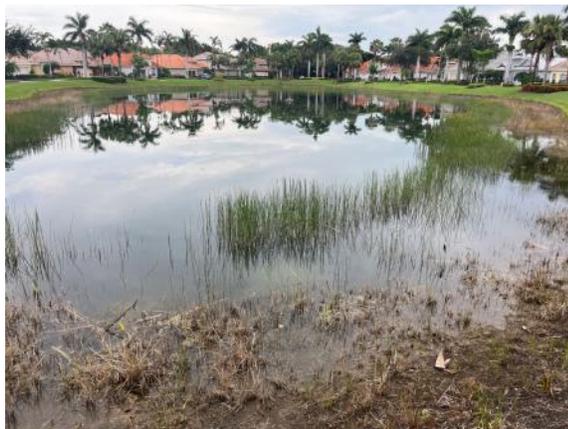
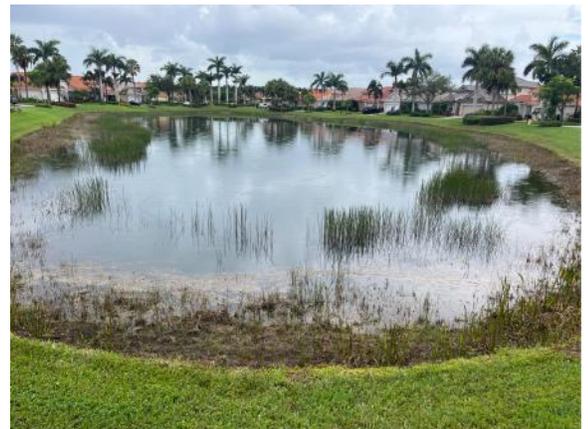
Site: 3B

Site looks good
Shoreline is well maintained.
Algae and submersed vegetation
are at controlled levels. Minimal
surface algae observed.

Routine maintenance next visit

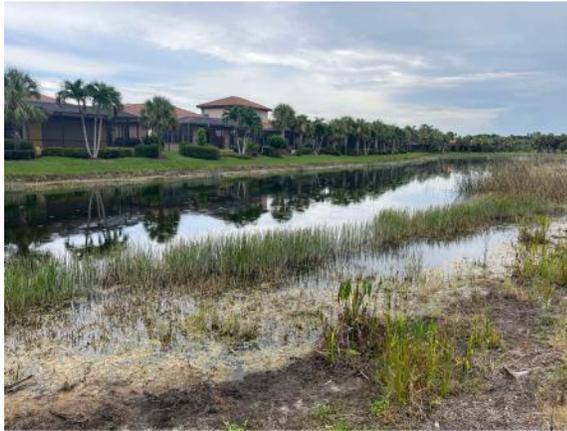
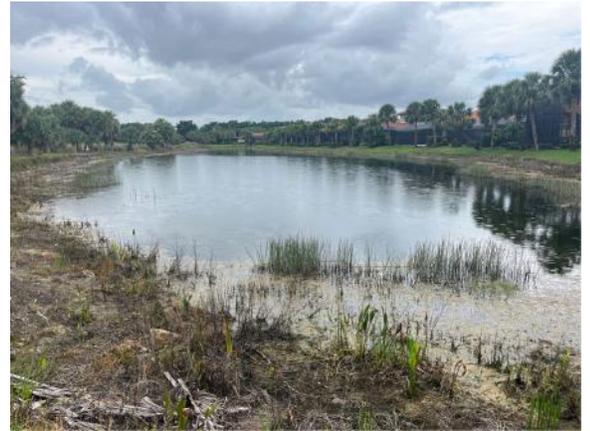
Site: 3C

Normal growth observed

Treatment for shoreline weeds is in progress. Algae and submersed vegetation are at controlled levels. Some surface algae observed in the littorals, spot treat in any open areas.

Routine maintenance next visit

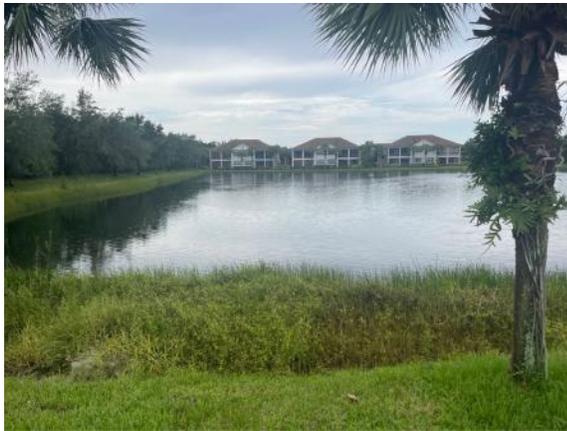
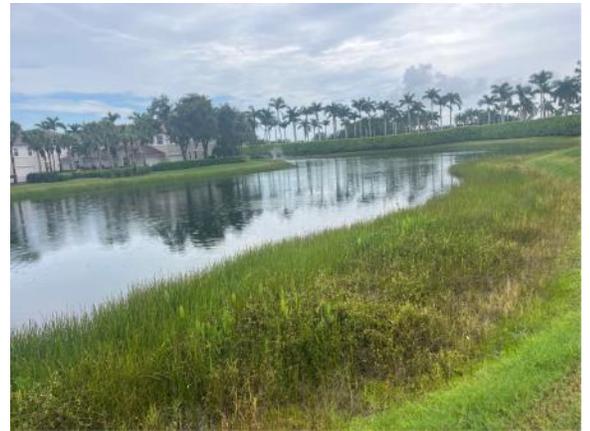
Site: 6A

Requires attention

Some treatment was evident for vines and grasses. Needs additional treatment to target remaining growth. Algae and submersed are controlled.

Routine maintenance next visit

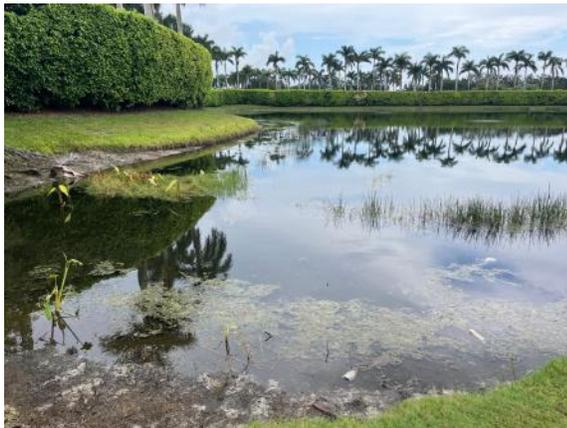
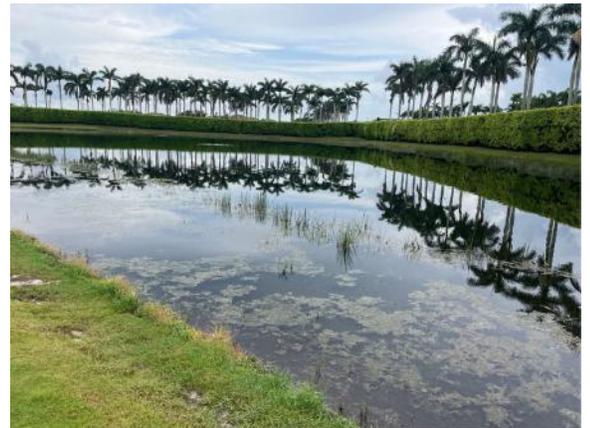
Site: 6B

Normal growth observed

Treatment for shoreline weeds was evident. Algae growth is likely a result of grass clippings and previous shoreline treatment.

Routine maintenance next visit

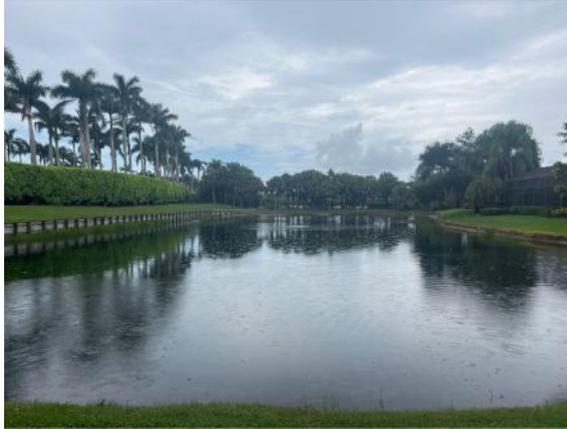
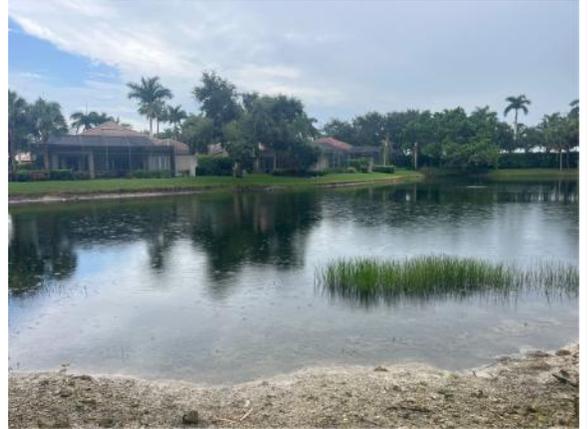
Site: 6C

Site looks good

Shoreline is well maintained.
Algae and submersed vegetation
are at controlled levels

Routine maintenance next visit

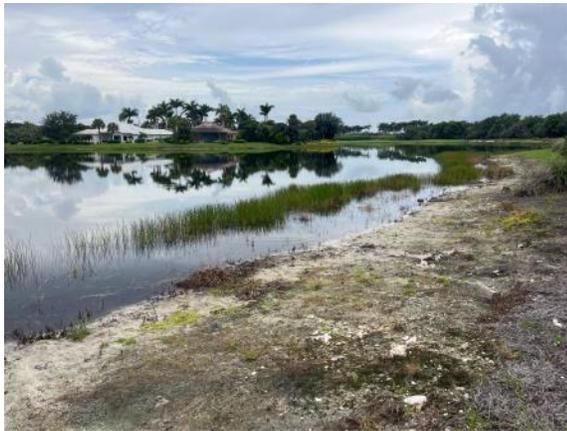
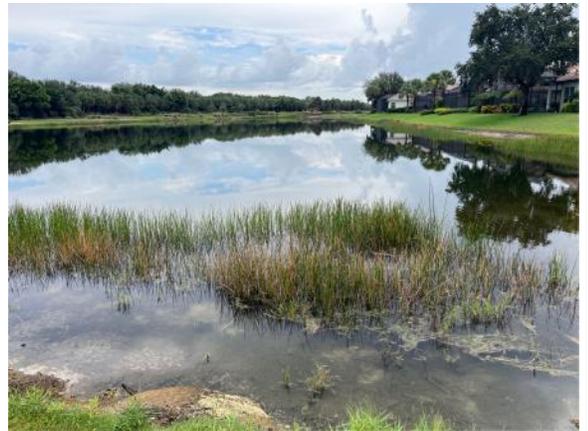
Site: 6D

Site looks good

Shoreline is well maintained.
Algae and submersed vegetation
are at controlled levels. Minimal
surface algae observed.

Routine maintenance next visit

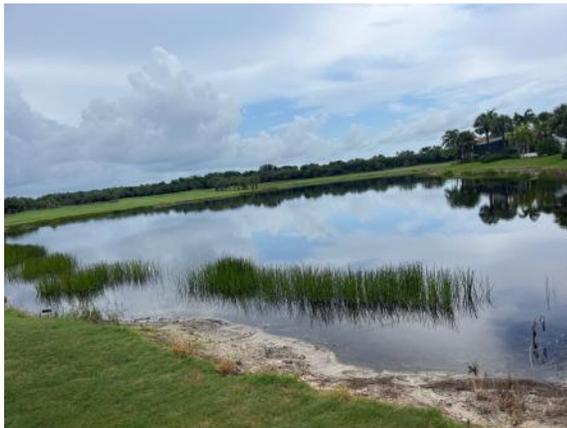
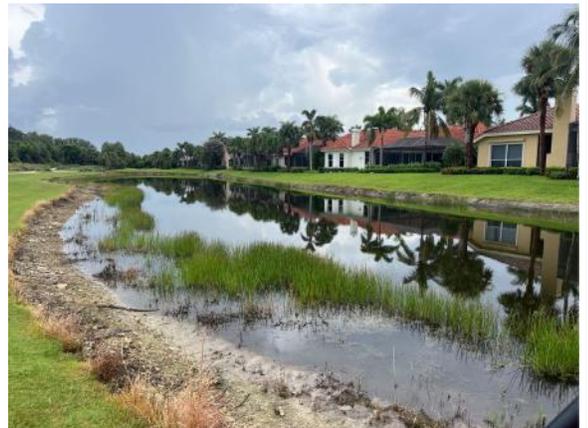
Site: 6E

Site looks good

Shoreline is well maintained.
Algae and submersed vegetation
are at controlled levels.

Routine maintenance next visit

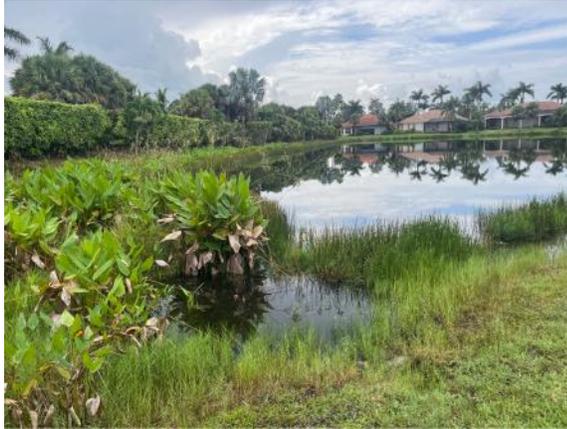
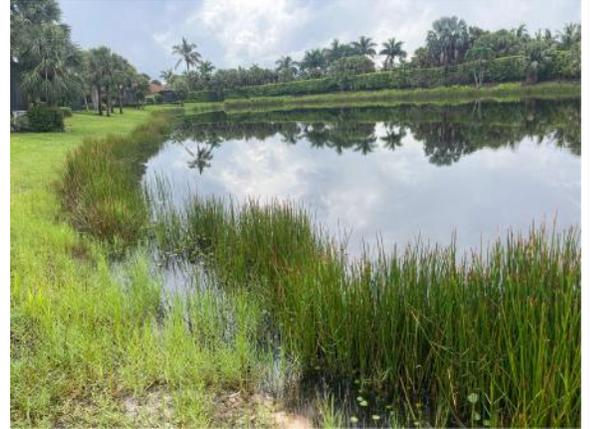
Site: 6F

Normal growth observed

Spot treat for pennywort, dog fennel and torpedograss in littorals. Algae and submersed vegetation are at controlled levels.

Routine maintenance next visit

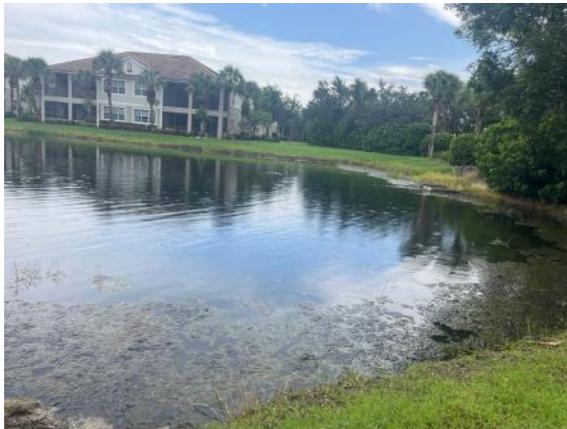
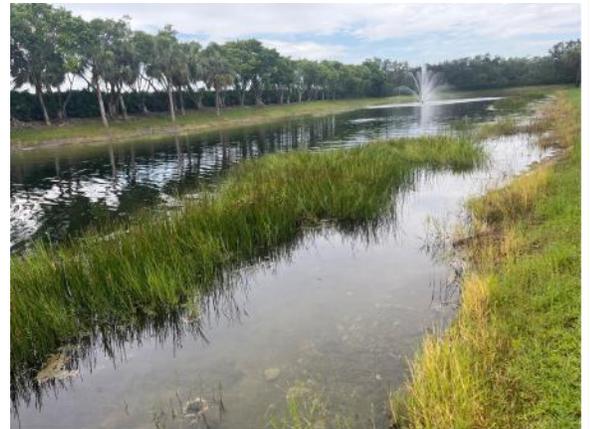
Site: 6G

Normal growth observed

Shoreline is well maintained. Algae and submersed vegetation are at controlled levels. Minimal surface algae observed, treat in open areas.

Routine maintenance next visit

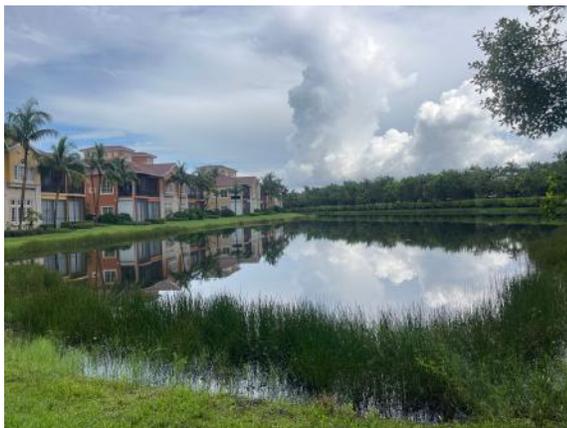
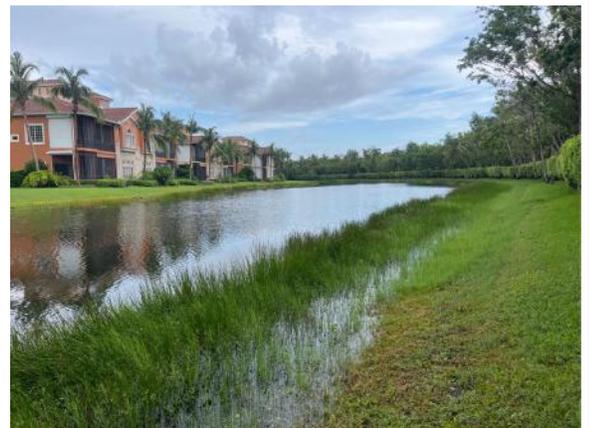
Site: 6H

Requires attention

Spot treat vines and torpedograss. Algae and submersed vegetation are at controlled levels.

Re-inspect next visit

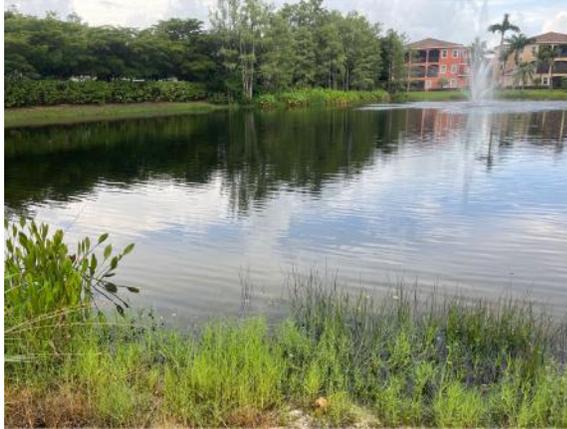
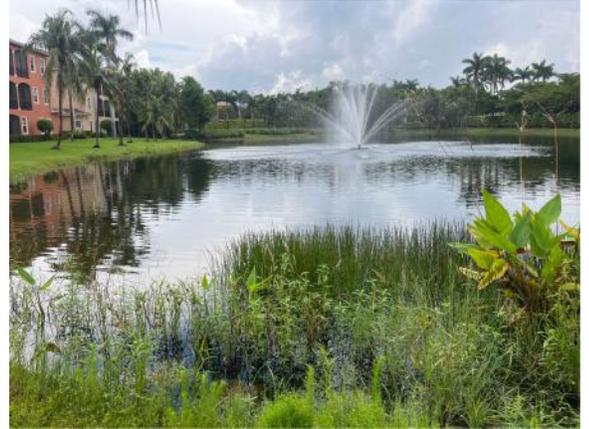
Site: 6I

Requires attention

Spot treat willow, torpedograss and dog fennel. Algae and submersed vegetation are at controlled levels.

Re-inspect next visit

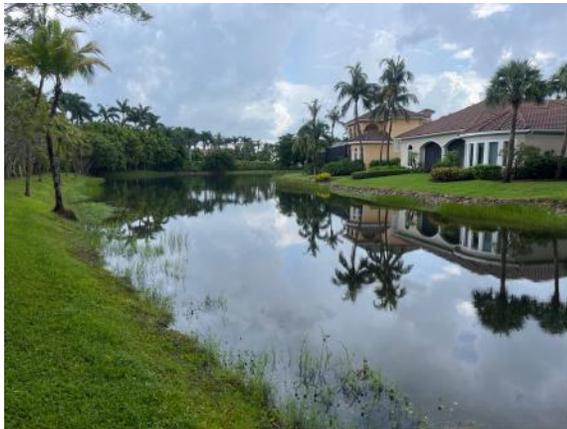
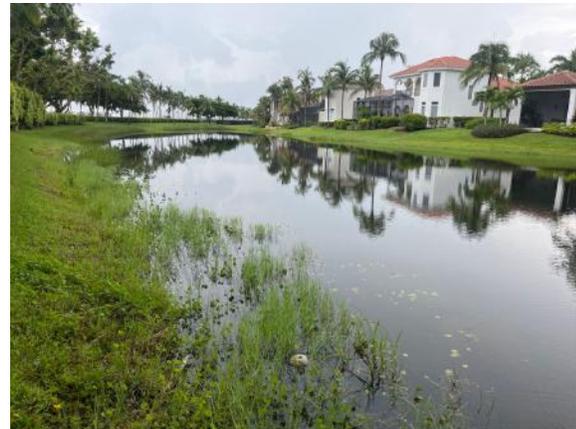
Site: 6J

Requires attention

Spot treat sedge and torpedograss. Algae and submersed vegetation are at controlled levels.

Re-inspect next visit

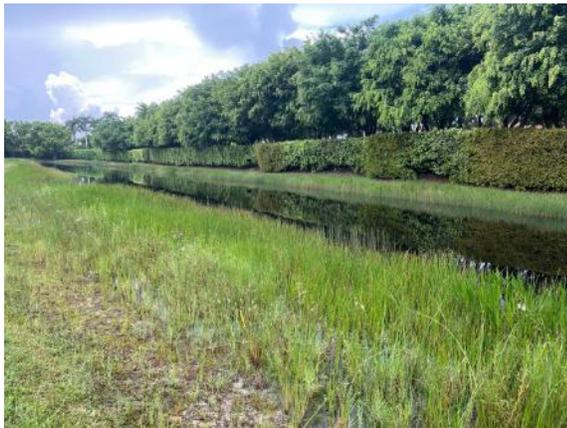
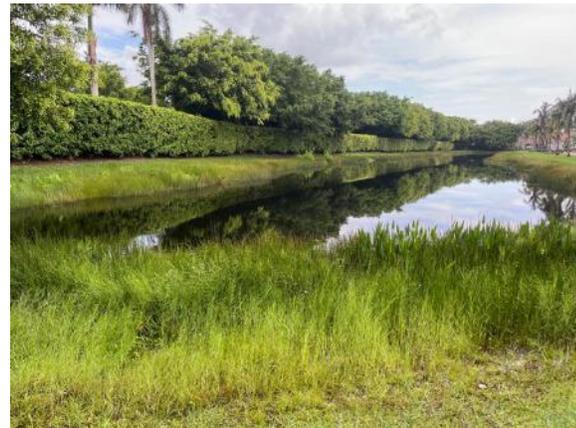
Site: 6K

Requires attention

Spot treat willow, vines and torpedograss. Algae and submersed vegetation are at controlled levels.

Re-inspect next visit

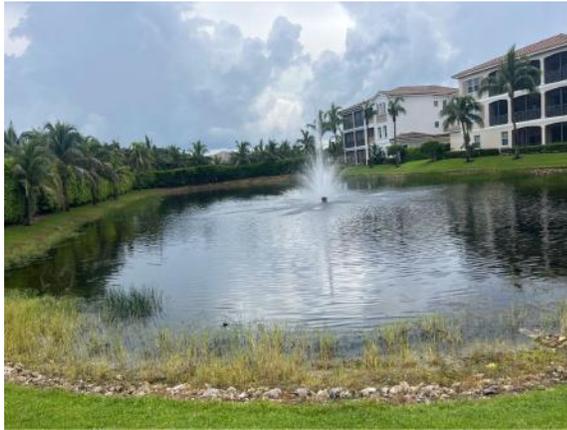
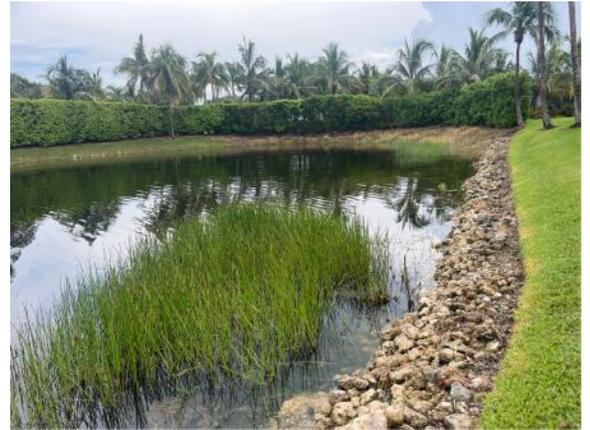
Site: 6L

Treatment in progress

Treatment for torpedograss was evident. Algae and submersed vegetation are at controlled levels.

Re-inspect next visit

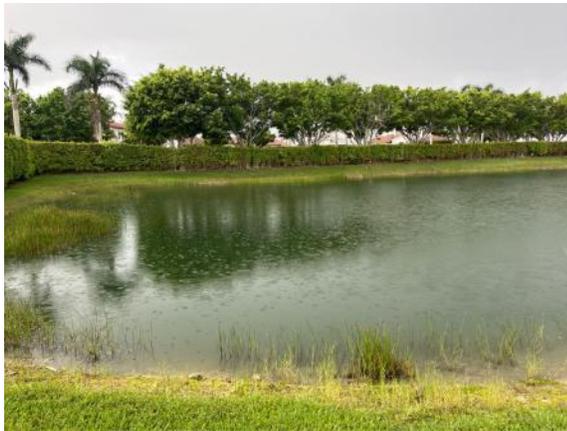
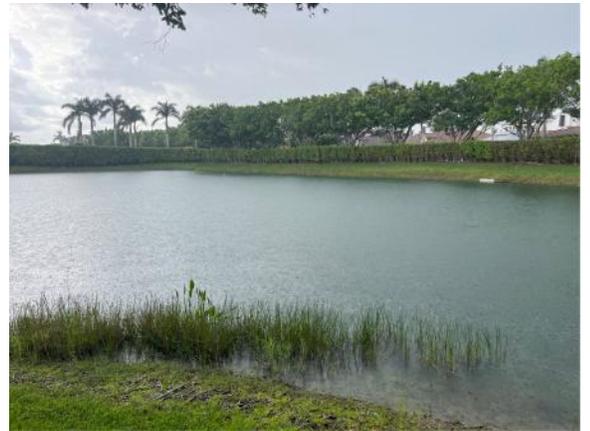
Site: 6M

Site looks good

Shoreline is well maintained. Algae and submersed vegetation are at controlled levels.

Routine maintenance next visit

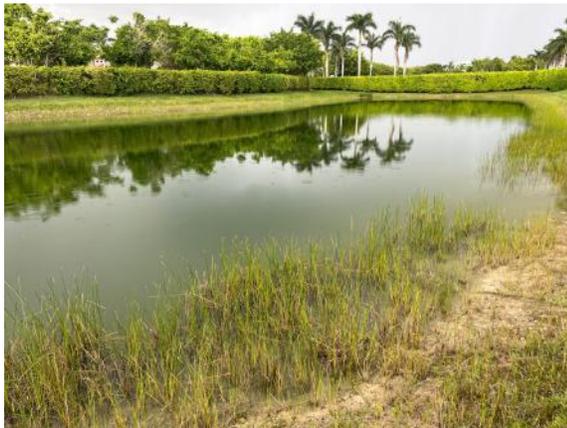
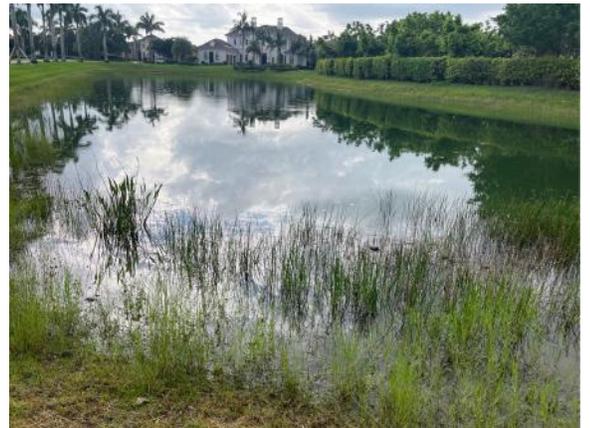
Site: 6N

Normal growth observed

Shoreline is well maintained. Spot treat minimal torpedograss. Algae and submersed vegetation are at controlled levels.

Routine maintenance next visit

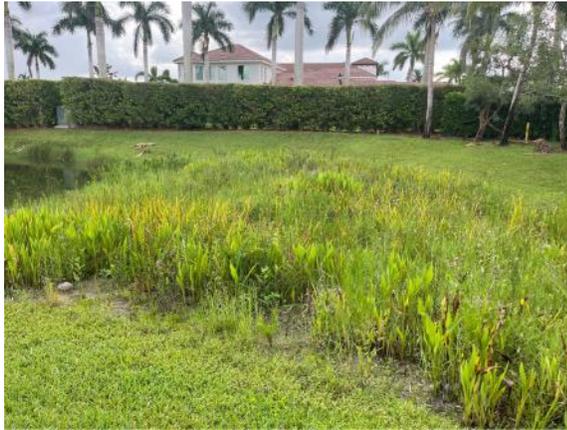
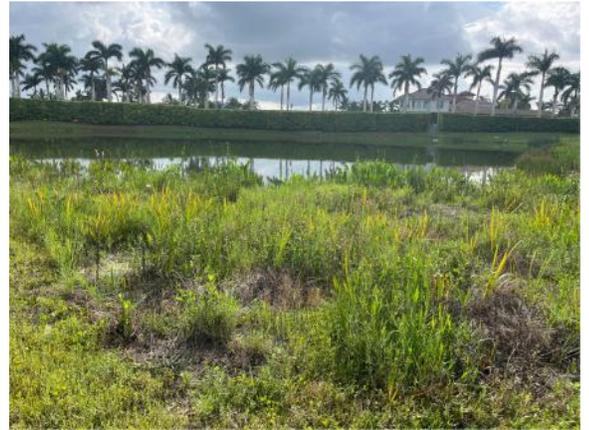
Site: 6O

Requires attention

Treatment for shoreline weeds was evident, requires additional treatment to target remaining growth. Algae and submersed vegetation are at controlled levels.

Re-inspect next visit

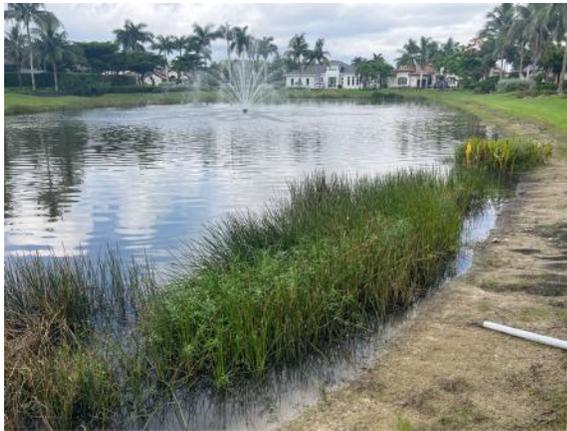
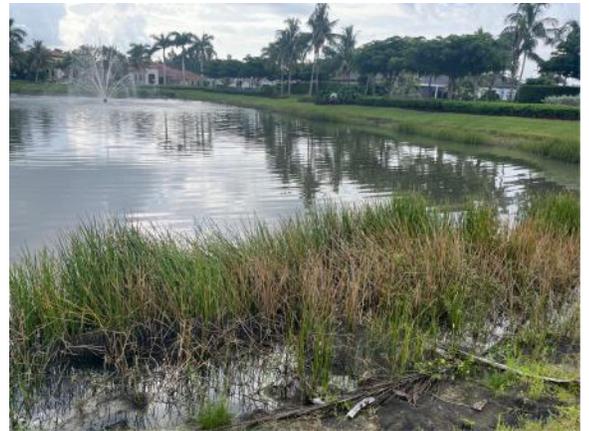
Site: 6P

Requires attention

Spot treat alligatorweed and willow. Algae and submersed vegetation are at controlled levels.

Re-inspect next visit

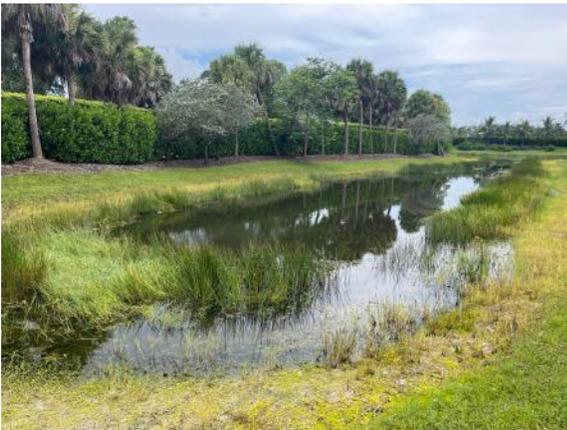
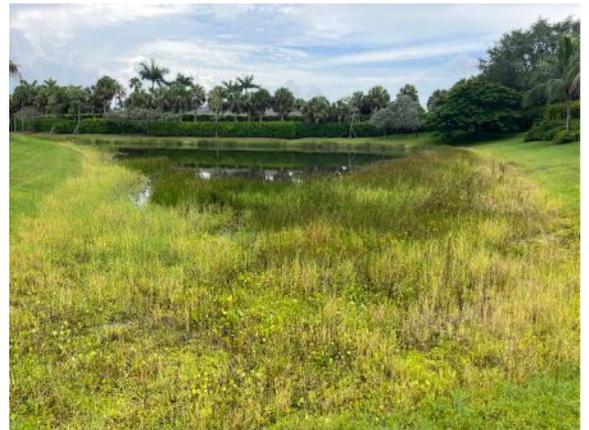
Site: 6R

Treatment in progress

Treatment for shoreline weeds was evident, will reinspect to determine if additional treatment is needed. Algae and submersed vegetation are at controlled levels.

Re-inspect next visit

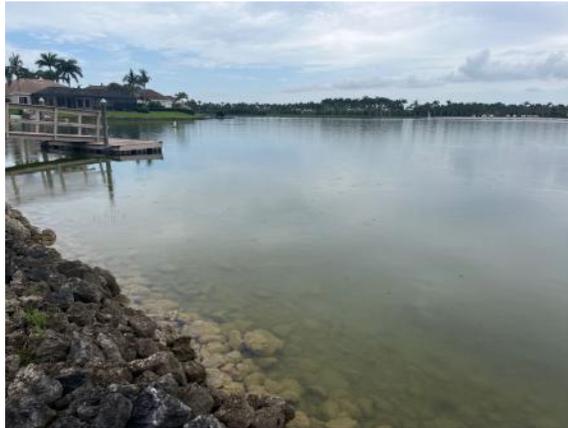
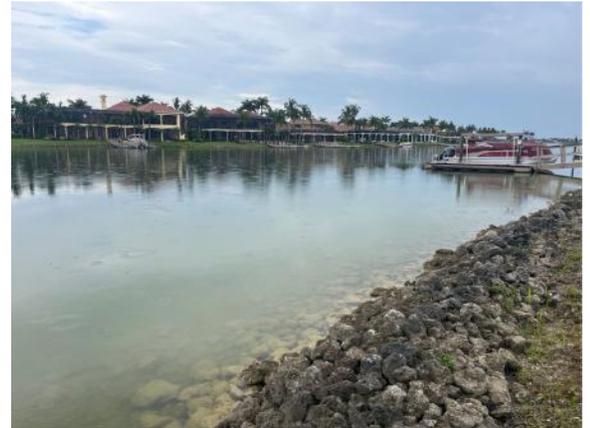
Site: 5/6-1

Site looks good

Shoreline is well maintained. Algae and submersed vegetation are at controlled levels.

Routine maintenance next visit

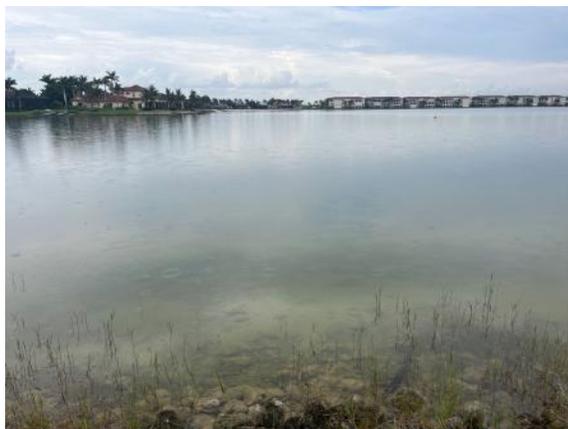
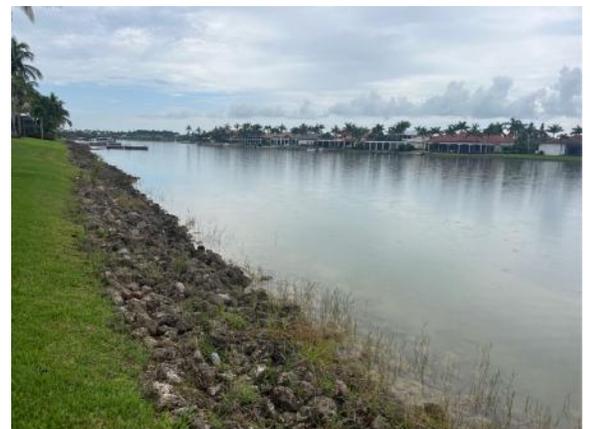
Site: 5/6-2

Normal growth observed

Shoreline is well maintained. Spot treat minimal torpedograss growth. Algae and submersed vegetation are at controlled levels.

Routine maintenance next visit

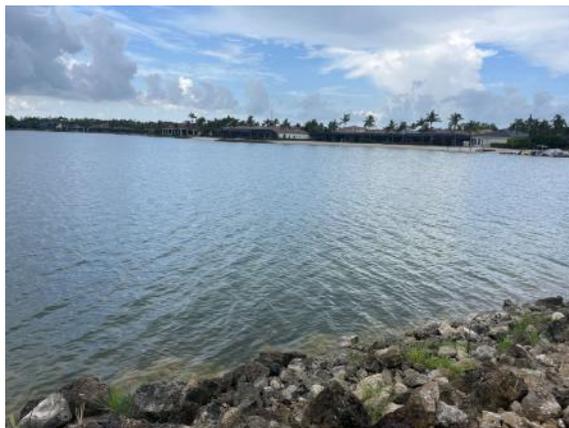
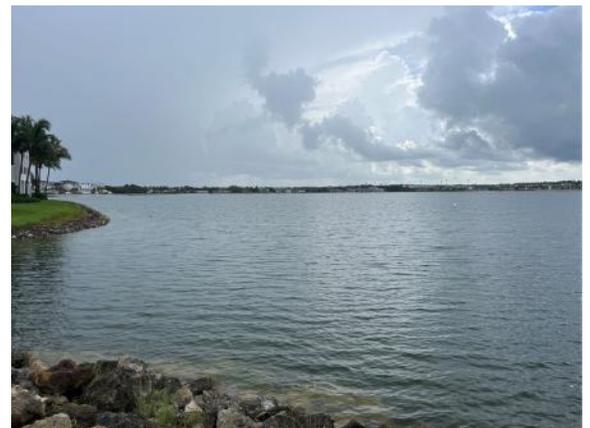
Site: 5/6-3

Normal growth observed

Shoreline is well maintained. Spot treat minimal sedge and torpedograss growth. Algae and submersed vegetation are at controlled levels.

Routine maintenance next visit

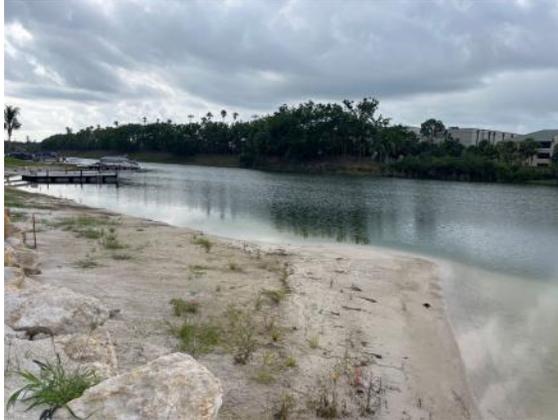
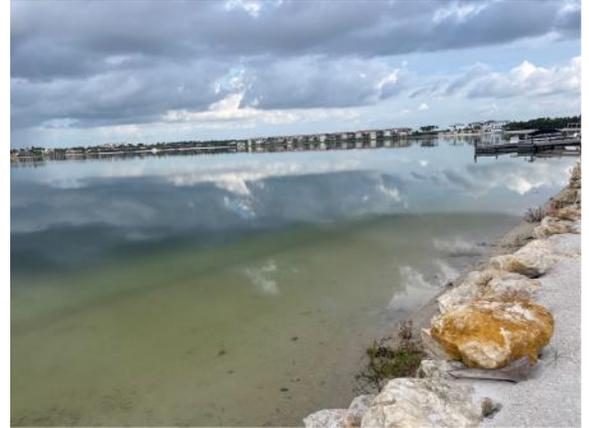
Site: 5/6-4

Site looks good

Shoreline is well maintained. Treatment for shoreline weeds was evident. Algae and submersed vegetation are at controlled levels.

Routine maintenance next vis
