Wentworth Estates CDD at Treviso Bay Waterway Inspection Report

Reason for Inspection: Routine Scheduled

Inspection Date: 2025-10-28

Wentworth Estates CDD at Treviso Bay
Treviso Bay Clubhouse, 9800 Treviso Bay Boulevard
Naples, Florida 34113

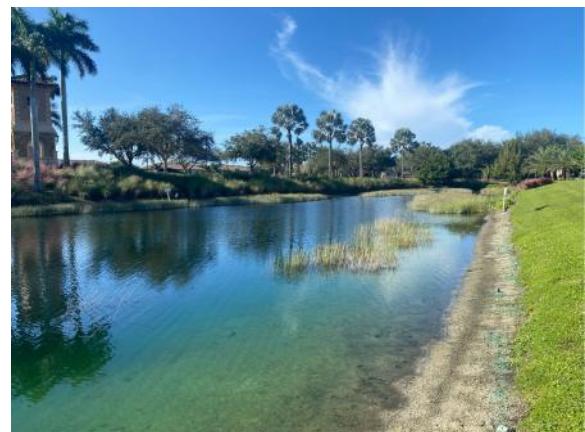
Site: 1**Comments:**

Site looks good

Shoreline is well maintained.
Algae and submerged vegetation
are at controlled levels.

Routine maintenance next visit

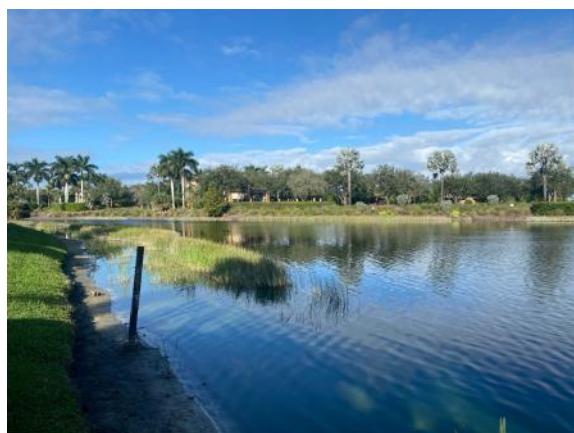
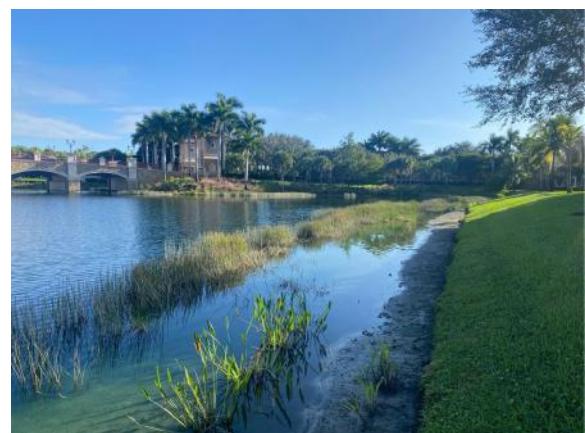
Site: 2**Comments:**

Site looks good

Shoreline is well maintained.
Algae and submerged vegetation
are at controlled levels.

Routine maintenance next visit

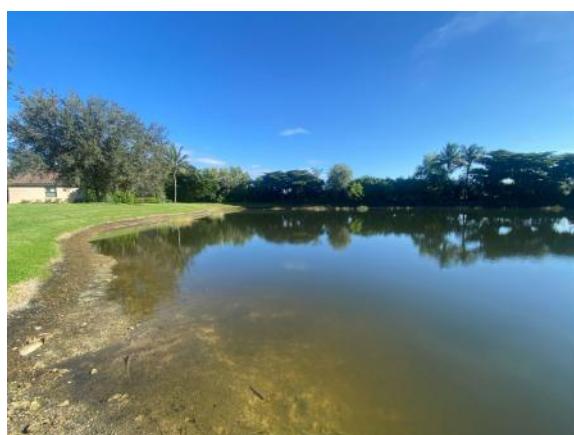
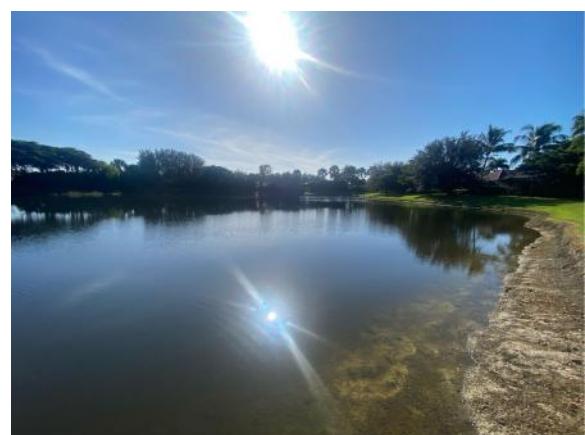
Site: 3**Comments:**

Normal growth observed

Shoreline is well maintained.
Minor patches of regrowth
observed on bank. Algae and
submerged vegetation are at
controlled levels.

Routine maintenance next visit

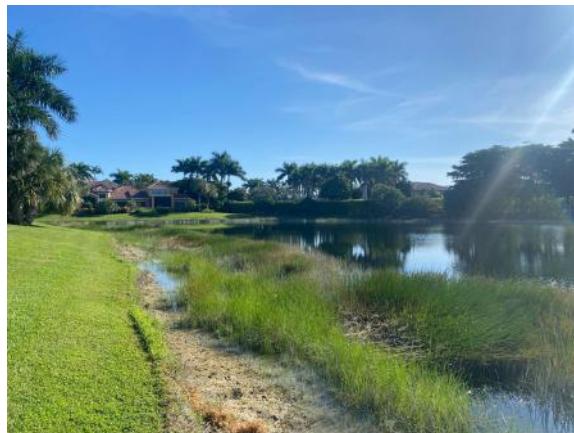
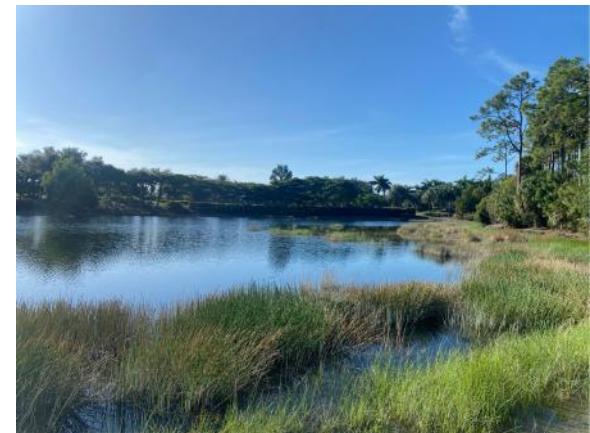
Site: 4**Comments:**

Site looks good

Shoreline is well maintained.
Submersed vegetation is at
controlled levels.

Routine maintenance next visit

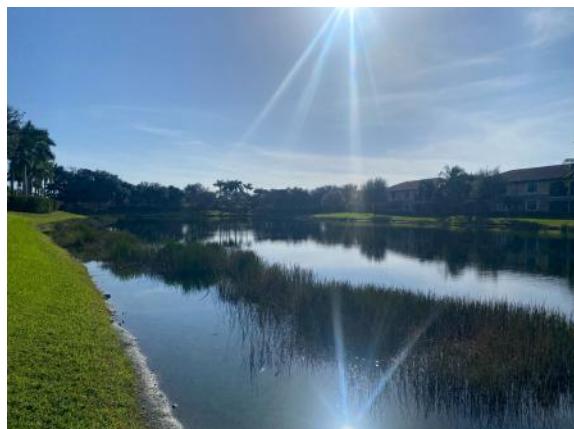
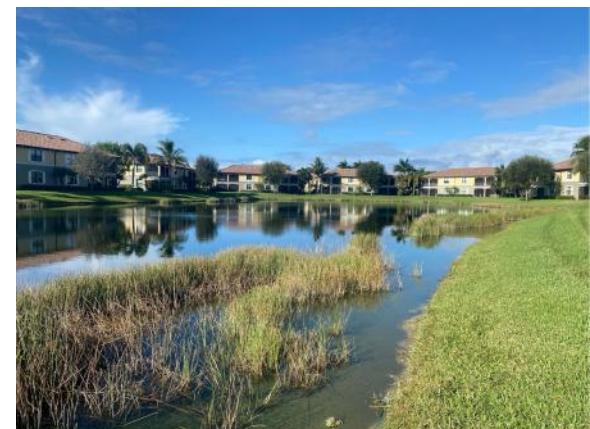
Site: 5**Comments:**

Normal growth observed

Shoreline is well maintained.
Algae and submerged vegetation
are at controlled levels.

Routine maintenance next visit

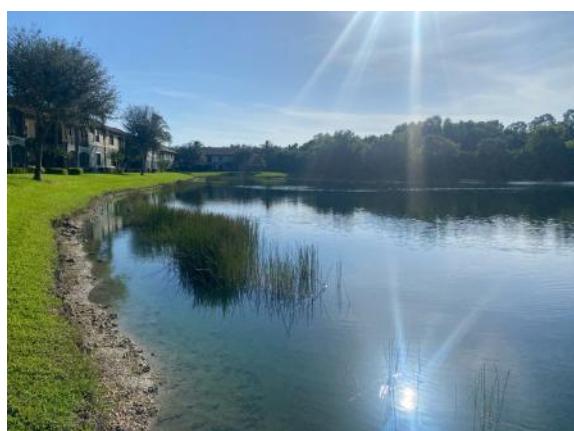
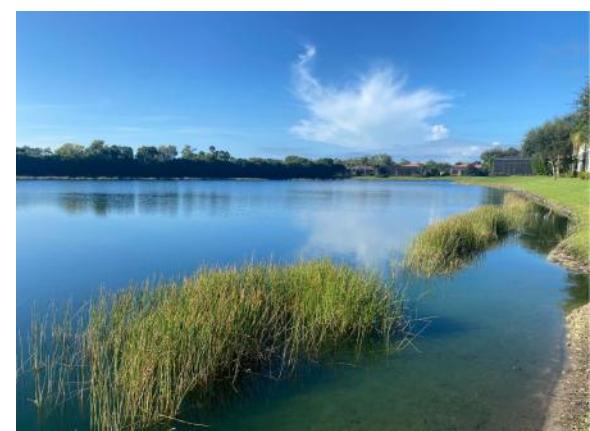
Site: 6**Comments:**

Normal growth observed

Shoreline is well maintained.
Algae and submerged vegetation
are at controlled levels.

Routine maintenance next visit

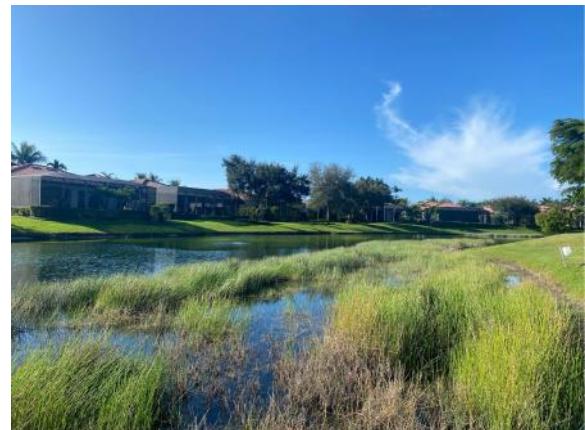
Site: 7**Comments:**

Normal growth observed

Some areas of torpedo grass observed along shoreline and within littorals. Algae and submerged vegetation are at controlled levels.

Routine maintenance next visit

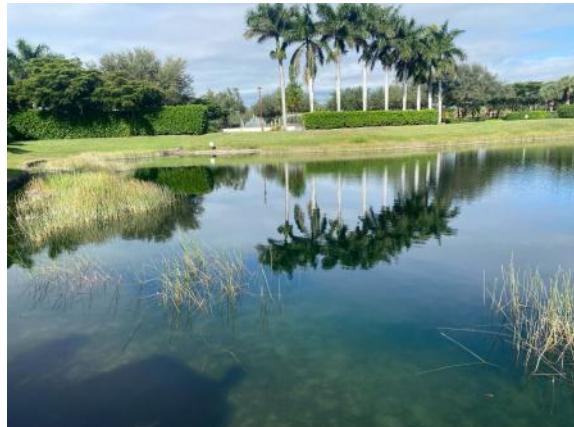
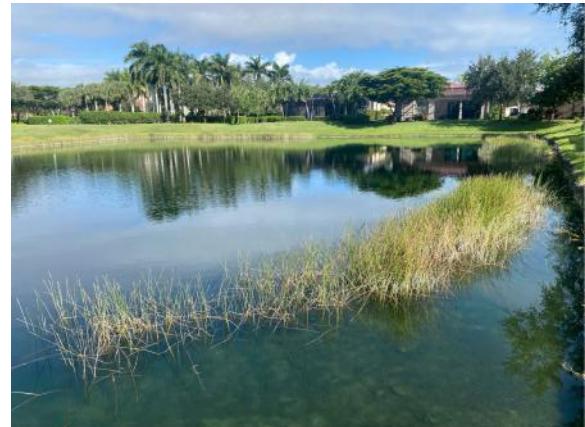
**Site: 8****Comments:**

Site looks good

Shoreline is well maintained. Minor submerged algae present at the bottom of lake.

Routine maintenance next visit

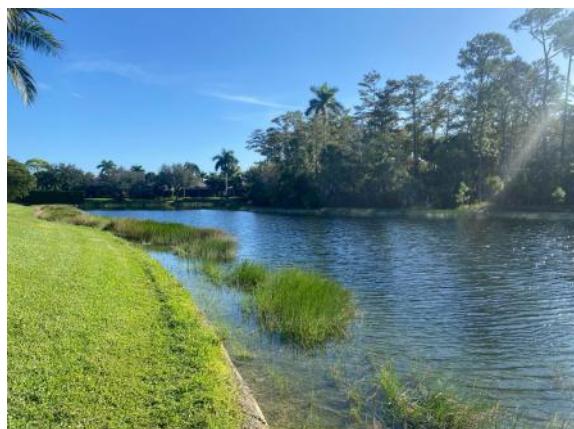
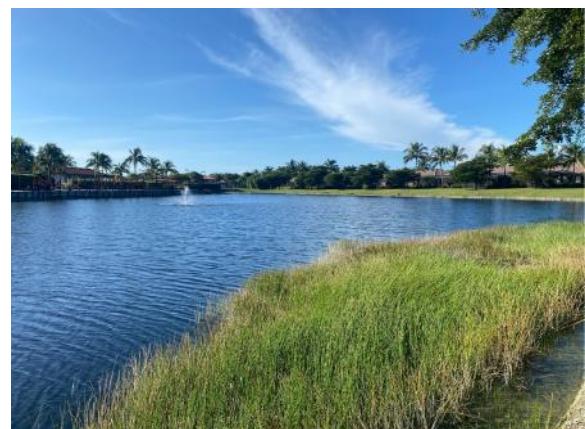
**Site: 9****Comments:**

Normal growth observed

Minor regrowth of torpedo grass observed along shoreline. Algae and submerged vegetation are at controlled levels.

Routine maintenance next visit

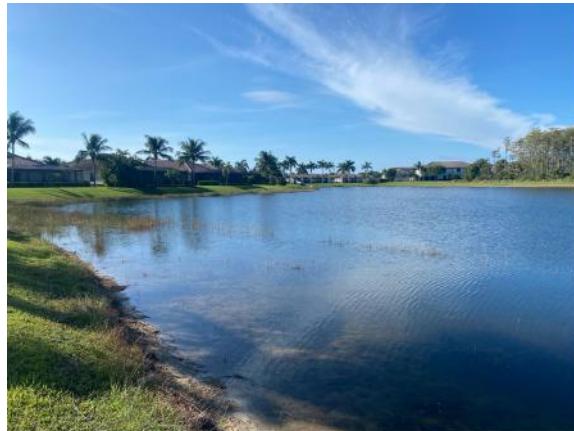
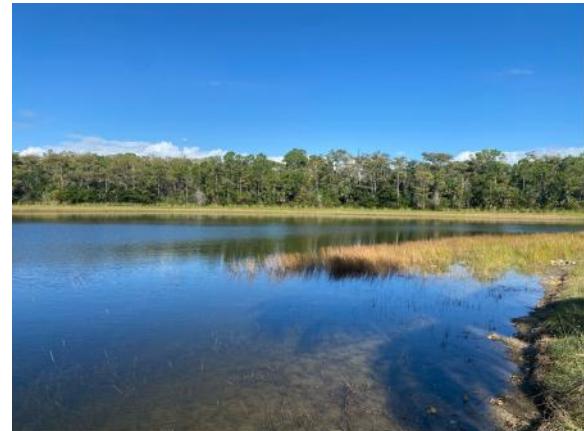
Site: 10**Comments:**

Normal growth observed

Shoreline is well maintained.
Algae and submerged vegetation
are at controlled levels.

Routine maintenance next visit

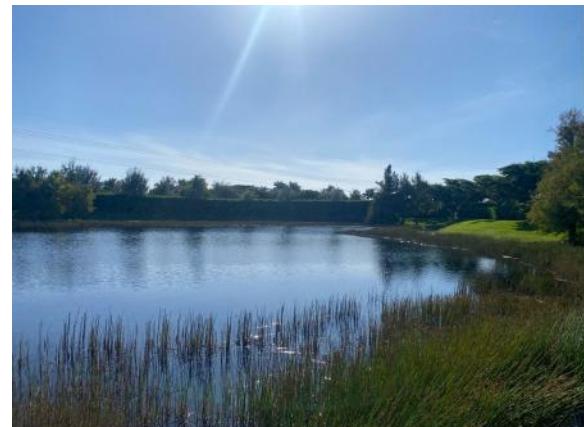
**Site: 11****Comments:**

Normal growth observed

Shoreline is well maintained with
some areas of regrowth present.
Algae and submersed vegetation
is at controlled levels.

Routine maintenance next visit

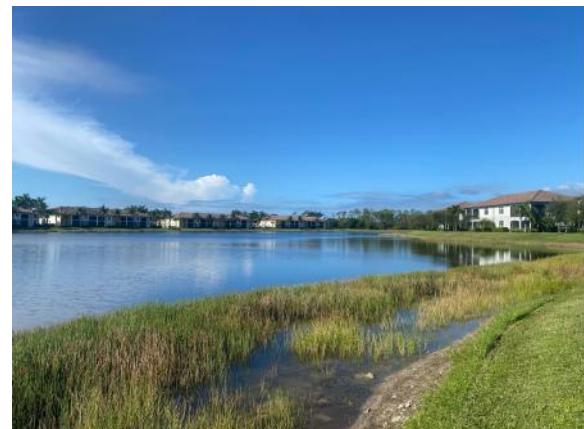
**Site: 12****Comments:**

Treatment in progress

Shoreline is well maintained.
Algae is at controlled levels.
Submersed vegetation present
and is being treated.

Routine maintenance next visit

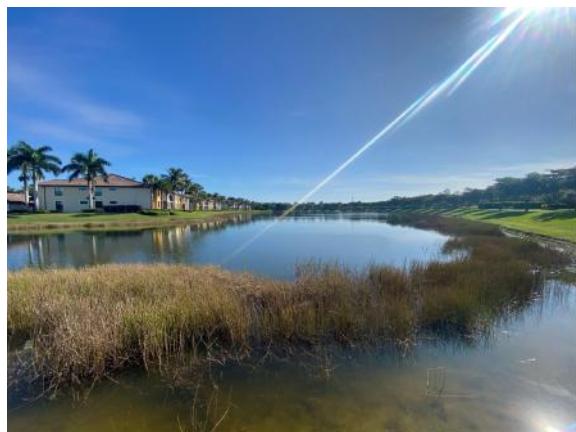
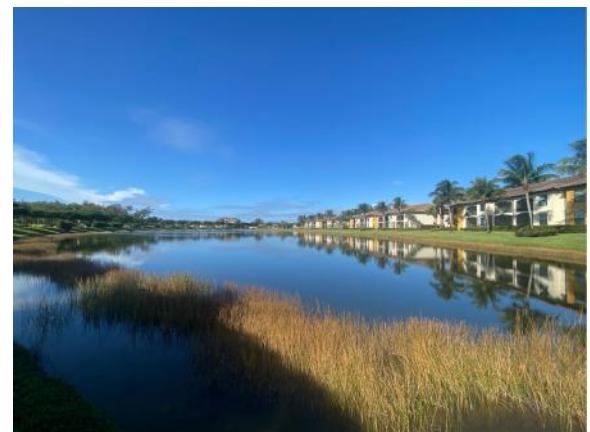
Site: 13**Comments:**

Treatment in progress

Shoreline is well maintained.
Submerged vegetation present
and receiving treatment.

Routine maintenance next visit

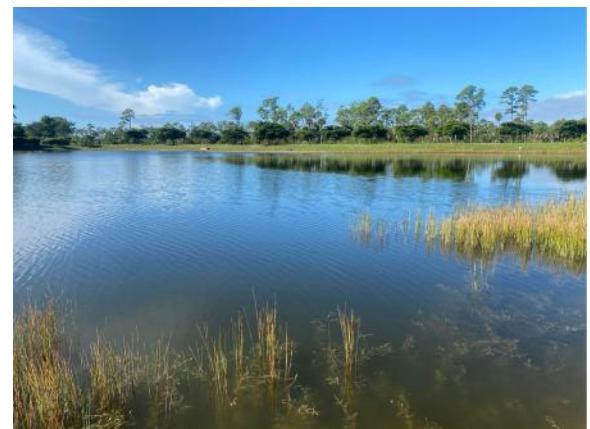
Site: 14**Comments:**

Treatment in progress

Shoreline is well maintained.
Submerged vegetation is present
and receiving treatment.

Routine maintenance next visit

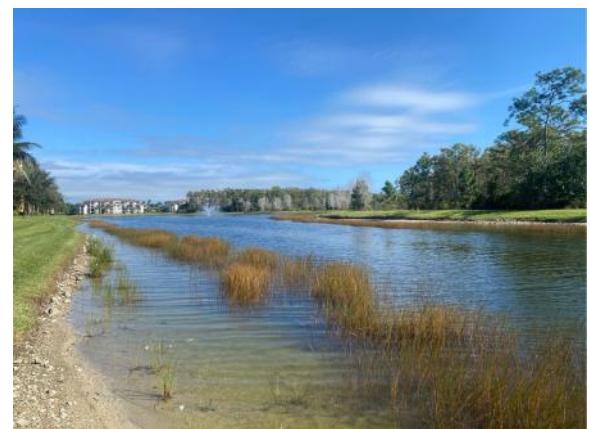
Site: 15**Comments:**

Site looks good

Shoreline is well maintained.
Algae and submerged vegetation
are at controlled levels.

Routine maintenance next visit

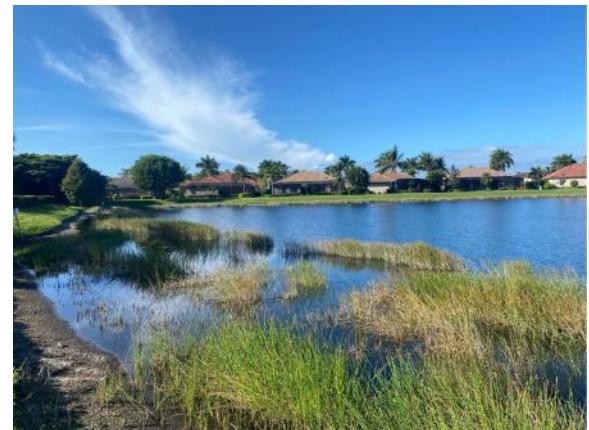
Site: 16**Comments:**

Site looks good

Shoreline is well maintained.
Algae and submerged vegetation
are at controlled levels.

Routine maintenance next visit

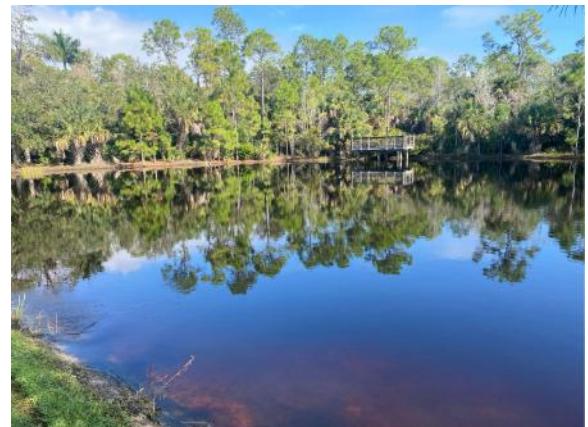
Site: 17**Comments:**

Site looks good

Shoreline is well maintained.
Algae and submerged vegetation
are at controlled levels.

Routine maintenance next visit

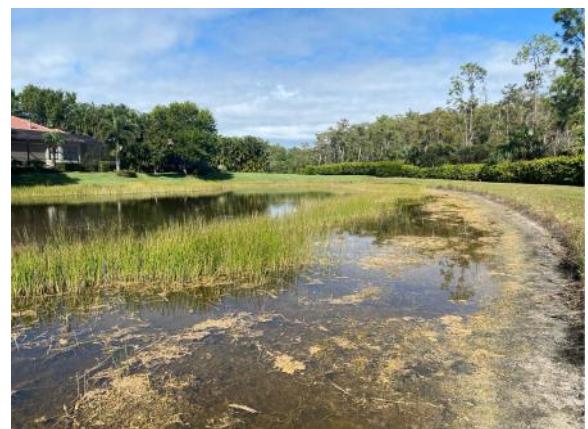
Site: 18**Comments:**

Requires attention

Surface algae present and requires treatment. Shoreline weeds are well maintained.

Treat within 7 days

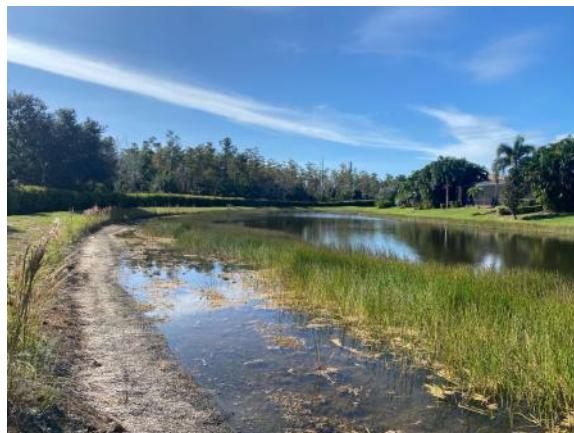
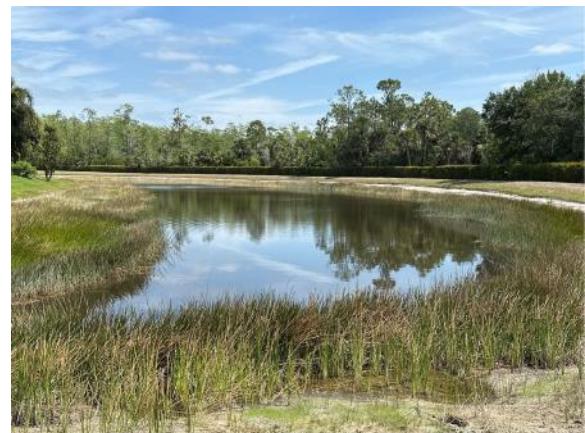
Site: 19**Comments:**

Requires attention

Shoreline is well maintained. Submerged Chara algae and surface algae present and require treatment.

Treat within 7 days

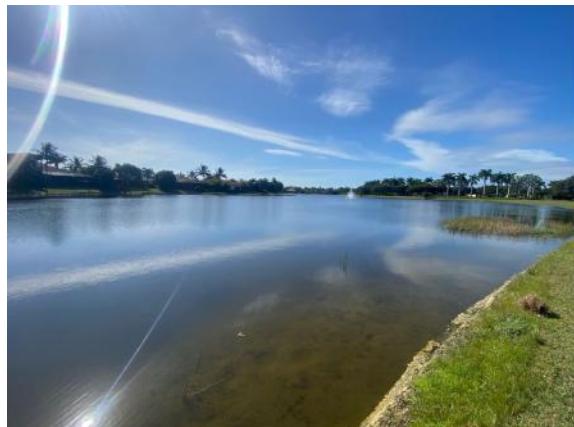
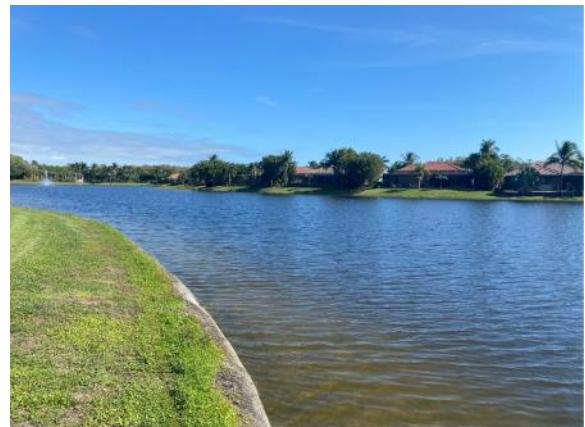
**Site: 20****Comments:**

Site looks good

Shoreline is well maintained. Algae and submerged vegetation are at controlled levels.

Routine maintenance next visit

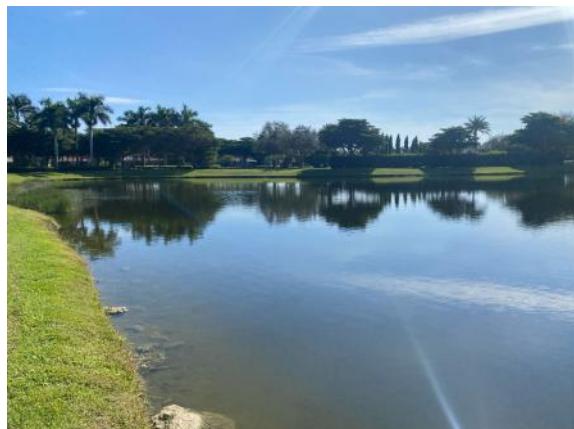
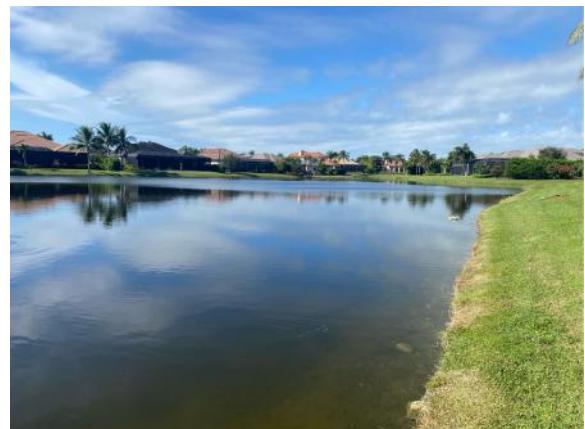
**Site: 21****Comments:**

Normal growth observed

Shoreline is well maintained. Minor surface/planktonic algae present.

Routine maintenance next visit

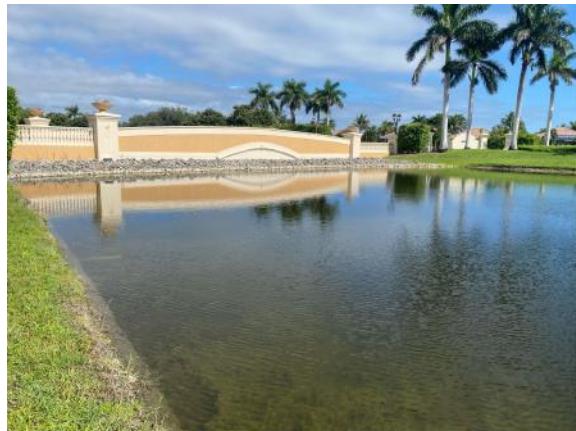
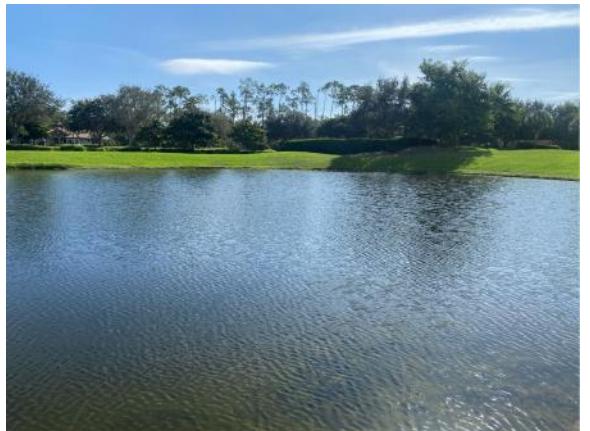
Site: 22**Comments:**

Normal growth observed

Shoreline is well maintained.
Charra present in lake and
requires treatment.

Treat within 7 days

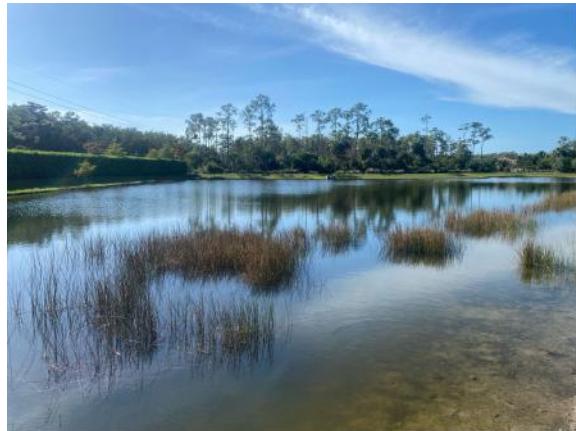
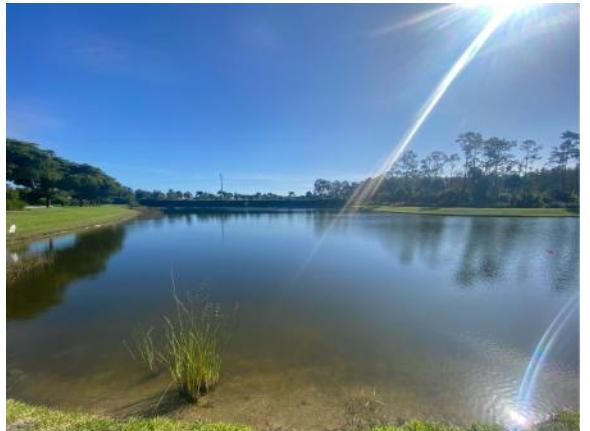
Site: 23**Comments:**

Site looks good

Shoreline is well maintained.
Algae and submerged vegetation
are at controlled levels.

Routine maintenance next visit

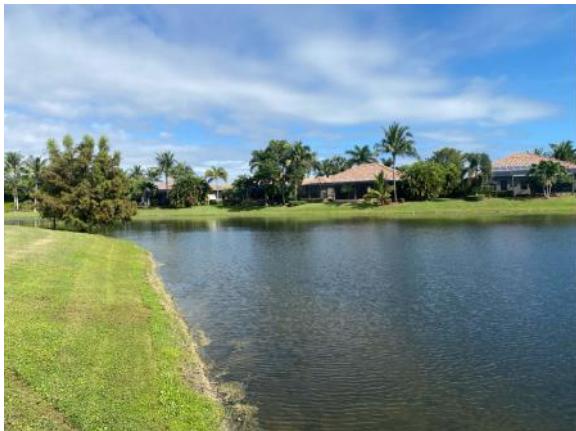
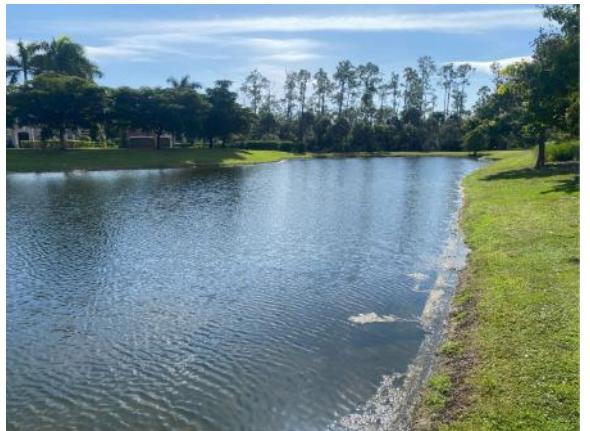
Site: 24**Comments:**

Normal growth observed

Shoreline is well maintained.
Minor surface algae present
around perimeter of the lake.

Routine maintenance next visit

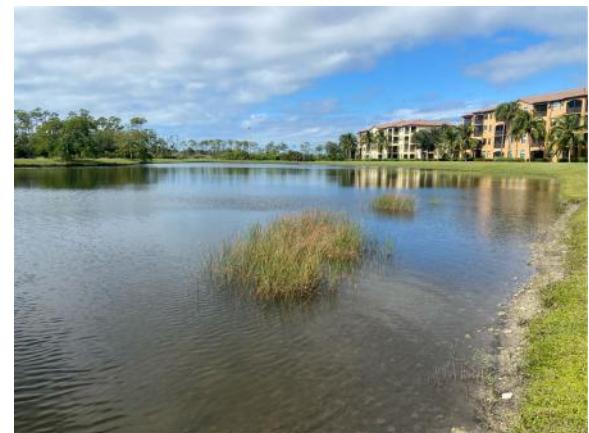
Site: 25**Comments:**

Site looks good

Shoreline is well maintained.
Algae and submersed vegetation
are at controlled levels.

Routine maintenance next visit

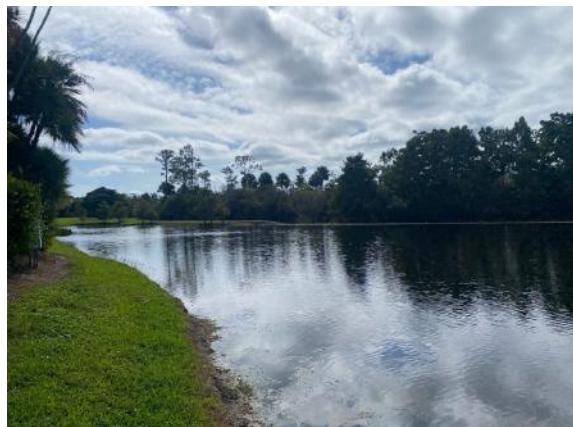
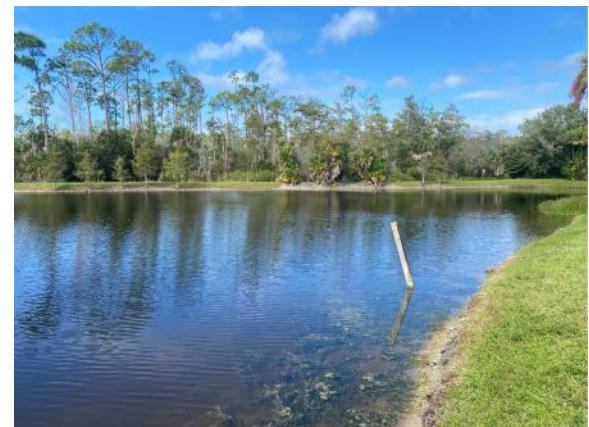
Site: 26**Comments:**

Normal growth observed

Shoreline is well maintained.
Some areas of submersed
vegetation present in lake.

Treat within 7 days

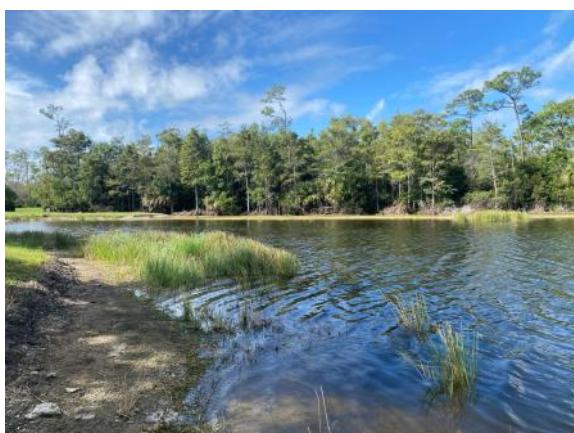
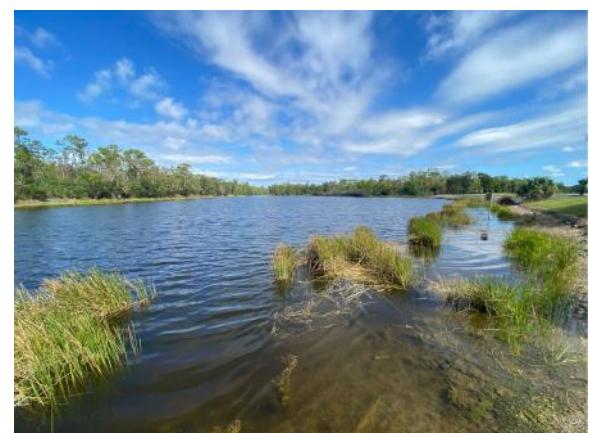
Site: 27**Comments:**

Normal growth observed

Shoreline is well maintained.
Submersed vegetation present in
areas of the lake.

Routine maintenance next visit

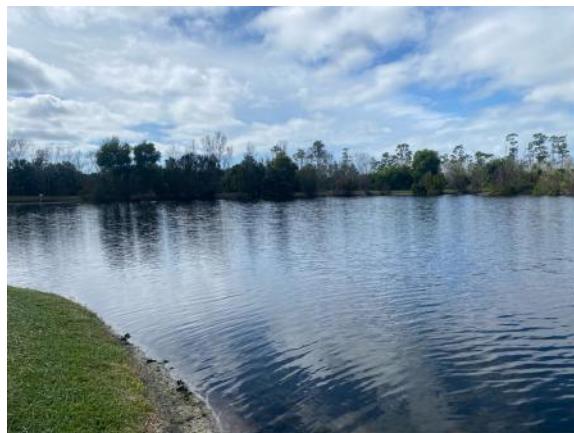
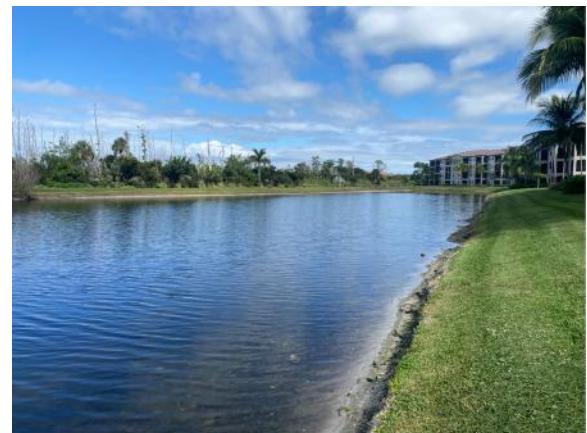
Site: 28**Comments:**

Site looks good

Shoreline is well maintained.
Submersed vegetation and algae
are at controlled levels.

Routine maintenance next visit

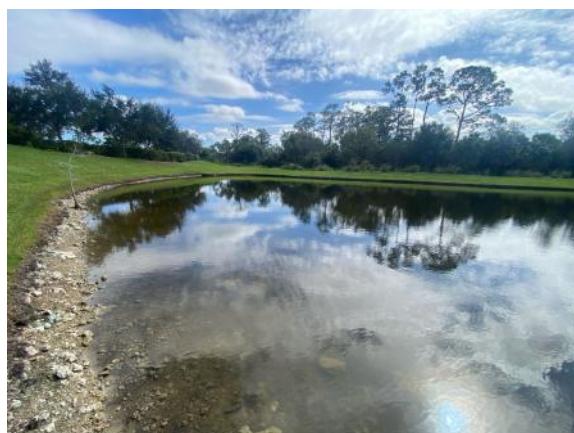
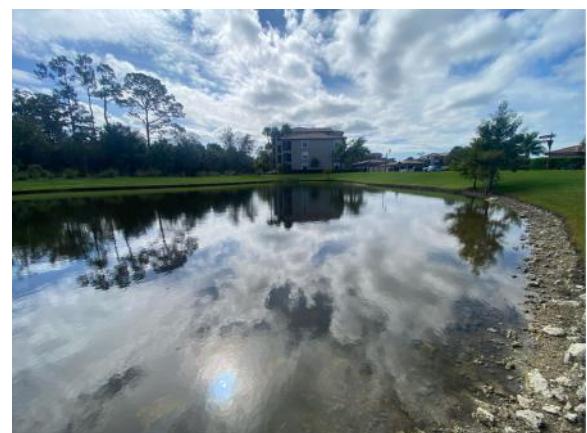
Site: 29**Comments:**

Site looks good

Shoreline is well maintained.
Algae and submerged vegetation
are at controlled levels.

Routine maintenance next visit

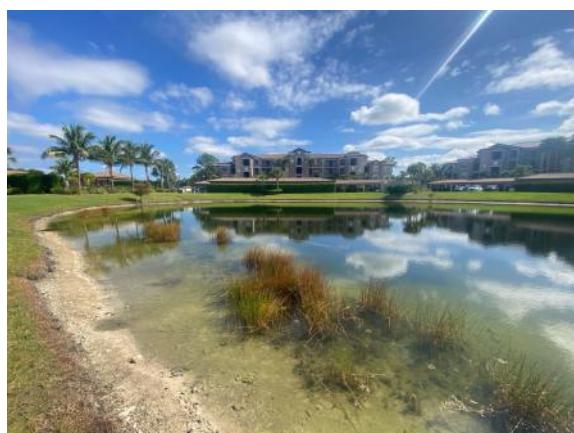
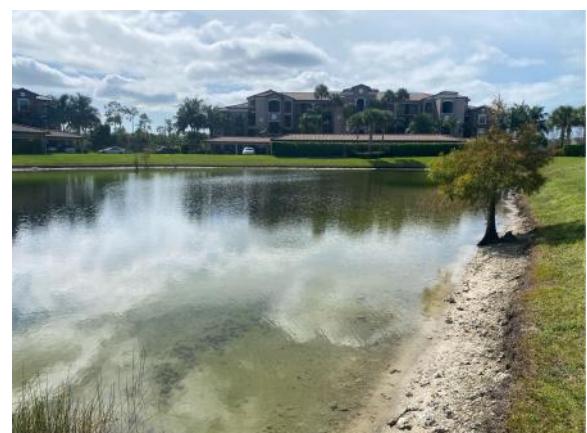
Site: 30**Comments:**

Site looks good

Shoreline is well maintained.
Submersed vegetation and algae
are at controlled levels.

Routine maintenance next visit

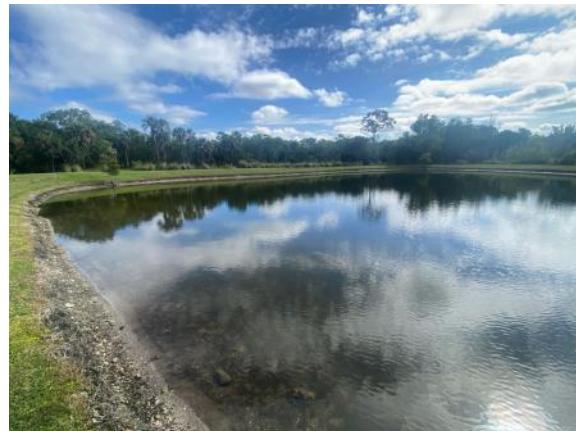
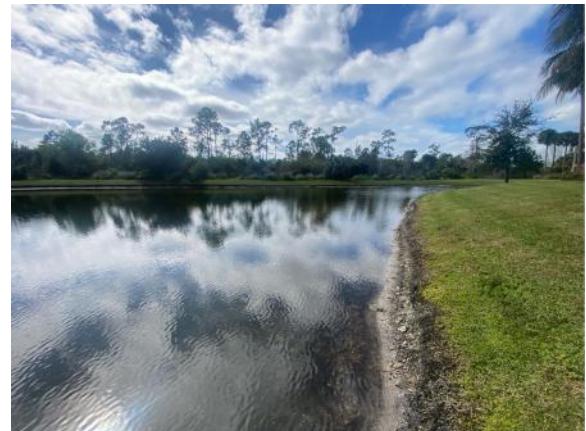
Site: 31**Comments:**

Site looks good

Shoreline is well maintained.
Algae and submersed vegetation
are at controlled levels.

Routine maintenance next visit

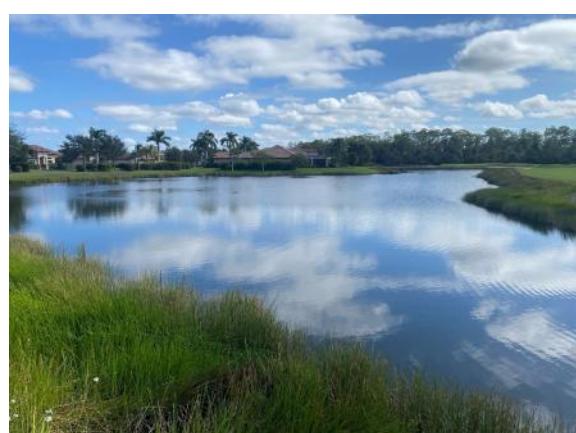
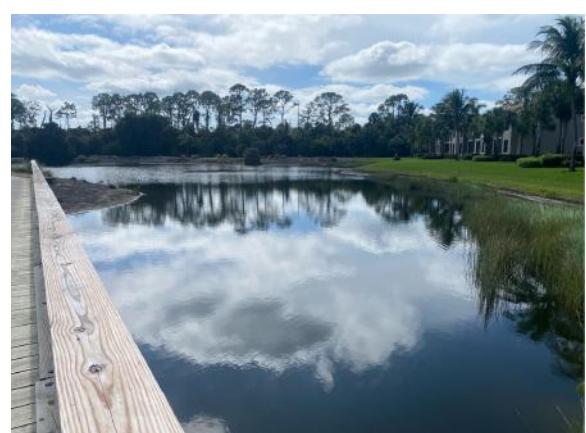
Site: 32**Comments:**

Normal growth observed

Shoreline is well maintained.
Minor patches of charra present in
lake.

Routine maintenance next visit

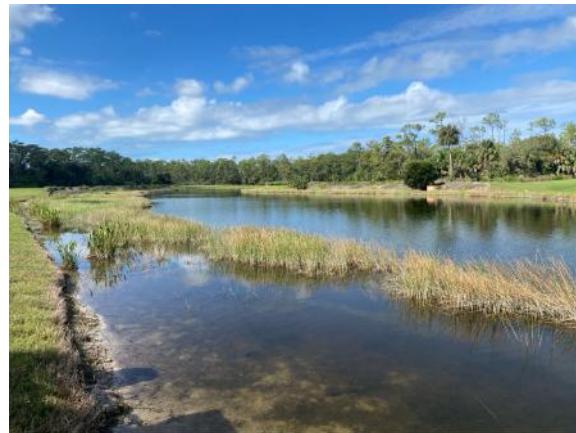
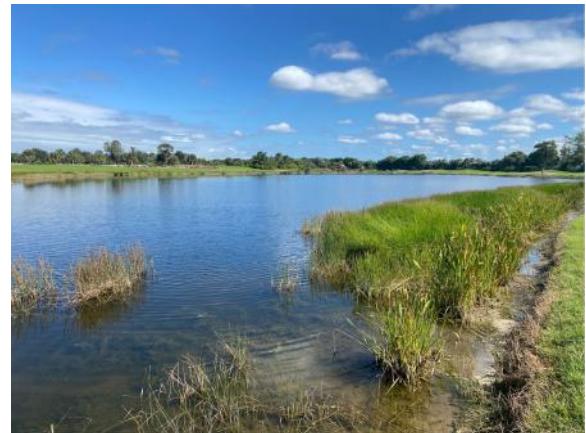
Site: 33**Comments:**

Normal growth observed

Shoreline is well maintained.
Algae present within littorals.
Areas of submerged vegetation
present in lake.

Routine maintenance next visit

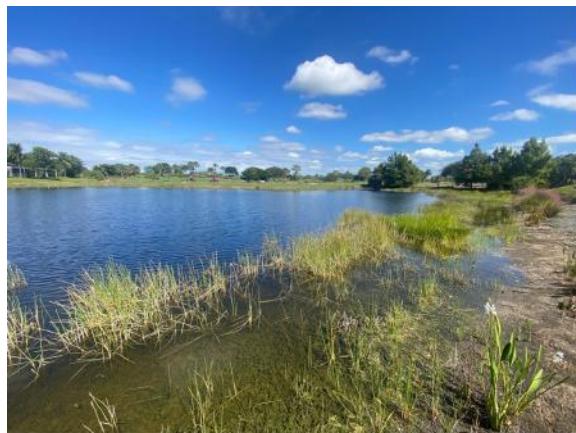
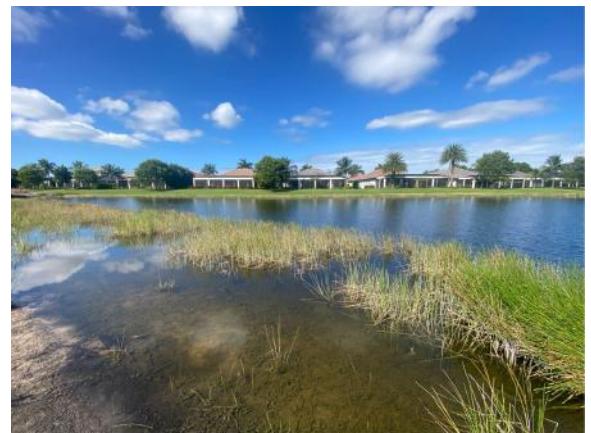
Site: 34**Comments:**

Normal growth observed

Shoreline is well maintained.
Submerged vegetation present in a few areas of the lake.

Treat within 7 days

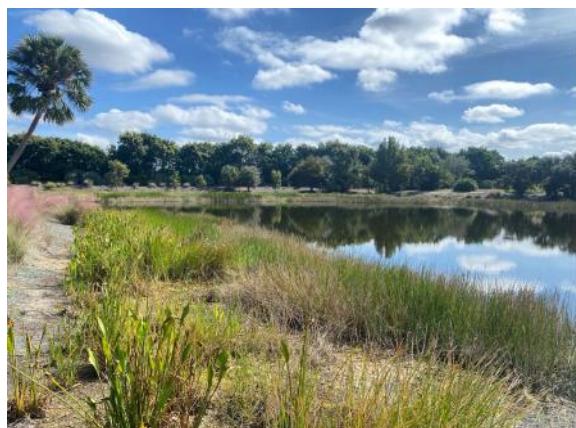
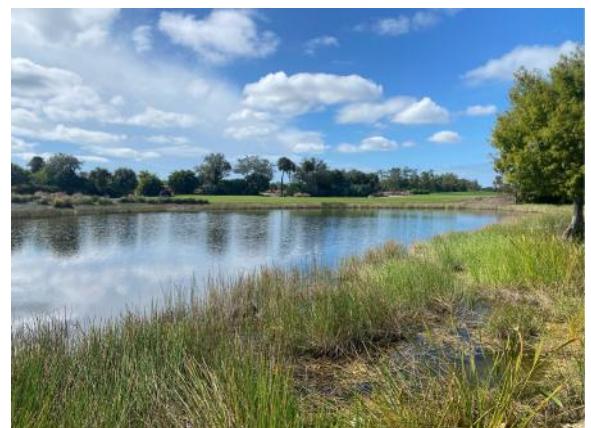
**Site: 35****Comments:**

Normal growth observed

Shoreline has minimal weed regrowth. Algae and submersed vegetation are at controlled levels.

Routine maintenance next visit

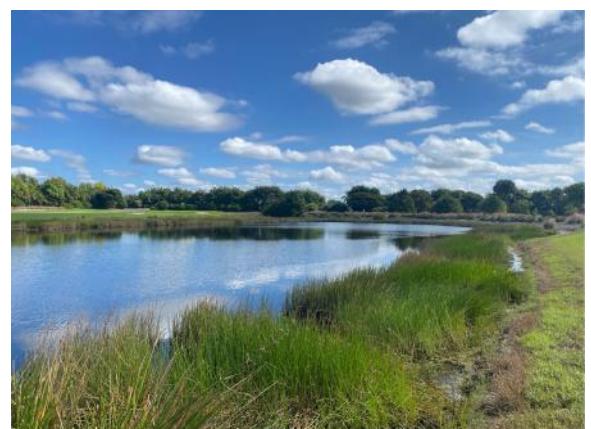
**Site: 36****Comments:**

Normal growth observed

Shoreline is well maintained.
Submersed vegetation is at controlled levels. Small amount of surface algae in littorals.

Routine maintenance next visit

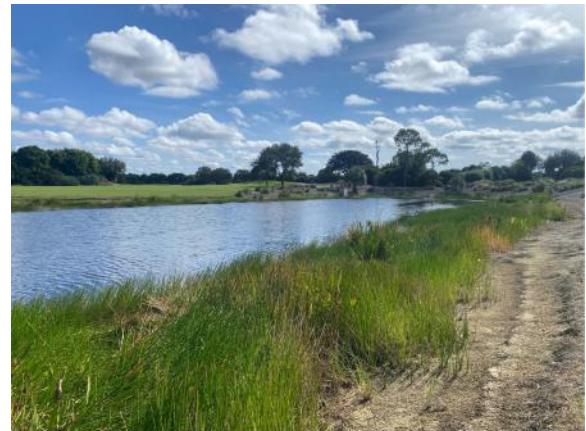
Site: 37**Comments:**

Site looks good

Shoreline is well maintained.
Algae and submerged vegetation
are at controlled levels.

Routine maintenance next visit

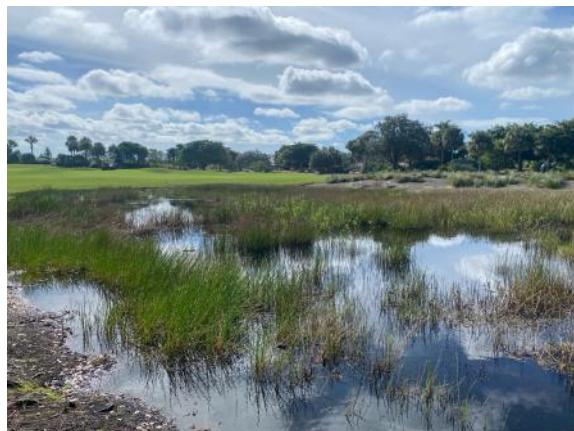
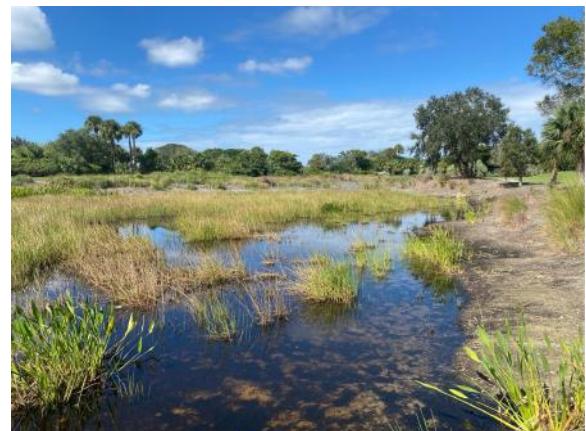
Site: 38**Comments:**

Normal growth observed

Shoreline is well maintained.
Some regrowth of shoreline
weeds observed.

Routine maintenance next visit

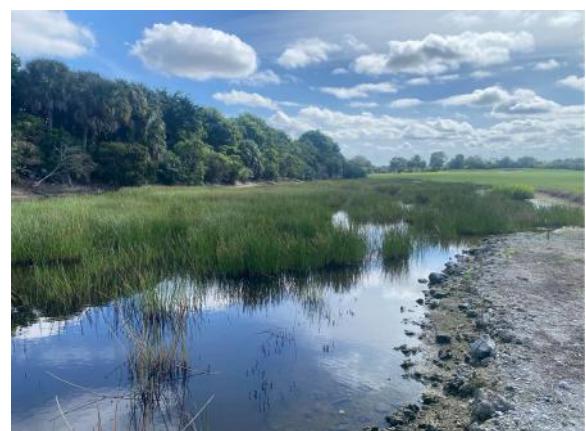
Site: 39**Comments:**

Site looks good

Shoreline is well maintained.
Algae and submerged vegetation
are at controlled levels.

Routine maintenance next visit

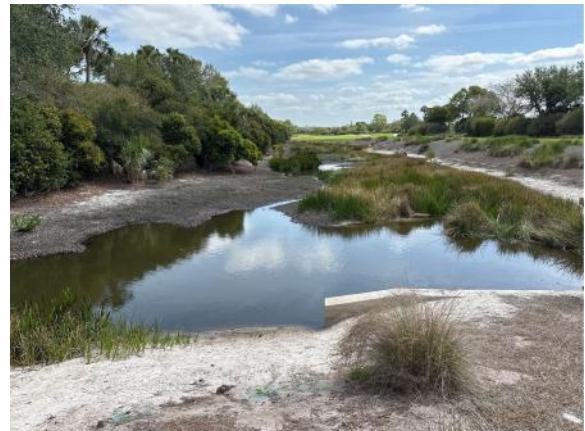
Site: 40**Comments:**

Site looks good

Shoreline is well maintained.
Algae and submerged vegetation
are at controlled levels.

Routine maintenance next visit

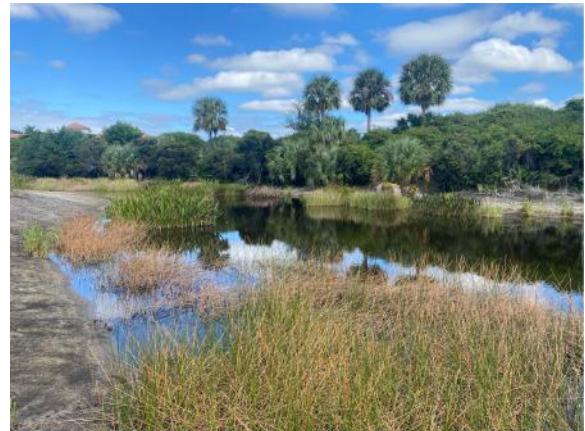
Site: 41**Comments:**

Site looks good

Shoreline is well maintained.
Algae and submerged vegetation
are at controlled levels.

Routine maintenance next visit

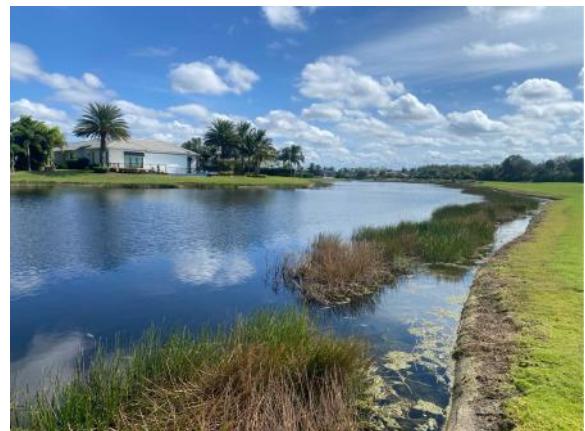
Site: 42**Comments:**

Requires attention

Shoreline is well maintained.
Some surface algae and
submerged vegetation present in
and around littorals.

Routine maintenance next visit
