Wentworth Estates CDD at Treviso Bay Waterway Inspection Report

Reason for Inspection: Routine Scheduled

Inspection Date: 2026-01-27

Mason Maher, Field Operations Manager- Environmental Scientist

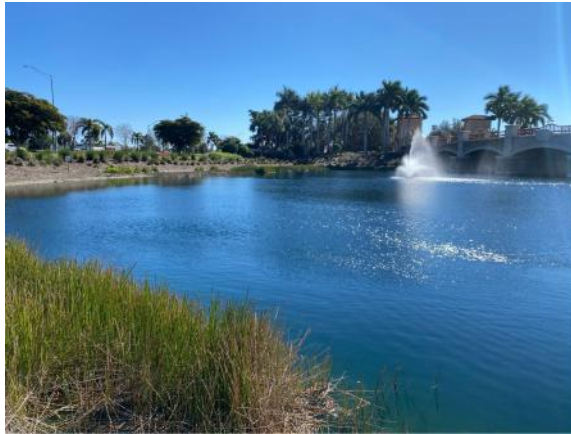
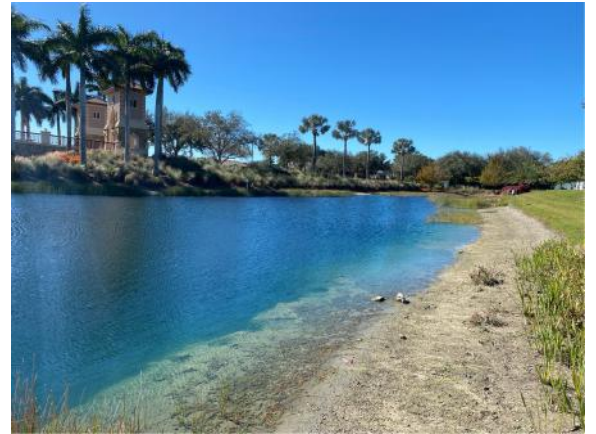
Site: 1

Site looks good

Shoreline is well maintained.
Algae and submerged vegetation are at controlled levels.

Routine maintenance next visit

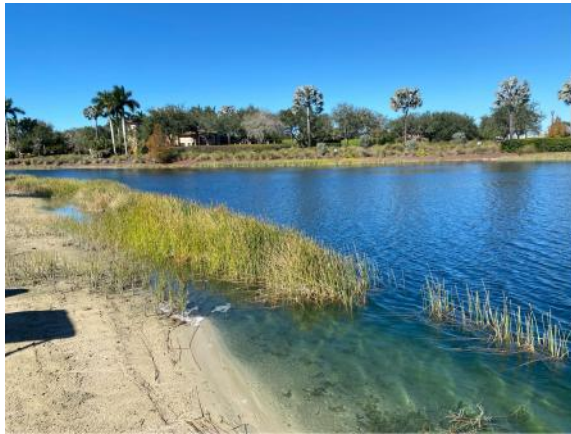
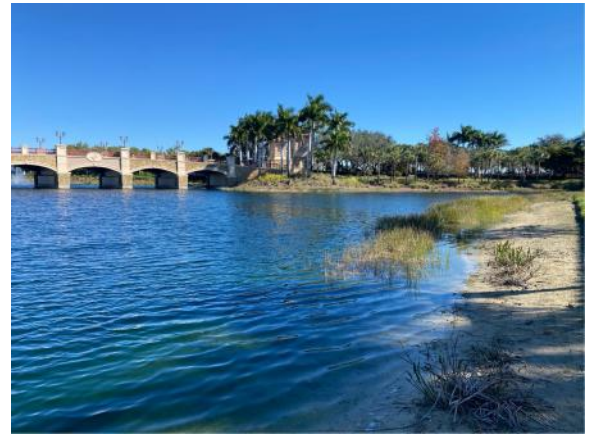
Site: 2

Site looks good

Shoreline is well maintained.
Algae and submerged vegetation are at controlled levels.

Routine maintenance next visit

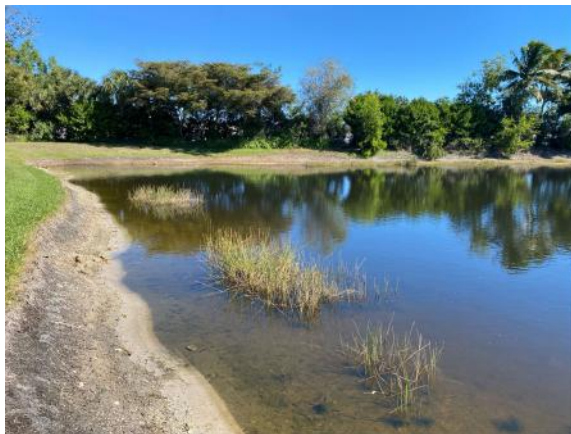
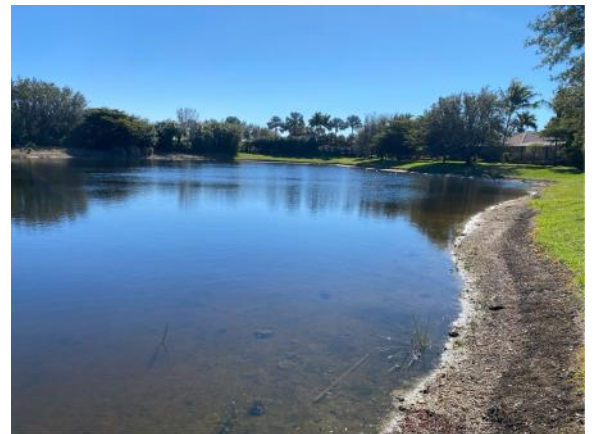
Site: 3

Site looks good

Shoreline is well maintained.
Algae and submerged vegetation are at controlled levels.

Routine maintenance next visit

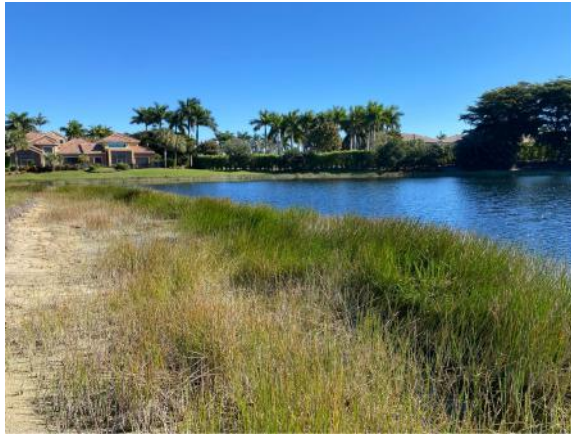
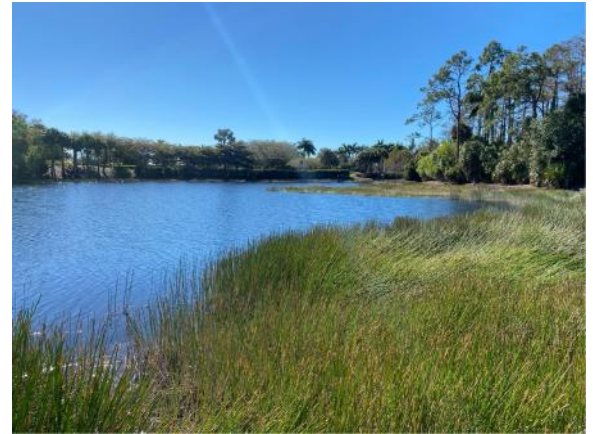
Site: 4

Site looks good
Shoreline is well maintained.
Submersed vegetation is at controlled levels.

Routine maintenance next visit

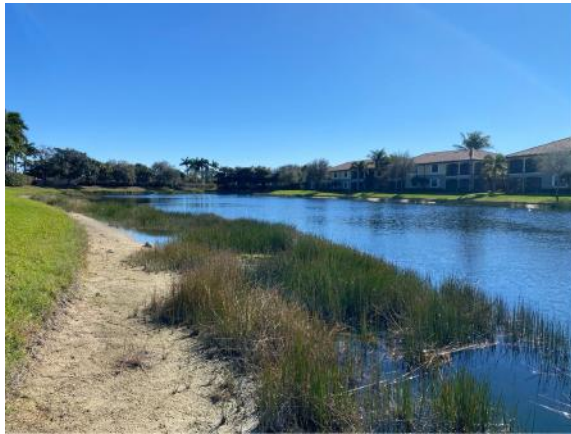
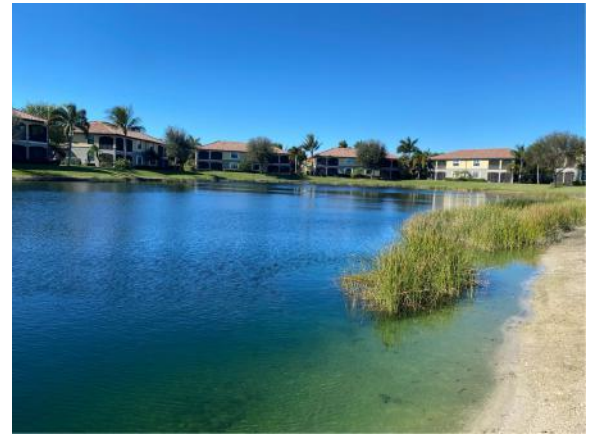
Site: 5

Site looks good
Shoreline is well maintained.
Algae and submersed vegetation are at controlled levels.

Routine maintenance next visit

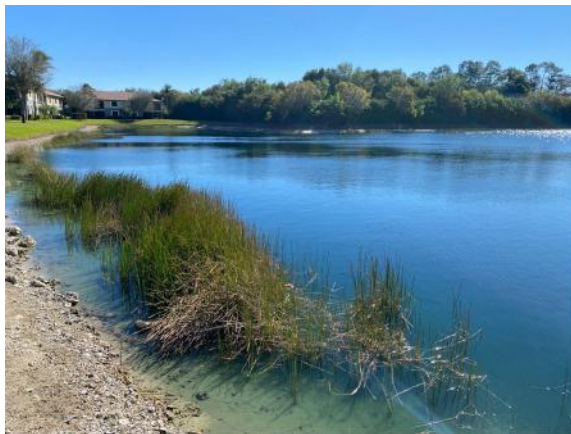
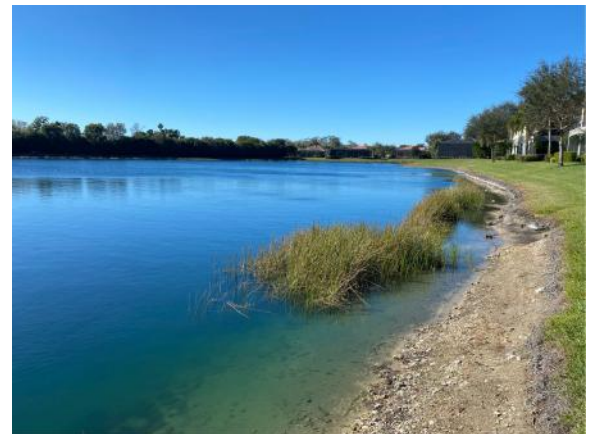
Site: 6

Site looks good
Shoreline is well maintained.
Algae and submersed vegetation are at controlled levels.

Routine maintenance next visit

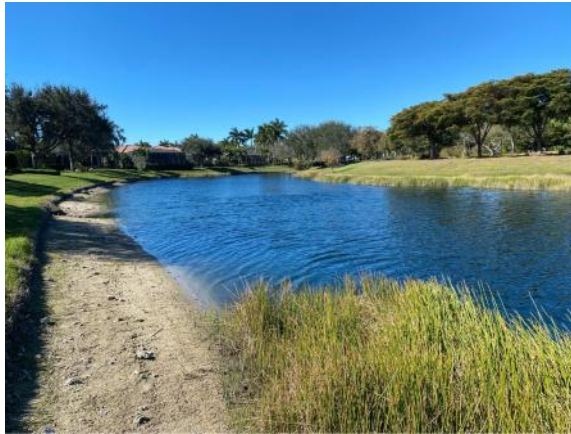
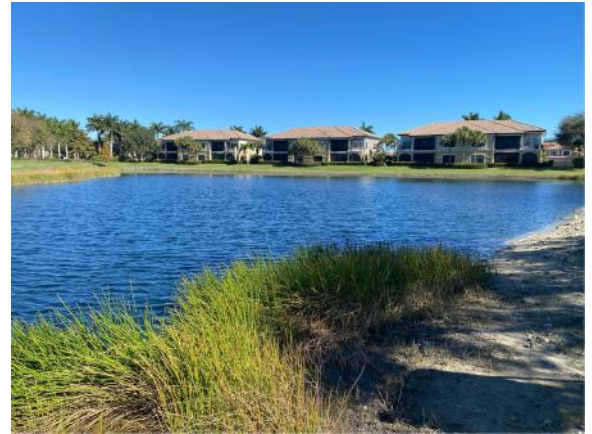
Site: 7

Site looks good
Shoreline is well maintained.
Algae and submerged vegetation are at controlled levels.

Routine maintenance next visit

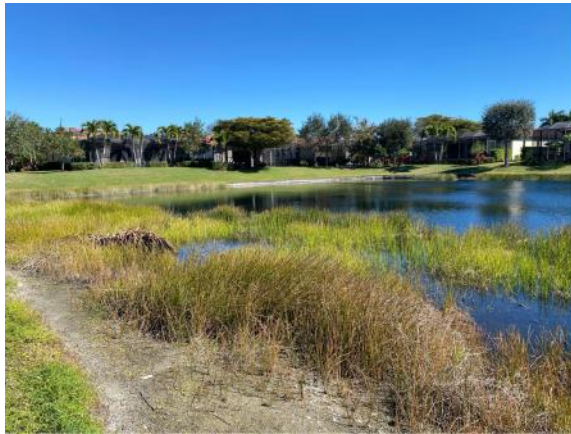
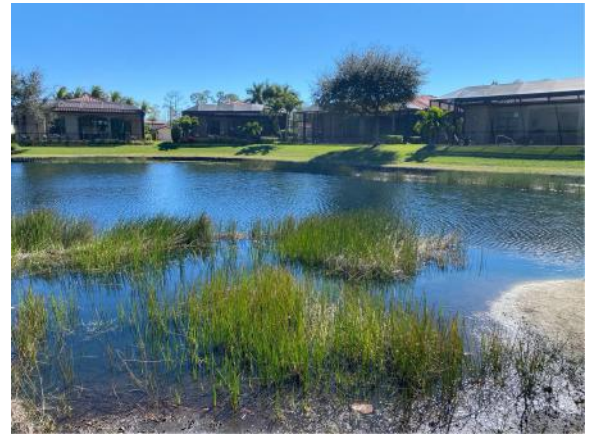
Site: 8

Site looks good
Shoreline is well maintained.
Algae and submerged vegetation are at controlled levels.

Routine maintenance next visit

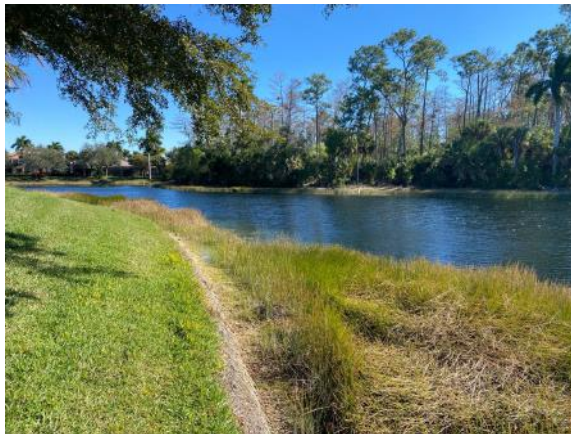
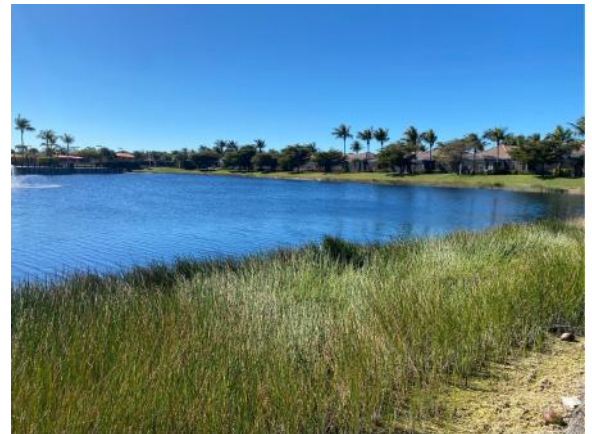
Site: 9

Site looks good
Minor regrowth of torpedo grass observed along shoreline. Algae and submerged vegetation are at controlled levels.

Routine maintenance next visit

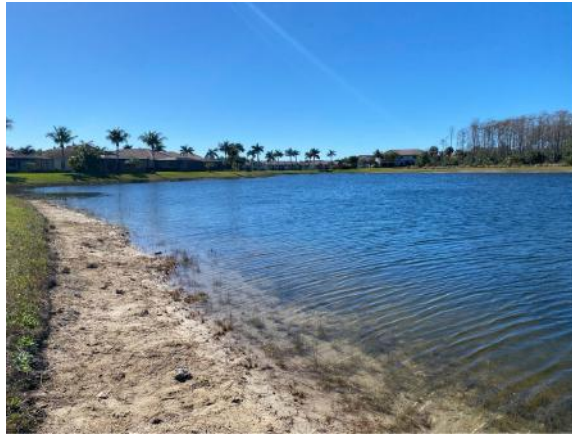
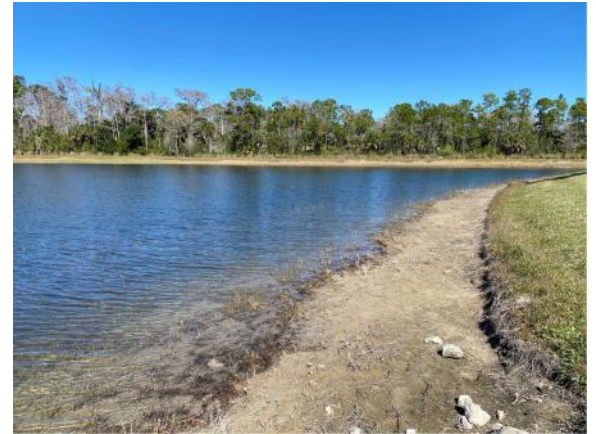
Site: 10

Site looks good
Shoreline is well maintained.
Algae and submerged vegetation are at controlled levels.

Routine maintenance next visit

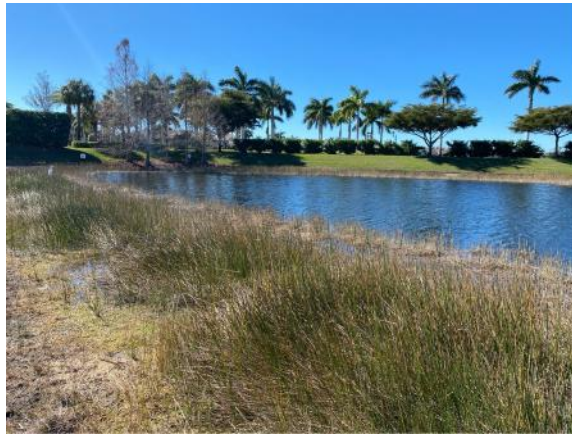
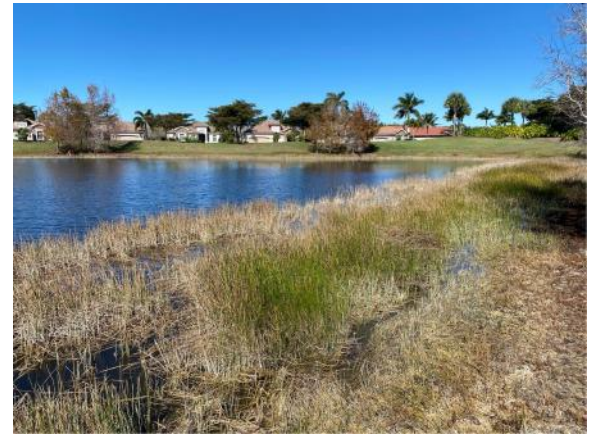
Site: 11

Normal growth observed
Shoreline is well maintained with some areas of regrowth present.
Algae and submersed vegetation is at controlled levels.

Routine maintenance next visit

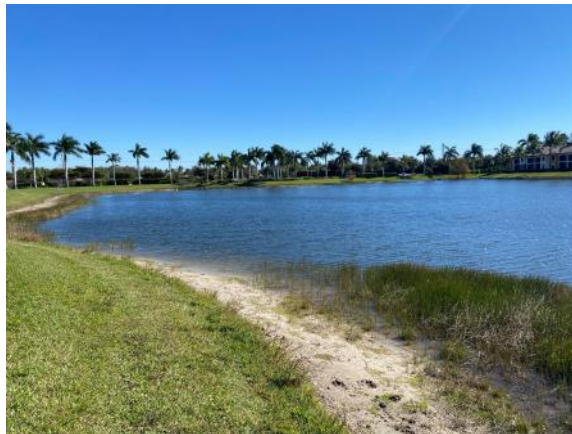
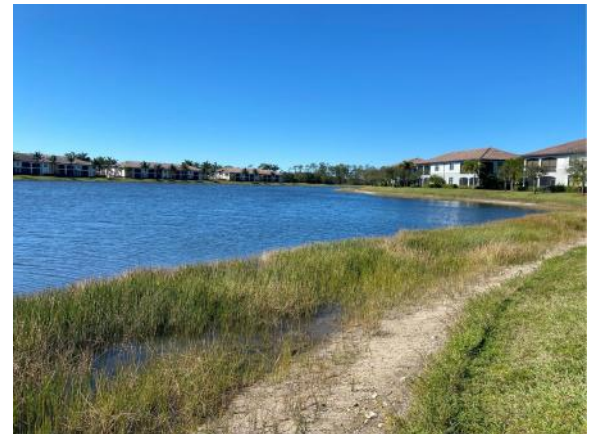
Site: 12

Site looks good
Shoreline is well maintained.
Algae and submerged vegetation are at controlled levels.

Routine maintenance next visit

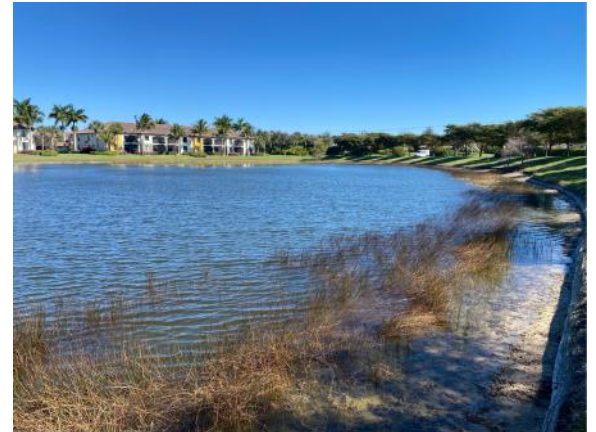
Site: 13

Normal growth observed

Shoreline is well maintained.
Submerged vegetation present and receiving treatment.

Routine maintenance next visit

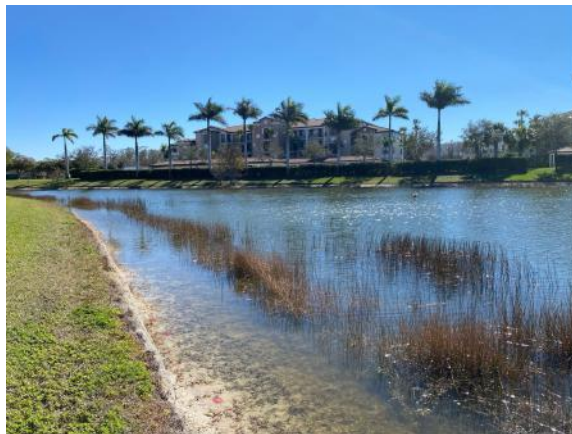
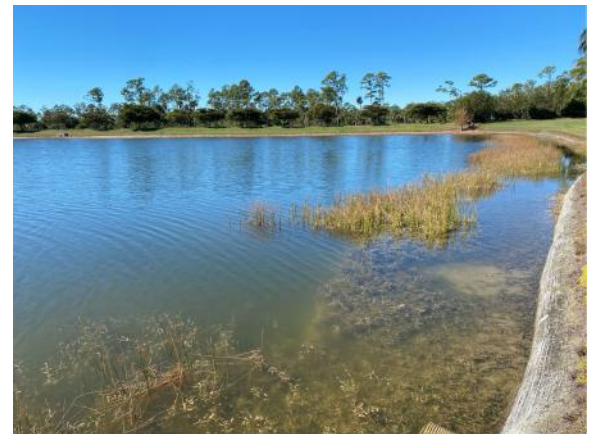
Site: 14

Treatment in progress

Shoreline is well maintained.
Submerged vegetation is present and is being treated.

Routine maintenance next visit

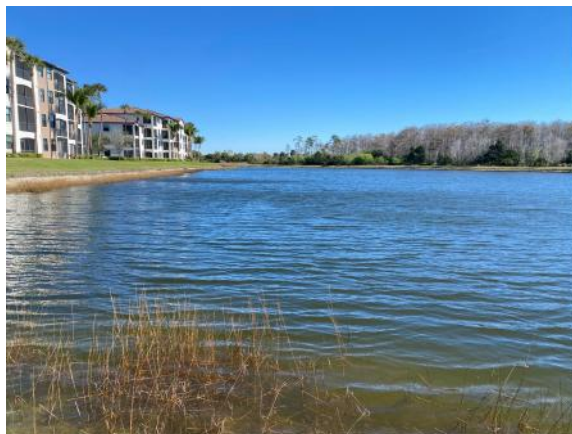
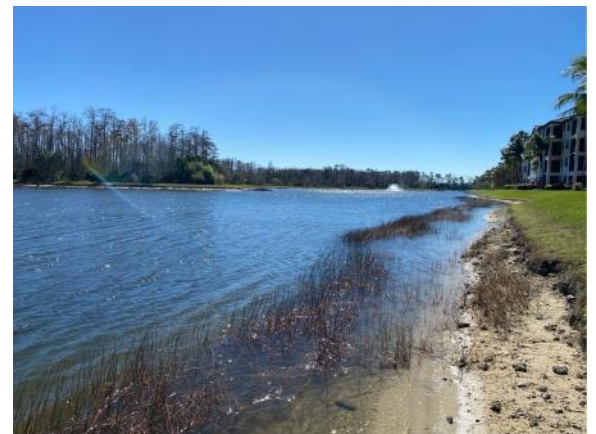
Site: 15

Site looks good

Shoreline is well maintained.
Algae and submerged vegetation are at controlled levels.

Routine maintenance next visit

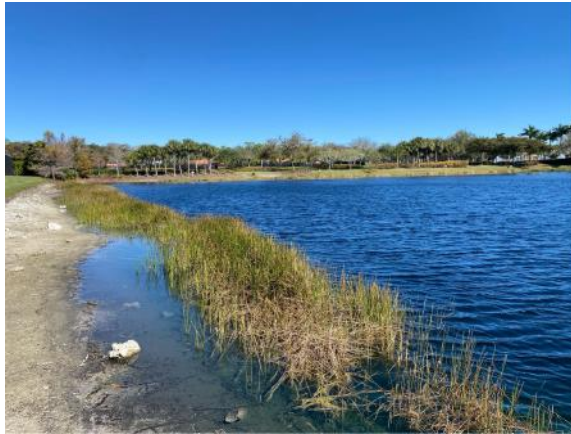
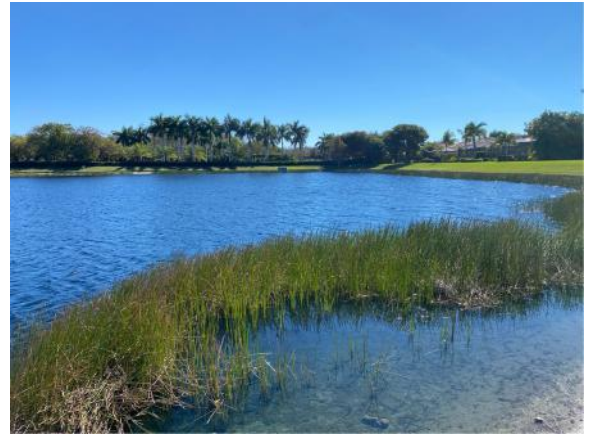
Site: 16

Site looks good

Shoreline is well maintained. Algae and submerged vegetation are at controlled levels.

Routine maintenance next visit

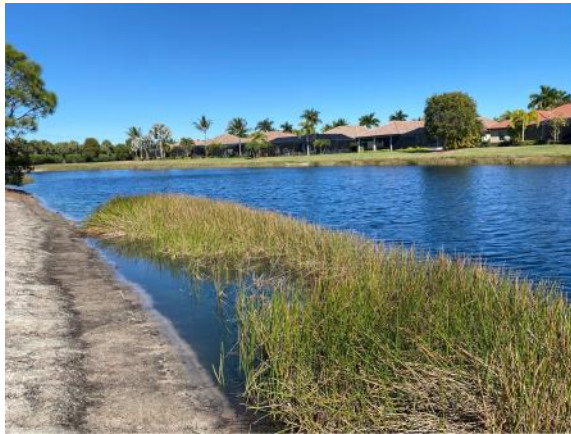
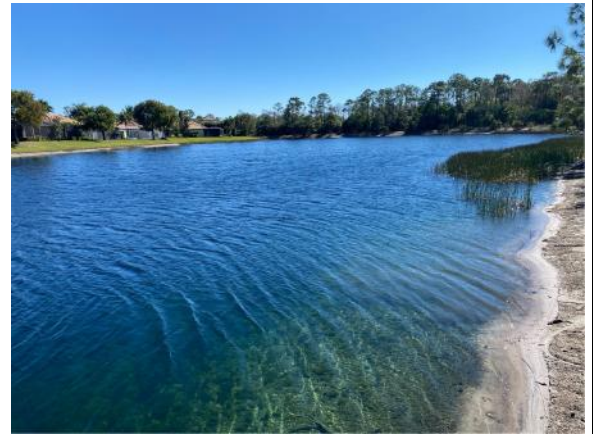
Site: 17

Site looks good

Shoreline is well maintained. Algae and submerged vegetation are at controlled levels.

Routine maintenance next visit

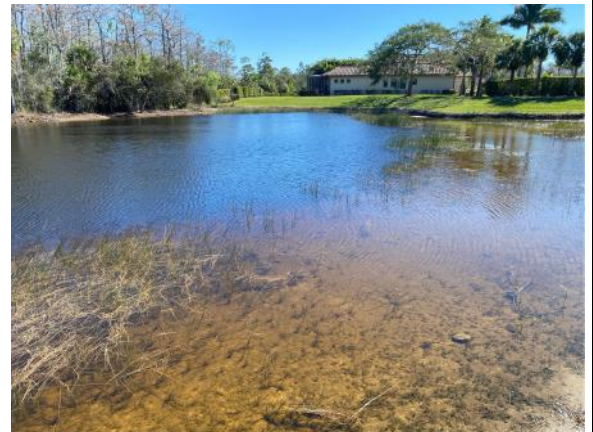
Site: 18

Normal growth observed

Shoreline is well maintained. Algae and submerged vegetation are at controlled levels.

Routine maintenance next visit

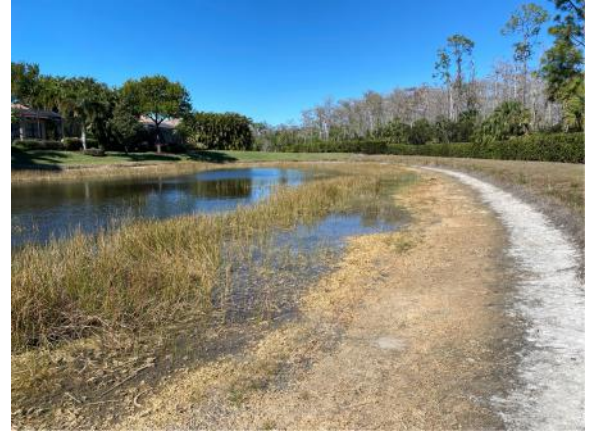
Site: 19

Treatment in progress

Shoreline is well maintained. Tall broom grass observed in landscape buffer zone. Minor algae present within littorals.

Routine maintenance next visit

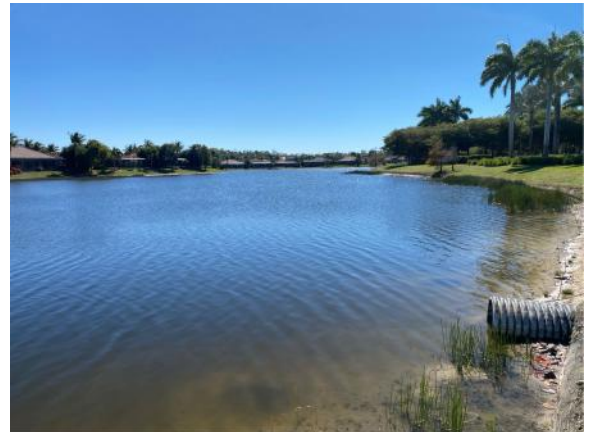
Site: 20

Site looks good

Shoreline is well maintained. Algae and submerged vegetation are at controlled levels.

Routine maintenance next visit

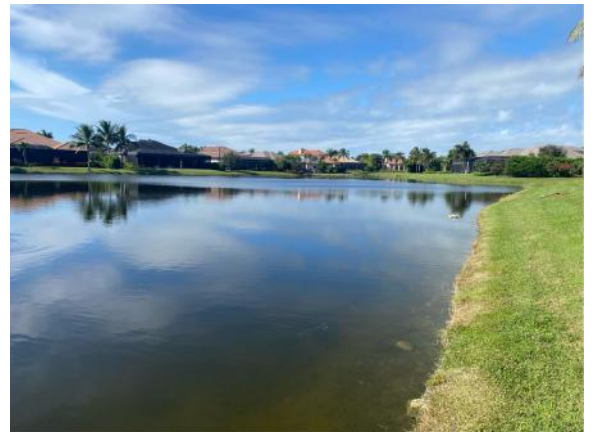
Site: 21

Normal growth observed

Shoreline is well maintained. Algae and submerged vegetation are at controlled levels.

Routine maintenance next visit

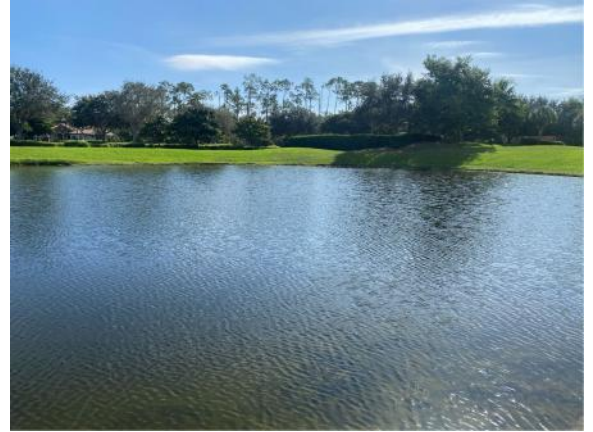
Site: 22

Normal growth observed

Shoreline is well maintained. Minor charra observed in lake has been treated.

Re-inspect next visit

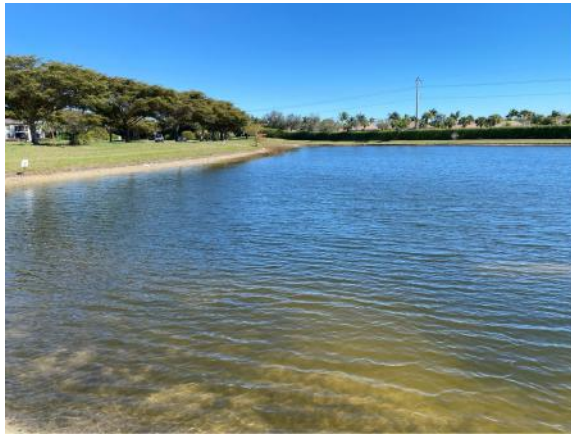
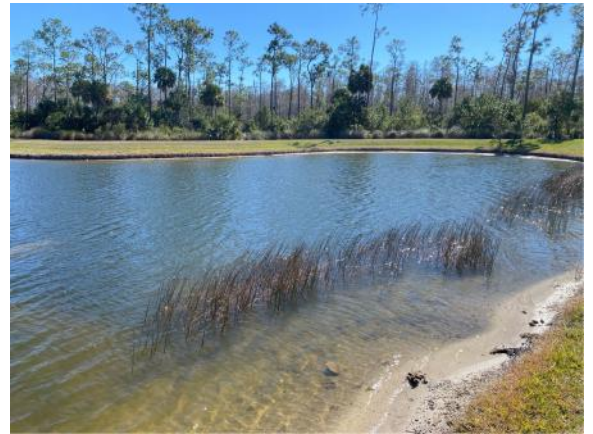
Site: 23

Site looks good

Shoreline is well maintained. Algae and submerged vegetation are at controlled levels.

Routine maintenance next visit

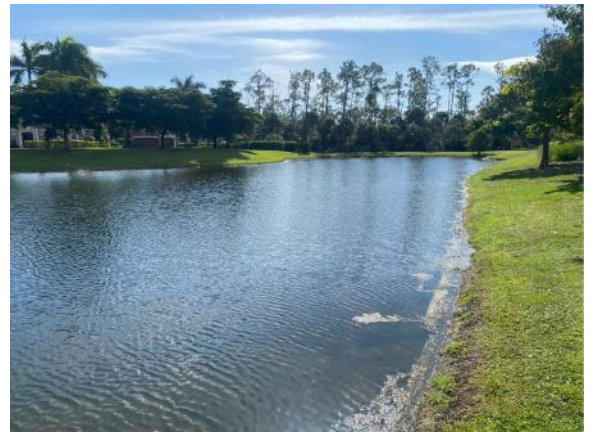
Site: 24

Normal growth observed

Shoreline is well maintained. Minor surface algae present around perimeter of the lake.

Routine maintenance next visit

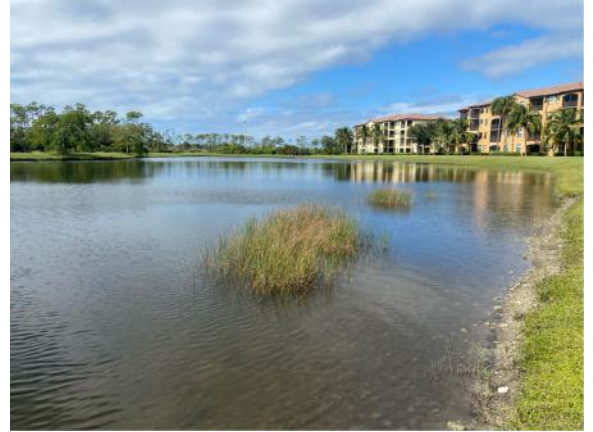
Site: 25

Site looks good

Shoreline is well maintained. Algae and submersed vegetation are at controlled levels.

Routine maintenance next visit

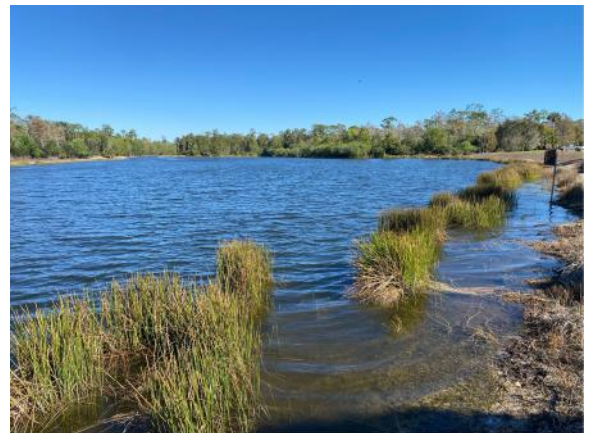
Site: 26

Treatment in progress

Shoreline is well maintained. Some areas of submerged vegetation present in lake.

Treat within 7 days

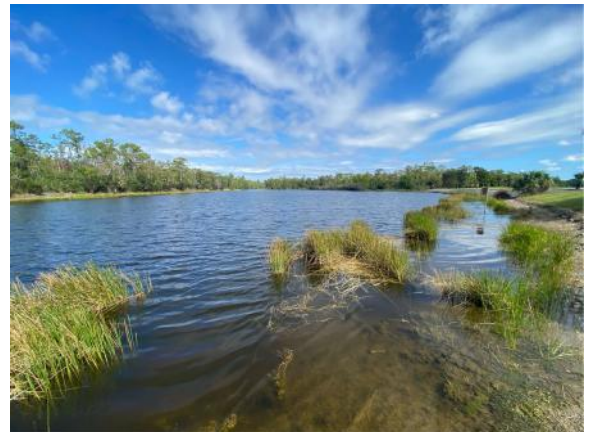
Site: 27

Normal growth observed

Shoreline is well maintained. Algae and submersed vegetation are at controlled levels.

Routine maintenance next visit

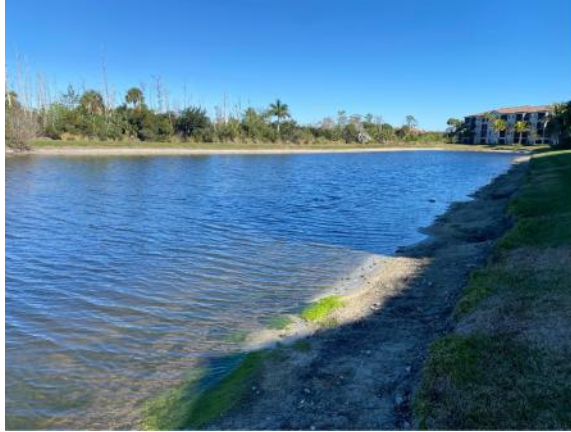
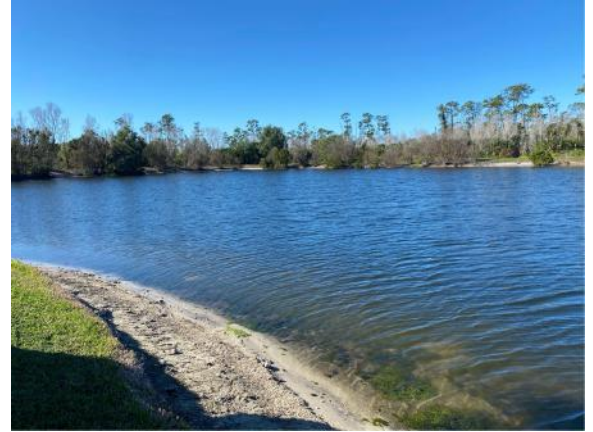
Site: 28

Normal growth observed

Shoreline is well maintained. Submersed vegetation and algae are at controlled levels.

Routine maintenance next visit

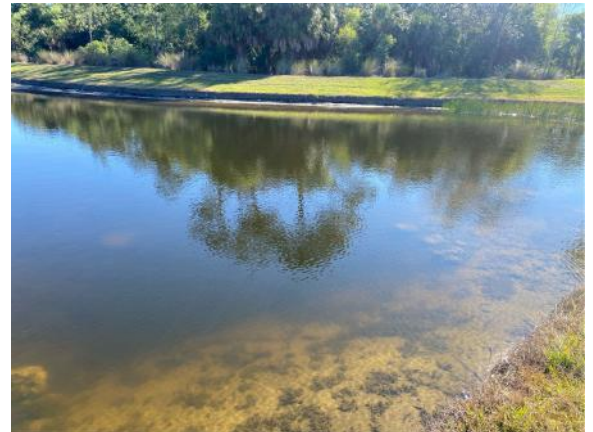
Site: 29

Treatment in progress

Shoreline is well maintained. Minor charra present in lake has been treated.

Re-inspect next visit

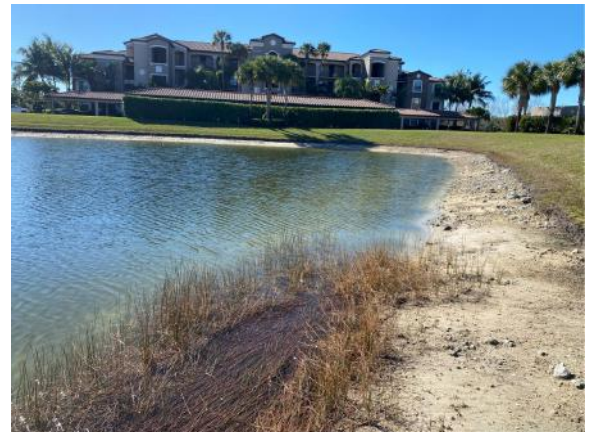
Site: 30

Site looks good

Shoreline is well maintained. Submersed vegetation and algae are at controlled levels.

Routine maintenance next visit

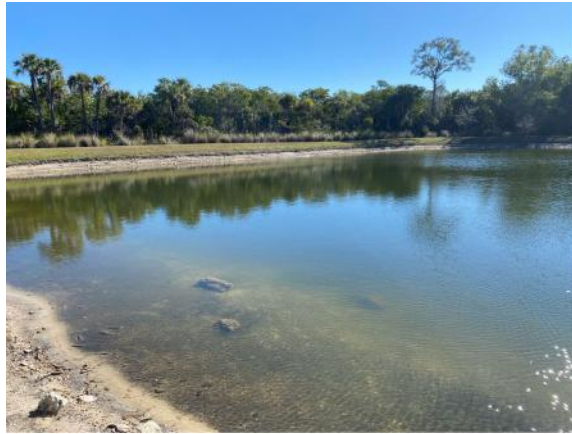
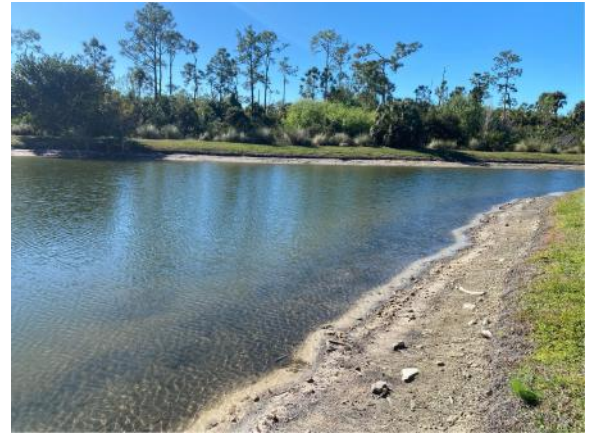
Site: 31

Site looks good
Shoreline is well maintained.
Algae and submersed vegetation
are at controlled levels.

Routine maintenance next visit

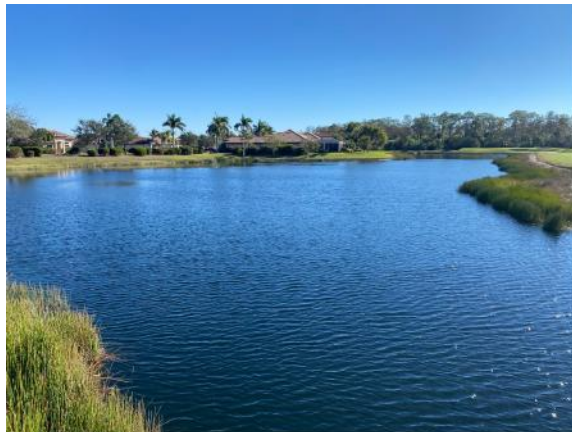
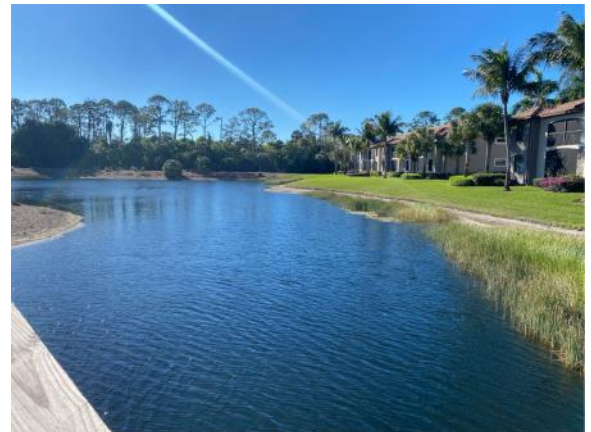
Site: 32

Normal growth observed
Shoreline is well maintained.
Algae and submersed vegetation
are at controlled levels.

Routine maintenance next visit

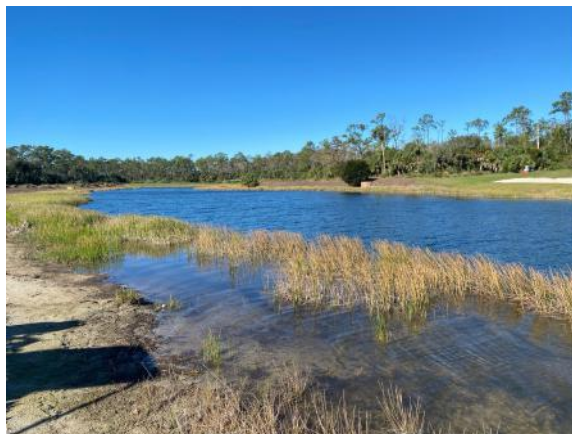
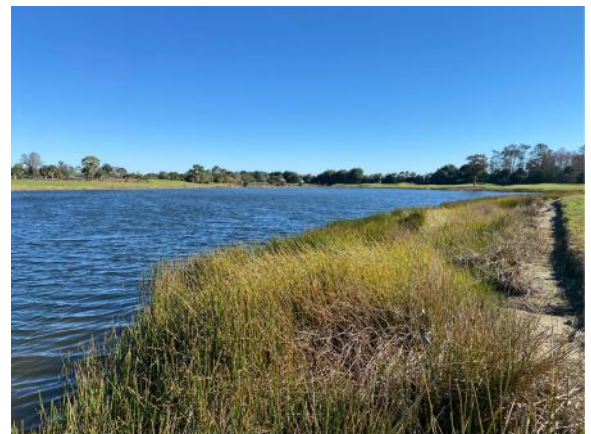
Site: 33

Site looks good
Shoreline is well maintained.
Algae and submersed vegetation
are at controlled levels.

Routine maintenance next visit

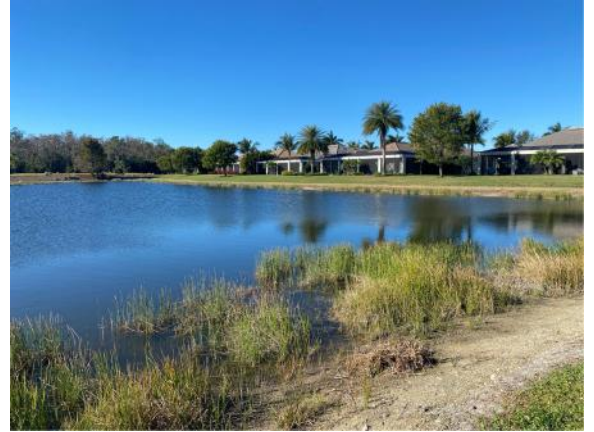
Site: 34

Normal growth observed

Shoreline is well maintained.
Minor charra present in lake has been treated.

Re-inspect next visit

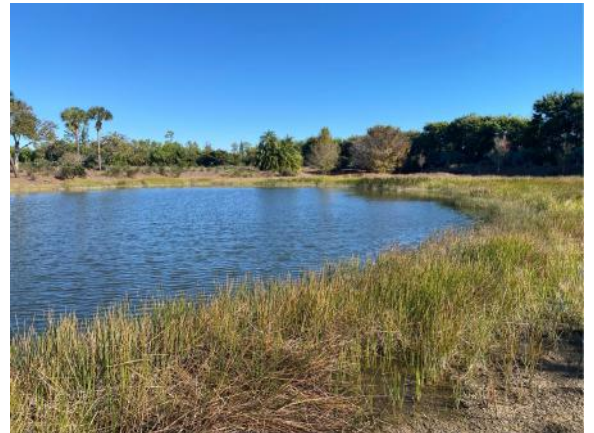
Site: 35

Site looks good

Shoreline is well maintained.
Algae and submersed vegetation are at controlled levels.

Routine maintenance next visit

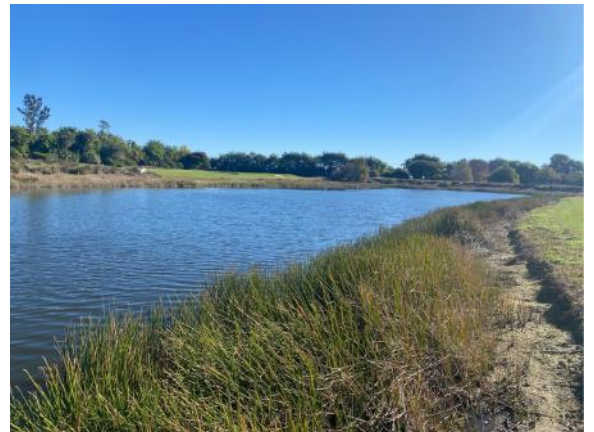
Site: 36

Site looks good

Shoreline is well maintained.
Algae and submersed vegetation are at controlled levels.

Routine maintenance next visit

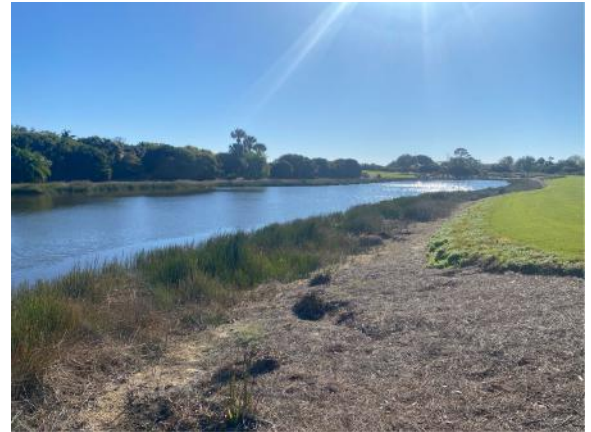
Site: 37

Site looks good
Shoreline is well maintained.
Algae and submerged vegetation are at controlled levels.

Routine maintenance next visit

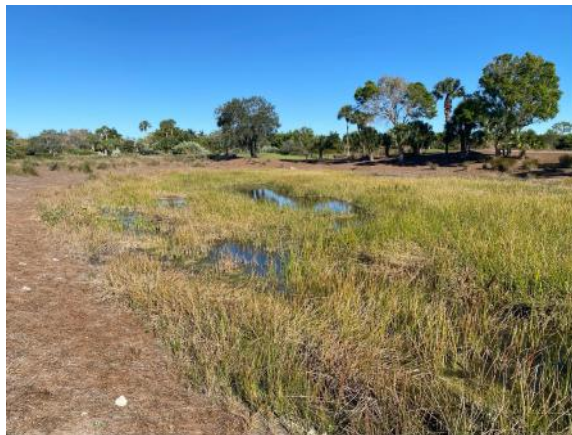
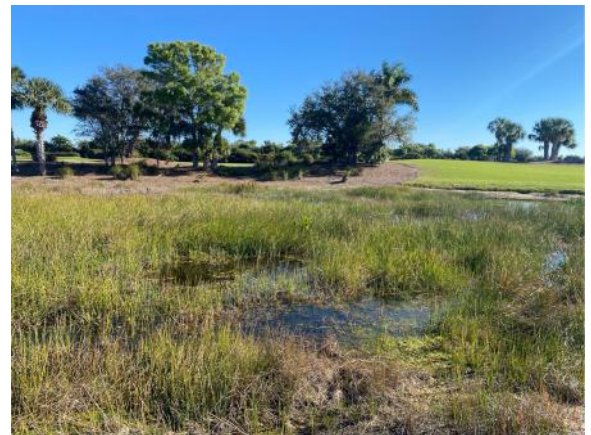
Site: 38

Normal growth observed
Shoreline is well maintained.
Algae and submerged vegetation are at controlled levels. Area is quite dry due to drought conditions and evaporation.

Routine maintenance next visit

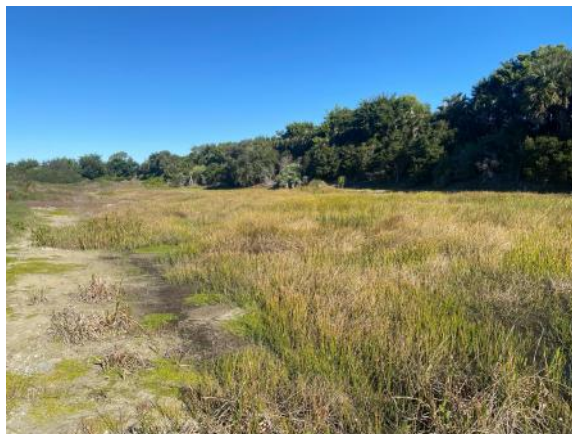
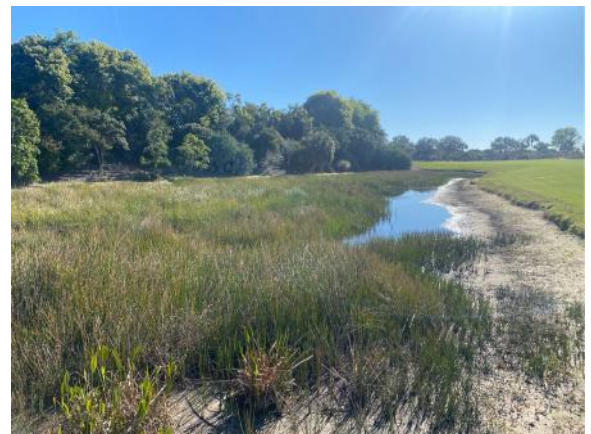
Site: 39

Site looks good
Shoreline is well maintained.
Area is quite dry due to drought conditions and evaporation.

Routine maintenance next visit

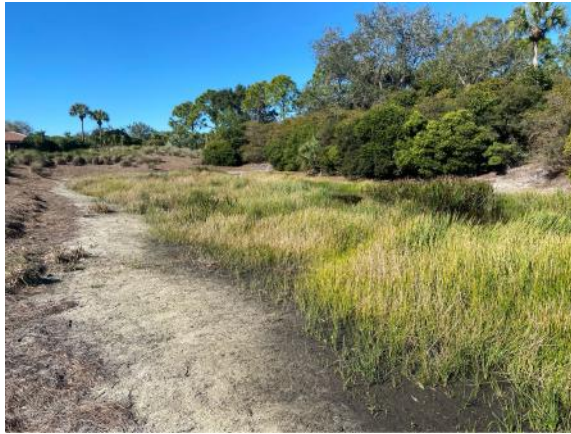
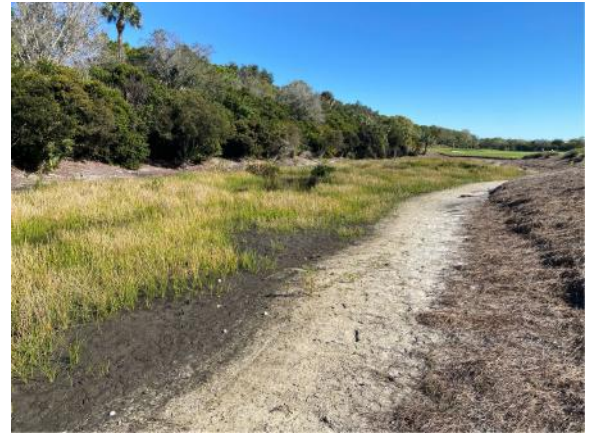
Site: 40

Site looks good
Shoreline is well maintained.
Area is quite dry due to drought conditions and evaporation.

Routine maintenance next visit

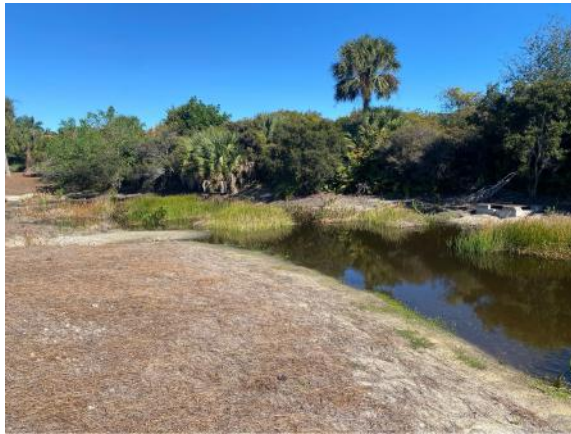
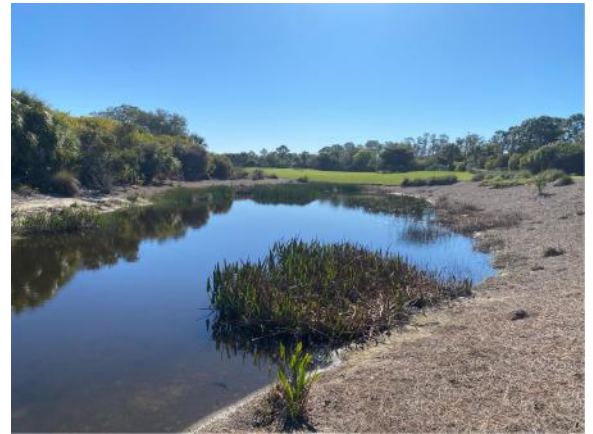
Site: 41

Site looks good
Shoreline is well maintained.
Algae and submerged vegetation are at controlled levels. Erosion present.

Routine maintenance next visit

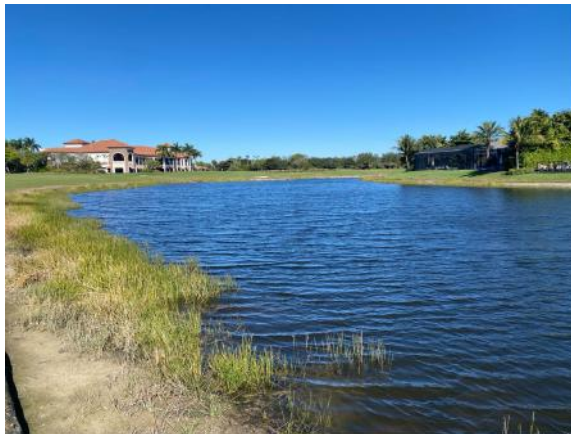
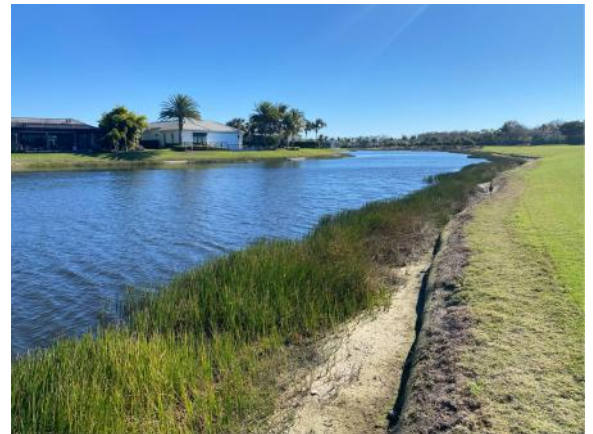
Site: 42

Normal growth observed
Shoreline is well maintained.
Area is quite dry due to drought conditions and evaporation.

Routine maintenance next visit
