# MIROMAR LAKES COMMUNITY DEVELOPMENT DISTRICT

Monthly Asset Manager's Report December 2023

CGA Project No. 13-5692 January 1, 2024

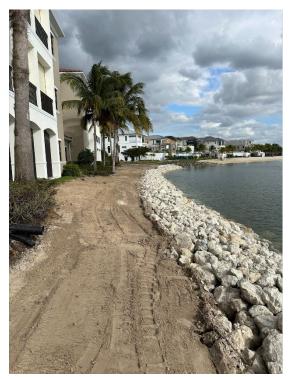
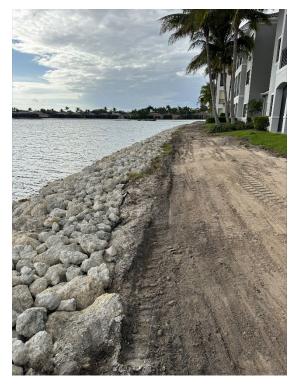
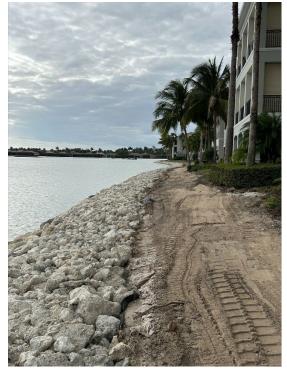
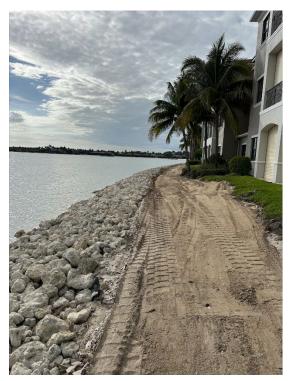
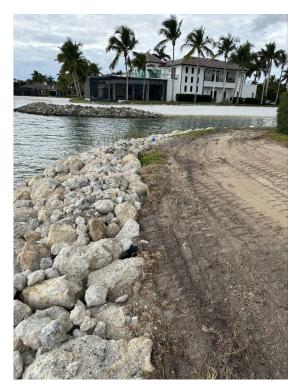
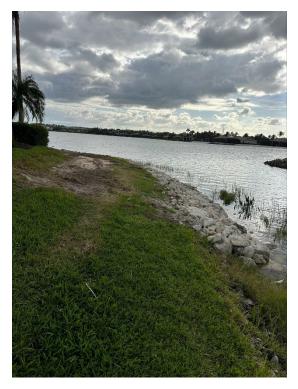
- The riprap vendor has completed the installation in Ravenna and is currently working on bank sod restoration.
- The aquatic vendor needs to stay on top of floating weeds and vegetation.

Rip Rap restoration in Ravenna.
