*Miromar Lakes Community Development District*

*Regular Meeting Agenda*

To: James Ward – District Manager  
From: Charles Krebs, P.E.  
Date: July 28, 2017  
Subject: Miromar Lakes CDD – Peninsula Phase III Lake  
Banks

**HM Project No. 2003.022**

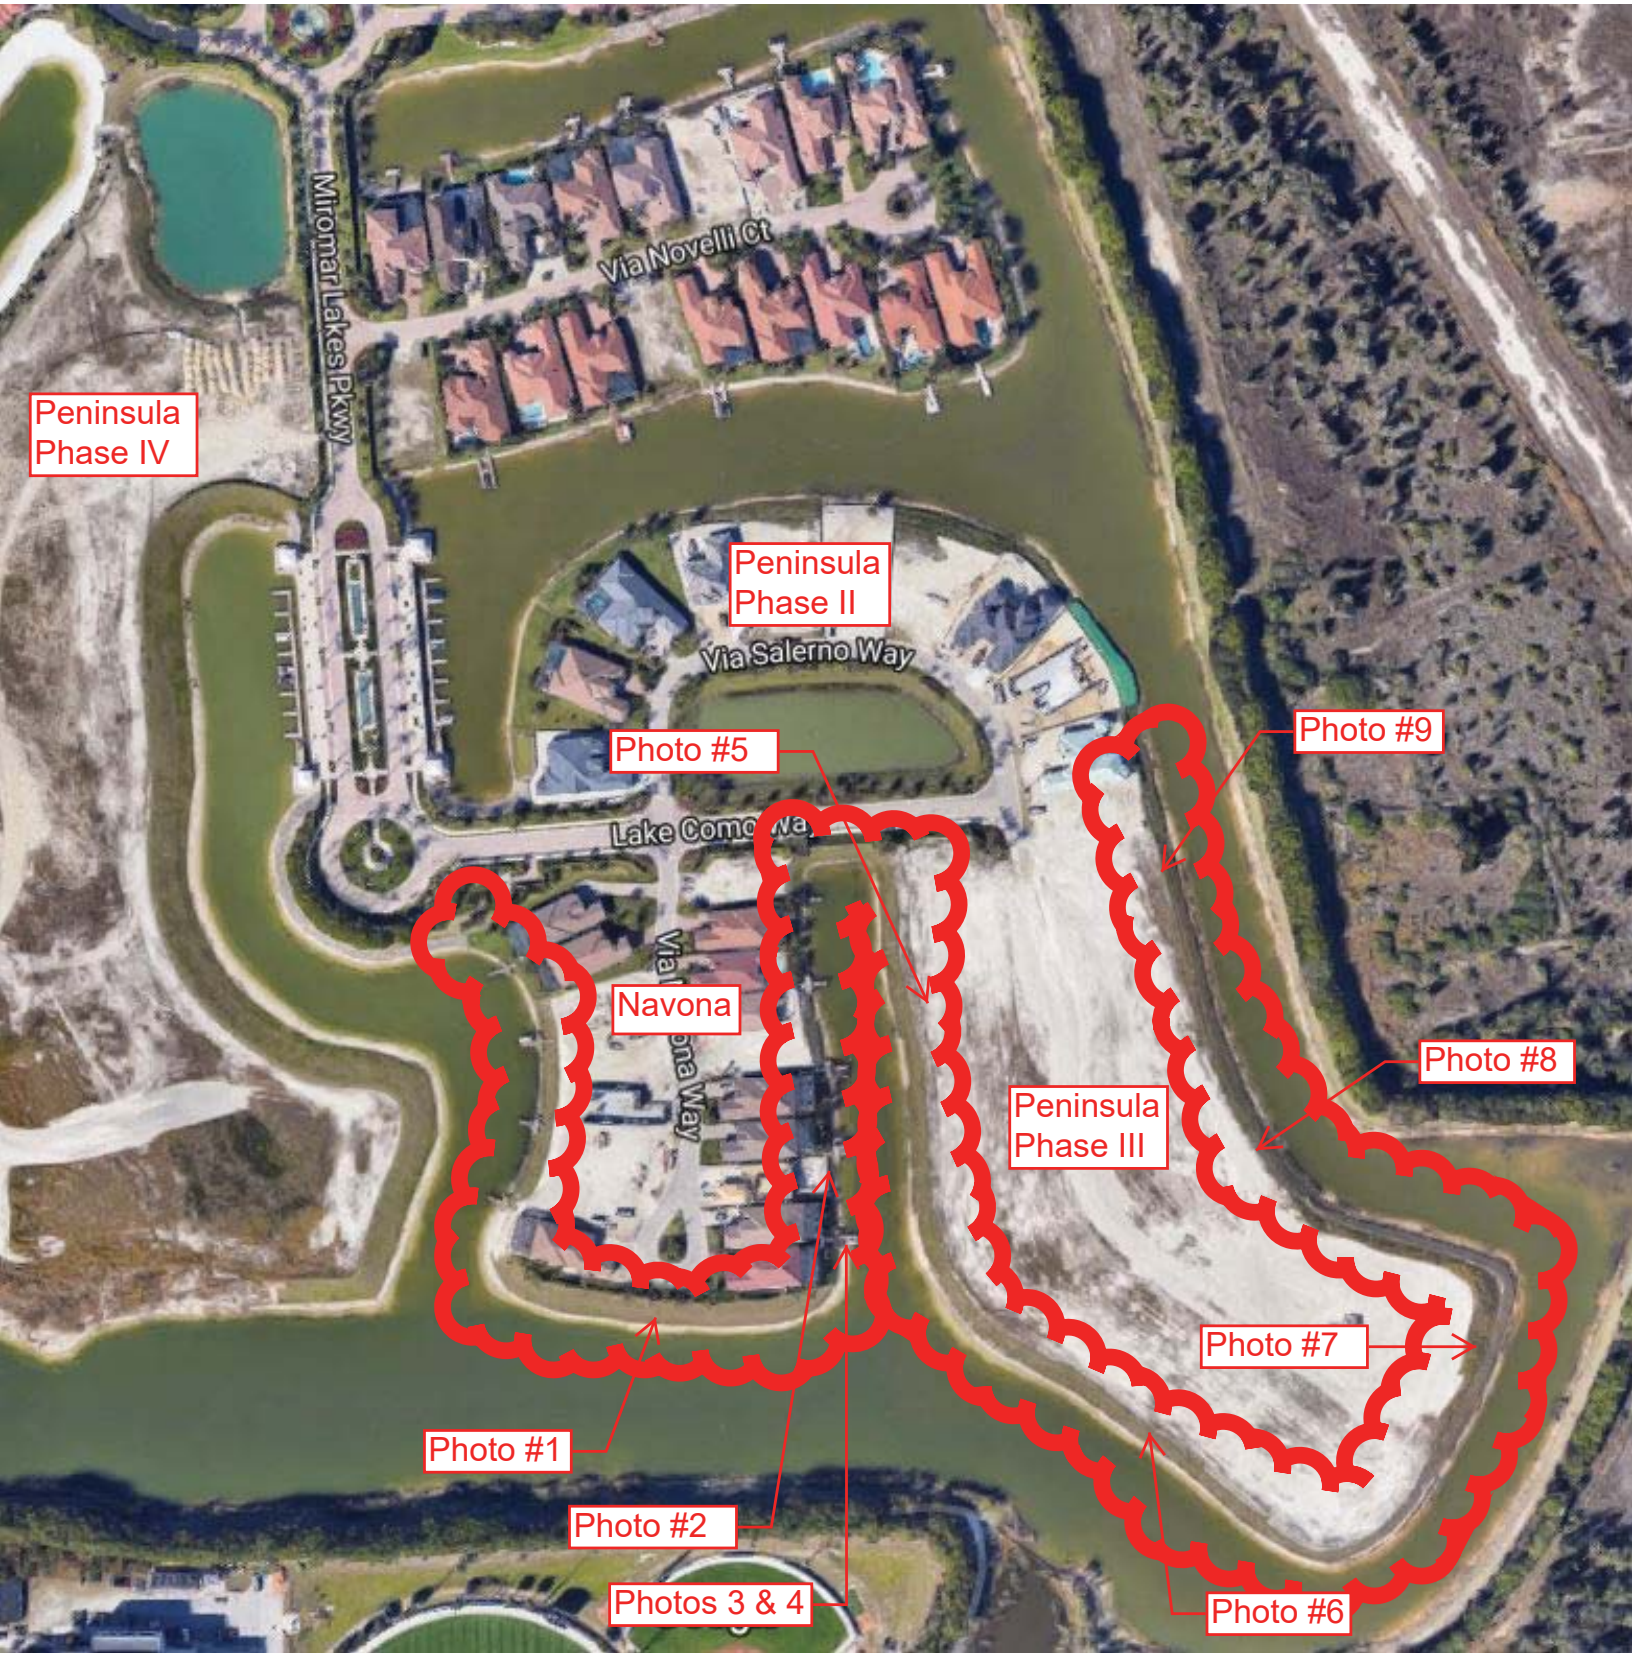
In response to Mr. Gold's questions regarding the lake banks along Navona and Peninsula Phase III, we performed an inspection of the lake banks looking for signs of erosion and undermining of the sod, which would be an indication of erosion taking place under the sod. We walked the shoreline from the northwest side of Navona to the east where Peninsula Phase III meets Peninsula Phase II. I have attached a sketch of the portions of the lake area that were inspected.

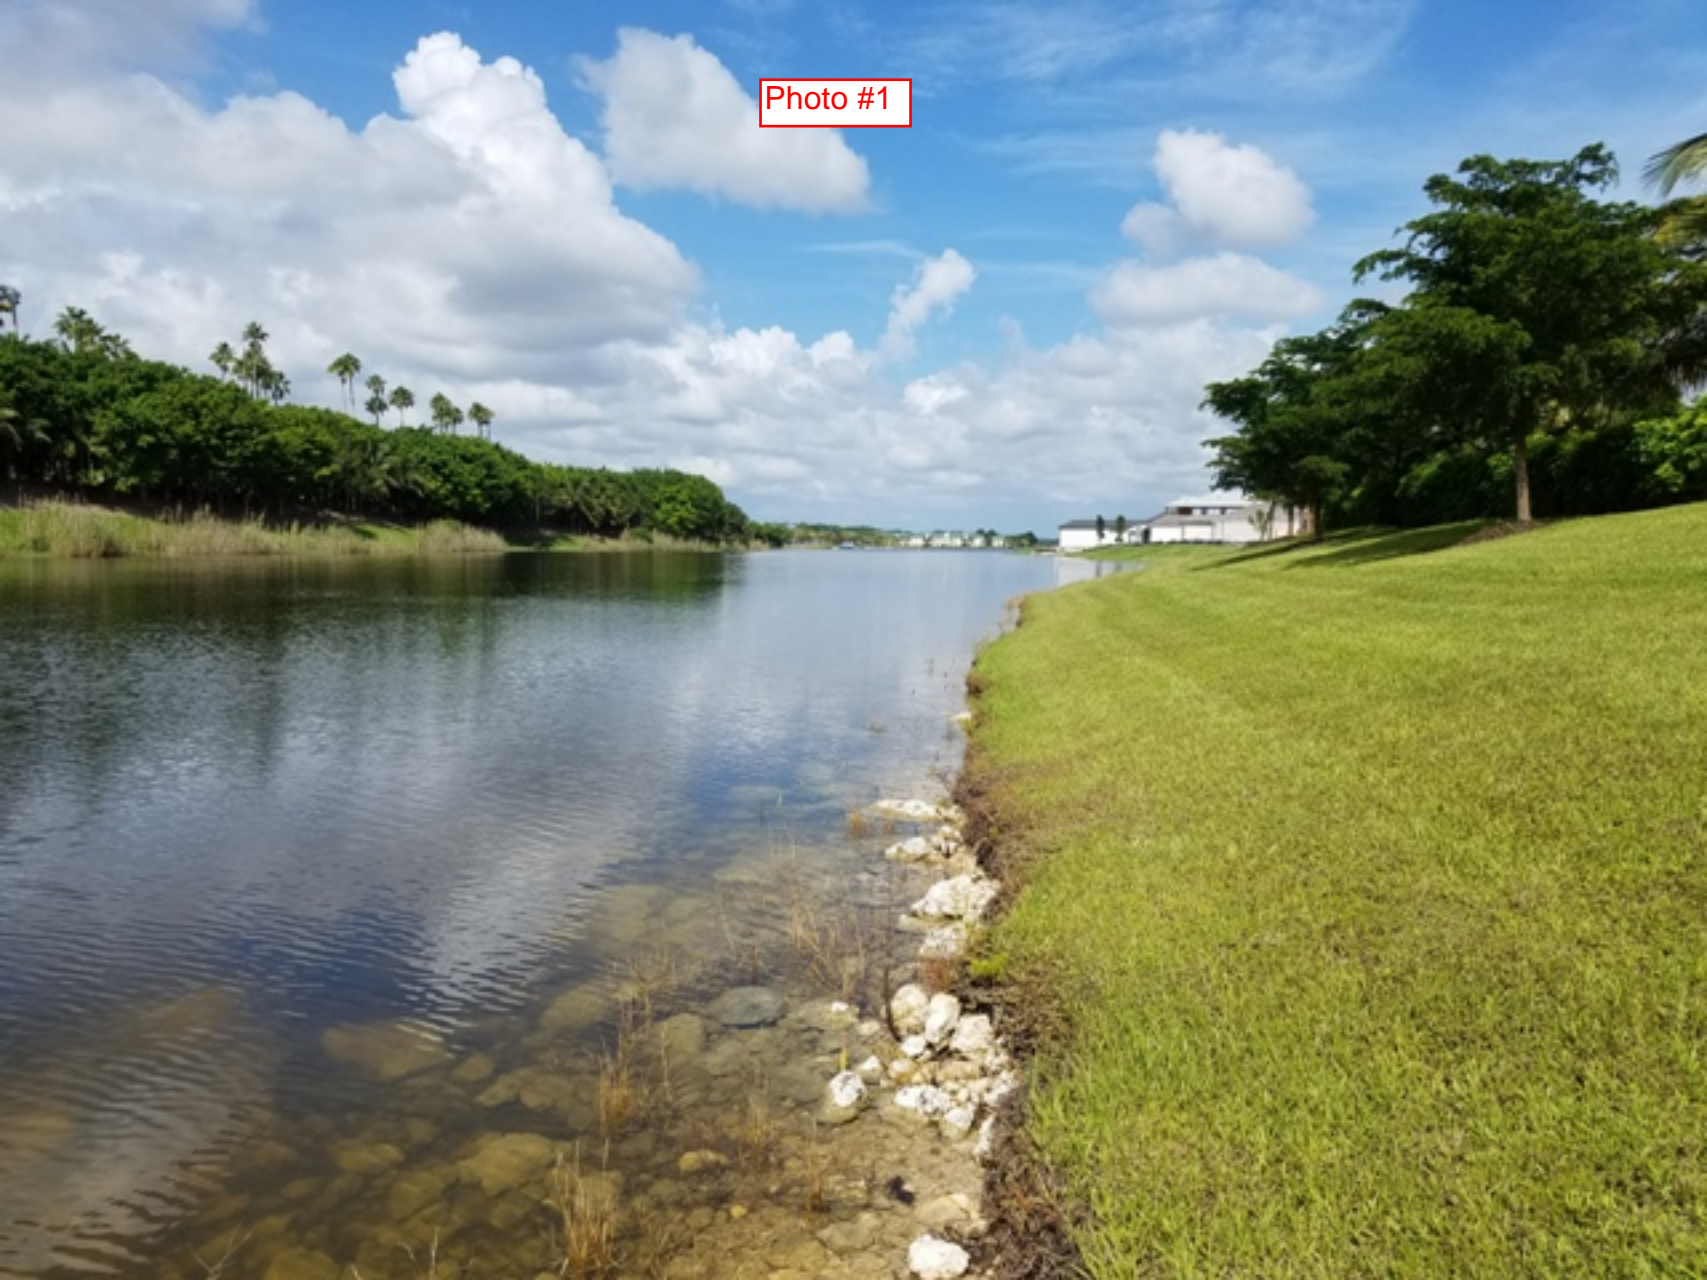
- Photo #1 -The south shoreline is the area facing FGCU. This is the line from the old mine operations and Miromar didn't change the shoreline so the rocks are left over from the mining. This looks the same as when we inspected as part of the discussion of the transfer.
- Photo #2 - The east shoreline is the shore line east of Via Navona Way. The water in the lake is above control but there doesn't appear to be any erosion in the shoreline.
- Photos #3 & 4 – Are examples of the erosion seen under the residential docks where the roof drains are causing the material to be washed into the lake. It is my opinion that CDD should be responsible to repair this. Based on my previous conversations with Mr. Gold, this appears to be a homebuilder design issue and should be taken up by the residents or the homebuilder.

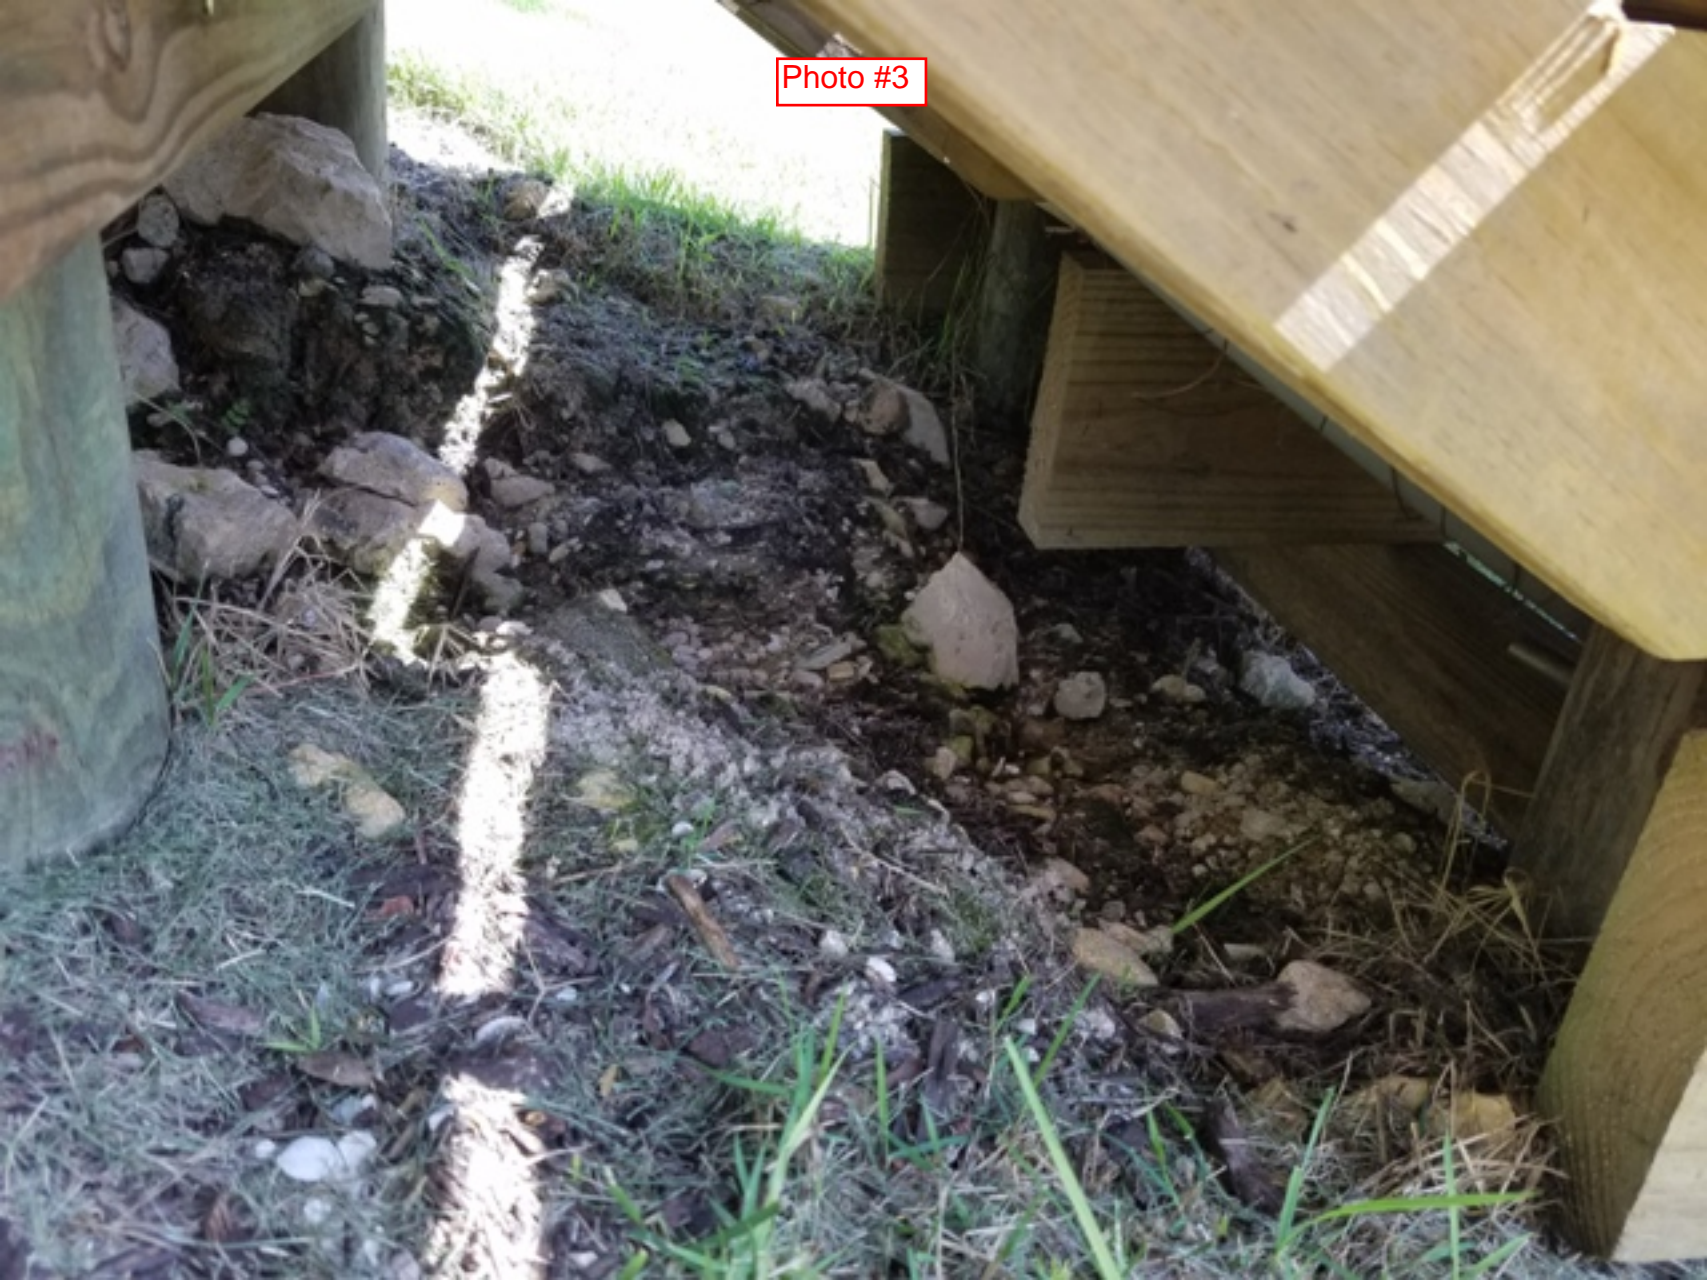
Photo #3

The lake banks along Navona looked in good condition. The water elevation in the lake appeared to be above control so an accurate account of what is happening below the water edge could not be determined at this time. The areas under the resident owned boat docks showed severe washout caused by a roof down spout located under the dock. I have attached the following photos of the lake slopes along Navona and some of the damage under the boat docks.

We can continue to monitor the shoreline during construction of the homes in Peninsula Phase III. We will also continue to monitor the shoreline in Navona for any additional erosion. At this point, it appears the erosion is limited to the areas under and near the resident boat docks and connected to homes under construction. Both items should not be the responsibility of the CDD to remedy, as they are connected to the activities and design of the homebuilder.

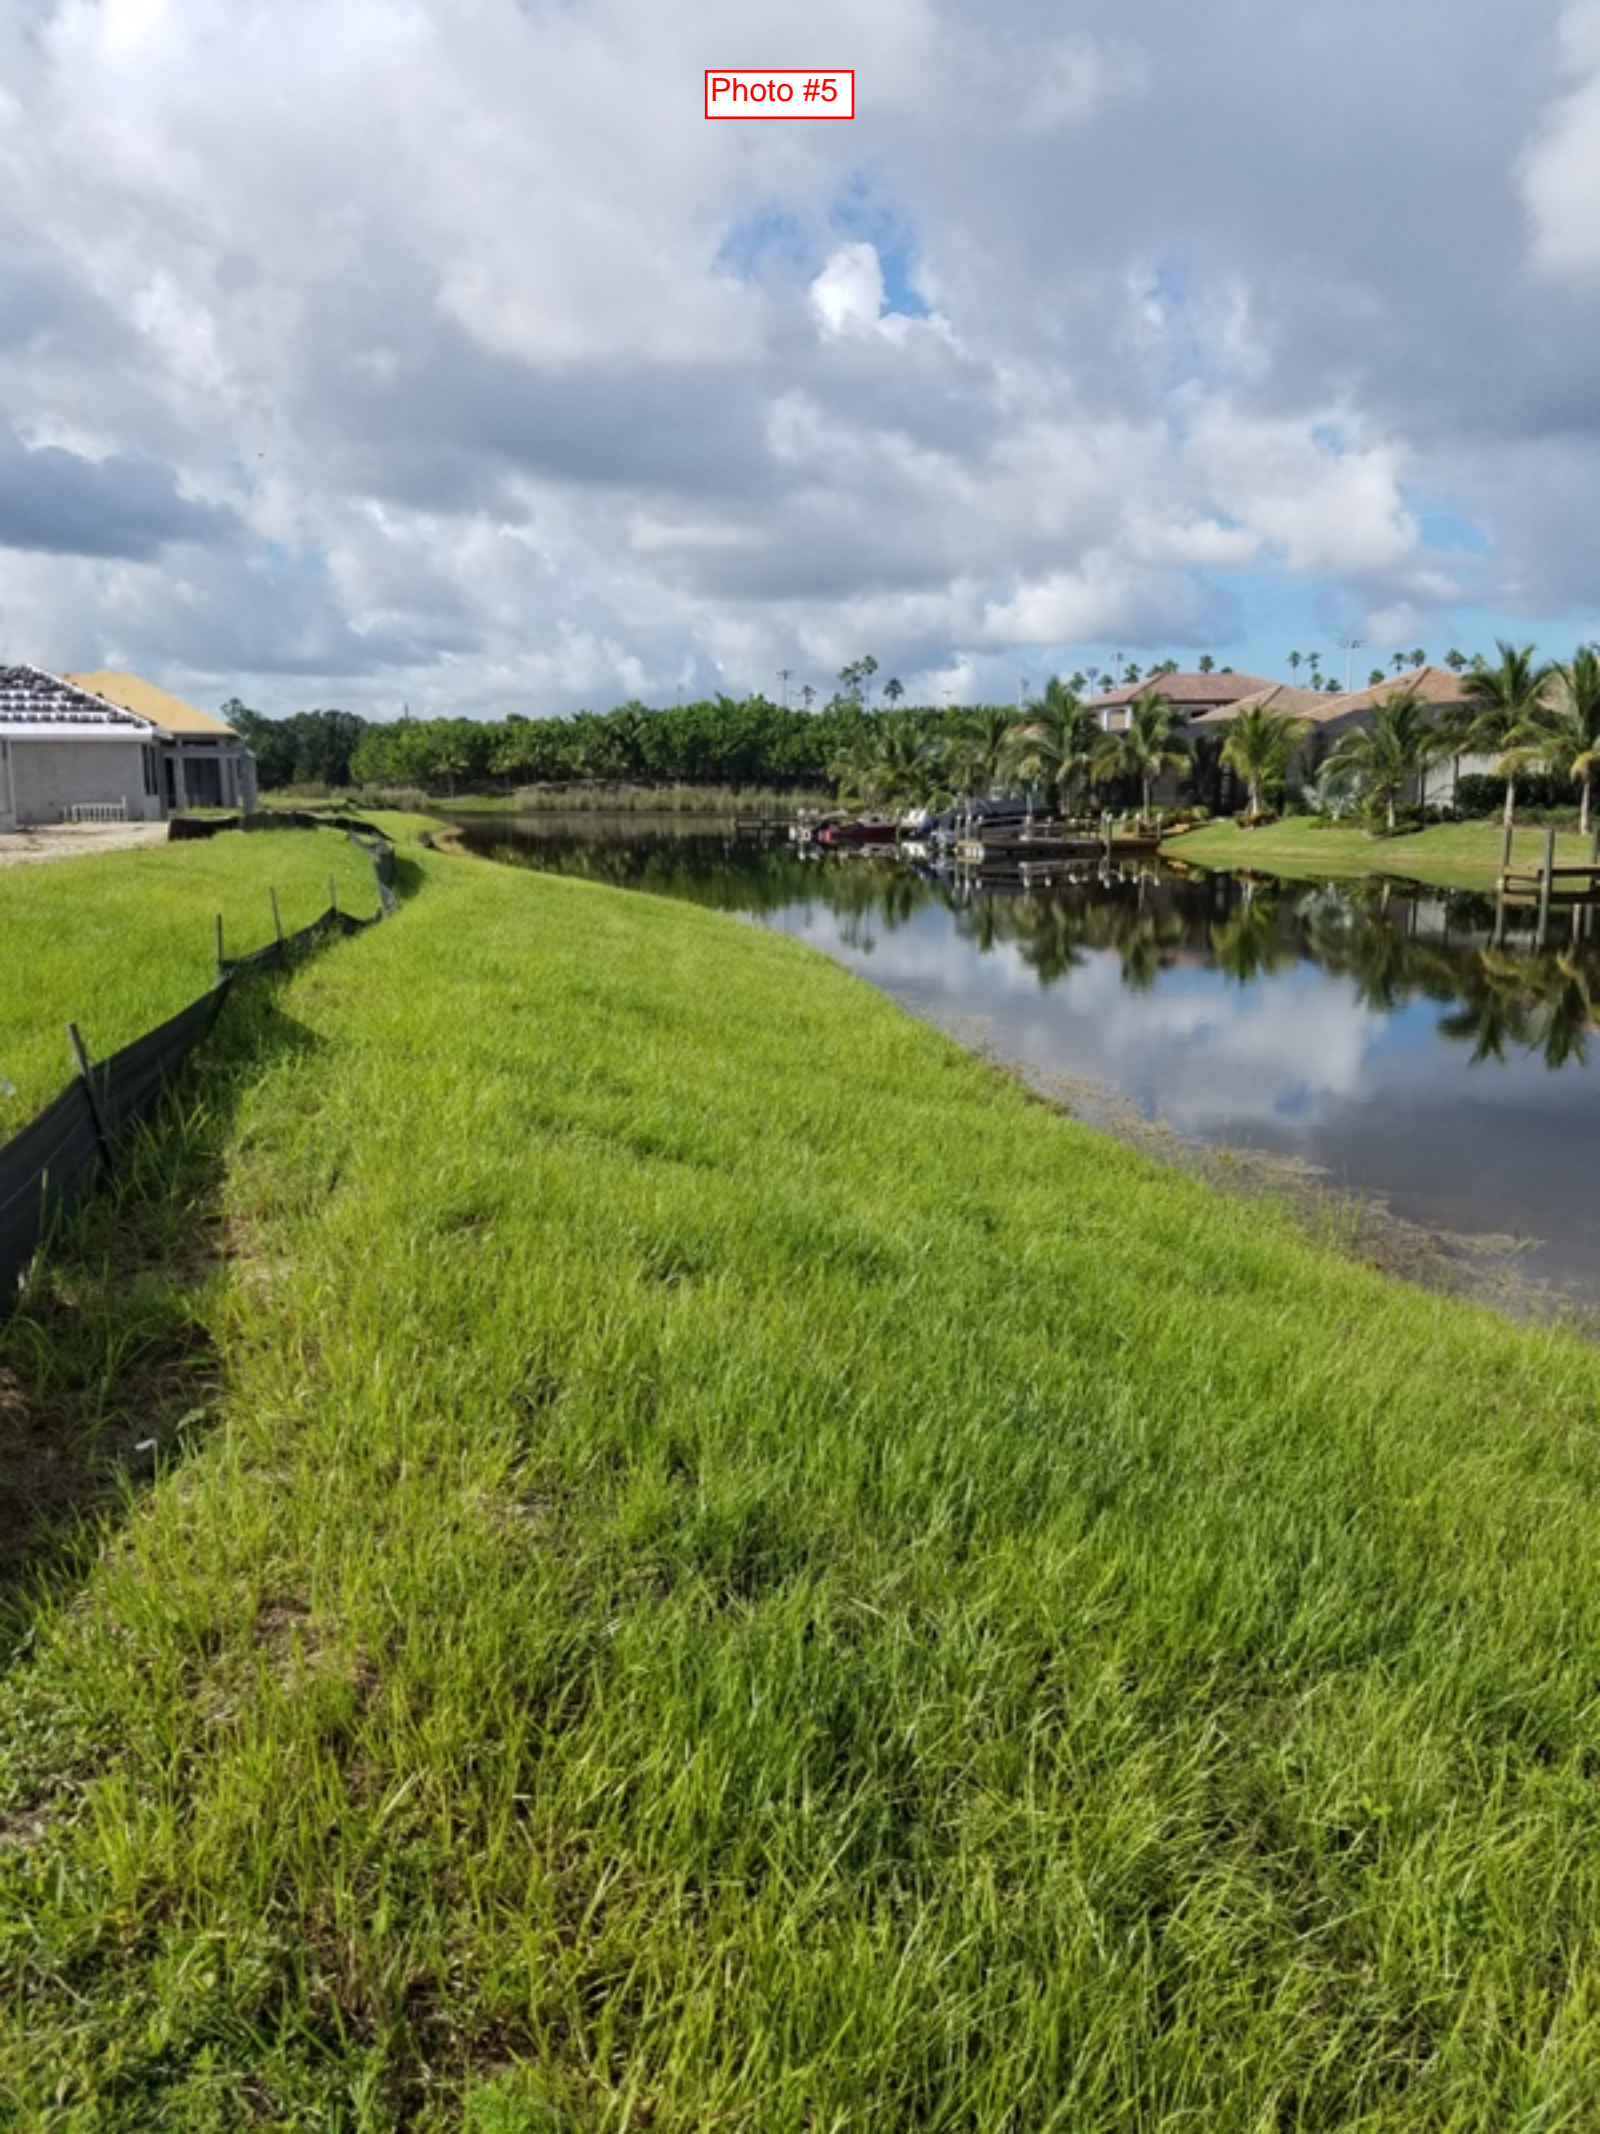
- Photo #5 – Lots to the east of Navona where the silt fence has been installed and construction is going to begin.
- Photo #6 – Lots farther down the lake shoreline on to the east of Navona. Construction is well under way. Additional silt fence has been installed as construction has progressed. Shoreline will need to be resodded as part of the final grading of the homesites.

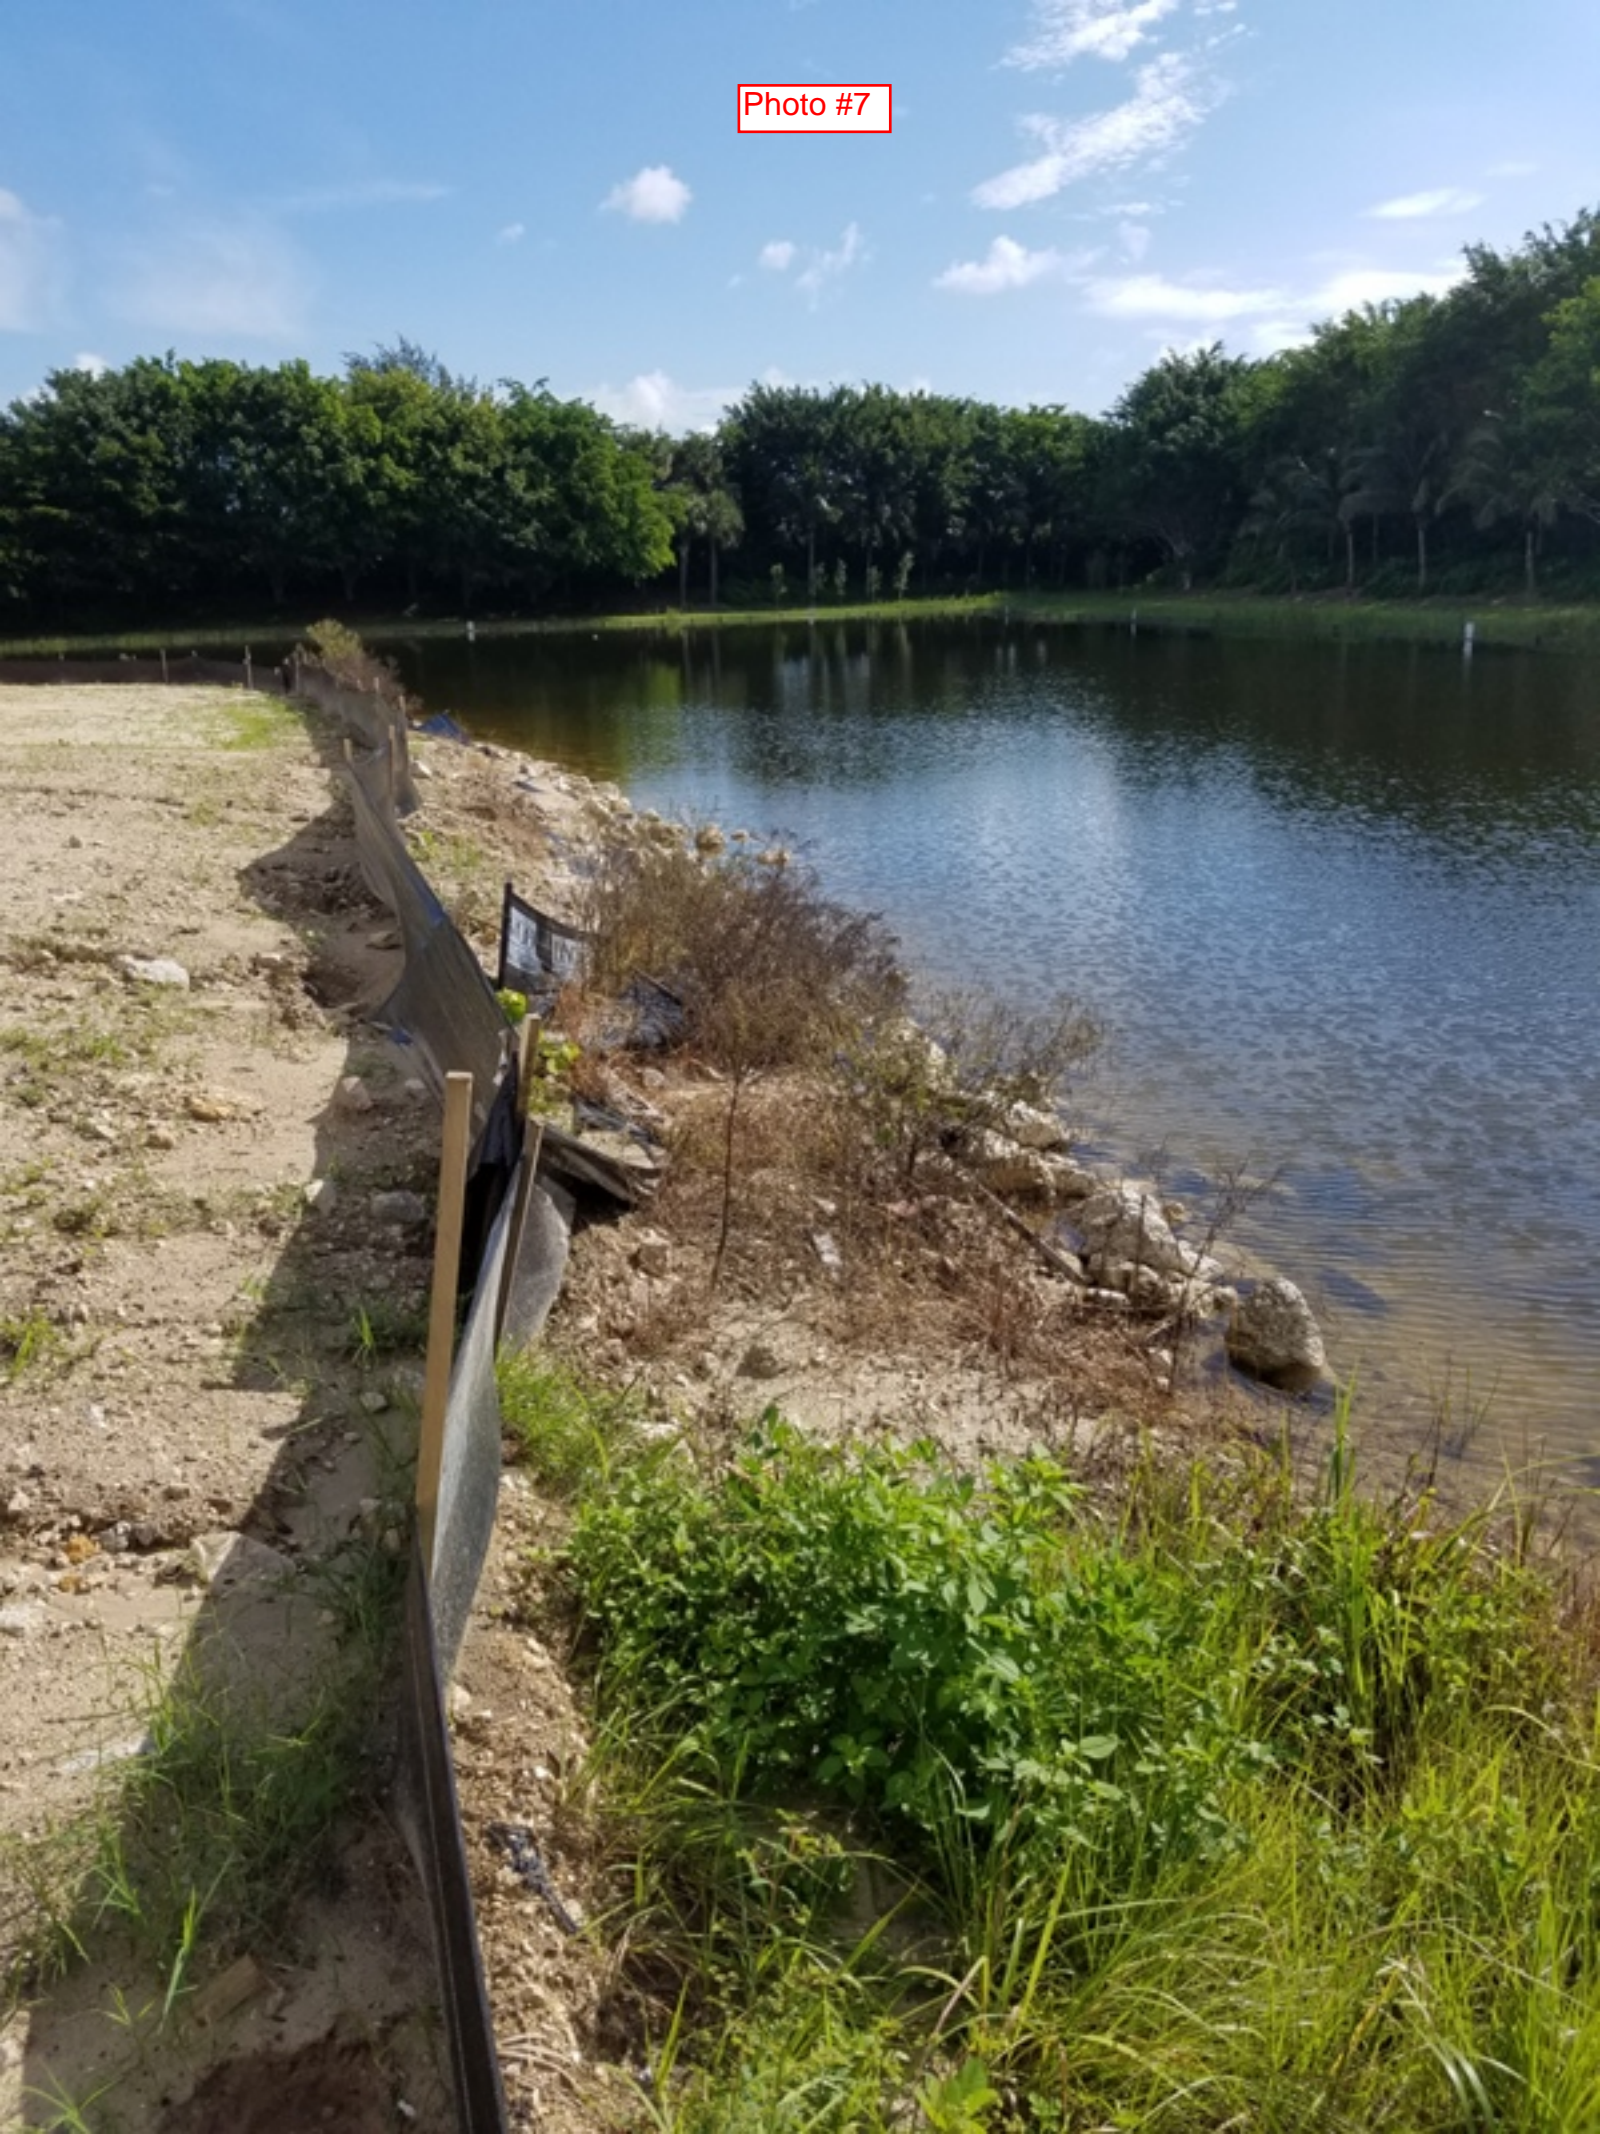
- Photo #7 – Lot under construction. Silt fence installed but some clearing has occurred on the lake side of the fence. Sod will need to be installed as part of the final site grading.
- Photo #8 – Completed lot. Regrading of the slope is completed. Site is ready for sod to be installed.
- Photo #9 – Completed lot. Lake slope graded and sodded. The sod looks like it was installed when the water elevation was higher.
