WENTWORTH ESTATES COMMUNITY DEVELOPMENT DISTRICT

Monthly Field Manager's Report
March 2024

CGA Project No. 17-9809

April 1, 2024

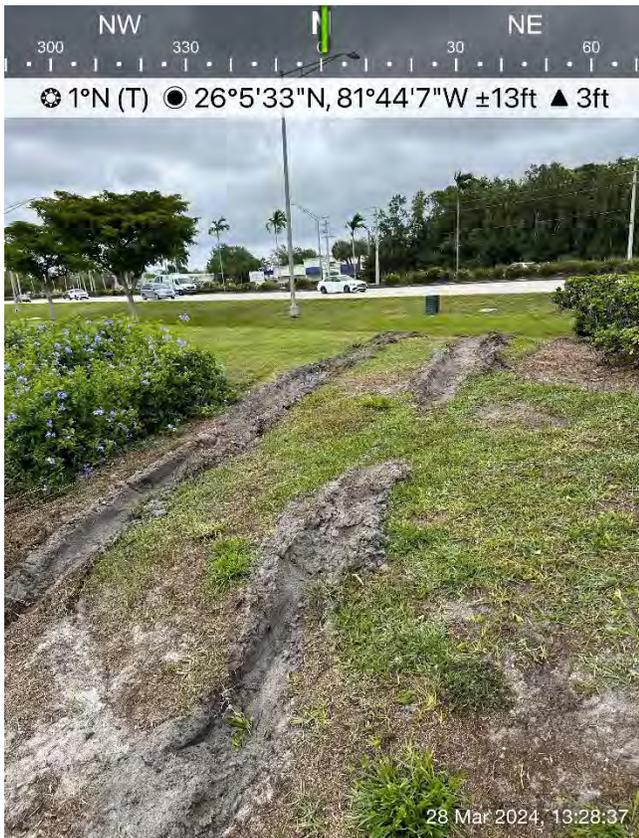
- Vehicle ran off SR 41 near lake two and causing considerable damage to the sod in this area. The landscape vendor was notified, and this work will be completed over the next two weeks.

Vehicular damage near lake two.

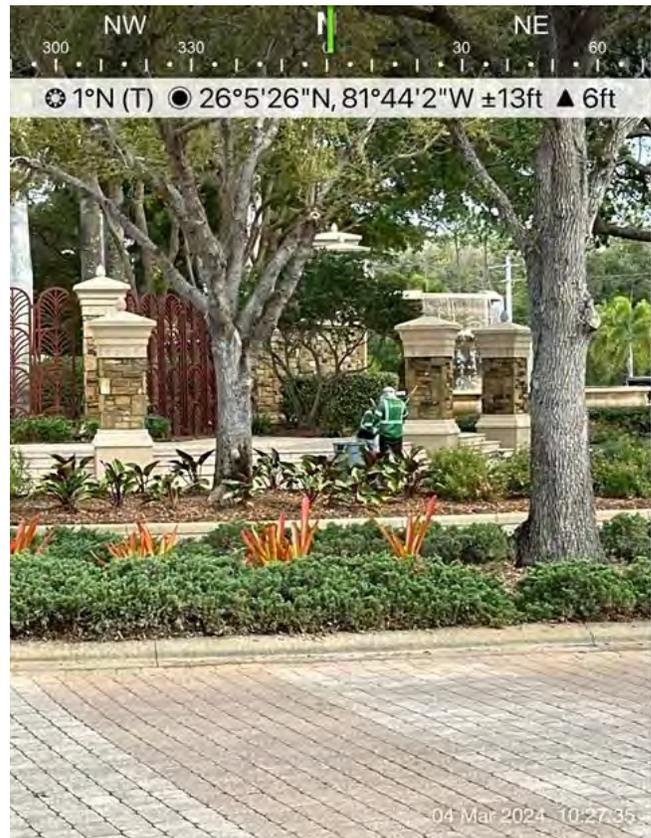
Landscape vendor performing monthly weeding.

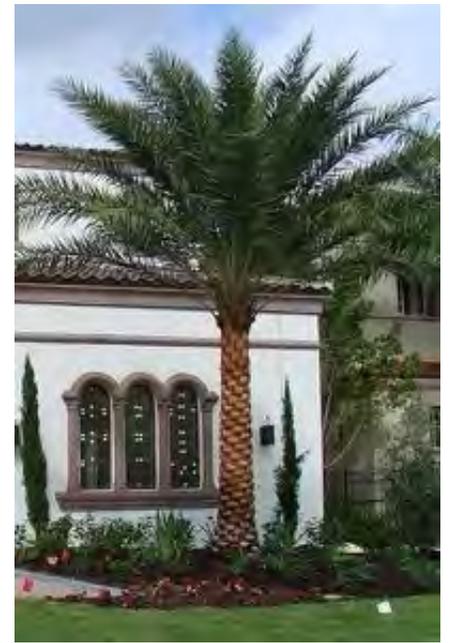
- The four (4) oak trees located in the center median off Treviso Bay Boulevard are not in a healthy state and they are never going to flourish. These four (4) oaks trees have some sparse foliage throughout the canopy and poor structural branching. This was determined by the CDD Landscape Architect. The CDD staff are currently looking for alternatives for the entrance trees that will correlate with our landscaping enhance plan. The recommended replacement is Phoenix Date Sylvester Date Palm (picture below).

Suggested replacement for the oak trees.

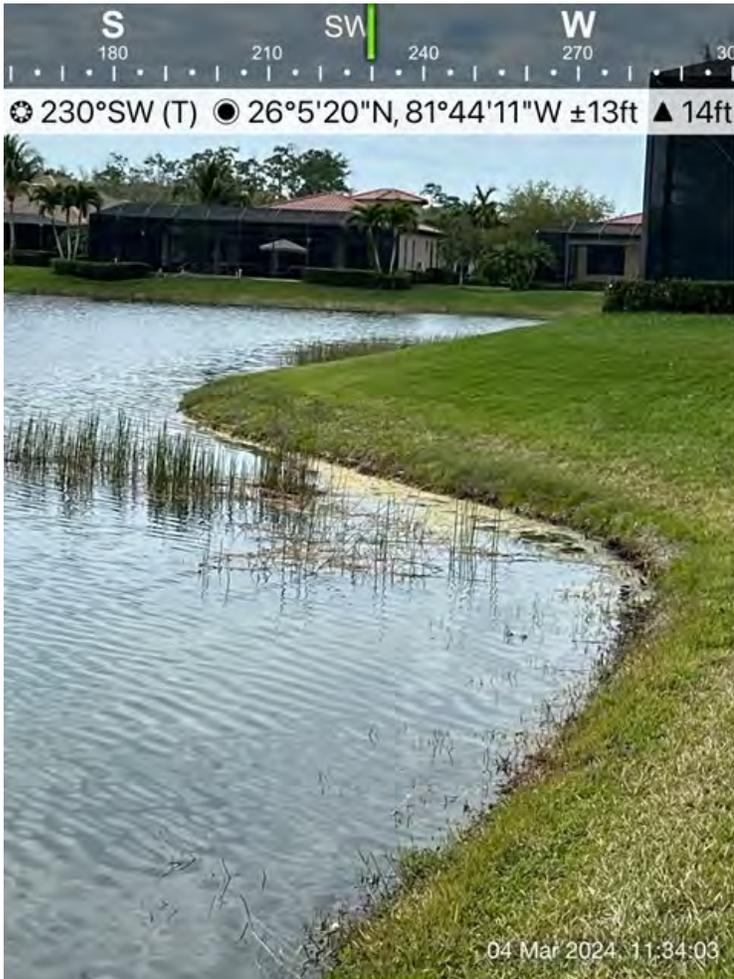
Lake 6 before treatment

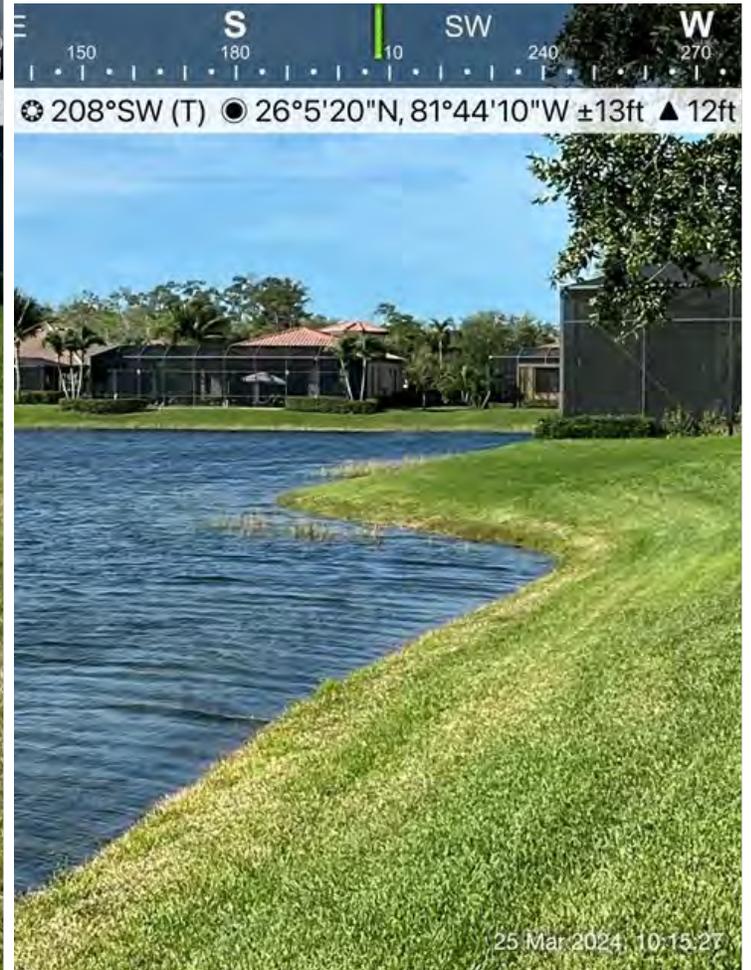
Lake 6 after treatment

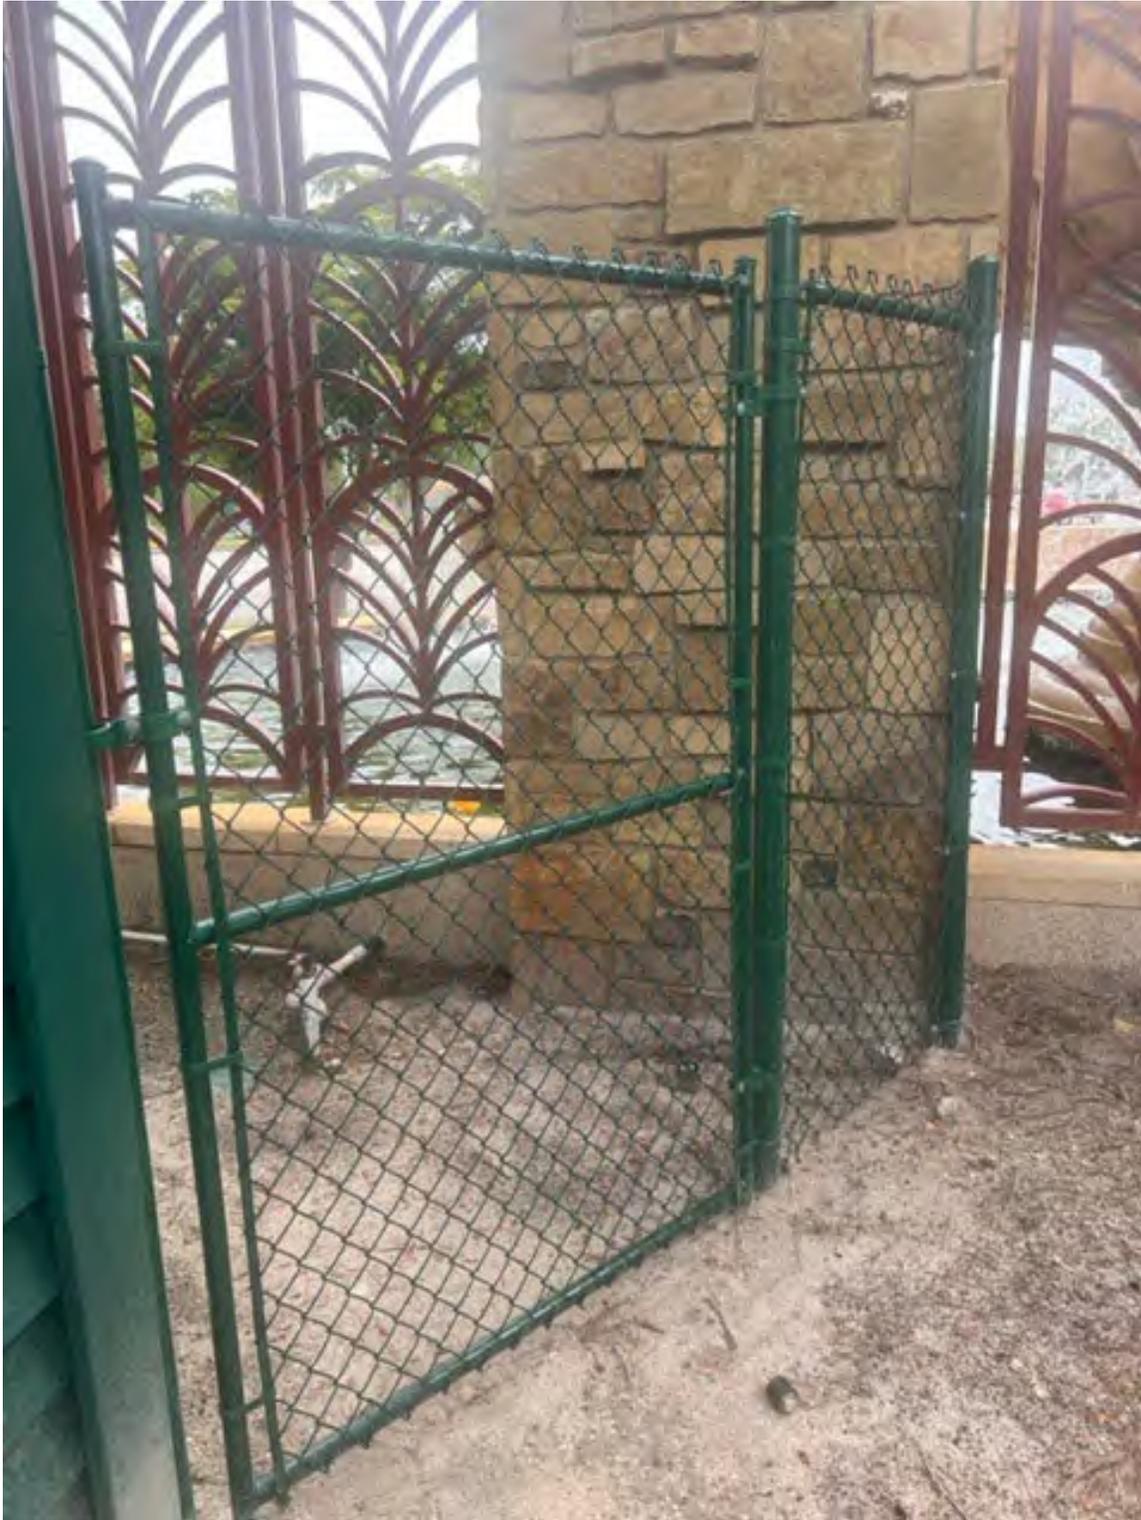
- A proposal was created and approved to add new reflective signs to the existing signs at the front entrance of Treviso Bay Boulevard. The new signs are scheduled to be installed in late April.
- A green 6-foot gate and fencing was installed around the irrigation pump house to prevent unwanted company accessing the pump house equipment.

New gate fencing

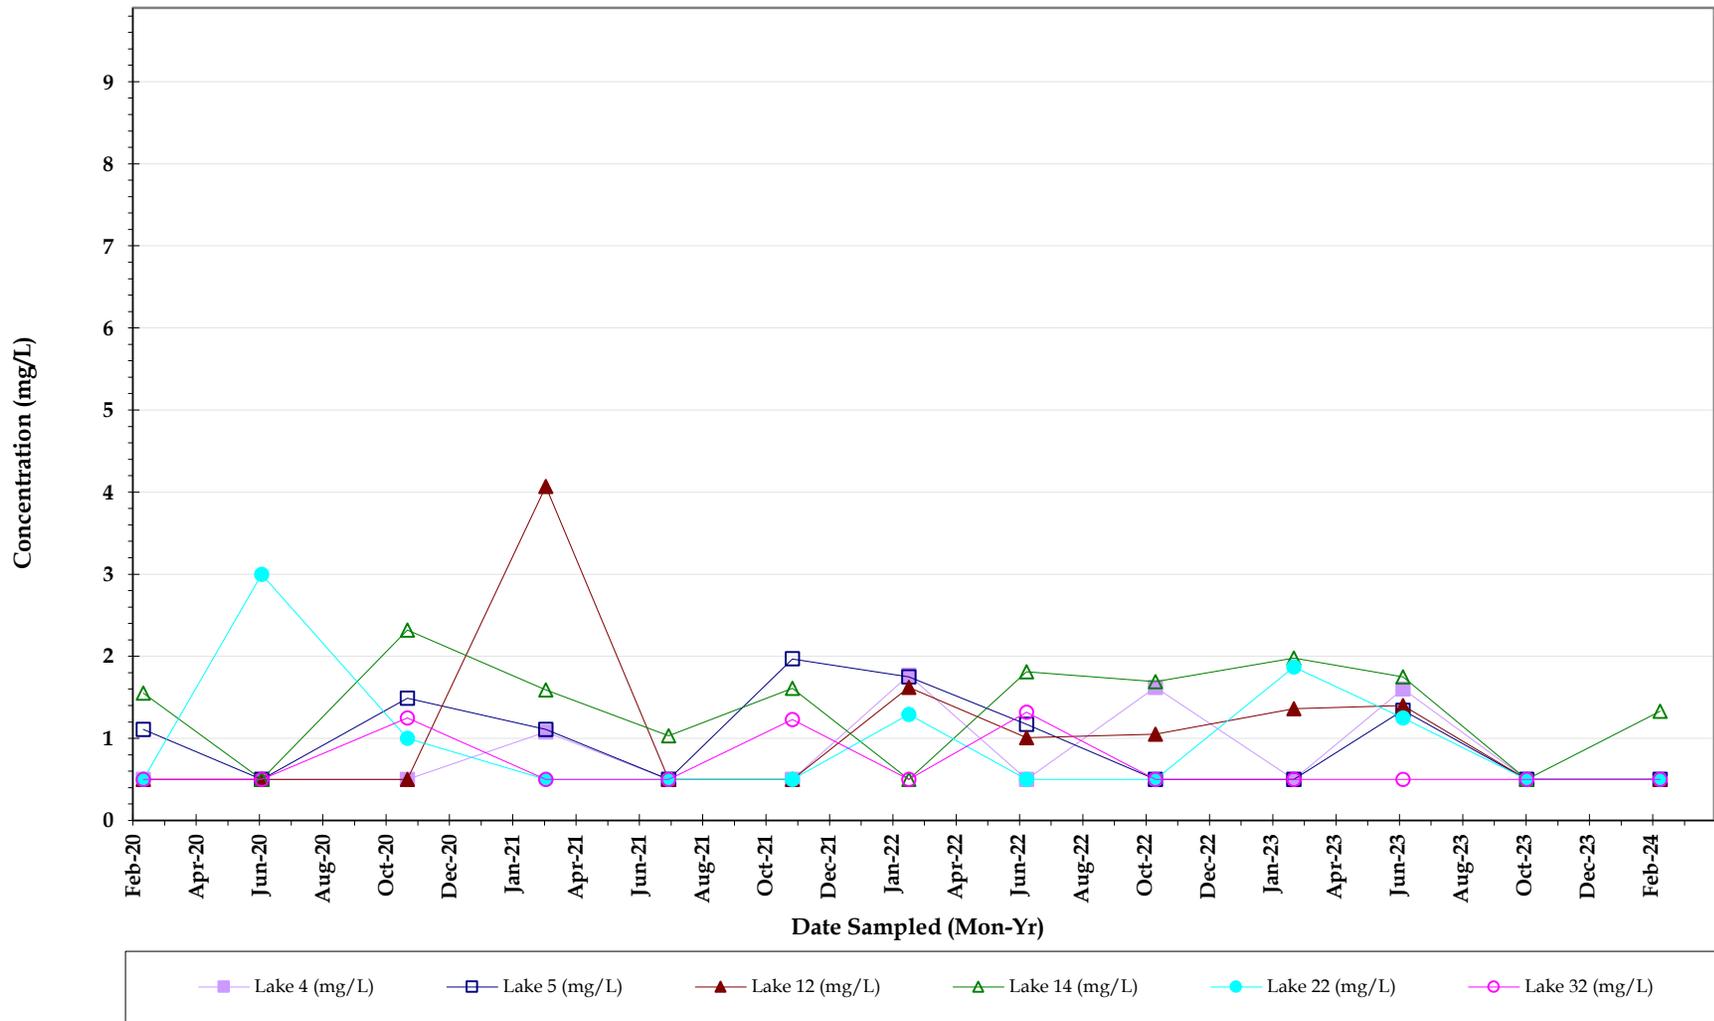
Biochemical Oxygen Demand

- BOD5 levels remain consistent and either below the method detection limit (MDL, noted by a "U" following the result), or between the method detection and practical quantitation limit (PQL, noted by a "I" following the result).

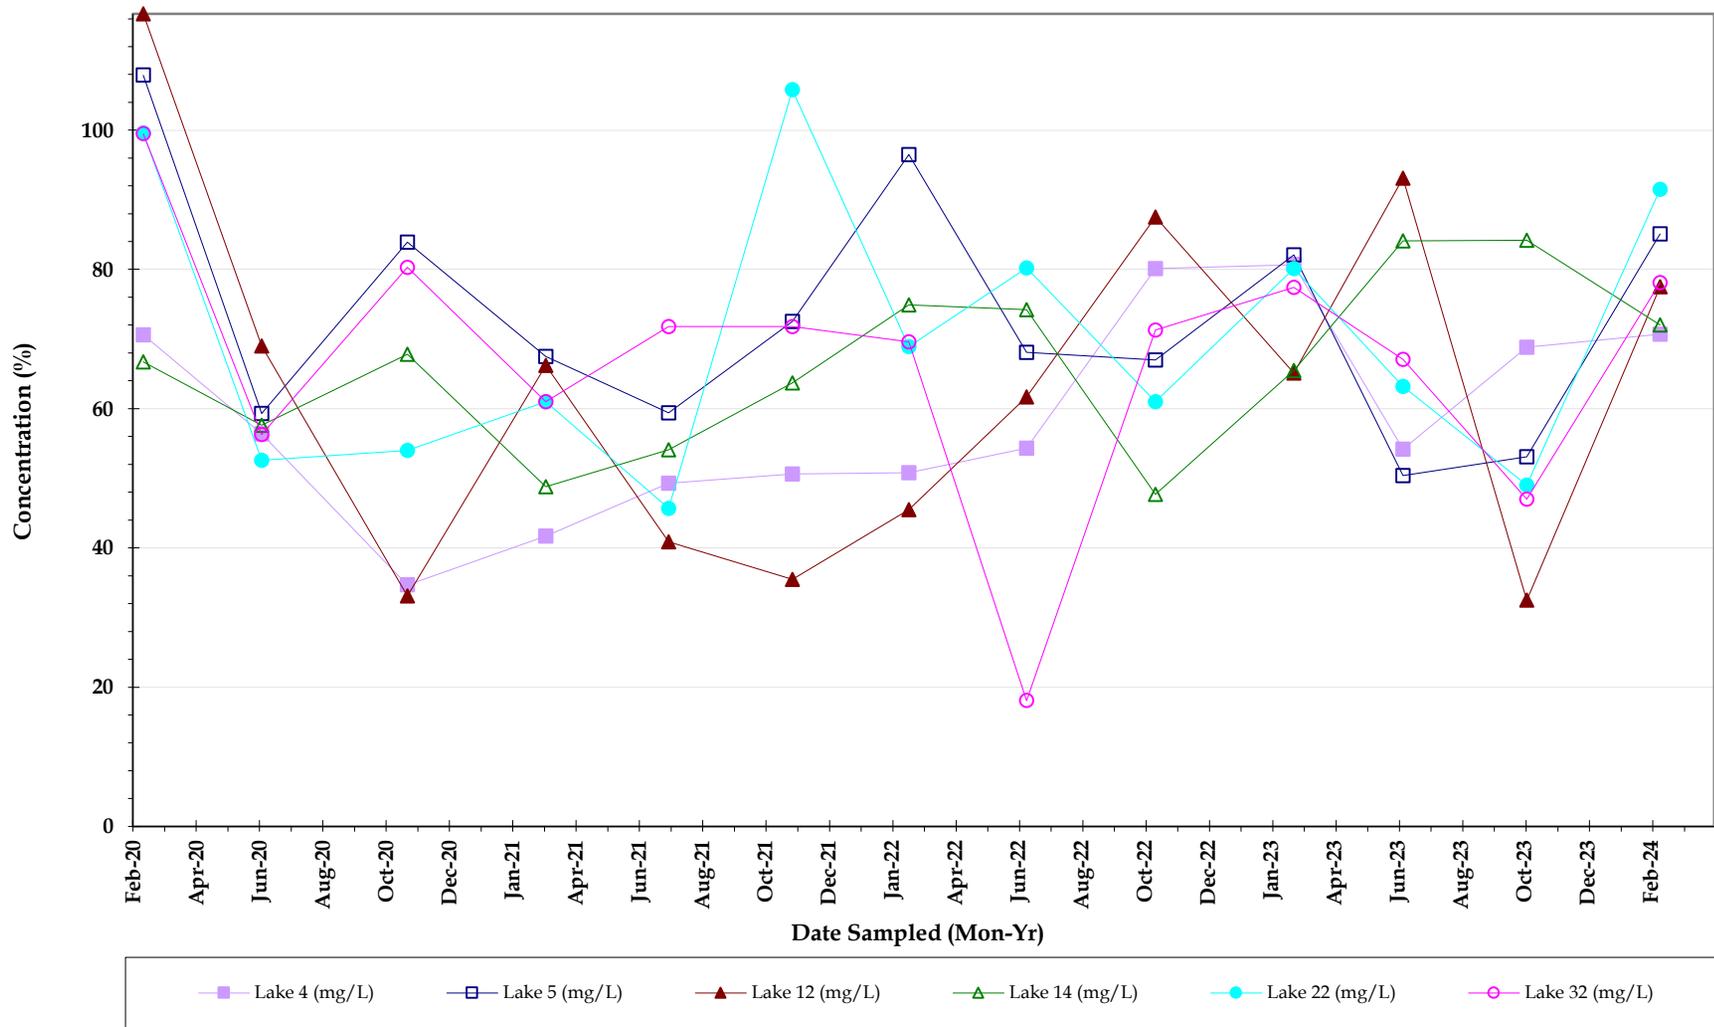
Dissolved Oxygen (%)

The highest concentration of DO was observed at Lake 22 (91.5%), and the lowest was at Lake 4 (70.7%). The dissolved oxygen content at the water quality locations is anticipated to fluctuate throughout the year given the temperature of the water. The action level for dissolved oxygen (%) is defined by the Florida Department of Environmental Protection (FDEP) for the Peninsula and Everglades bioregions as 38%. All sampling locations displayed DO concentrations above this standard. All sampling locations displayed an increasing trend when compared to the previous sampling event, except for Lake 14, which decreased (from 84.2% in October to 72.0% in February). Lake 12 was closely monitored during the current sampling event due to the low DO content previously observed in October (32.5%). Since October, the DO has significantly increased at this location and is now far above the defined standard.

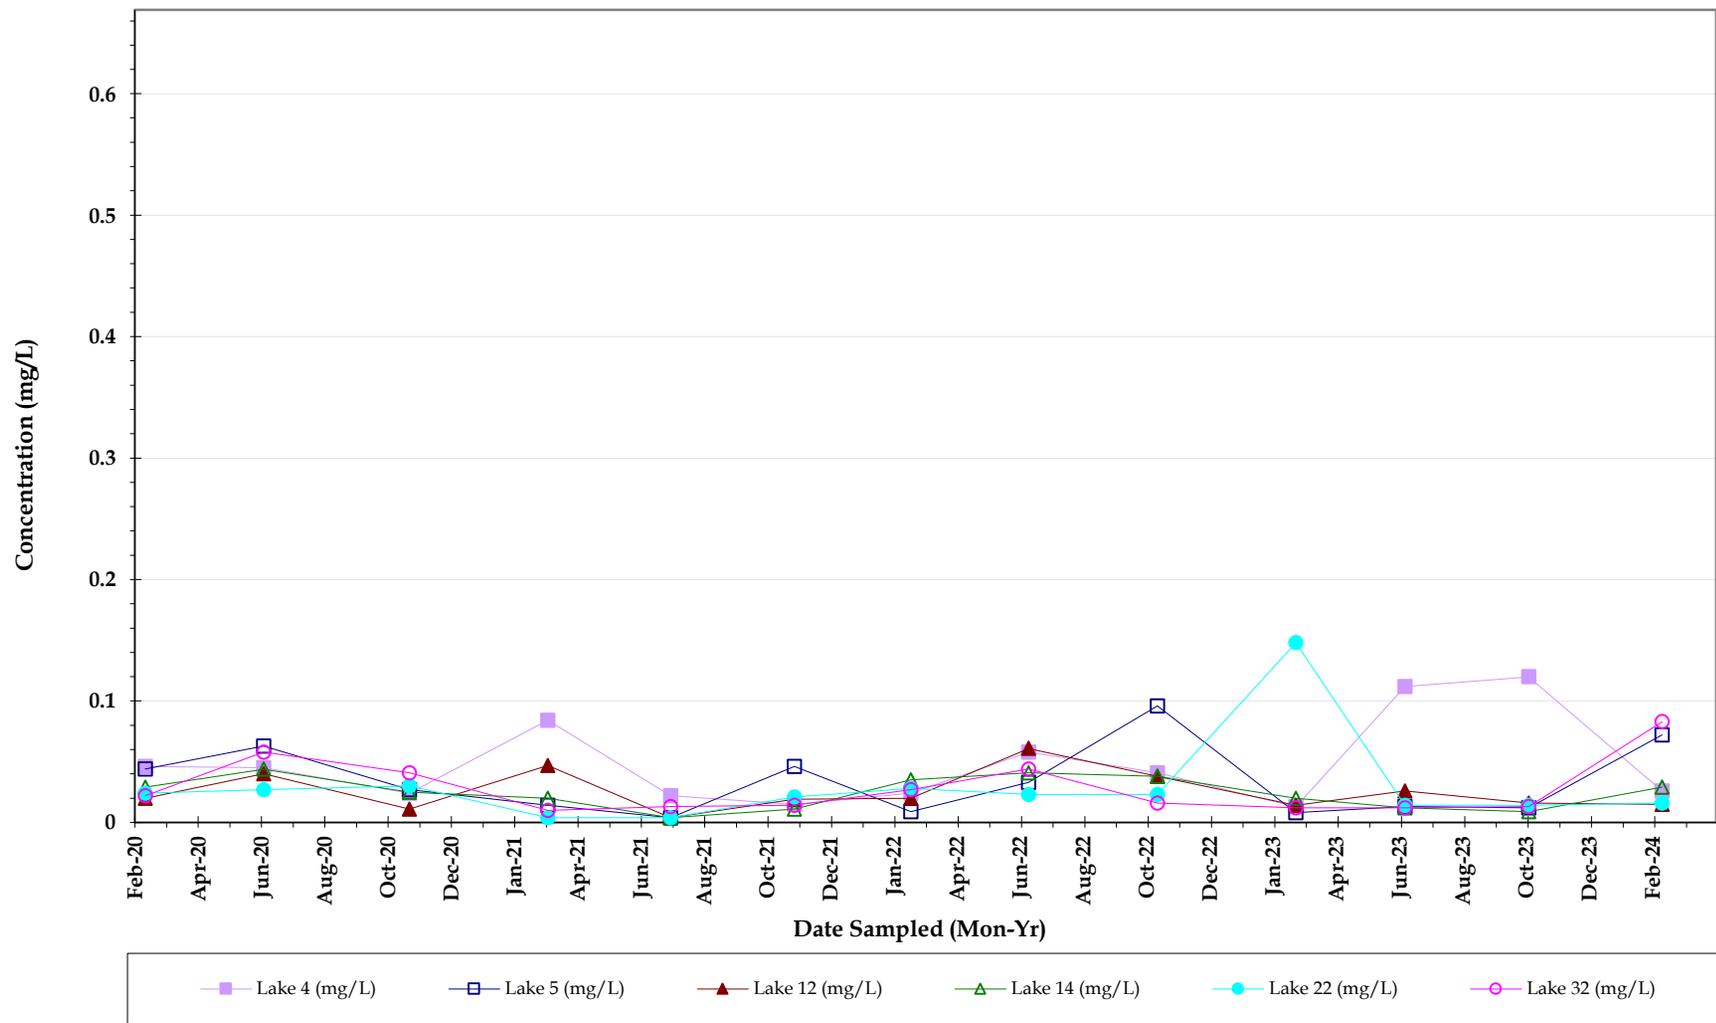
Total Phosphorus

The sampling location Lake 32 displayed the highest concentration of total phosphorus (0.083 mg/L). Although the concentration of total phosphorus remains low, all sampling locations either slightly increased or remained consistent when compared to the previous sampling event. The concentration of orthophosphate has historically fluctuated. The concentration has increased since the previous sampling event at Lakes 12, 14, and 32, and has decreased at the remaining Lakes (4, 5, and 22). A spike in orthophosphate concentration is observed in Lake 32 for the current sampling event (0.074 mg/L).

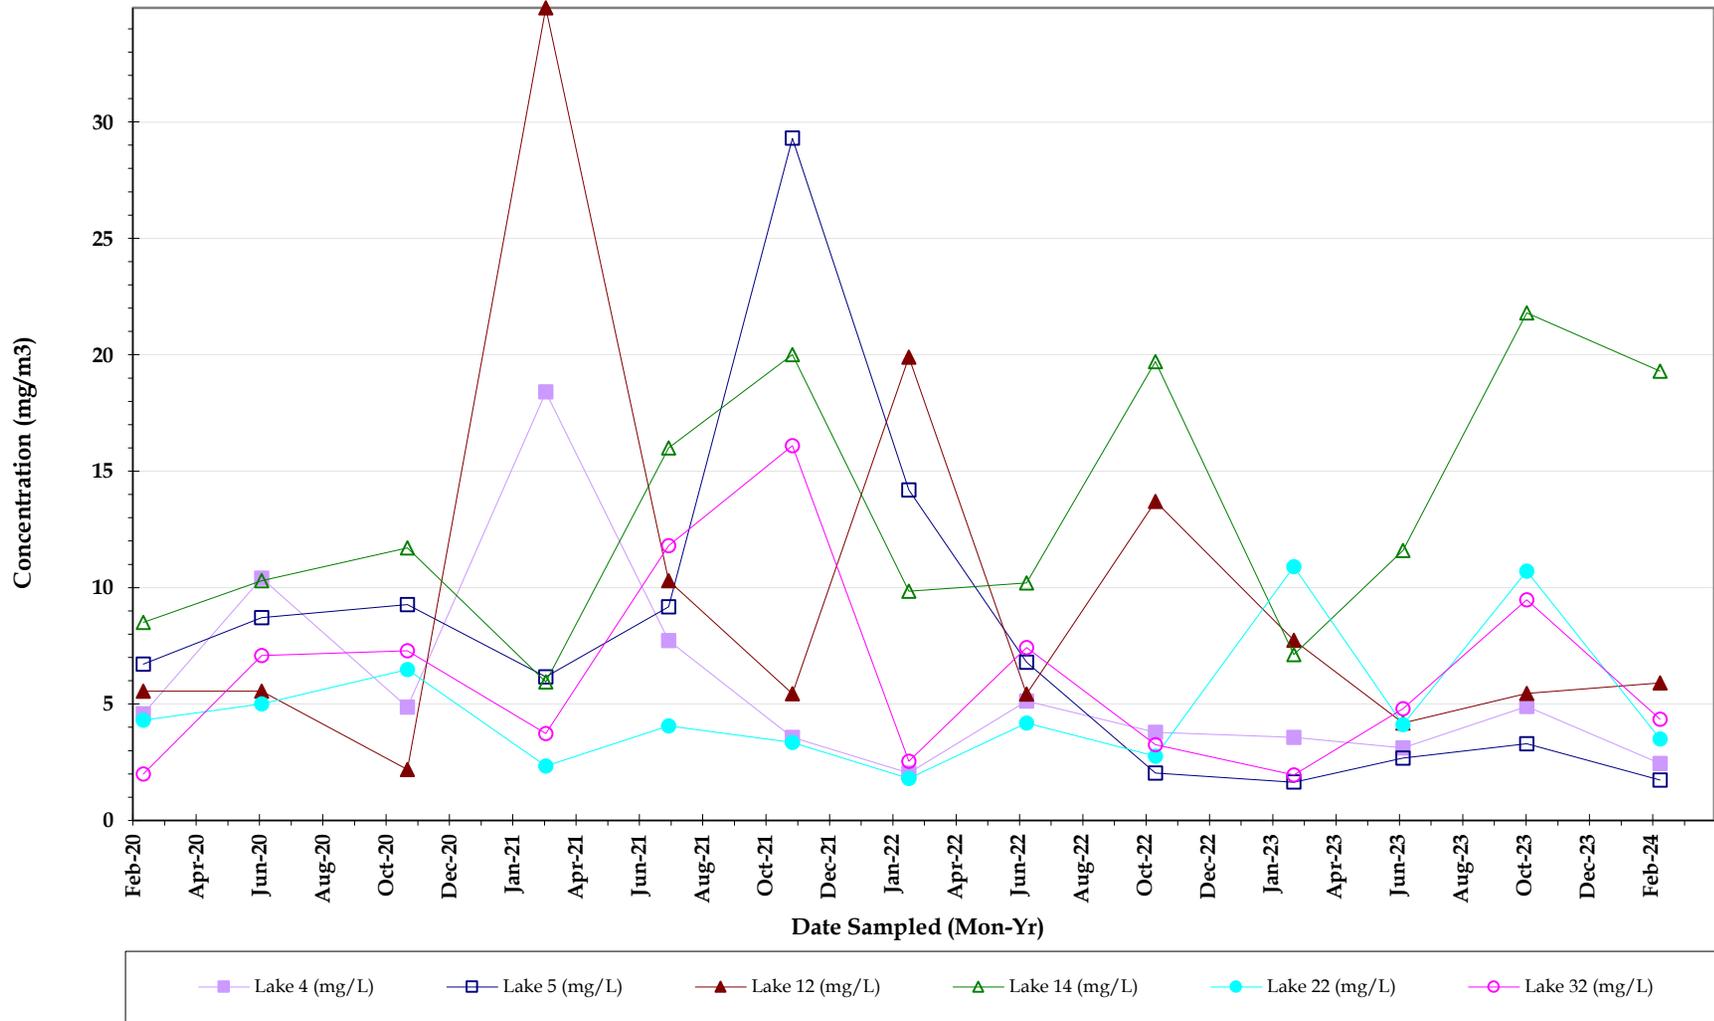
Chlorophyll a

As noted above, minor coagulated algae growth was noted along the banks of Lake 4 and Lake 22. Suspected suspended, filamentous algae was noted at Lake 32 and Lake 14. The average chlorophyll-a levels have decreased since the previous sampling event. Concentrations decreased at all lakes except for Lake 12, where they slightly increased. In general, chlorophyll-a levels below 10.0 mg/m³ are ideal for freshwater lakes to support a healthy ecosystem. One (1) sampling location exceeded this standard, Lake 14 (which displayed the highest concentration, 19.3 mg/L). Lake 14 has displayed the highest concentration of chlorophyll-a over the past three (3) sampling events; however, a decreasing trend is displayed when compared to October 2023. Contrastingly, Lake 5 has displayed the lowest concentration over the past five (5) sampling events. The chlorophyll-a concentrations appear to confirm the presence of filamentous algae within Lake 14. Chlorophyll-a levels appear to display a cyclic trend, with increasing concentrations during the warmer months of the year, with peaks recorded in October, and decreasing concentrations in the cooler months, with lows recorded in January/February. GHD will continue to closely monitor chlorophyll-a concentrations to confirm and define this cyclic pattern.

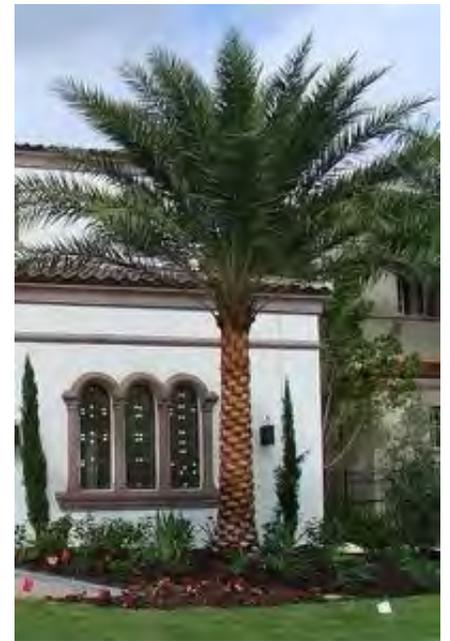
The four (4) oak trees proposed to be removed on the center median off US 41 just as you enter Treviso Bay

Suggested replacement for the oak trees.

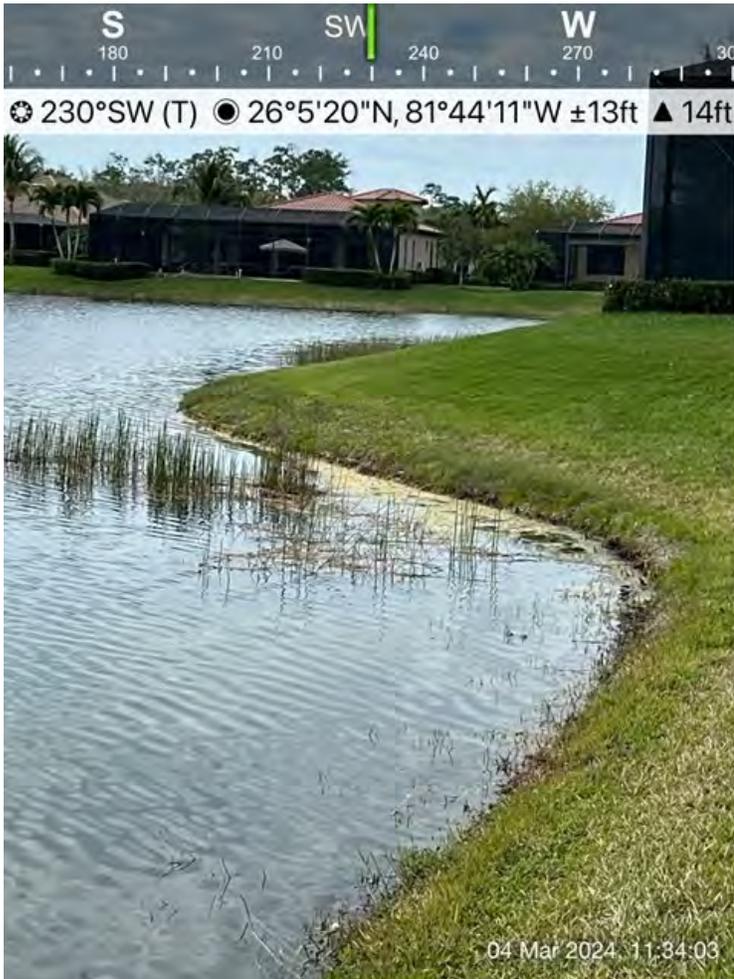
Lake 6 before treatment

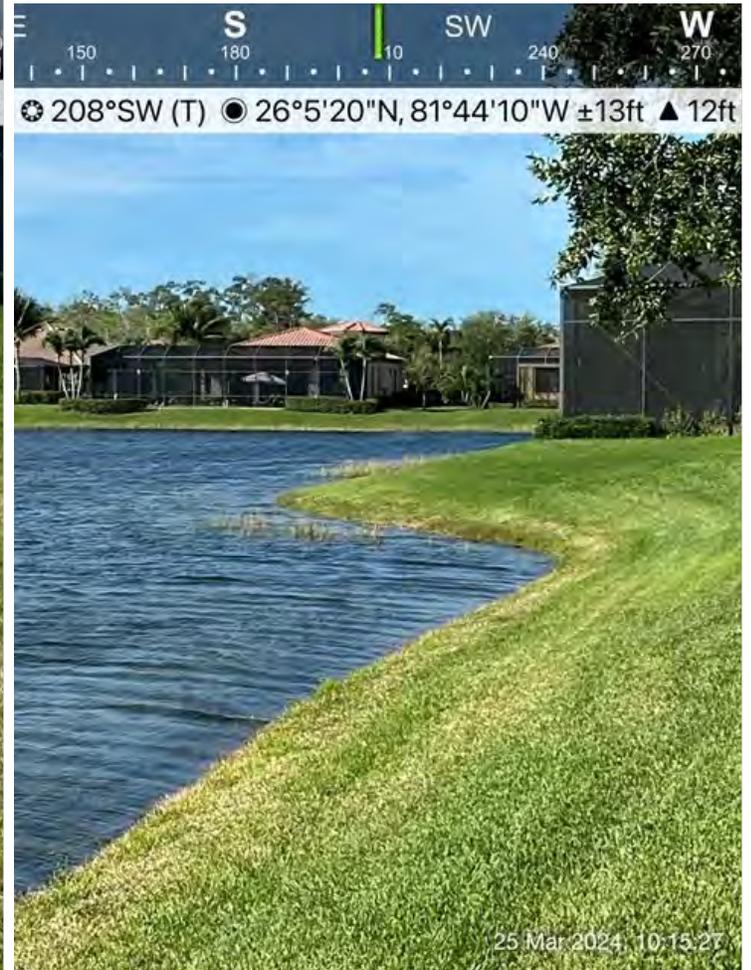
Lake 6 after treatment

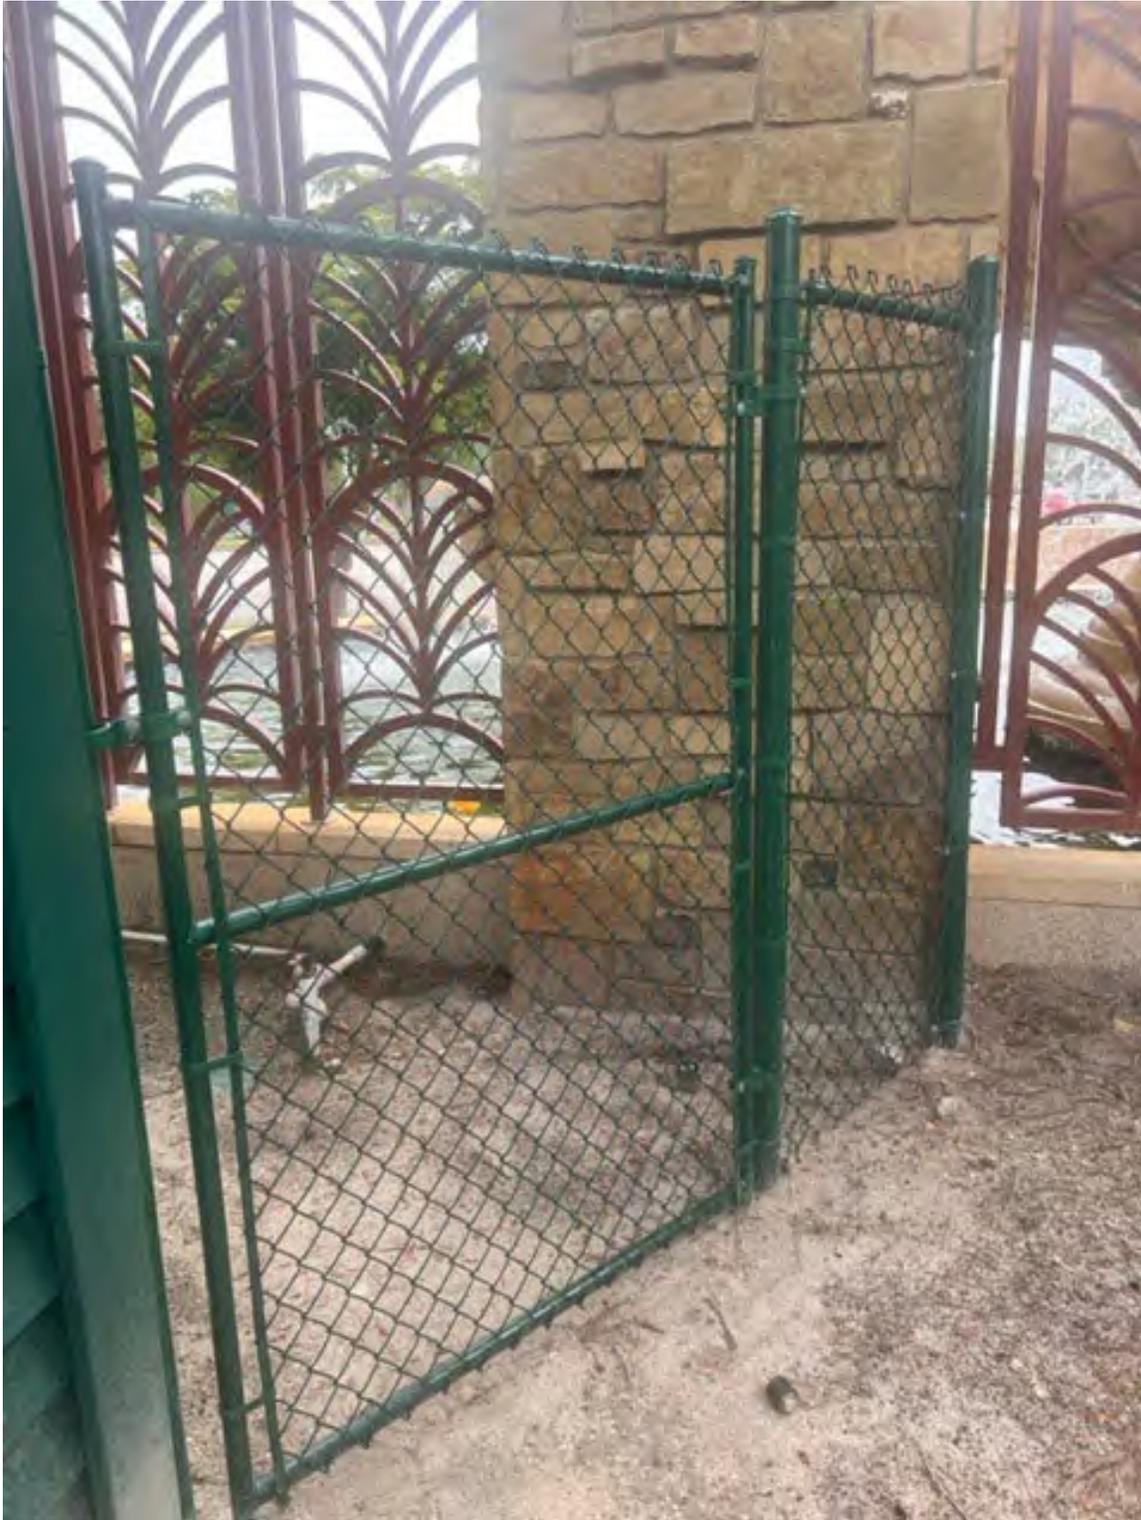
- A proposal was created and approved to add new reflective signs to the existing signs at the front entrance of Treviso Bay Boulevard. The new signs are scheduled to be installed in late April.
- A green 6-foot gate and fencing was installed around the irrigation pump house to prevent unwanted company accessing the pump house equipment.

New gate fencing

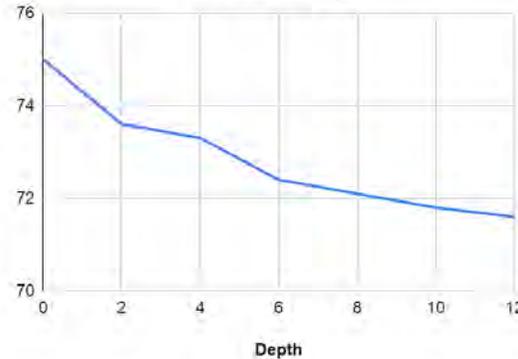
Water Column Profile

Mixed: The dissolved oxygen and temperature profile shows this lake's water column is adequately mixed resulting in acceptable dissolved oxygen levels at lower depths, expanded fisheries habitat, less bottom muck and bad odors. It is recommended to monitor oxygen levels closely, particularly with seasonal changes.

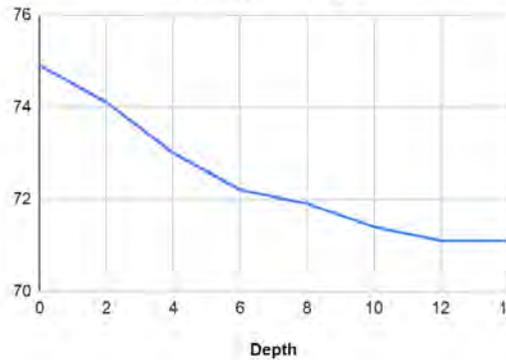
Water Column Profile

Mixed: The dissolved oxygen and temperature profile shows this lake's water column is adequately mixed resulting in acceptable dissolved oxygen levels at lower depths, expanded fisheries habitat, less bottom muck and bad odors. It is recommended to monitor oxygen levels closely, particularly with seasonal changes.

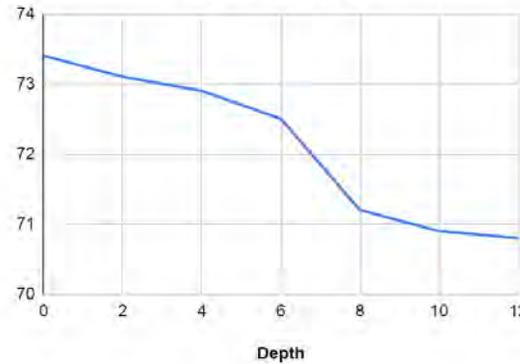
Water Column Profile

Mixed: The dissolved oxygen and temperature profile shows this lake's water column is adequately mixed resulting in acceptable dissolved oxygen levels at lower depths, expanded fisheries habitat, less bottom muck and bad odors. It is recommended to monitor oxygen levels closely, particularly with seasonal changes.

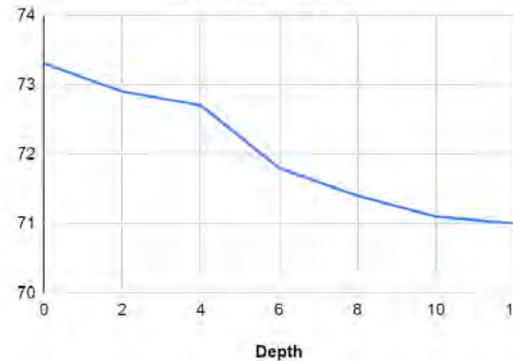
Water Column Profile

Mixed: The dissolved oxygen and temperature profile shows this lake's water column is adequately mixed resulting in acceptable dissolved oxygen levels at lower depths, expanded fisheries habitat, less bottom muck and bad odors. It is recommended to monitor oxygen levels closely, particularly with seasonal changes.

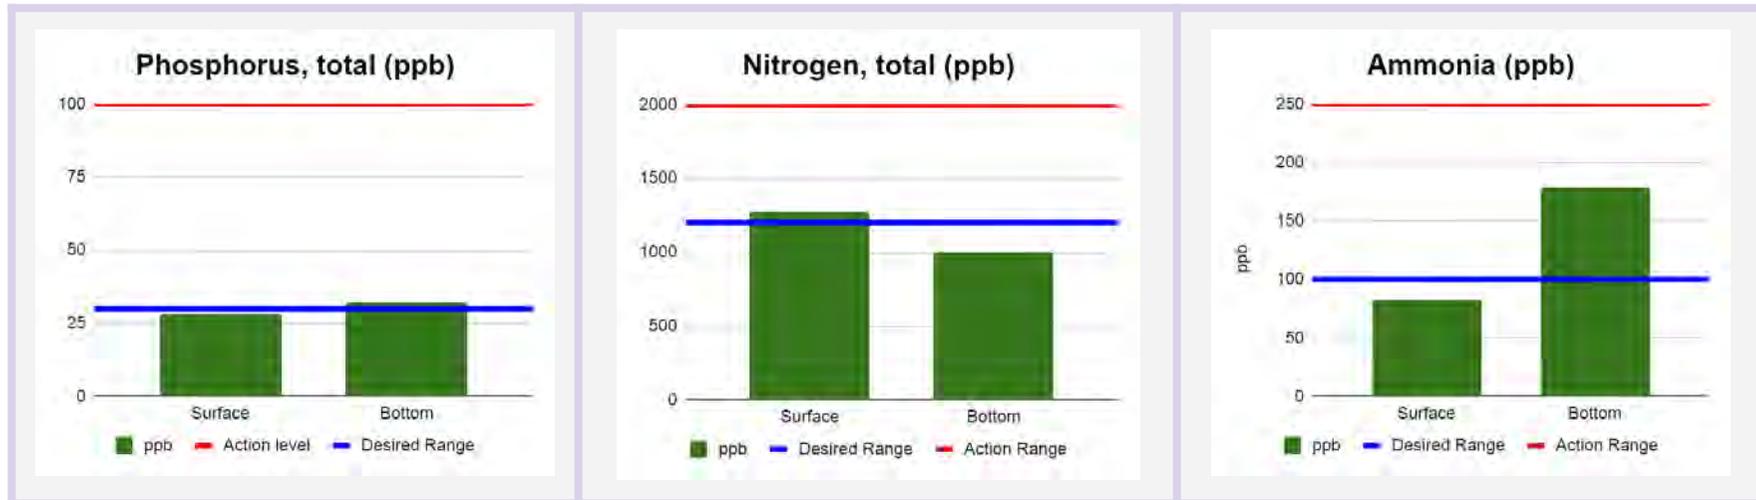
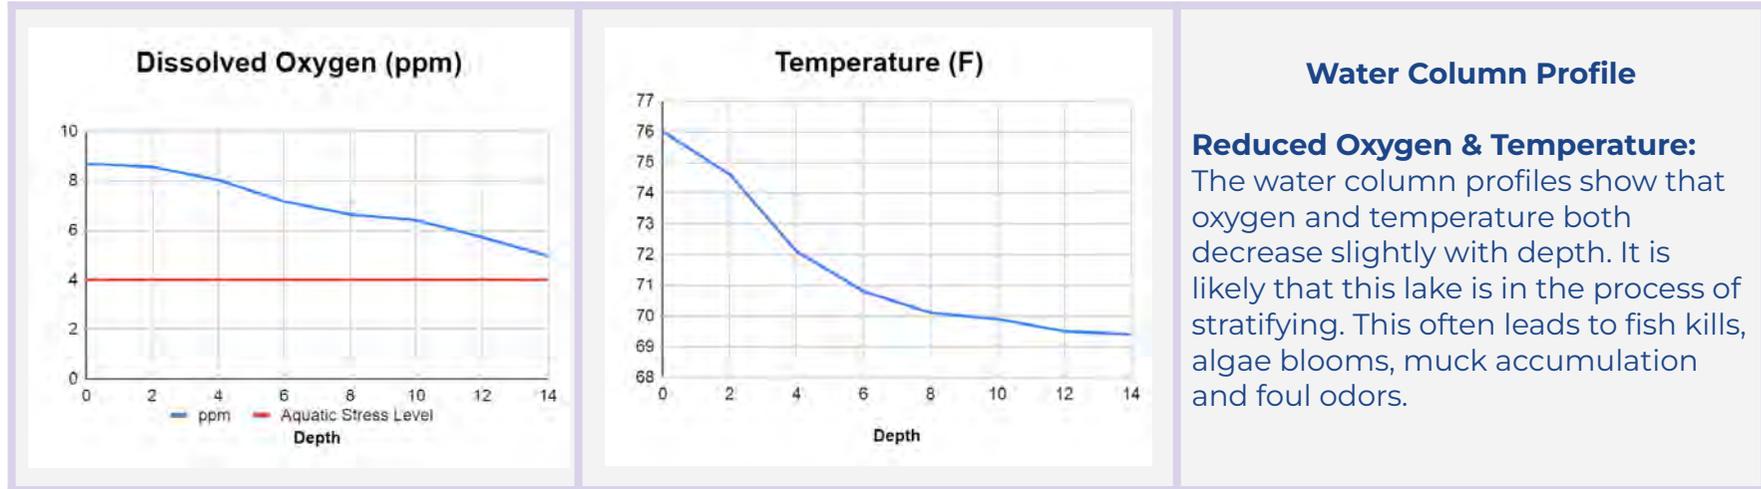
Reduced Oxygen & Temperature:

The water column profiles show that oxygen and temperature both decrease slightly with depth. It is likely that this lake is in the process of stratifying. This often leads to fish kills, algae blooms, muck accumulation and foul odors.

Water quality analysis suggests that this site is experiencing reduced oxygen levels. When oxygen levels are low it can cause nutrients to leach out of the bottom sediments. It is recommended to install an aeration system in order to circulate the water column, increase oxygen levels and reduce nutrient availability.

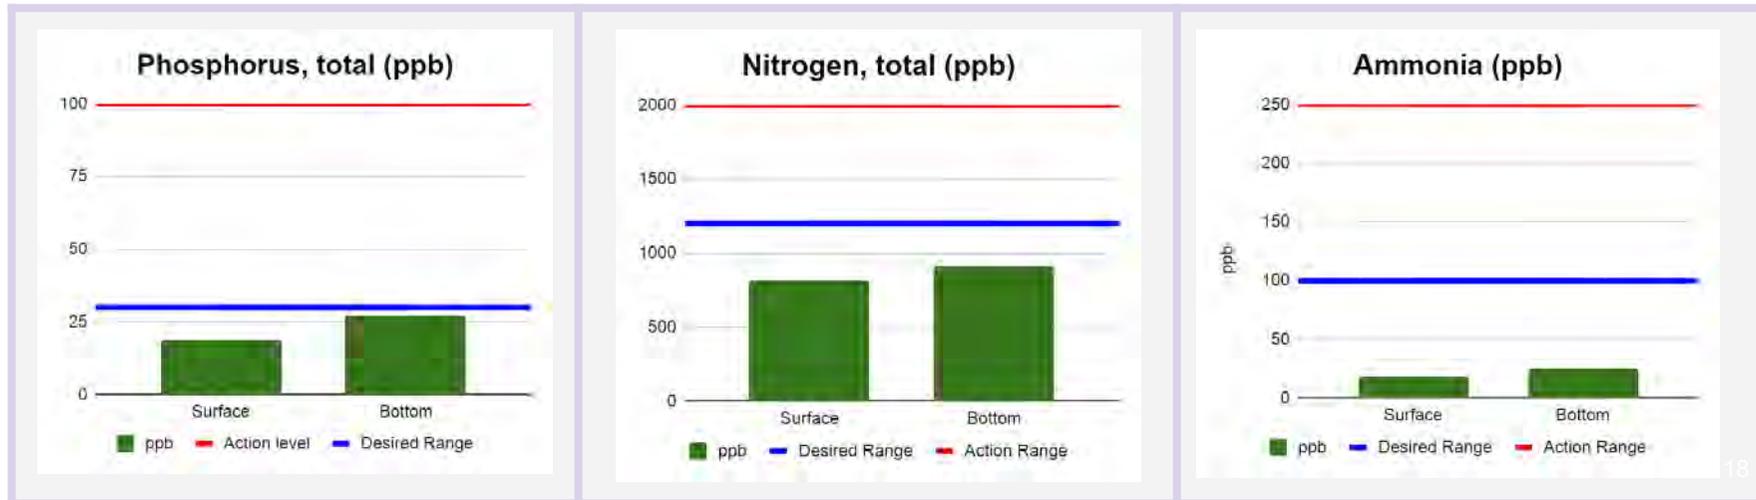
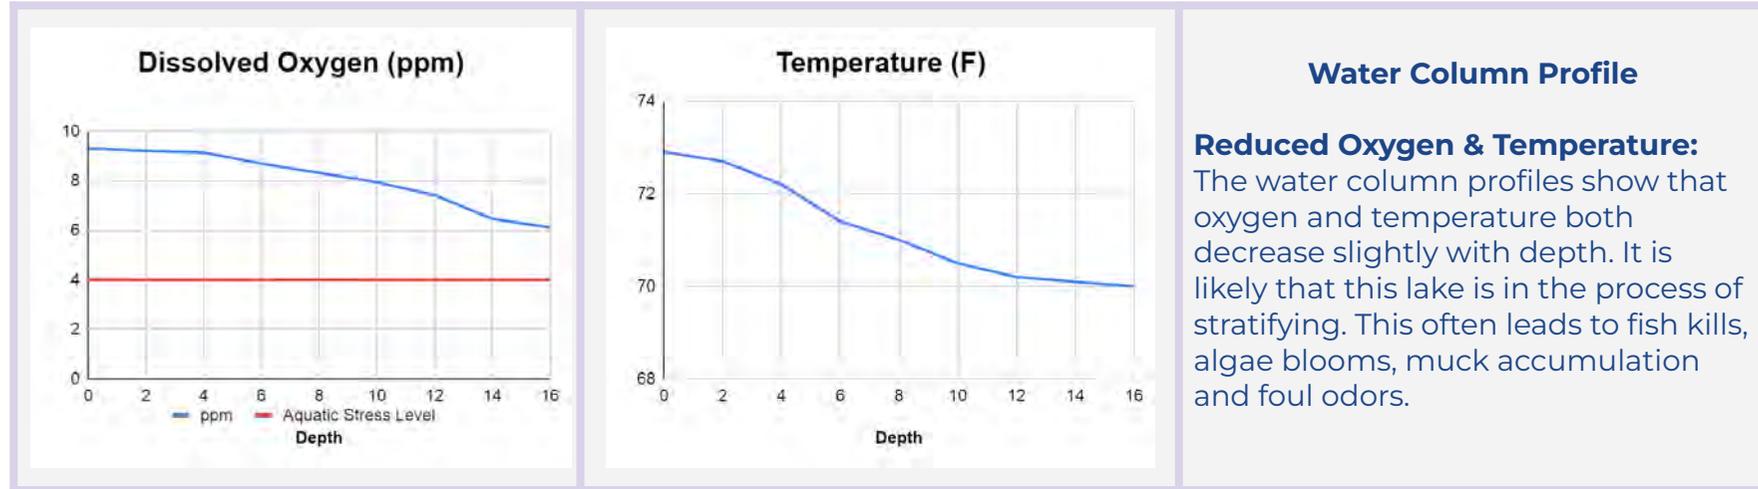
Water Column Profile

Reduced Oxygen & Temperature: The water column profiles show that oxygen and temperature both decrease slightly with depth. It is likely that this lake is in the process of stratifying. This often leads to fish kills, algae blooms, muck accumulation and foul odors.

| Observations | Recommendations |
|---|---|
| <p>Water quality analysis suggests that this site is experiencing reduced oxygen levels. When oxygen levels are low it can cause nutrients to leach out of the bottom sediments. It is recommended to install an aeration system in order to circulate the water column, increase oxygen levels and reduce nutrient availability.</p> | <ul style="list-style-type: none">• Aeration for increased dissolved oxygen• Watershed management• Ongoing water quality monitoring |

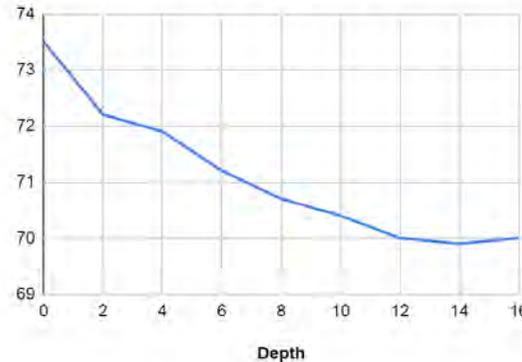
Water Column Profile

Mixed: The dissolved oxygen and temperature profile shows this lake's water column is adequately mixed resulting in acceptable dissolved oxygen levels at lower depths, expanded fisheries habitat, less bottom muck and bad odors. It is recommended to monitor oxygen levels closely, particularly with seasonal changes.

Water quality analysis suggests that this site is experiencing slightly elevated nitrogen levels. Elevated nitrogen may be due to fertilizer runoff, decaying plant material, or low oxygen levels at the bottom of the water column.

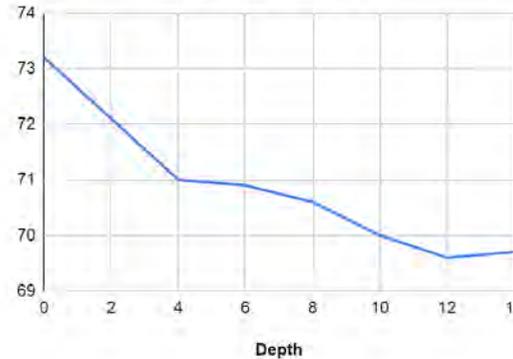
Water Column Profile

Mixed: The dissolved oxygen and temperature profile shows this lake's water column is adequately mixed resulting in acceptable dissolved oxygen levels at lower depths, expanded fisheries habitat, less bottom muck and bad odors. It is recommended to monitor oxygen levels closely, particularly with seasonal changes.
