RE: *Flow Way CDD v. Taylor Morrison of Florida, Inc., et al.*
NOTICE OF CLAIM, PURSUANT TO FLA. STAT. § 558.004

Thus, pursuant to Chapter 558 of the Florida Statutes, **YOU ARE HEREBY NOTIFIED of the construction defects existing within the CDD Boundaries, each of which are set forth in more detail in the enclosed Forge Engineering Report, dated June 2, 2021, and the CGA Report.**

FLOW WAY CDD PERIMETER FENCING INVESTIGATION MAP

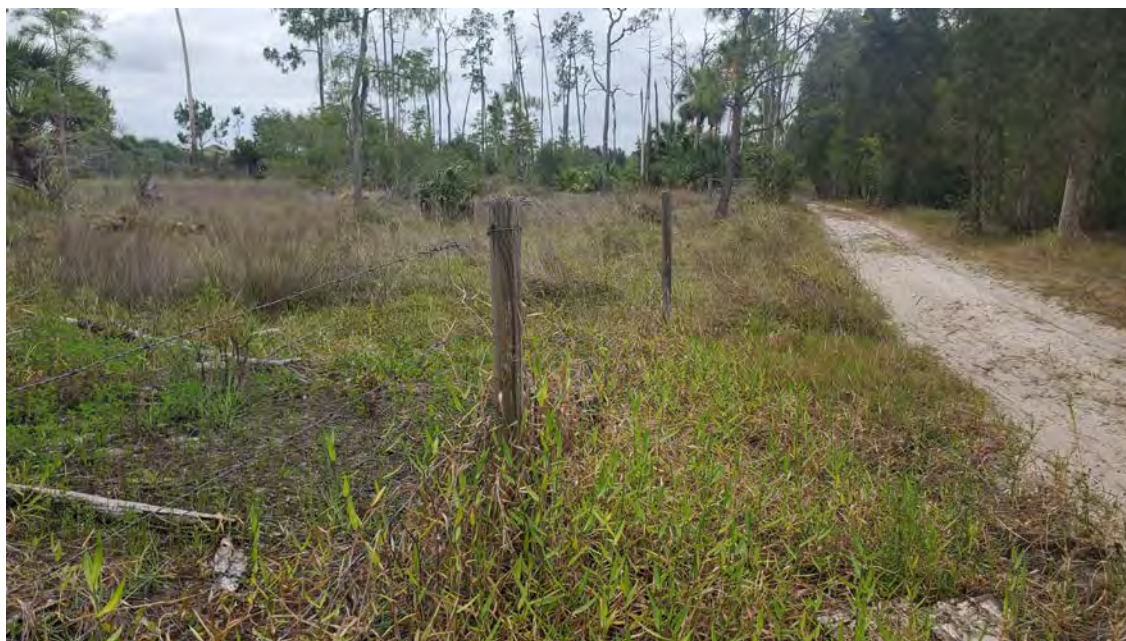
#74 - Collier ROW – Ex. Fence Terminal

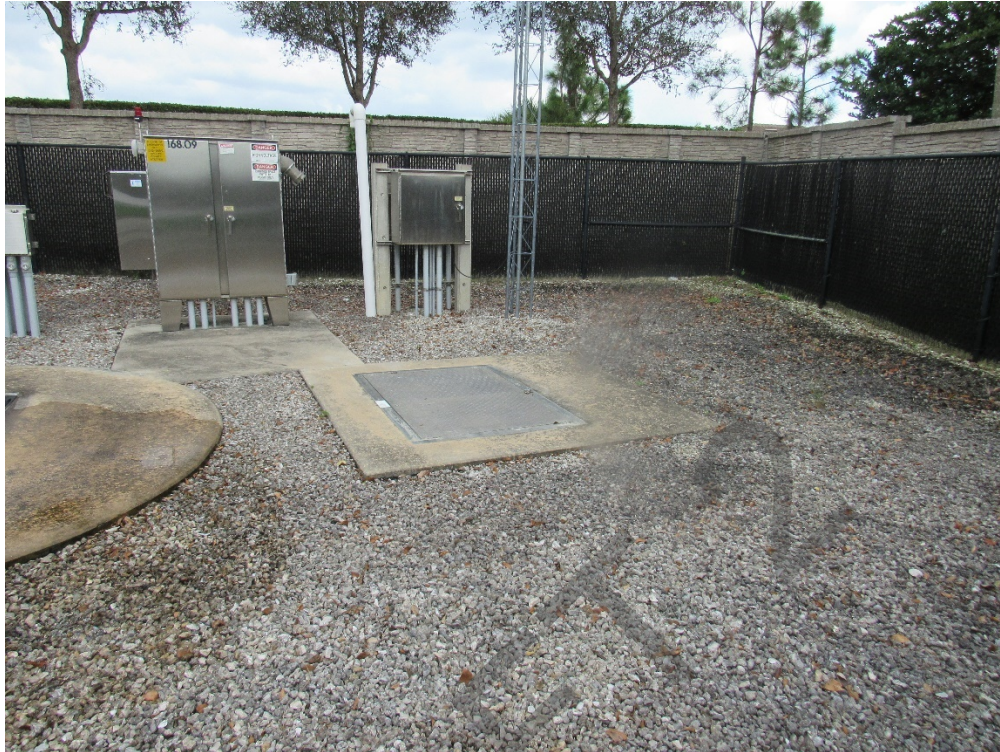
View of lift station 168.09.

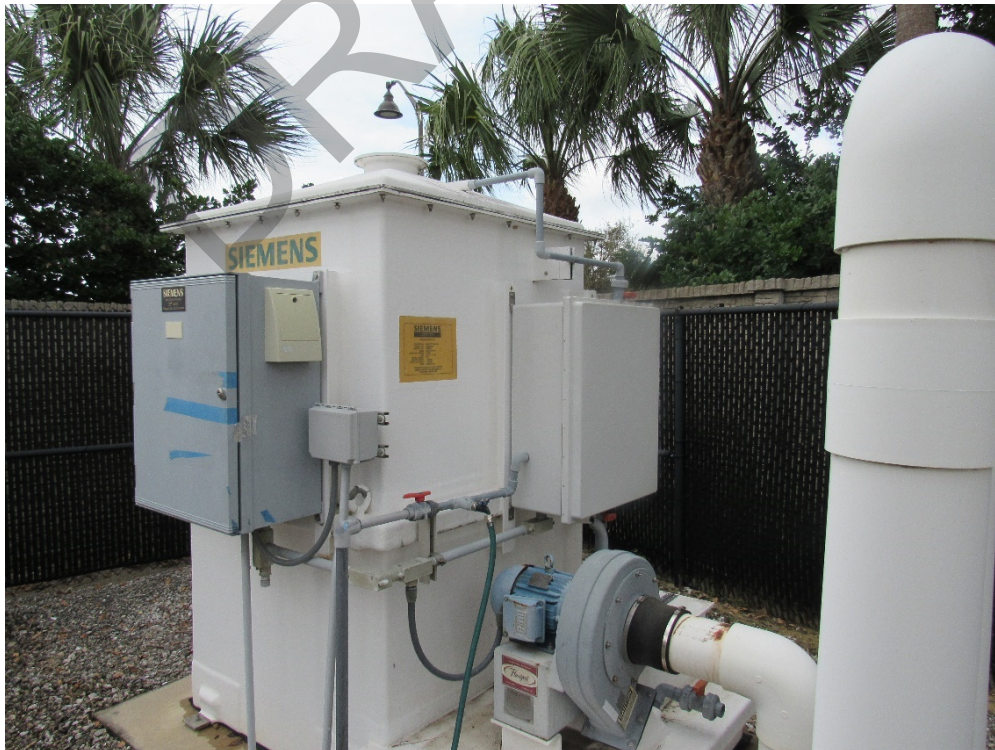
View of odor control system at 168.09.

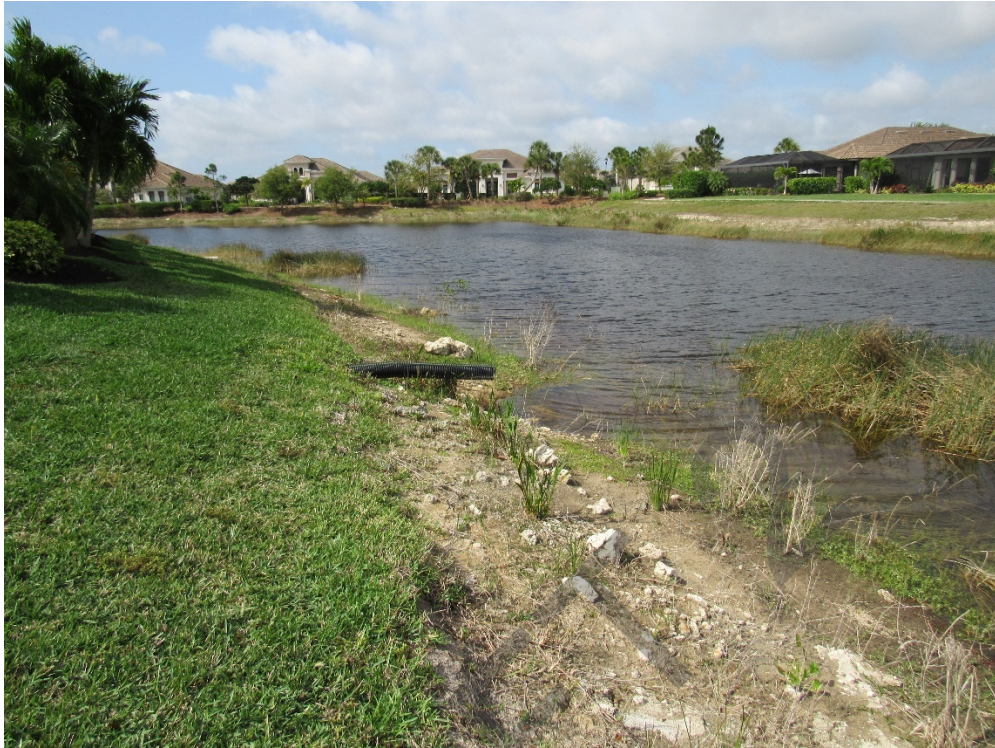
View of erosion at discharge line - Lake 14.

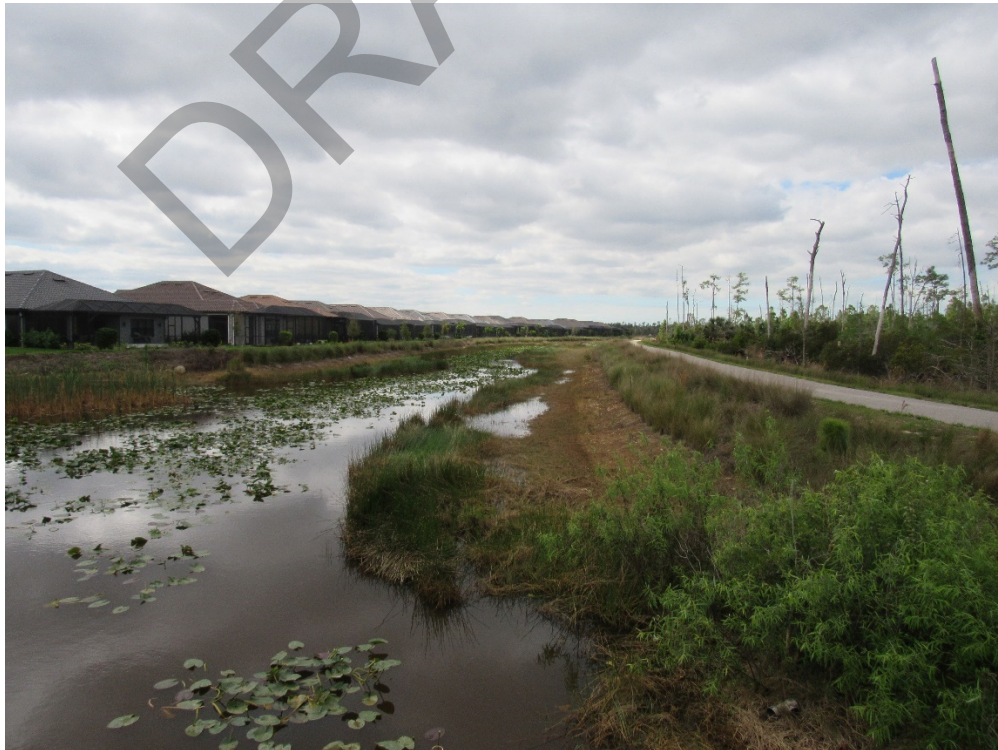
Typical view of Flow Way.

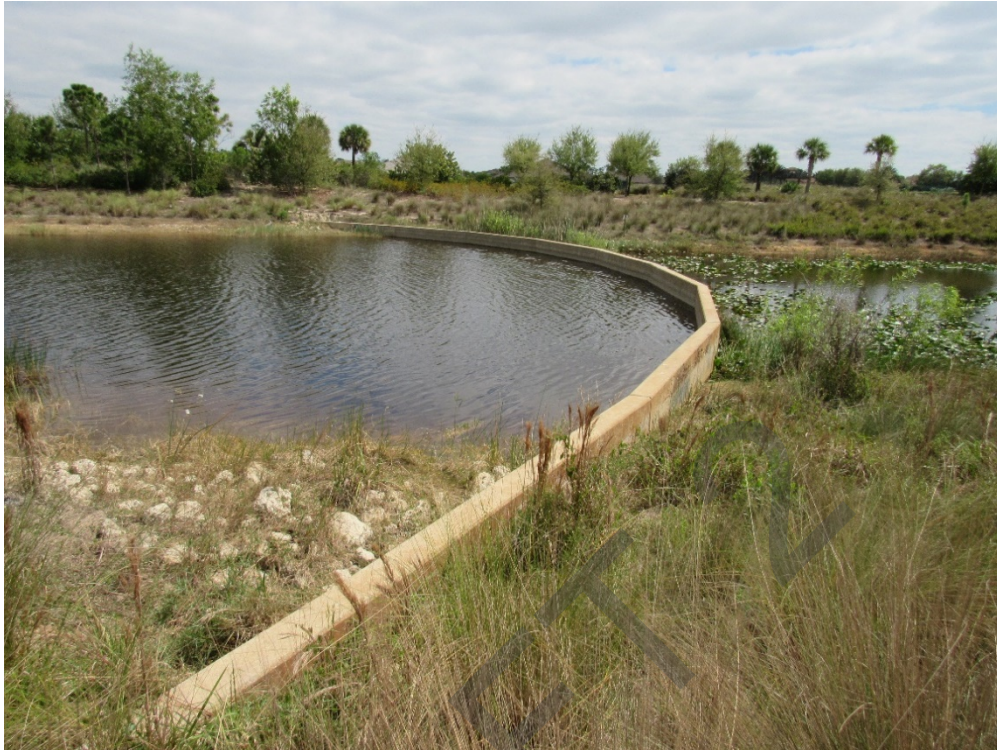
View of South Broad Crested Weir.

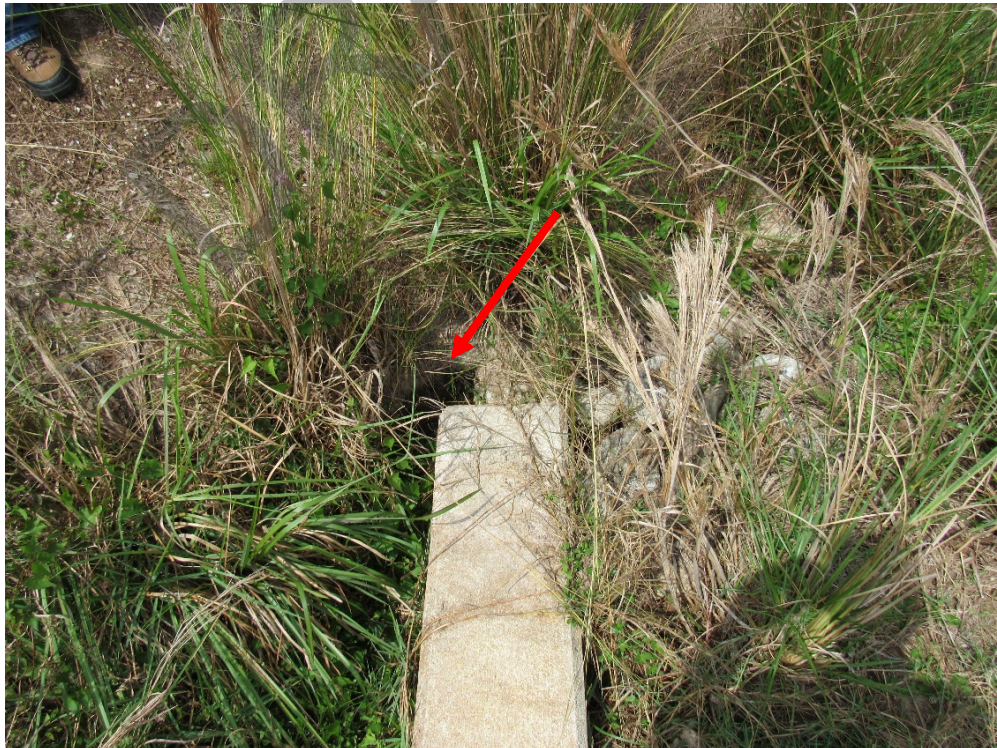
View of erosion - South Broad Crested Weir.

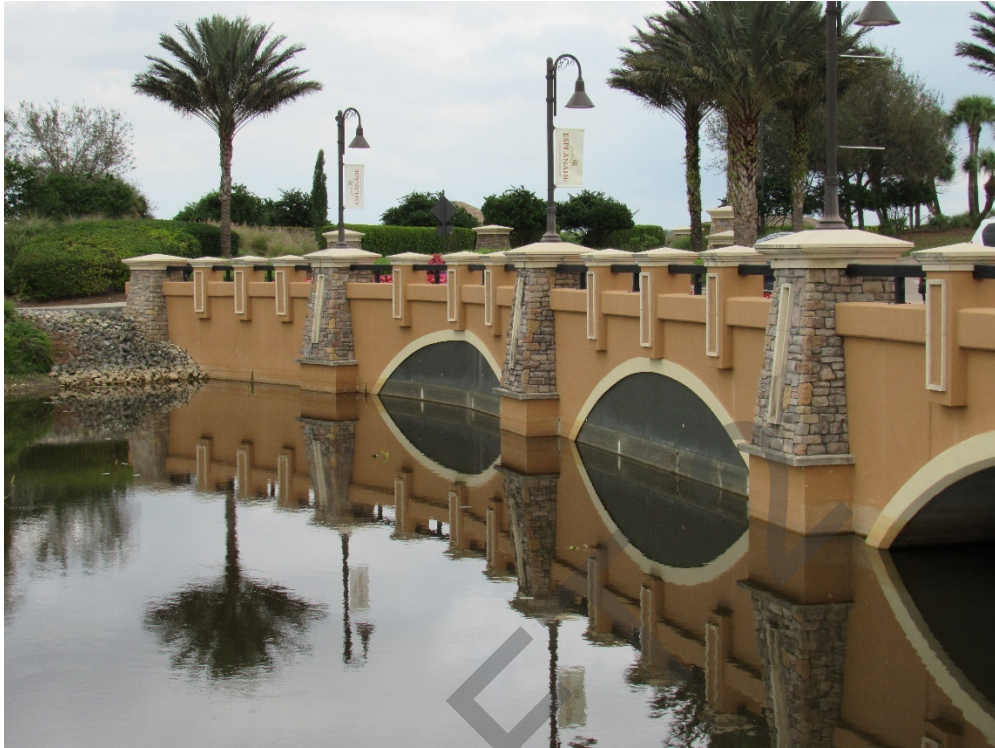
View of Entry Bridge

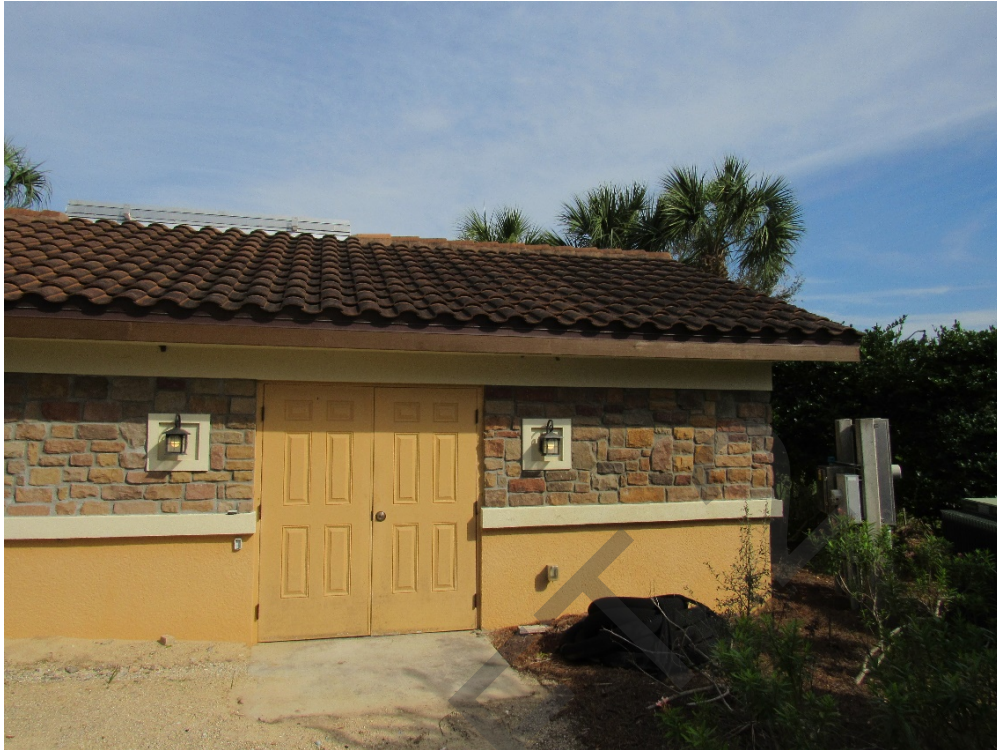
Exterior view of Community Irrigation Pump House.

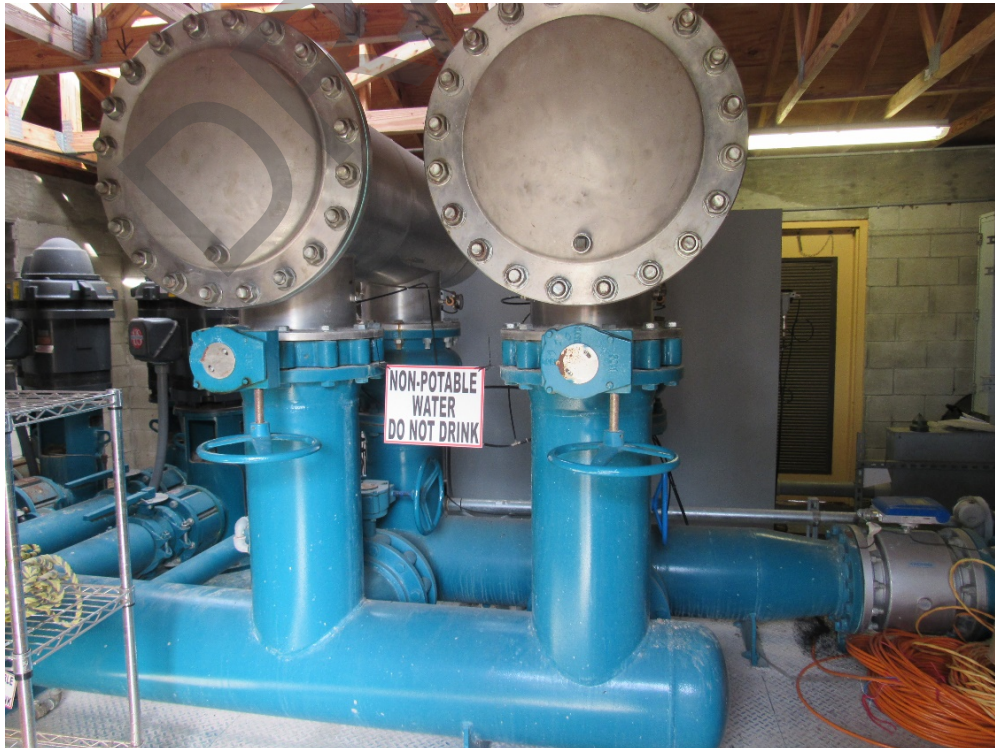
Interior view of Community Irrigation Pump House.

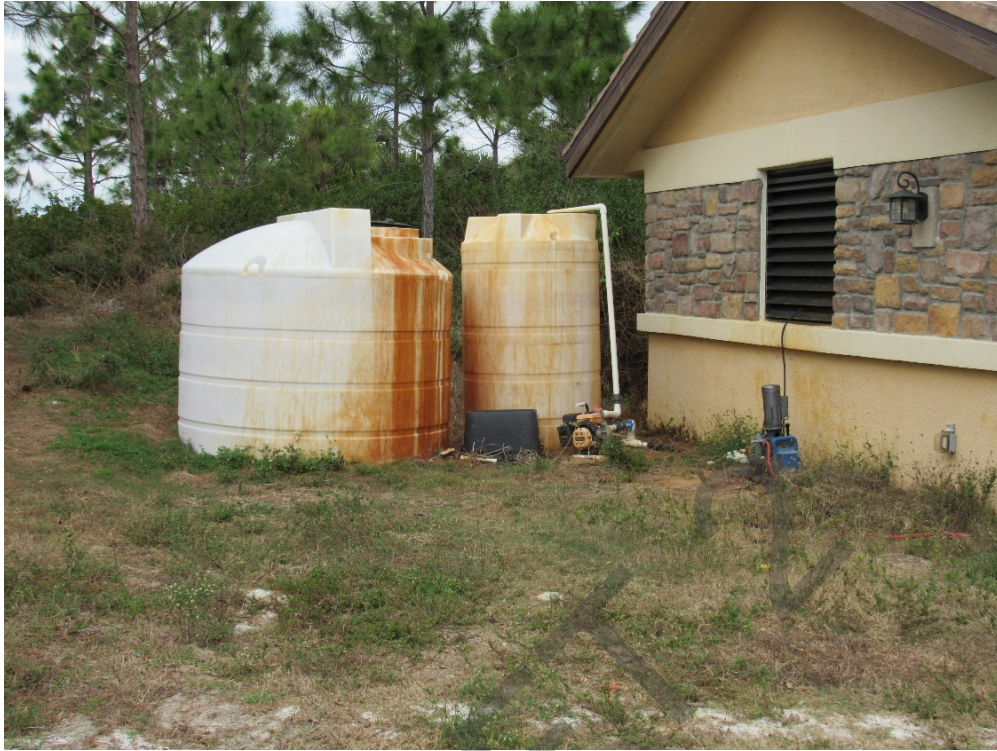
- We observed two unknown tanks at the exterior of the golf course pump house.

View of unknown tanks - Golf Course Irrigation Pump House.

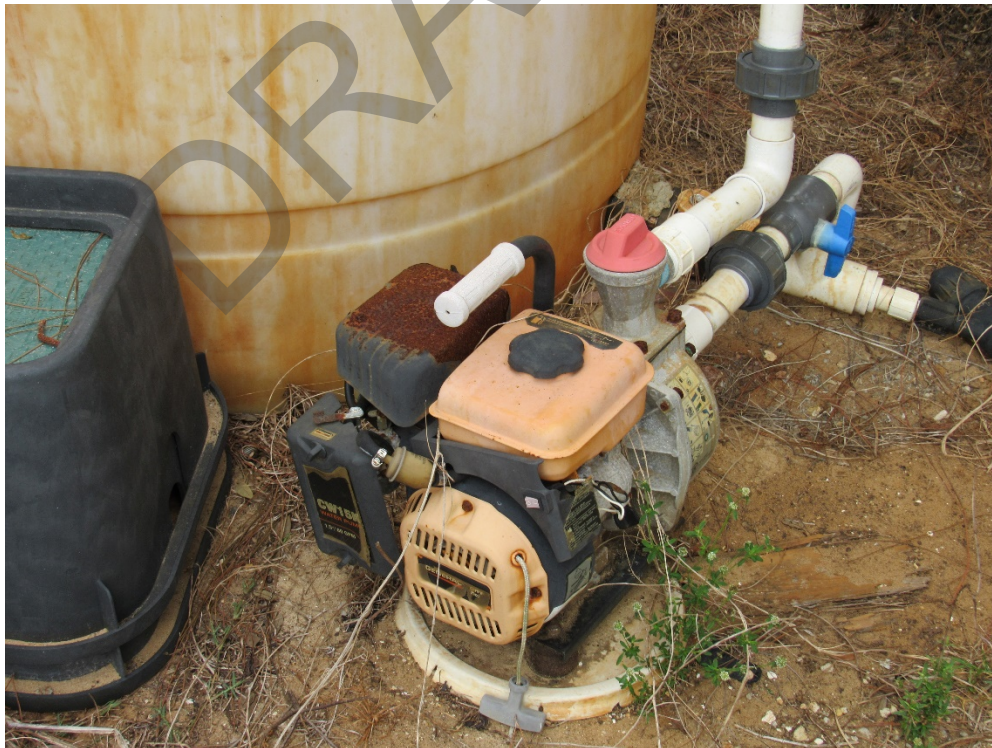
View of exterior gas pump - Golf Course Irrigation Pump House.

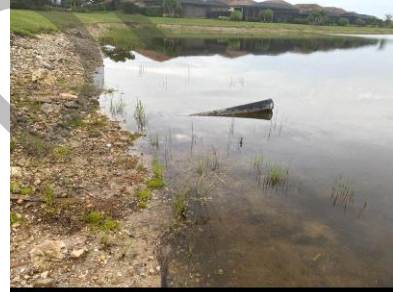
Pipe not anchored down

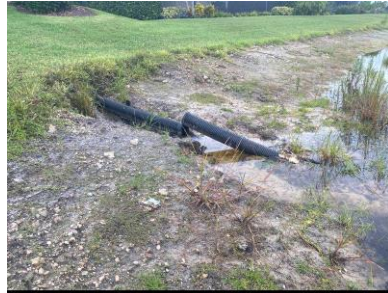
Drainage pipe broke causing washout

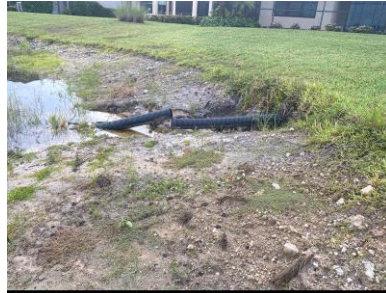
different angle of disconnected pipe

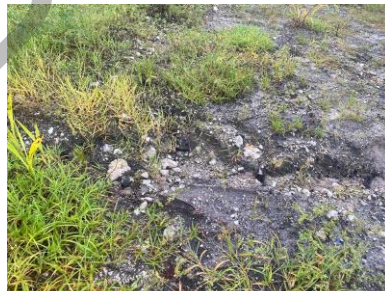
There is new erosion present at the time of inspection.

small washout starting

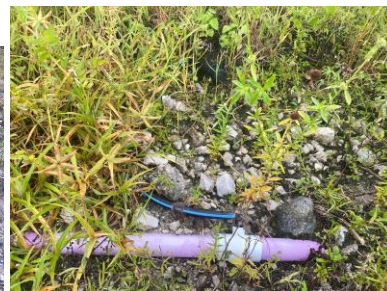
Sprinkler laying down causing washout
