**Report of Water Management System Study**

**FLOW WAY  
COMMUNITY DEVELOPMENT DISTRICT  
(FLOW WAY CDD)**

**Forge Engineering Project Number 5911-001.01**

**June 2021**

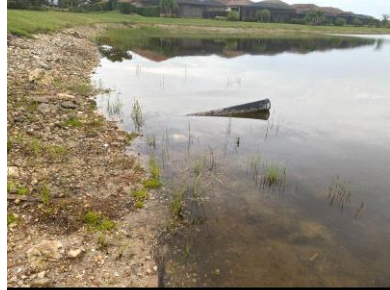
**Pipe not anchored down**

Repair should be considered at this time.  
There is no aeration present on the lake.  
There is no fountain present.

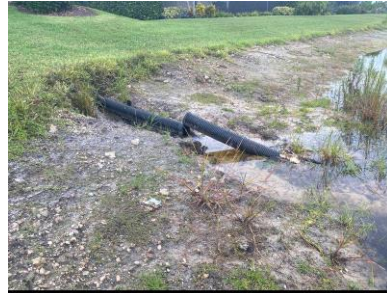
**Drainage pipe broke causing washout**

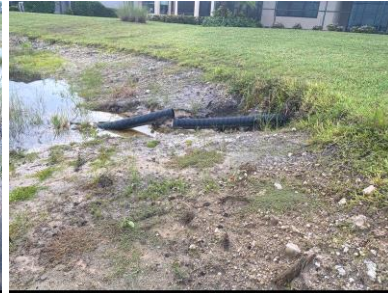
**different angle of disconnected pipe**

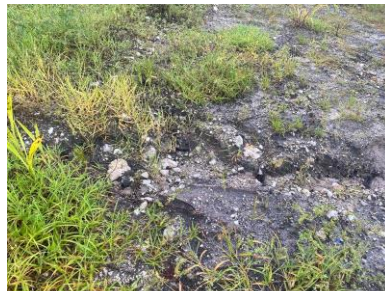
There is new erosion present at the time of inspection.

**small washout starting**

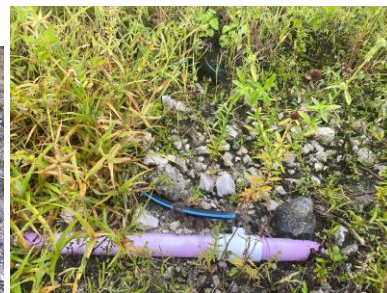
**Sprinkler laying down causing washout**

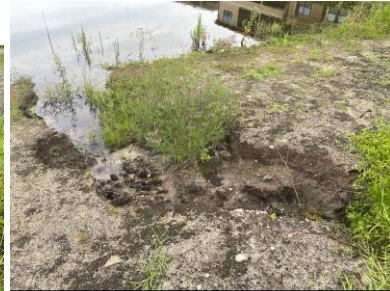
**Large washout needs attention**

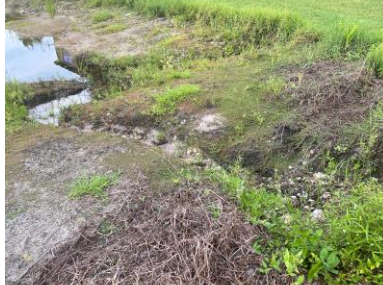
**Large washout in corner of lake**

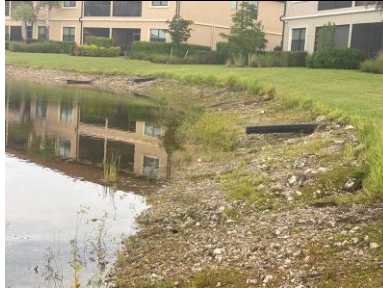
**Washout and escarment along homeowner side**
