Wentworth Estates CDD at Treviso Bay Waterway Inspection Report

Reason for Inspection: Routine Scheduled

Inspection Date: 2025-10-28

Wentworth Estates CDD at Treviso Bay
Treviso Bay Clubhouse, 9800 Treviso Bay Boulevard
Naples, Florida 34113

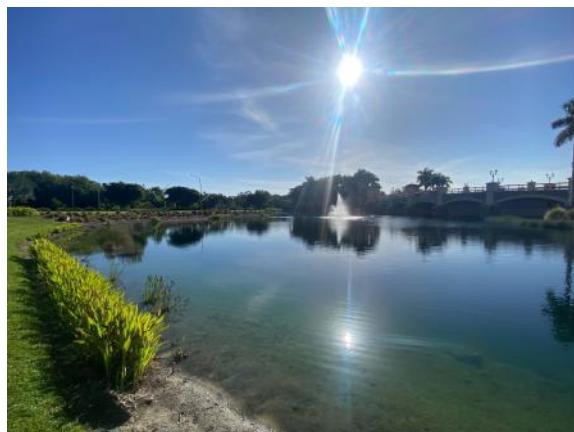
Site: 1**Comments:**

Site looks good

Shoreline is well maintained.
Algae and submerged vegetation
are at controlled levels.

Routine maintenance next visit

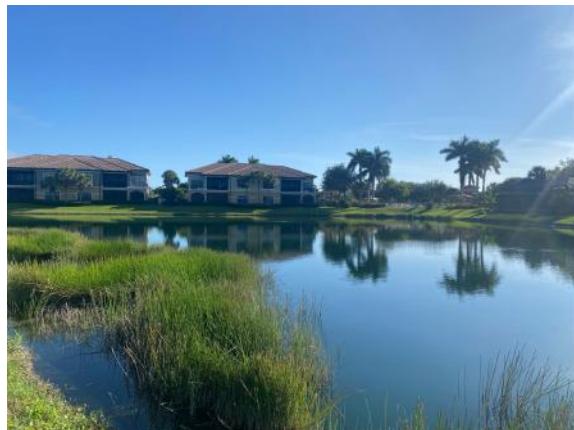
Site: 7**Comments:**

Normal growth observed

Some areas of torpedo grass observed along shoreline and within littorals. Algae and submerged vegetation are at controlled levels.

Routine maintenance next visit

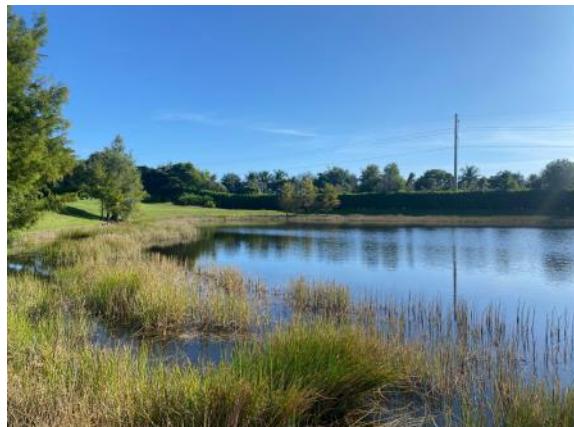
**Site: 11****Comments:**

Normal growth observed

Shoreline is well maintained with
some areas of regrowth present.
Algae and submersed vegetation
is at controlled levels.

Routine maintenance next visit

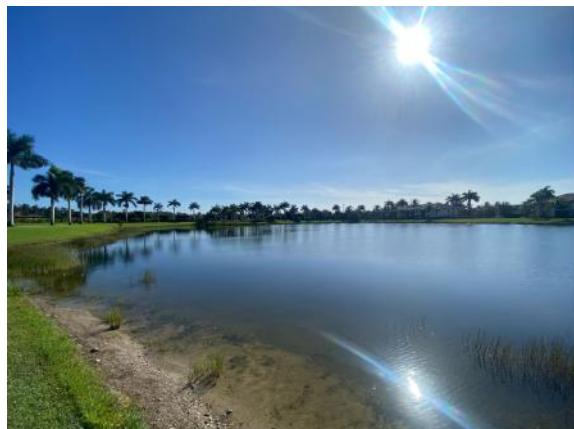
**Site: 12****Comments:**

Treatment in progress

Shoreline is well maintained.
Algae is at controlled levels.
Submersed vegetation present
and is being treated.

Routine maintenance next visit

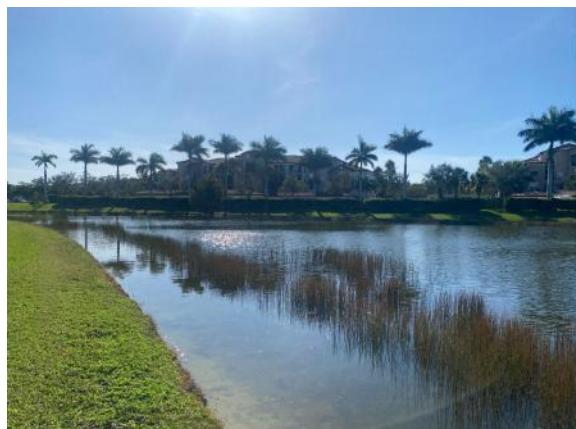
Site: 14**Comments:**

Treatment in progress

Shoreline is well maintained.
Submerged vegetation is present
and receiving treatment.

Routine maintenance next visit

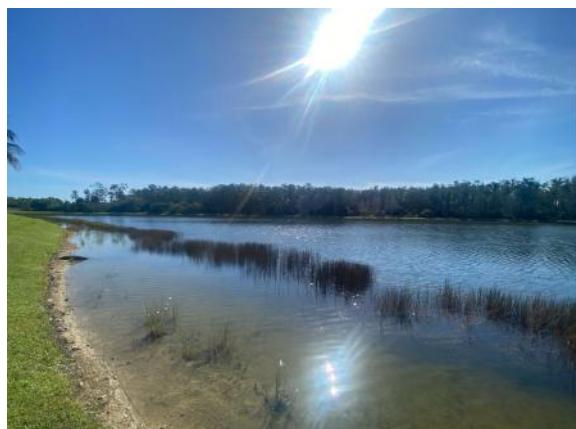
Site: 15**Comments:**

Site looks good

Shoreline is well maintained.
Algae and submerged vegetation
are at controlled levels.

Routine maintenance next visit

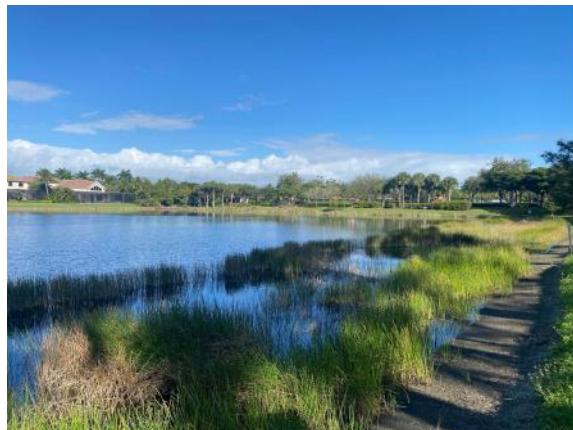
Site: 16**Comments:**

Site looks good

Shoreline is well maintained.
Algae and submerged vegetation
are at controlled levels.

Routine maintenance next visit

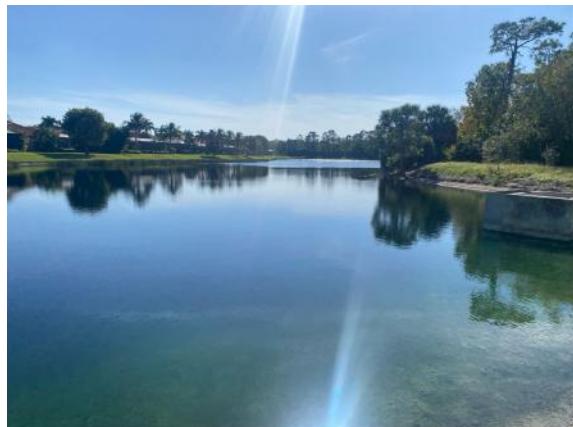
Site: 17**Comments:**

Site looks good

Shoreline is well maintained.
Algae and submerged vegetation
are at controlled levels.

Routine maintenance next visit

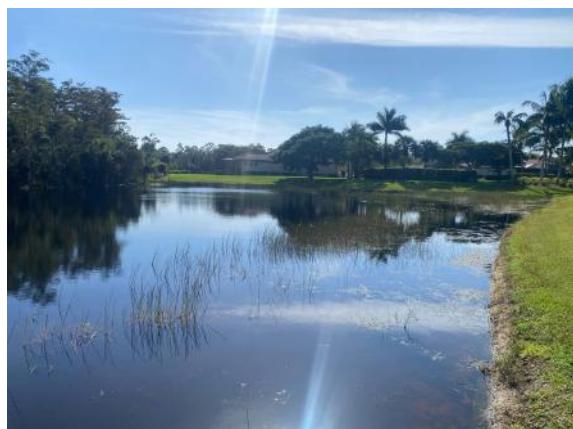
Site: 18**Comments:**

Requires attention

Surface algae present and requires treatment. Shoreline weeds are well maintained.

Treat within 7 days

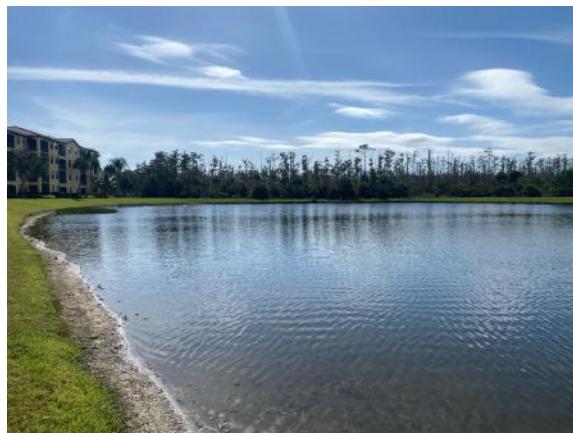
Site looks good

Shoreline is well maintained.
Algae and submersed vegetation
are at controlled levels.

Routine maintenance next visit

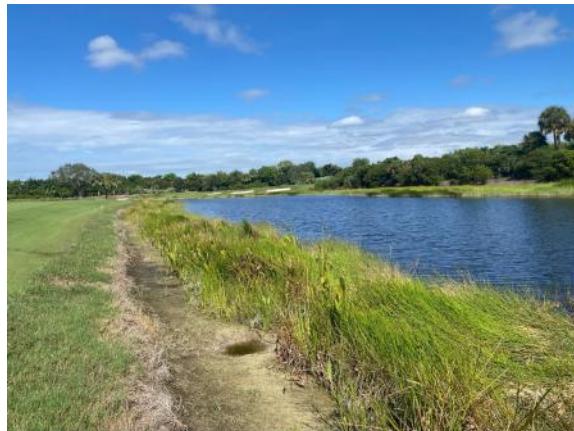
Site: 37**Comments:**

Site looks good

Shoreline is well maintained.
Algae and submerged vegetation
are at controlled levels.

Routine maintenance next visit

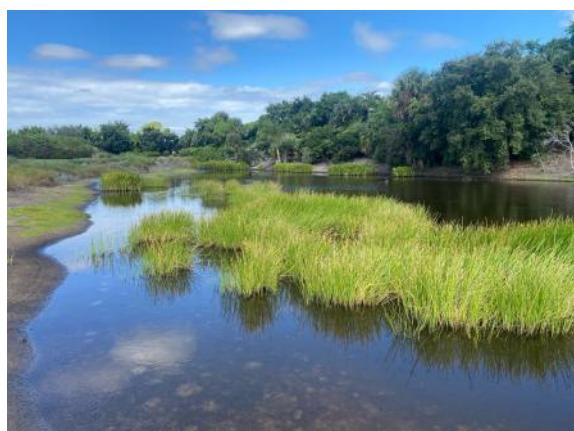
Site looks good

Shoreline is well maintained.
Algae and submerged vegetation
are at controlled levels.

Routine maintenance next visit

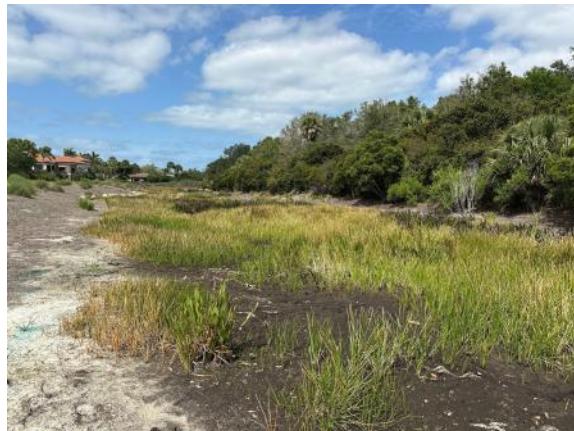
Site looks good

Shoreline is well maintained.
Algae and submerged vegetation
are at controlled levels.

Routine maintenance next visit

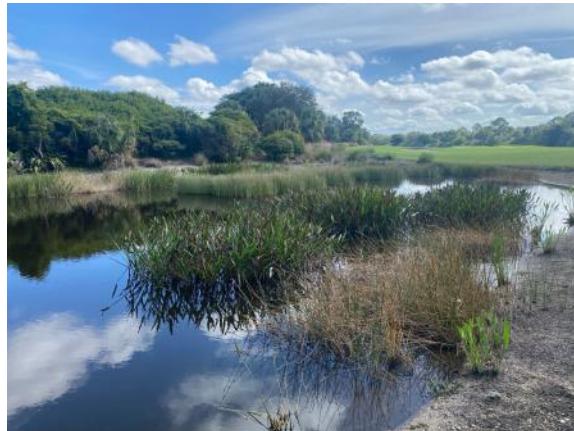
Site looks good

Shoreline is well maintained.
Algae and submerged vegetation
are at controlled levels.

Routine maintenance next visit

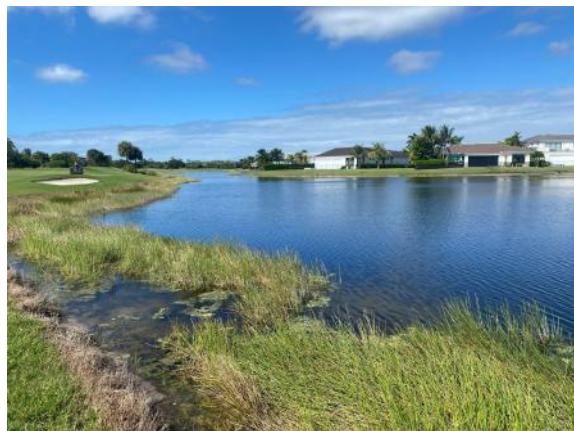
Requires attention

Shoreline is well maintained.
Some surface algae and
submerged vegetation present in
and around littorals.

Routine maintenance next visit
