Flow Way
Community Development District
Asset Replacement Costs

CGA Project No. 21-4271

February 2025

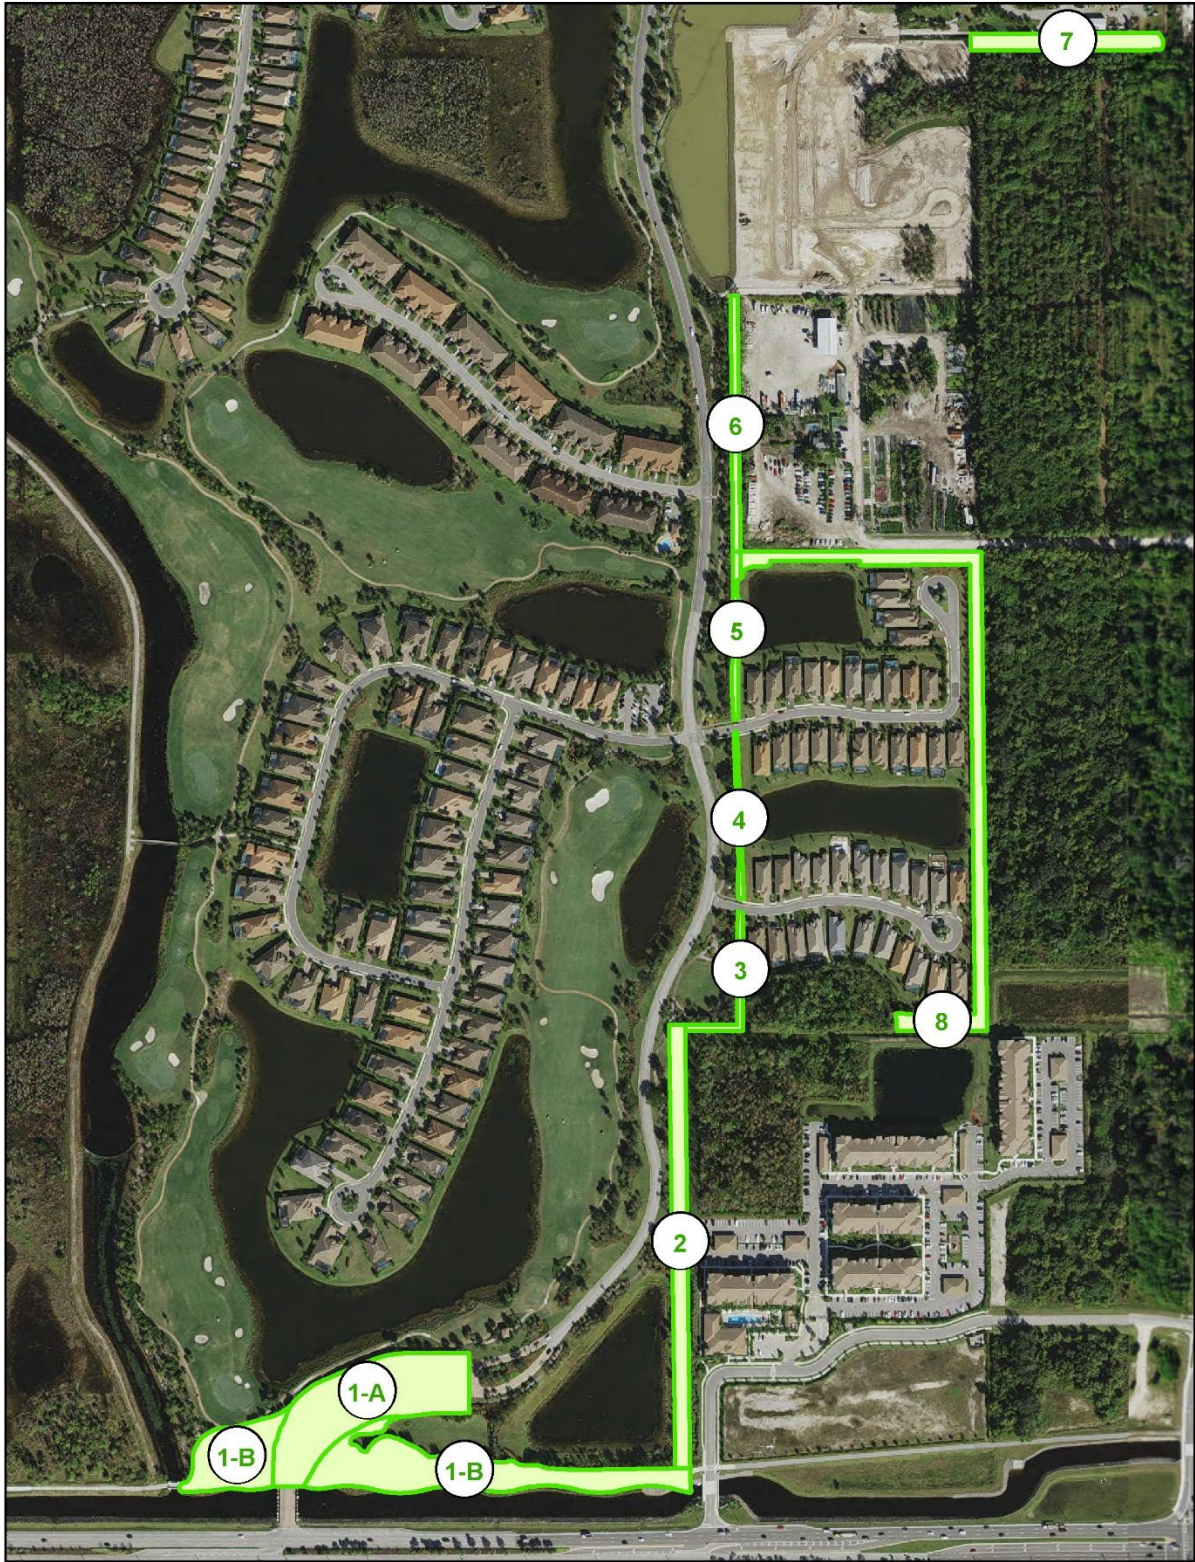
Figure 1 - Location Map of Existing Landscape Assets

Figure 1 below shows the locations of all existing landscape assets within the Flow Way CDD.
