**STONEBROOK AT VENICE
COMMUNITY DISTRICT DEVELOPMENT**

STORMWATER EROSION REPORT

JUNE 2019

Calvin, Giordano & Associates, Inc.
EXCEPTIONAL SOLUTIONS™

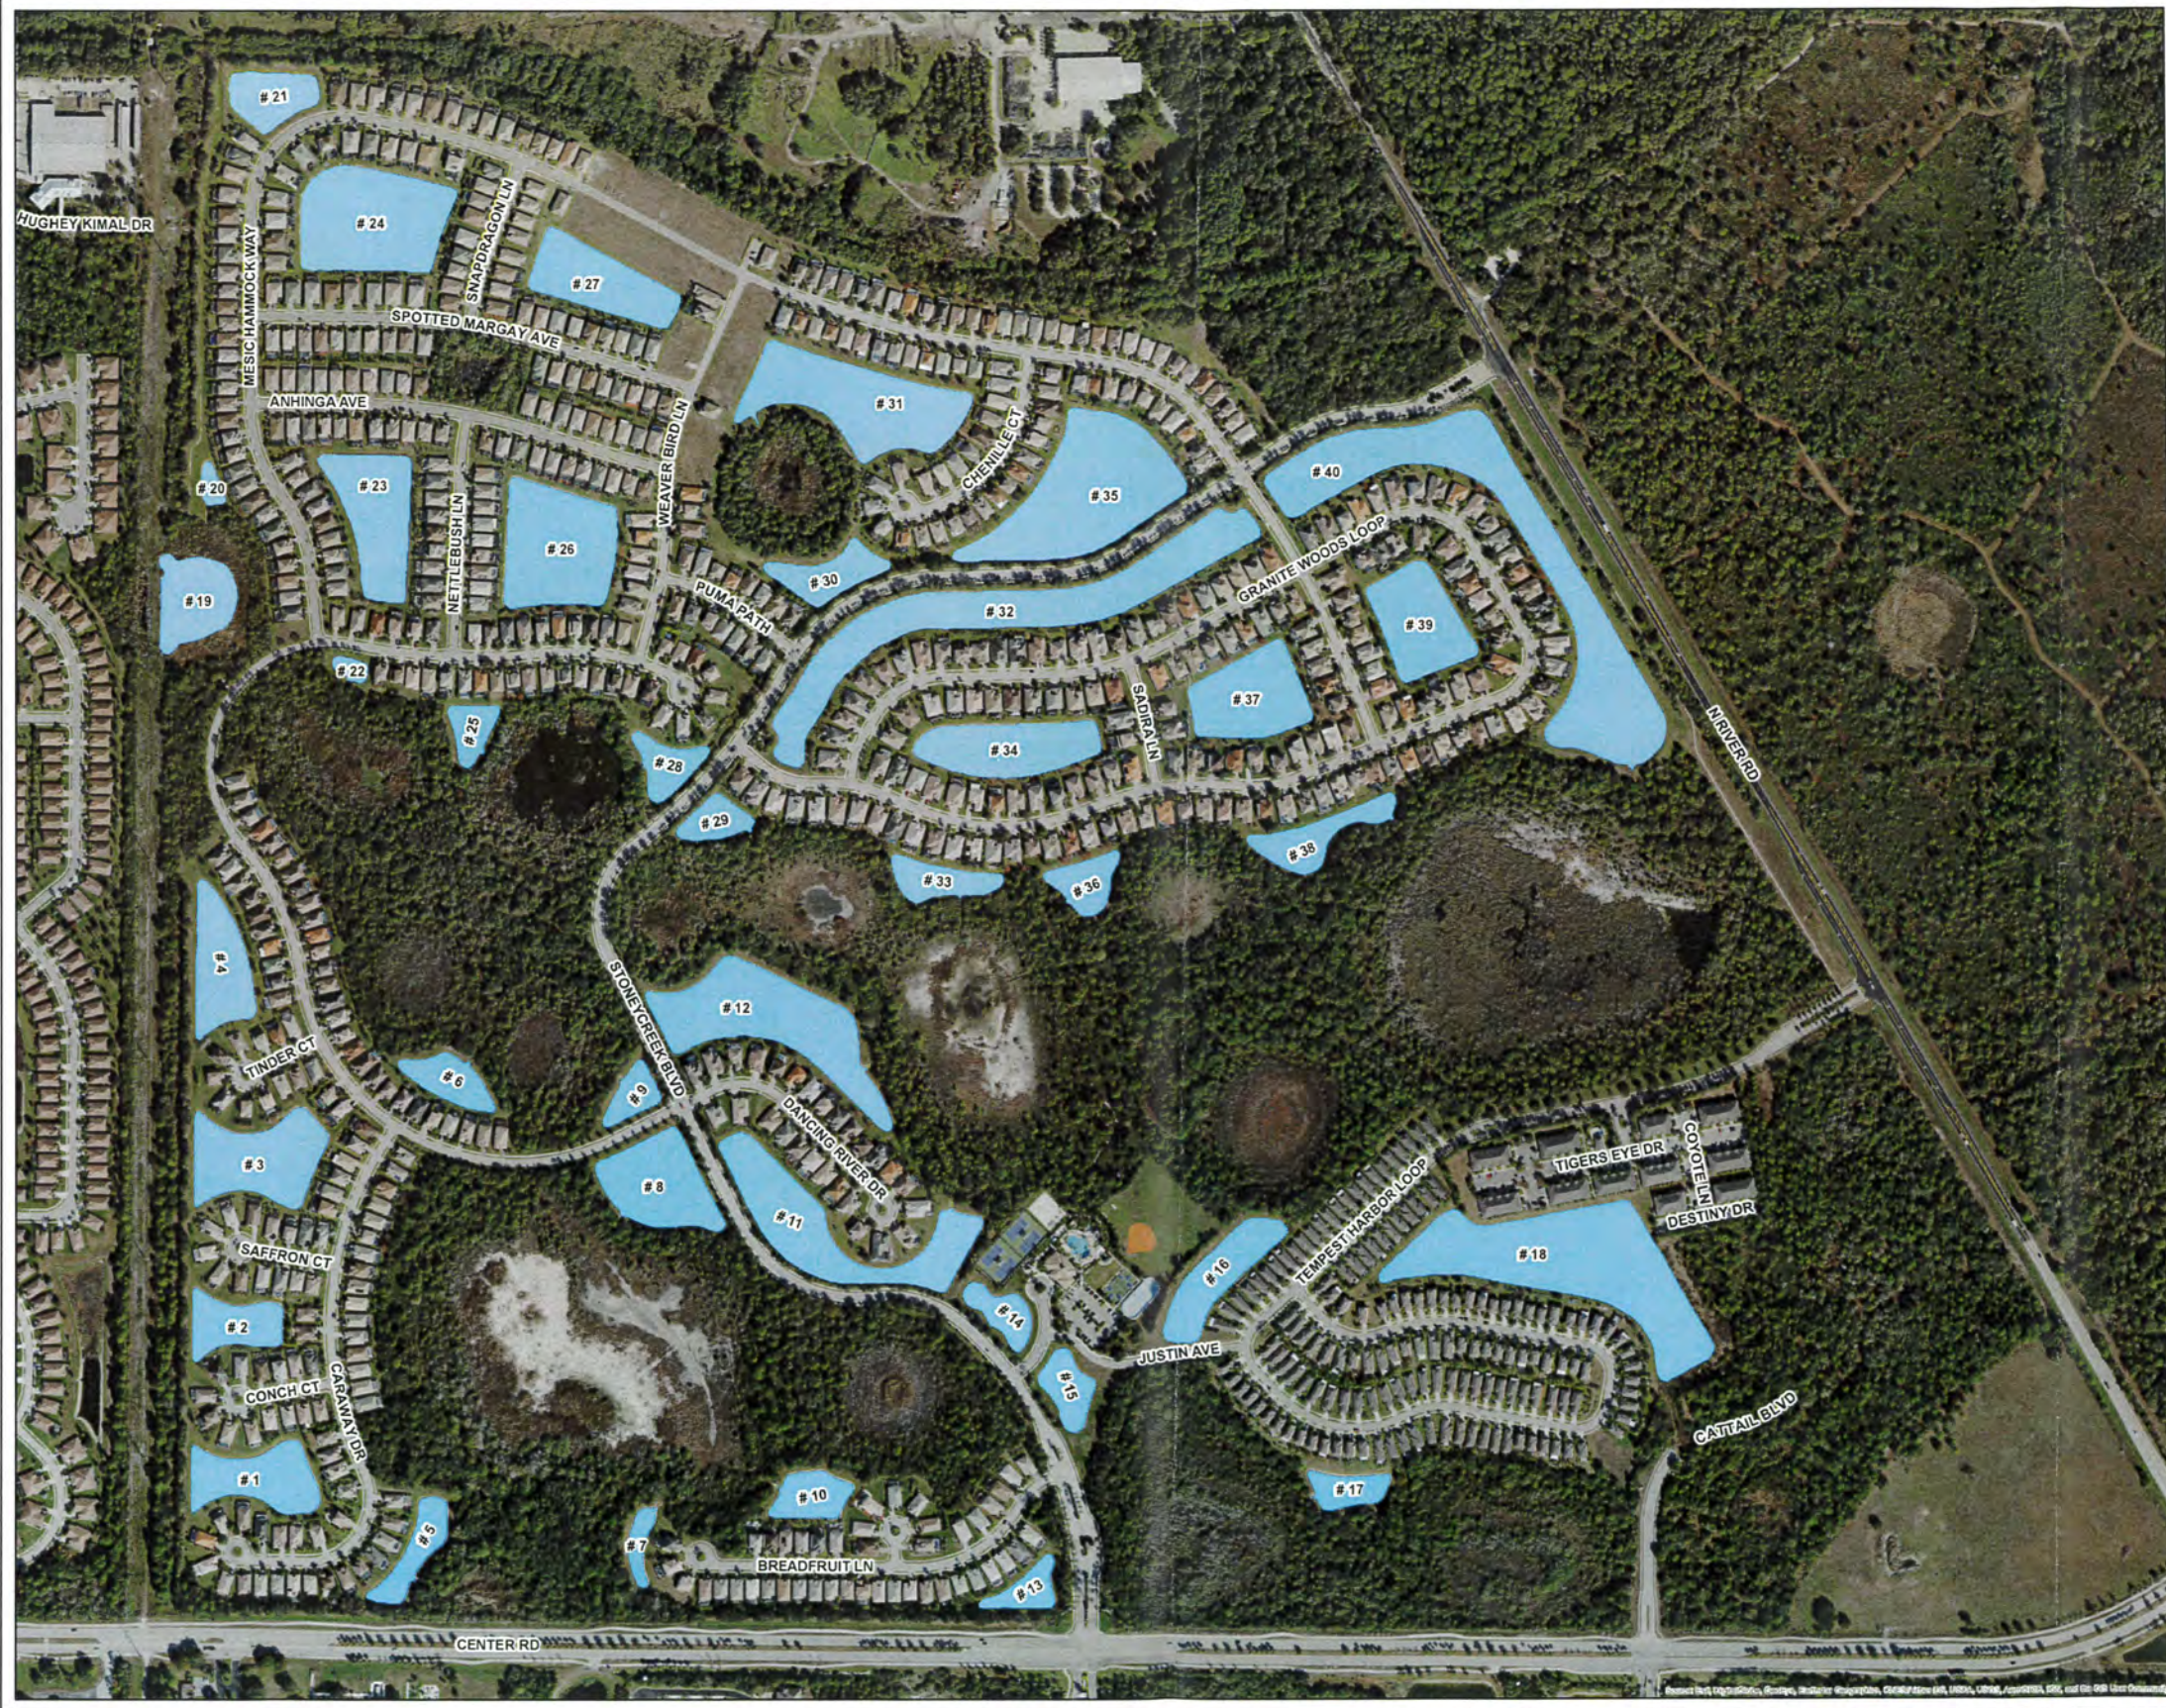
**Stoneybrook at Venice
Water Bodies**

Stoneybrook
at Venice
Community Development District
