Flow Way CDD at Esplanade Golf and Country Club Waterway Inspection Report

Reason for Inspection: Quality Control

Inspection Date: 2023-02-21

**Flow Way CDD at Esplanade Golf and Country Club
8910 Torre Vista Lane
Naples, FL 34119**

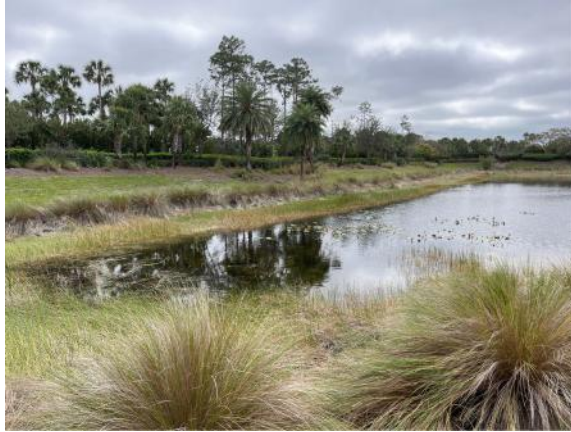
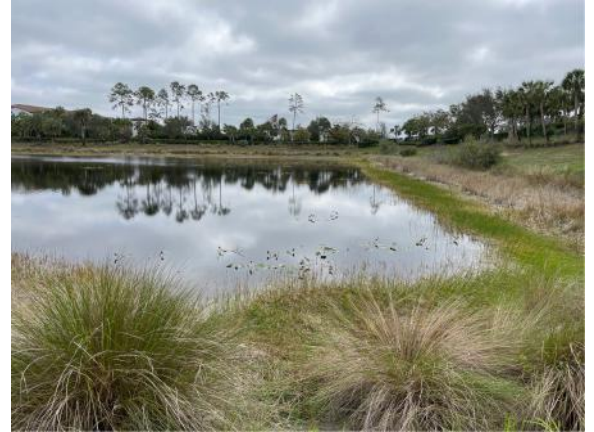
Site: 1

Requires attention

Shoreline grasses and brush are well-maintained. No algae. Treat for Illinois pondweed beginning to surface out and for spatterdock.

Submersed vegetation

Routine maintenance next visit

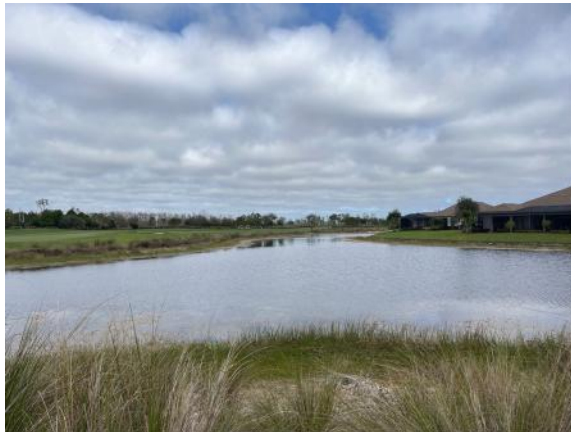
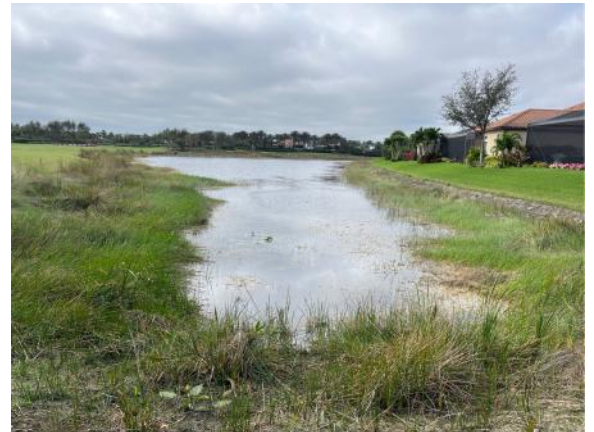
Site: 2

Requires attention

Shoreline grasses and brush are well-maintained. Treat for Illinois pondweed, fanwort and spatterdock. Some surface algae noted. Erosion noted between lot lines

Submersed vegetation

Routine maintenance next visit

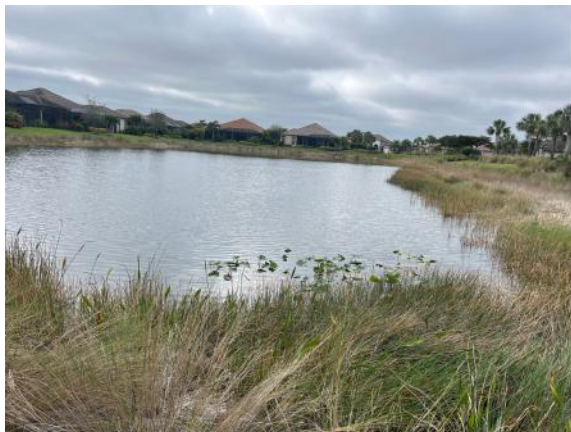
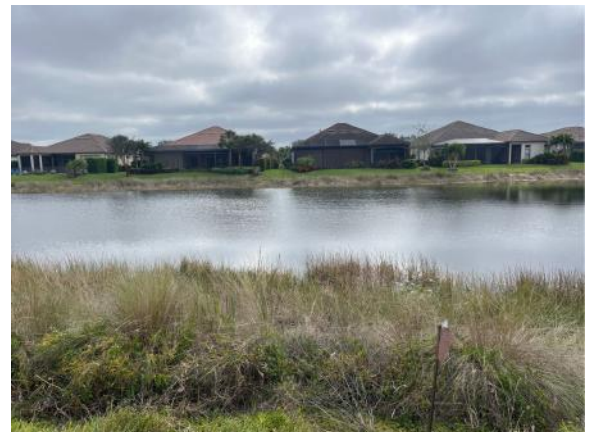
Site: 3

Requires attention

Shoreline is well maintained. No algae. Treat for red ludwigia, chara and spatterdock.

Submersed vegetation

Routine maintenance next visit

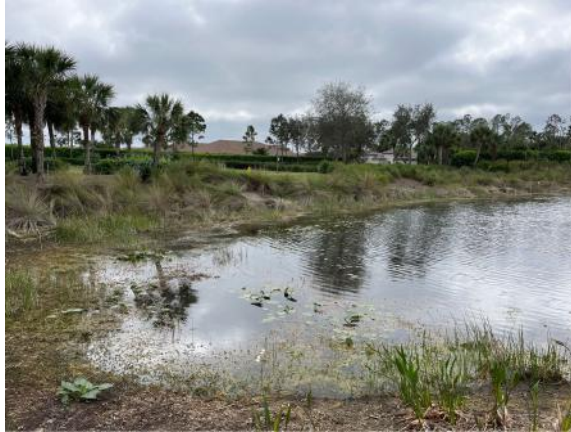
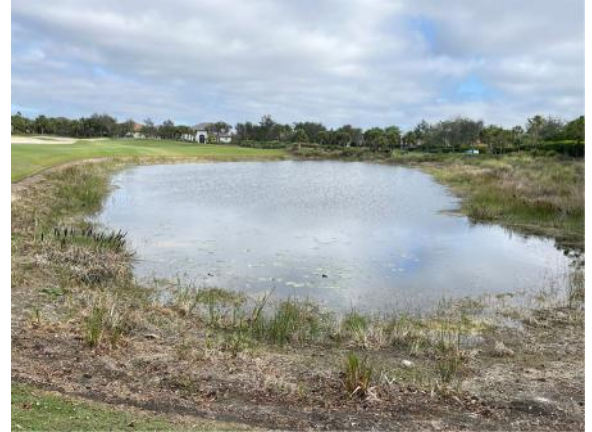
Site: 4

Requires attention
 Spot treat torpedograss in littorals. Some surface algae observed. Treat for fanwort, red ludwigia and spatterdock.

Submersed vegetation

Routine maintenance next visit

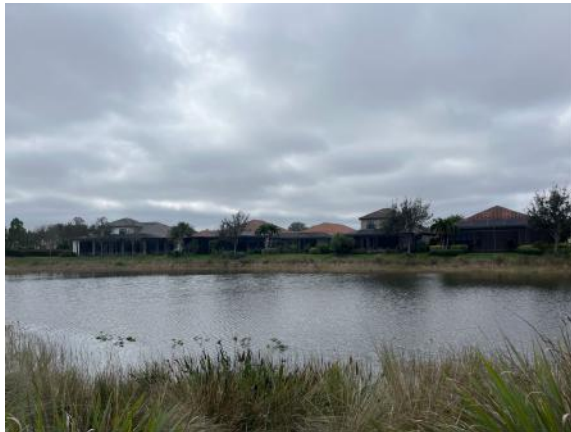
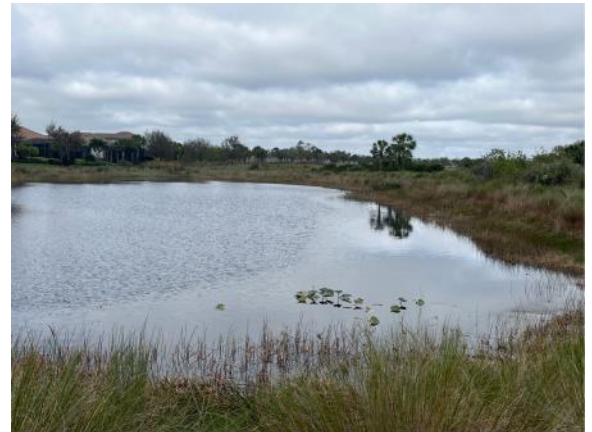
Site: 5A

Normal growth observed
 Shoreline grasses and brush are well-maintained. No algae. Treat for spatterdock.

Floating Weeds

Routine maintenance next visit

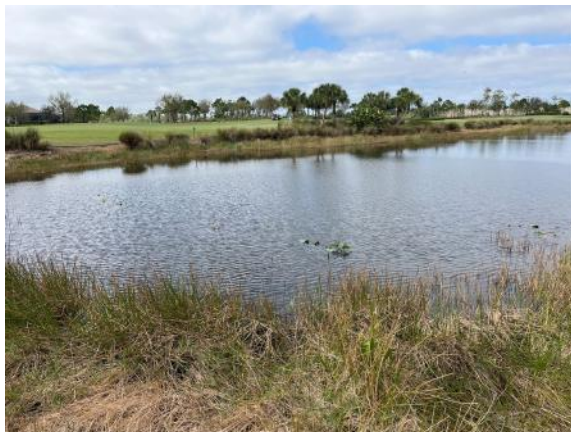
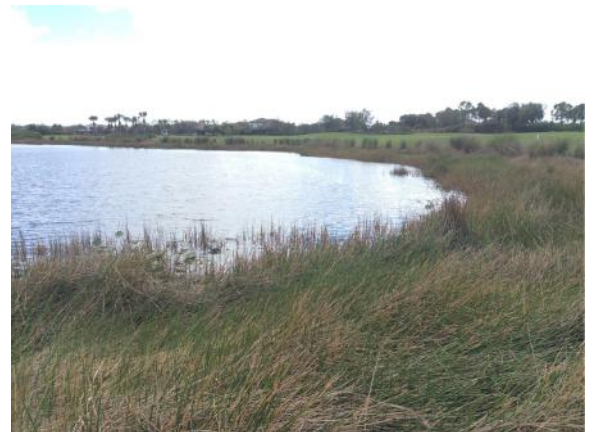
Site: 5B

Requires attention
 Shoreline grasses and brush are well-maintained. No algae. Treat for fanwort and spatterdock.

Floating Weeds

Routine maintenance next visit

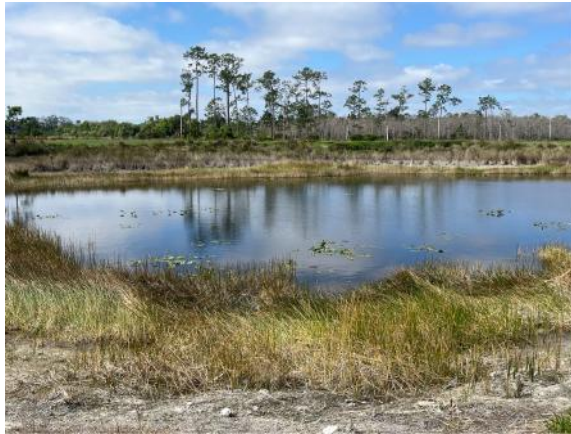
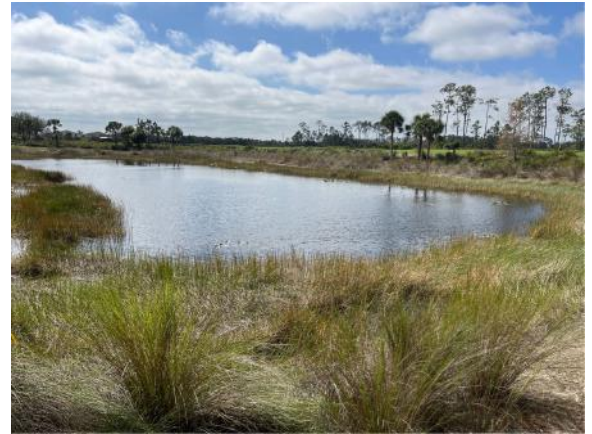
Site: 6

Requires attention

Shoreline grasses and brush are well-maintained. No algae. Treat for spatterdock.

Floating Weeds

Routine maintenance next visit

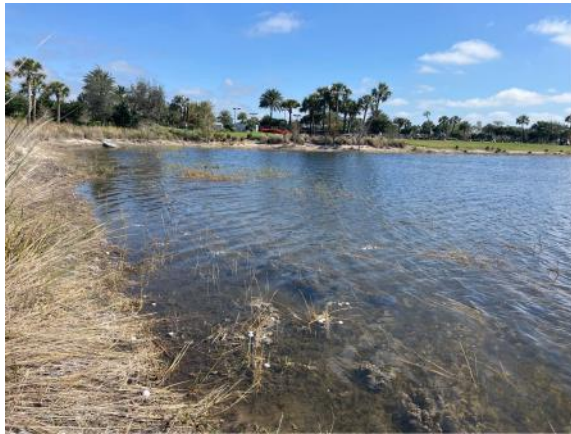
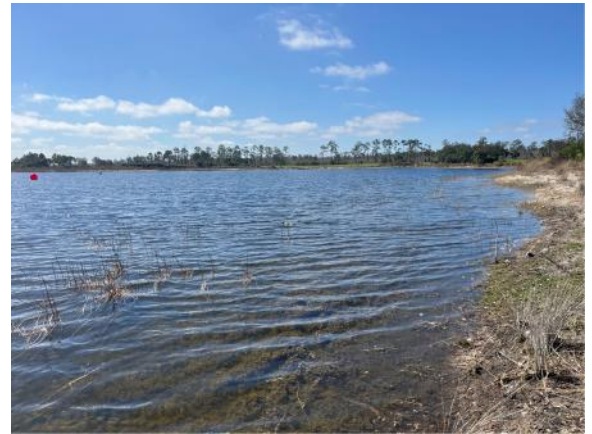
Site: 7

Normal growth observed

Shoreline grasses and brush are well-maintained. Treat for spatterdock and chara. Erosion occurring behind homes.

Floating Weeds

Routine maintenance next visit

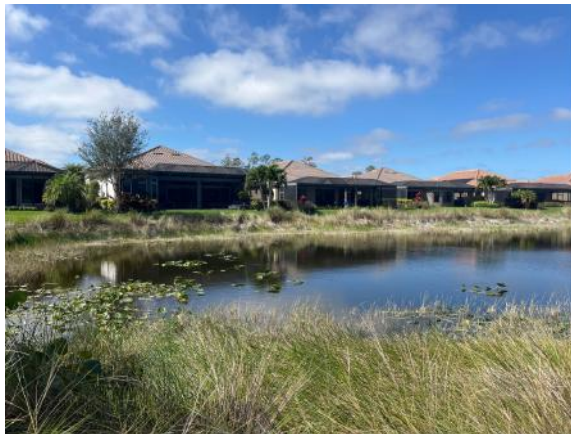
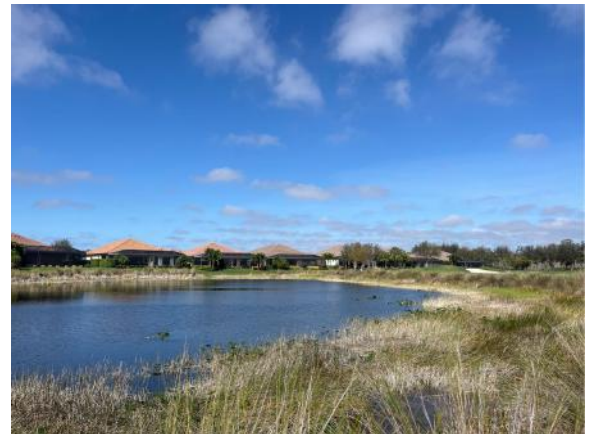
Site: 8

Requires attention

Shoreline grasses and brush are well-maintained. No algae. Treat for spatterdock.

Floating Weeds

Routine maintenance next visit

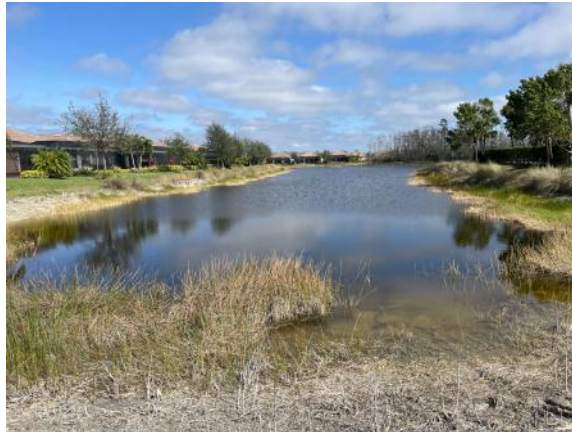
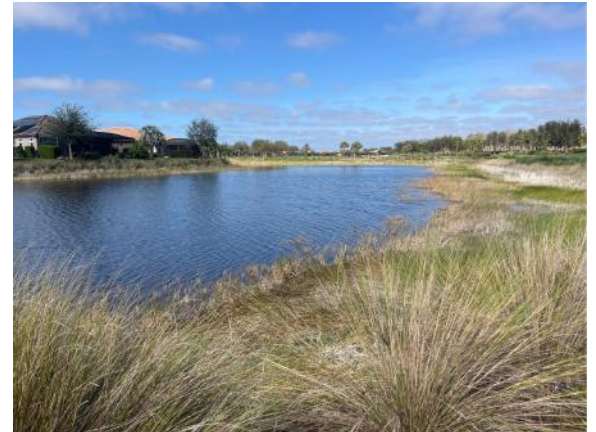
Site: 9

Normal growth observed
 Shoreline grasses and brush are well-maintained. No algae. Spot treat minimal spatterdock.

Floating Weeds

Routine maintenance next visit

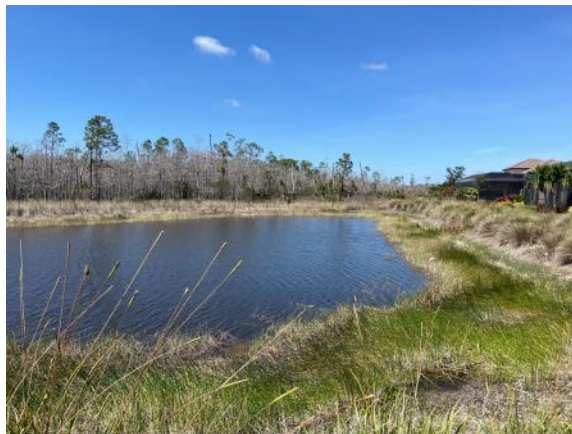
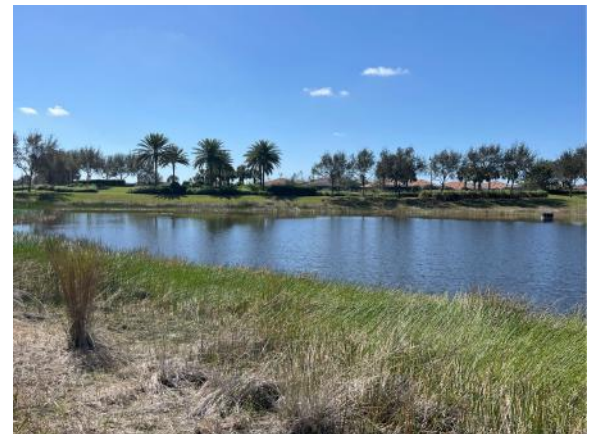
Site: 10

Normal growth observed
 Shoreline grasses and brush are well-maintained. No algae. Spot treat minimal spatterdock.

Submersed vegetation

Routine maintenance next visit

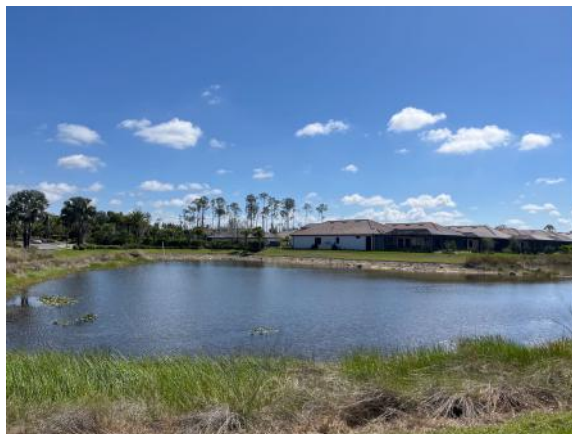
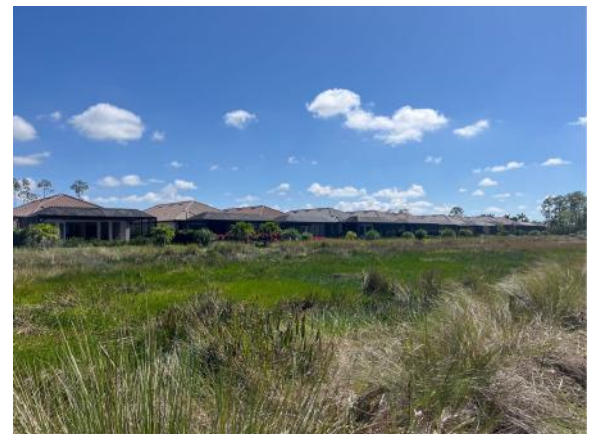
Site: 11

Normal growth observed
 Spot treat cattails and vine overgrowth within dense littoral shelf. No algae. Some erosion occurring on exposed banks.

Shoreline weeds

Routine maintenance next visit

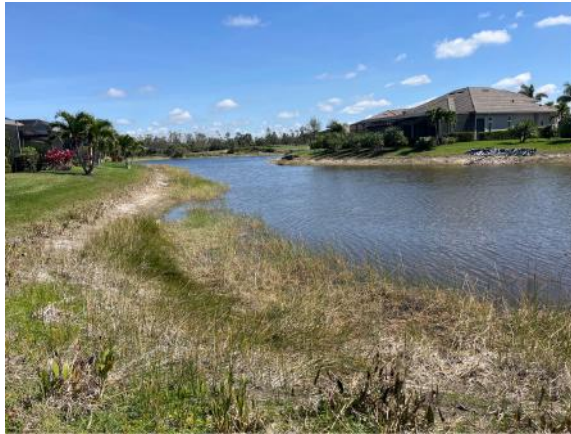
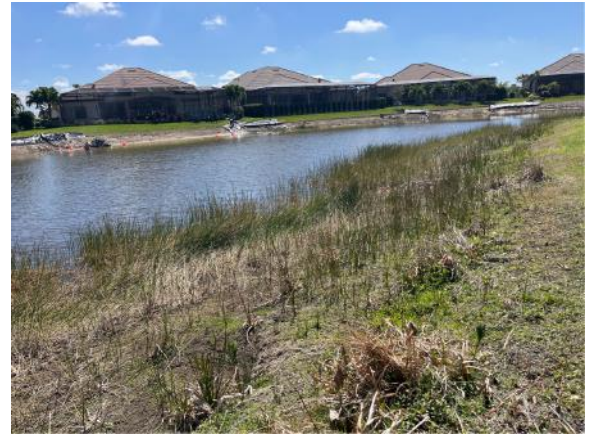
Site: 12

Requires attention

Shoreline grasses and brush are well-maintained. No algae. Treat for fanwort.

Submersed vegetation

Routine maintenance next visit

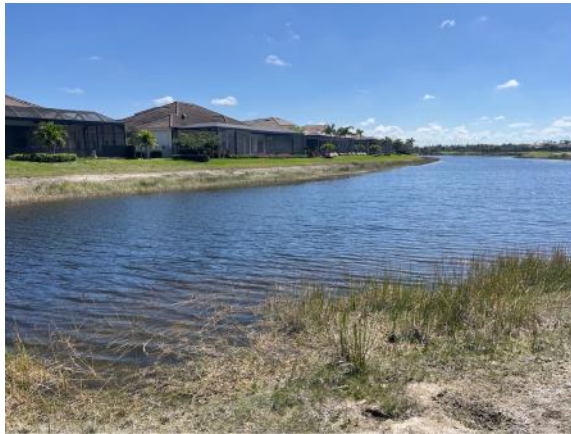
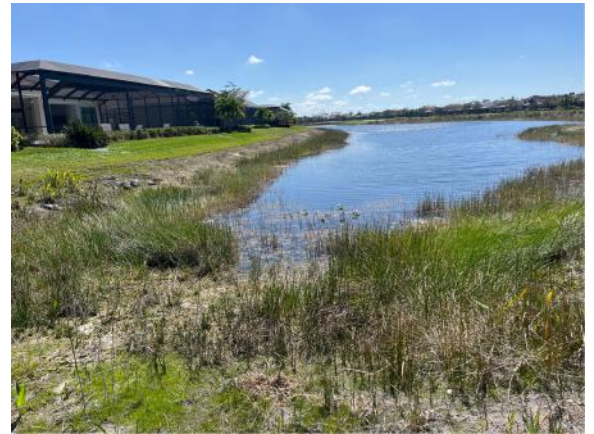
Site: 13

Requires attention

Shoreline well-maintained. No algae. Treat Illinois pondweed. Red ludwigia, slender spikerush, bacopa, and spatterdock present. Erosion noted along lot lines.

Submersed vegetation

Routine maintenance next visit

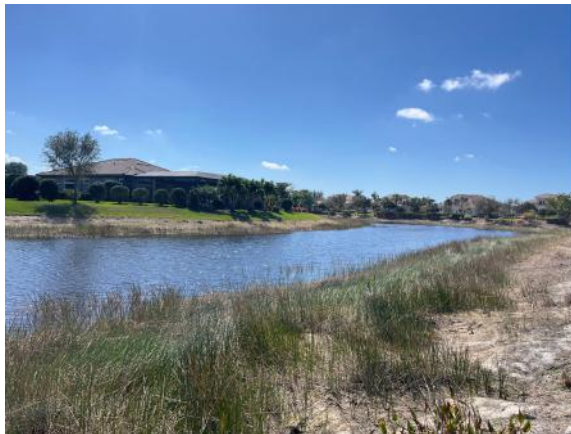
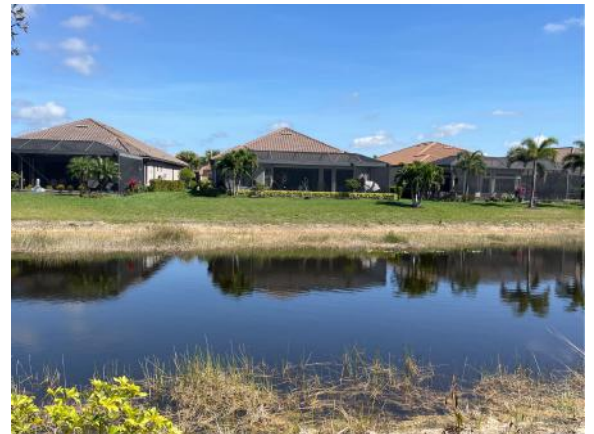
Site: 14

Requires attention

Spot treat torpedograss along shoreline. No algae. Treat for fanwort and spatterdock. Lot line erosion noted, with larger washouts in N. branch of lake.

Floating Weeds

Routine maintenance next visit

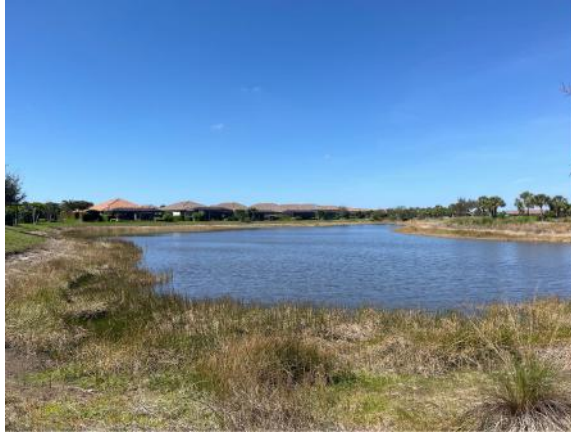
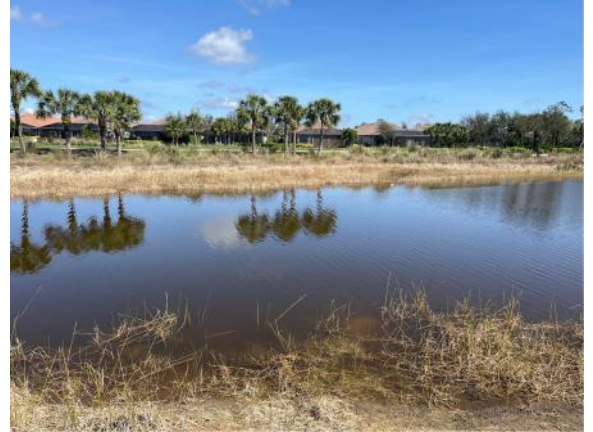
Site: 15A

Requires attention

Shoreline grasses and brush are well-maintained. No algae. Treat for fanwort and slender spikerush. Lot line erosion occurring.

Submersed vegetation

Routine maintenance next visit

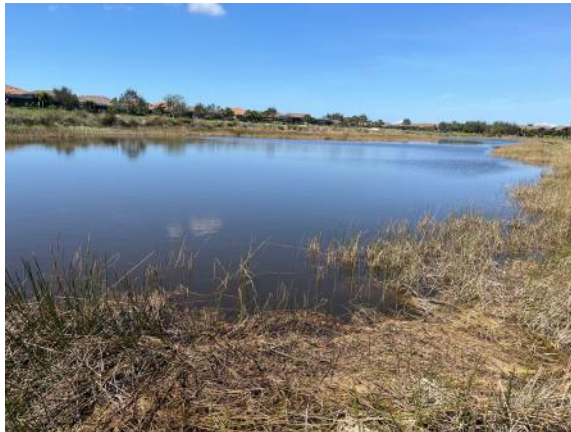
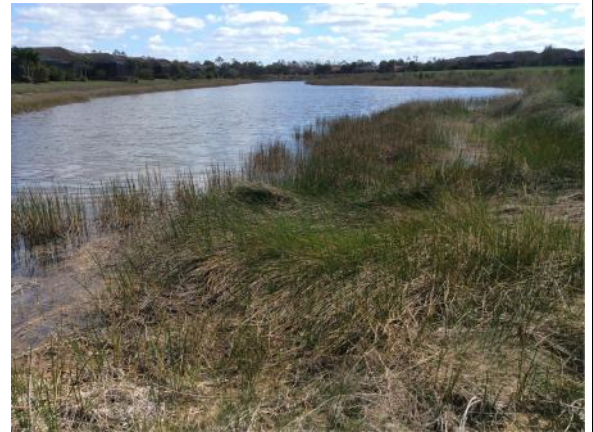
Site: 15B

Requires attention

Shoreline grasses and brush are well-maintained. Treat for fanwort and chara. Lot line erosion occurring.

Submersed vegetation

Routine maintenance next visit

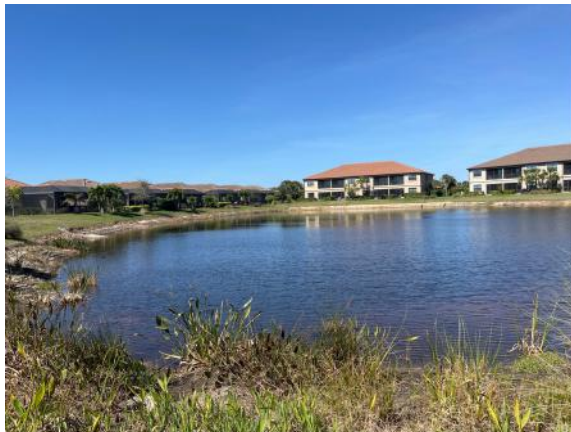
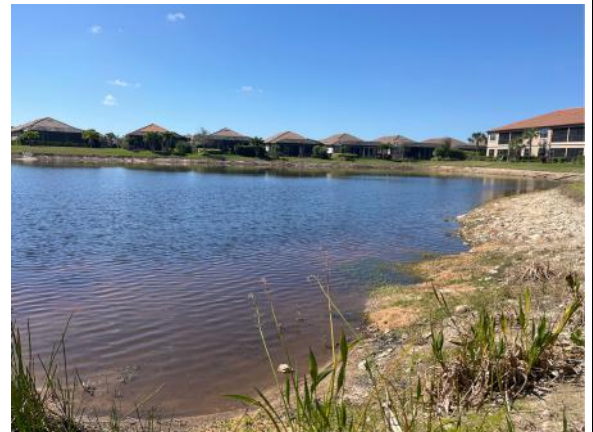
Site: 16

Normal growth observed

Shoreline grasses and brush are well-maintained. No algae. Treat for alligator weed. Traces of parrots feather growth noted.

Submersed vegetation

Routine maintenance next visit

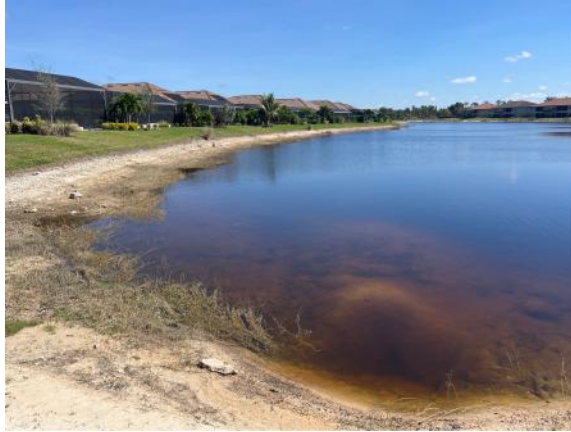
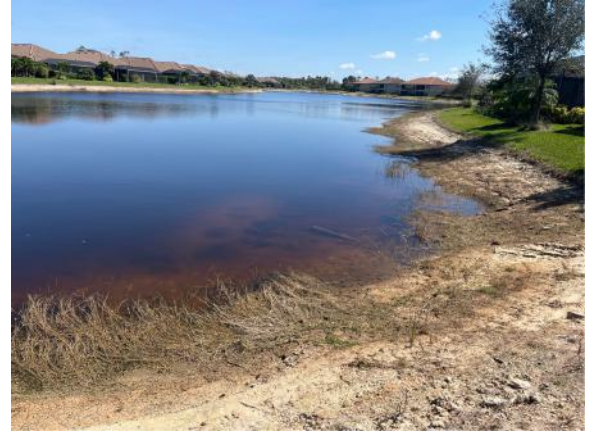
Site: 17

Requires attention

Spot treat for torpedograss. No algae. Algae and submersed vegetation are at controlled levels.

Torpedograss

- Many of the lakes do not have good coverage of littorals high on the lake banks and this may be exacerbating the erosion issues noted during this inspection. Some lakes also had substantial washouts, lake 17 being a good example. Most of the erosion was found between homes where downspouts are located, the sheet flow from the concentrated runoff often causes this erosion. Some of the washouts were also likely from pool drains though this seemed much less common.

Routine maintenance next visit

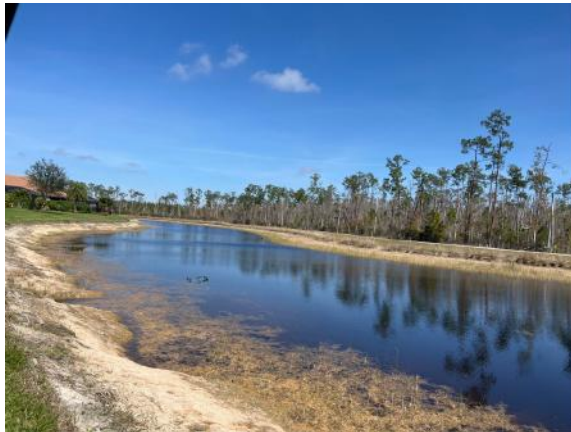
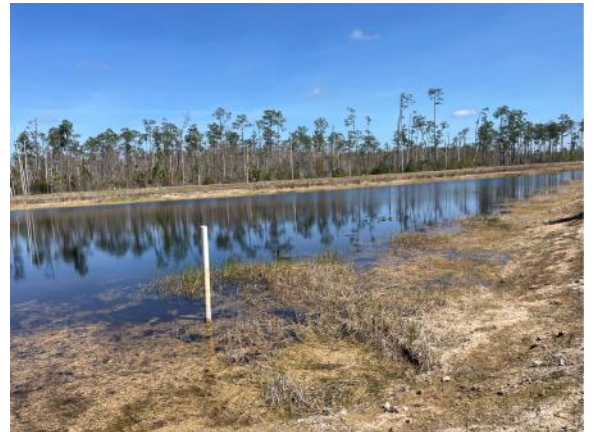
Site: 18

Requires attention

Shoreline grasses and brush are well-maintained. Treat for surface algae, purple bladderwort and spatterdock.

Submersed vegetation

Routine maintenance next visit

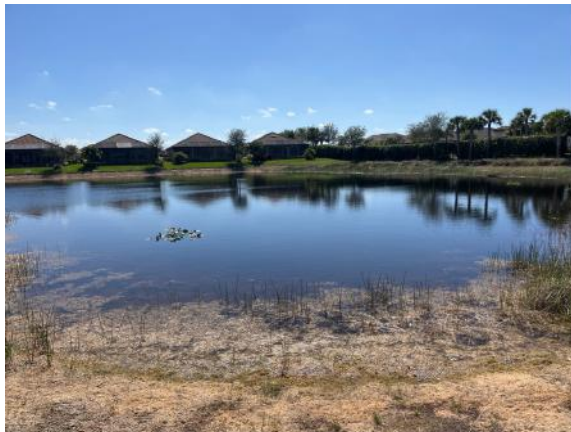
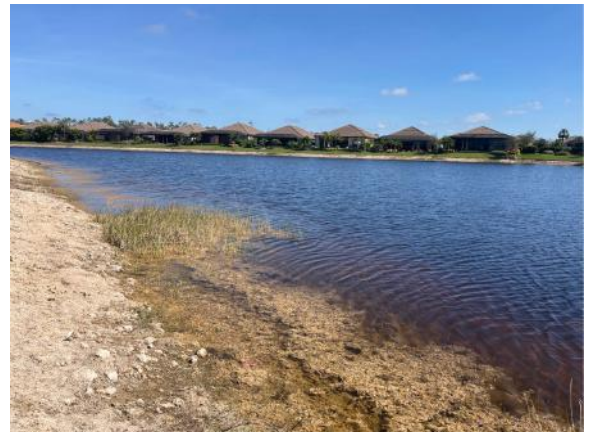
Site: 19

Requires attention

Shoreline is well maintained. Treat for purple bladderwort and spatterdock. Erosion along lot lines and washouts noted.

Floating Weeds

Routine maintenance next visit

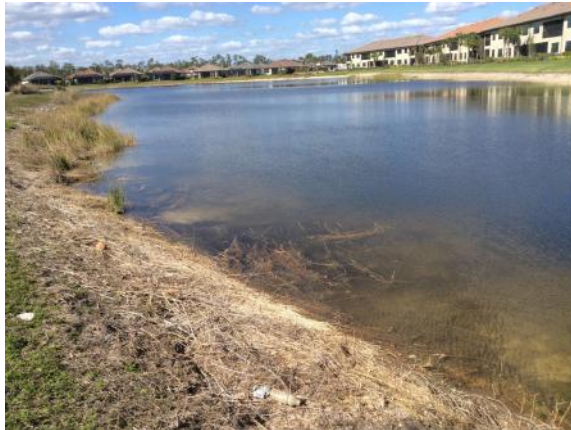
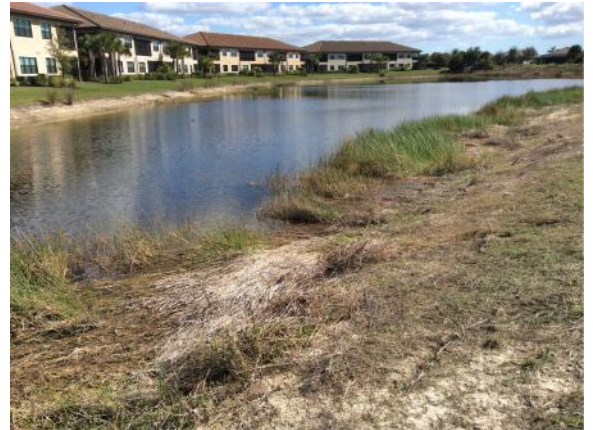
Site: 20

Normal growth observed

Shoreline grasses and brush are well-maintained. No algae. Minimal chara noted. Erosion and washouts noted behind homes.

Species non-specific

Routine maintenance next visit

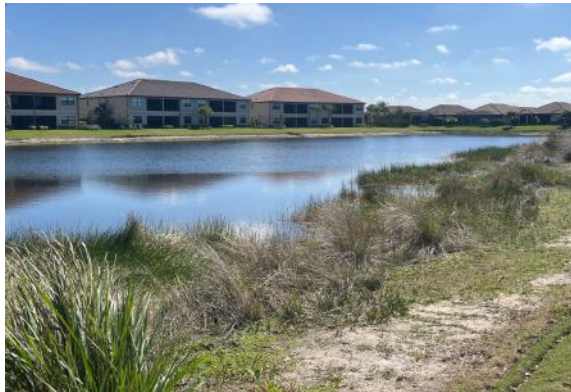
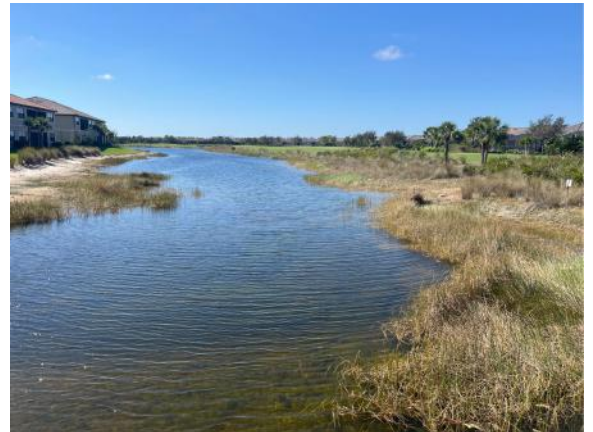
Site: 21

Normal growth observed

Spot treat vines within littorals. No algae. Minimal chara noted. Erosion and washouts noted behind homes.

Shoreline weeds

Routine maintenance next visit

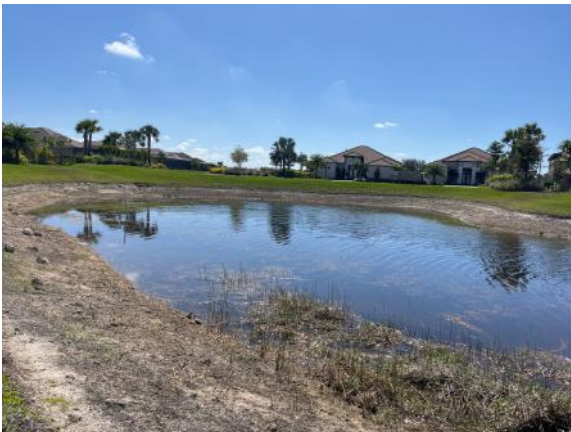
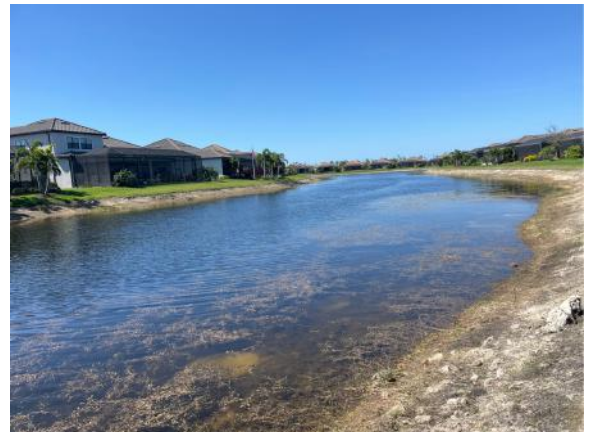
Site: 22

Requires attention

Shoreline grasses and brush are well-maintained. No algae. Treat for Illinois pondweed, and slender spikerush. Lot line erosion and washouts noted.

Submersed vegetation

Routine maintenance next visit

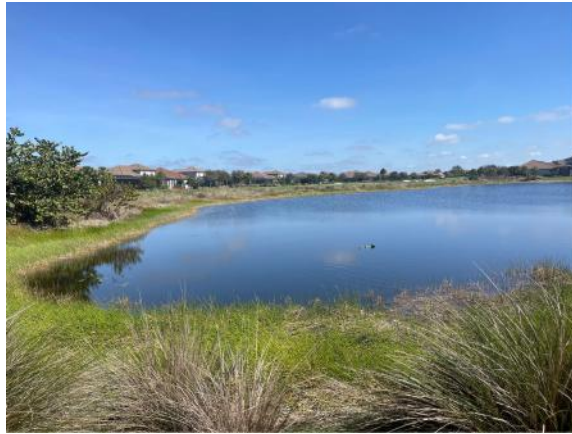
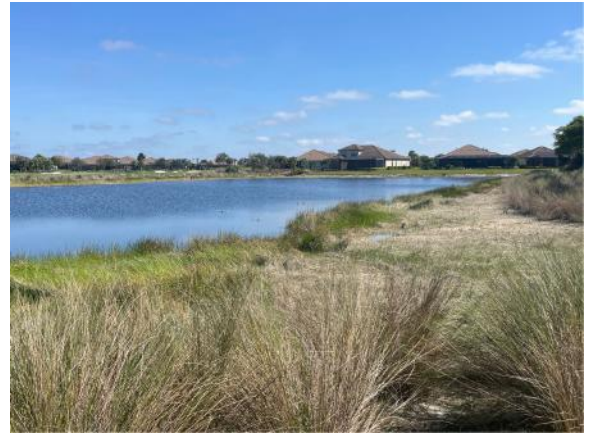
Site: 23

Normal growth observed

Shoreline grasses and brush are well-maintained. No algae. Trace spatterdock noted. Mild erosion in SE cove of lake.

Floating Weeds

Routine maintenance next visit

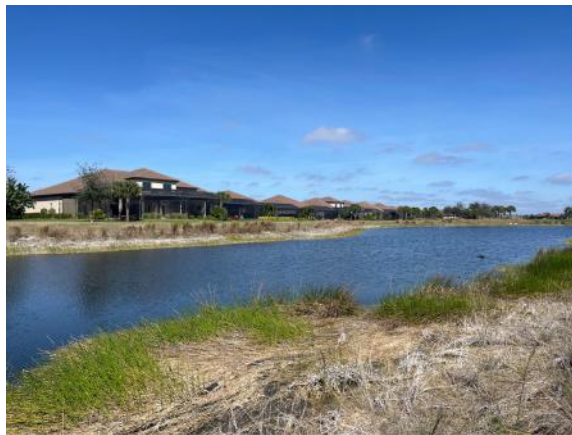
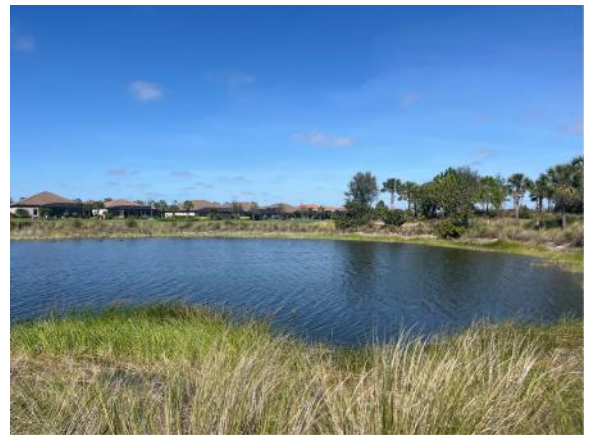
Site: 24

Normal growth observed

Shoreline grasses and brush are well-maintained. Some surface algae noted. Trace spatterdock noted.

Floating Weeds

Routine maintenance next visit

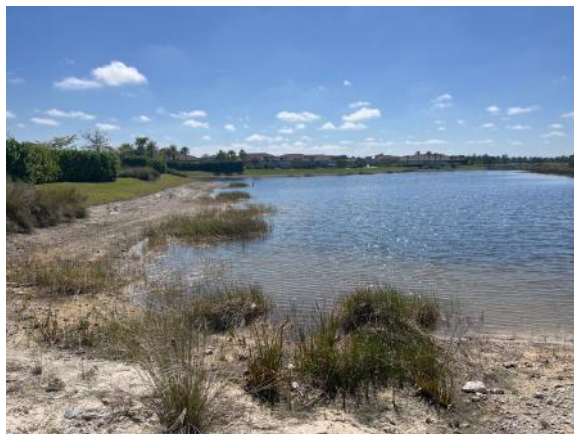
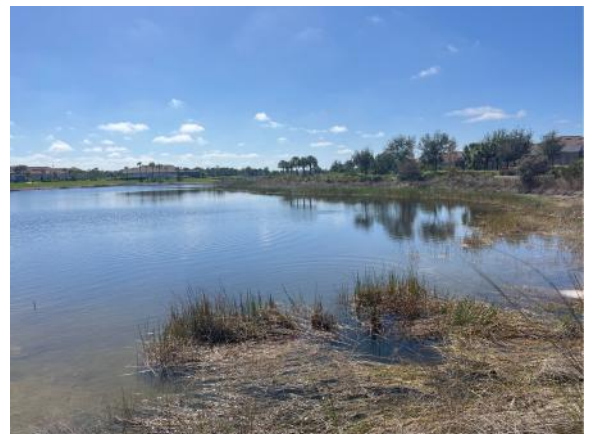
Site: 25

Normal growth observed

Spot treat minimal torpedograss in littorals. No algae. Minor erosion and washouts noted behind homes.

Torpedograss

Routine maintenance next visit

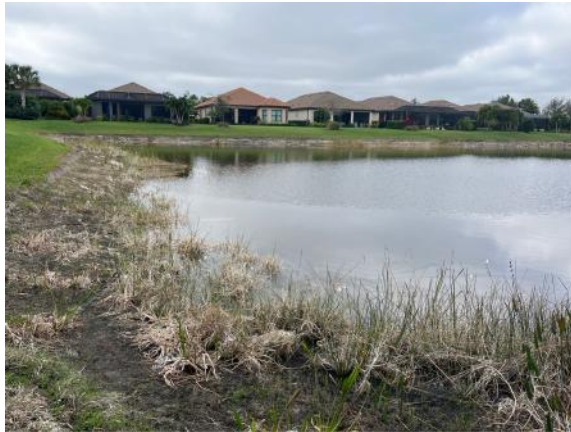
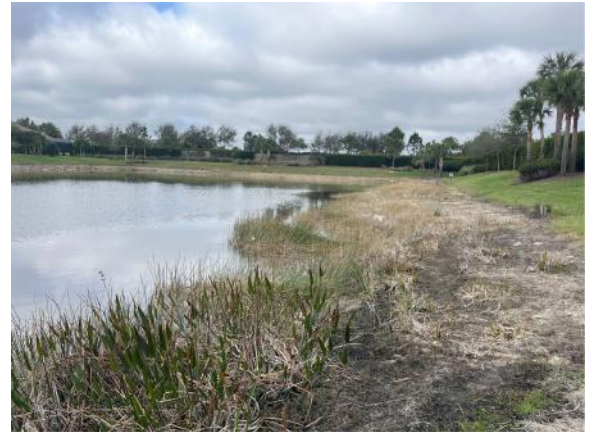
Site: 26

Site looks good

Shoreline grasses and brush are well-maintained. Lake is slightly planktonic. Lot line and pool drain erosion occurring.

Species non-specific

Routine maintenance next visit

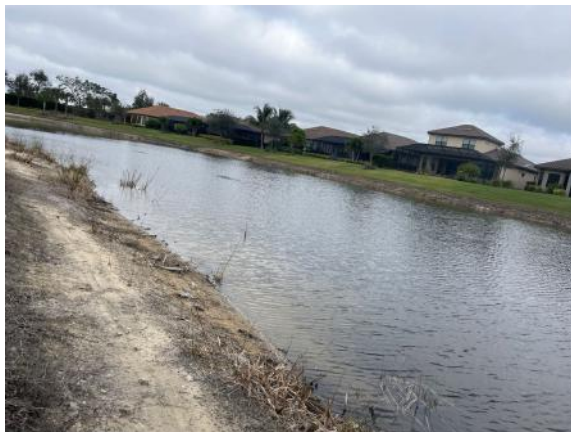
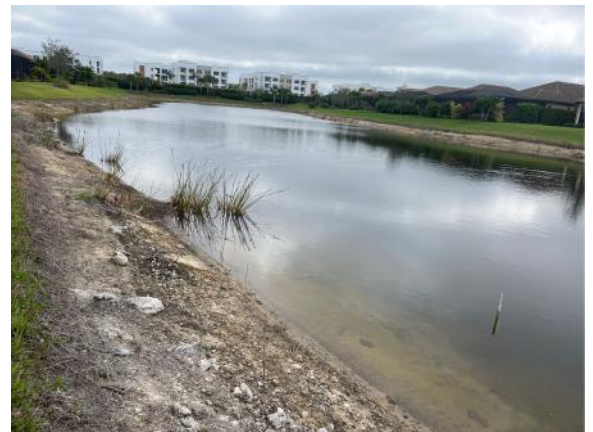
Site: 27

Normal growth observed

Shoreline grasses and brush are well-maintained. No algae. Traces of spatterdock observed. Lot line erosion occurring.

Species non-specific

Routine maintenance next visit

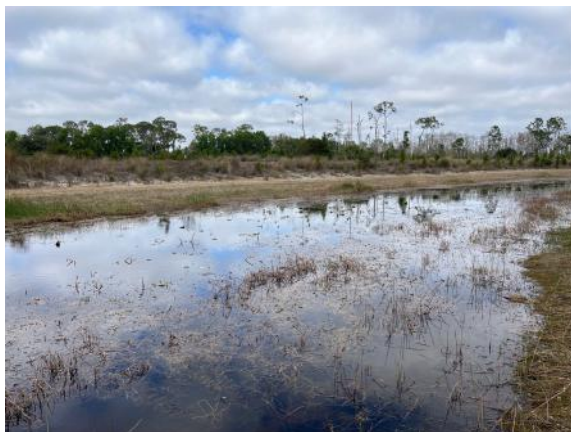
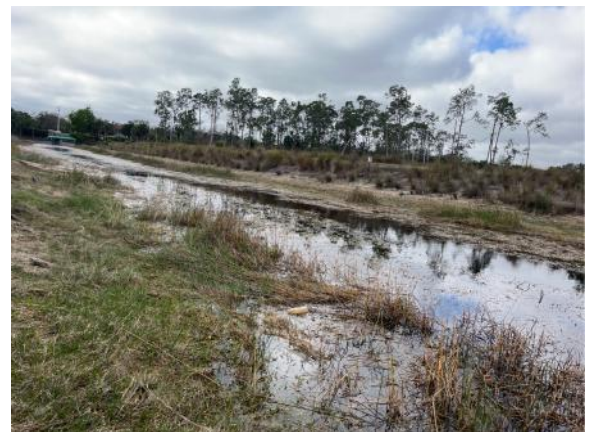
Site: FW1

Requires attention

Shoreline grasses and brush are well-maintained. No algae. Treat for spatterdock, red luwigia, slender spikerush and bladderwort.

Submersed vegetation

Routine maintenance next visit

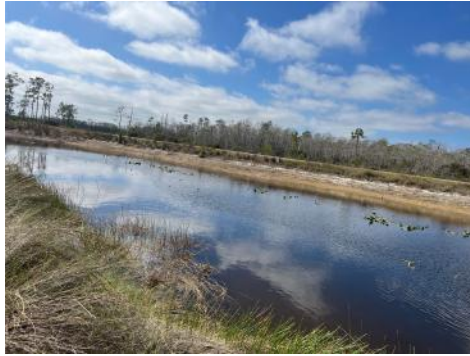
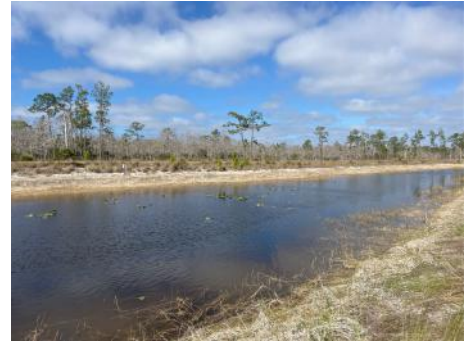
Site: FW2**Comments:**

Requires attention

Shoreline grasses and brush are well-maintained. Treat for spatterdock, red ludwigia, slender spikerush and bladderwort

Submersed vegetation

Routine maintenance next visit

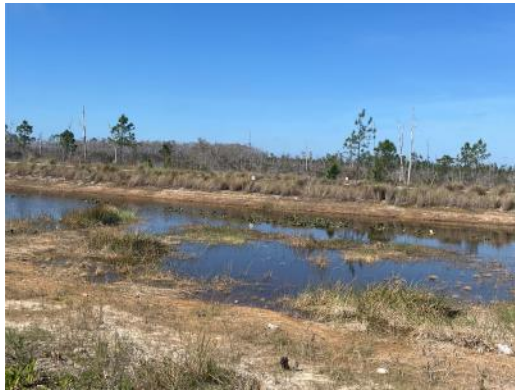
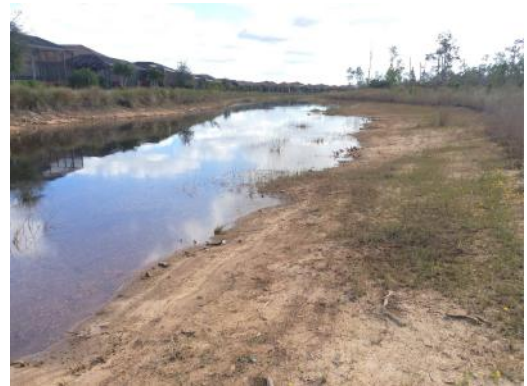
**Site:** FW3**Comments:**

Requires attention

Shoreline grasses and brush are well-maintained. No algae. Treat for spatterdock, red ludwigia, slender spikerush and bladderwort.

Submersed vegetation

Routine maintenance next visit
