RE: *Flow Way CDD v. Taylor Morrison of Florida, Inc., et al.*
NOTICE OF CLAIM, PURSUANT TO FLA. STAT. § 558.004

Thus, pursuant to Chapter 558 of the Florida Statutes, **YOU ARE HEREBY NOTIFIED of the construction defects existing within the CDD Boundaries, each of which are set forth in more detail in the enclosed Forge Engineering Report, dated June 2, 2021, and the CGA Report.**

FLOW WAY CDD PERIMETER FENCING INVESTIGATION MAP

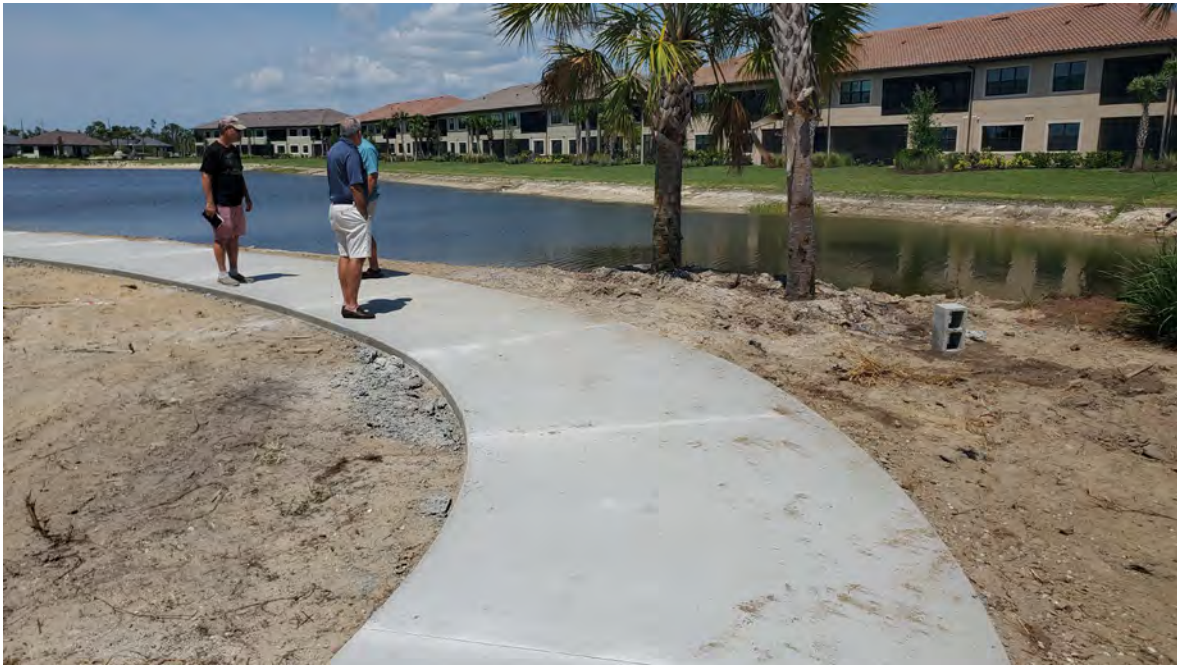
Executive Summary – Golf Cart Path relocation is in suitable location, but additional barrier(s) are recommended. We recommend developer include both physical barrier (concrete curb) and visual barrier (shrub hedge) to prevent drivers from accidentally driving off path and down lake's backslope into water.

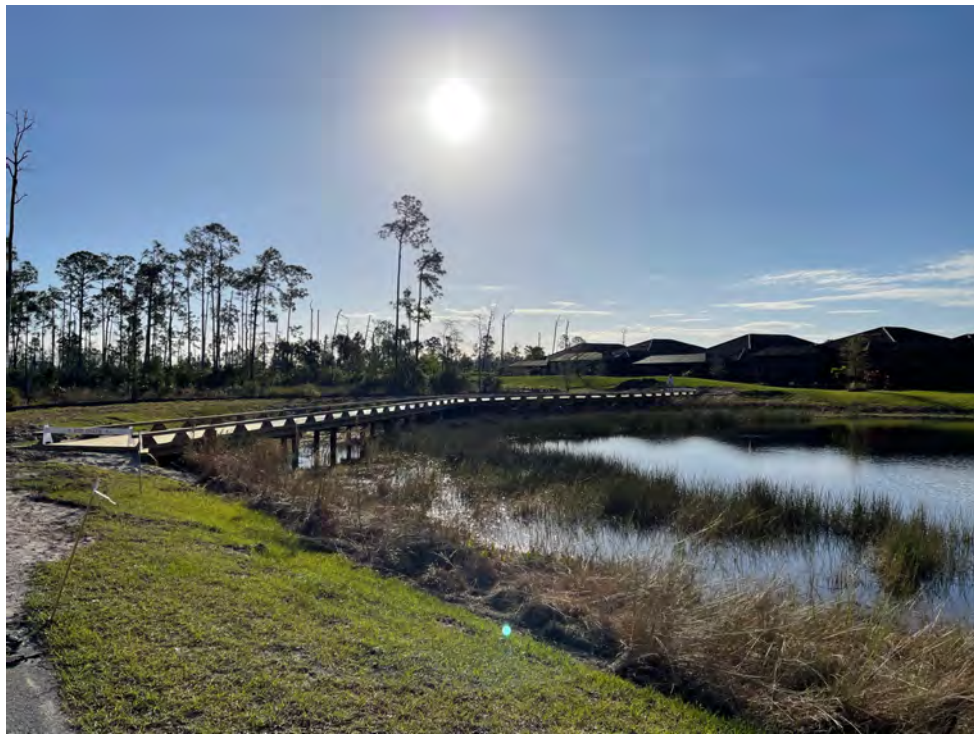
Executive Summary – The Pedestrian Bridge does not meet Florida Building Code for handrails adjacent to waterways or drop conditions. We recommend developer add code compliant handrails to existing bridge structure to provide safe conditions for residents using the pedestrian paths.

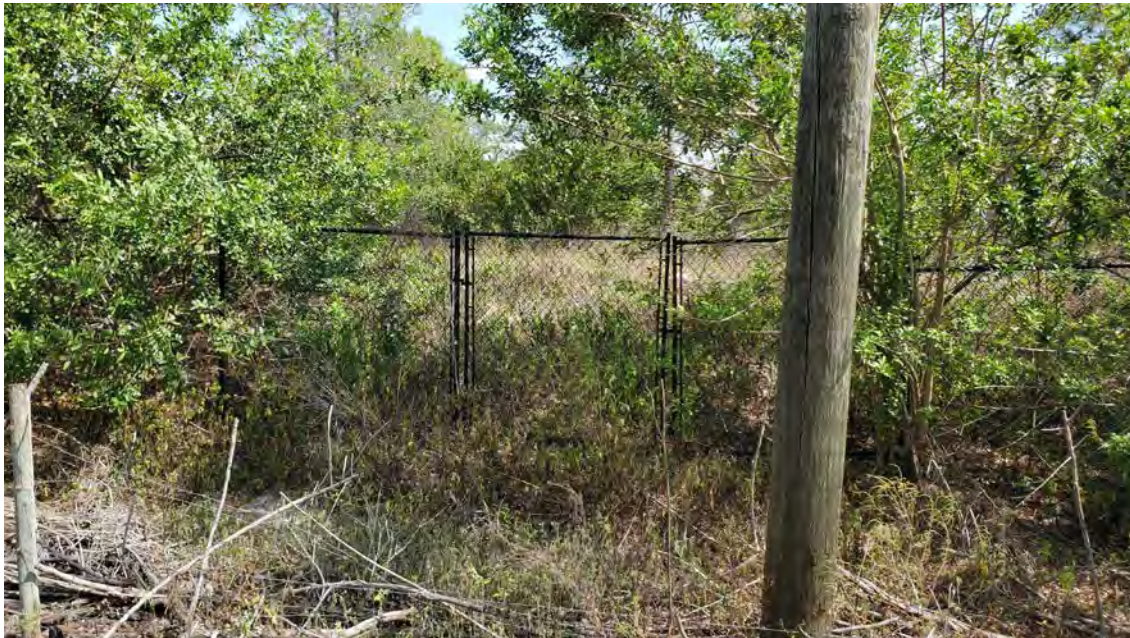
#11 - Village Walk of Bonita Springs – Chain link fence (others)

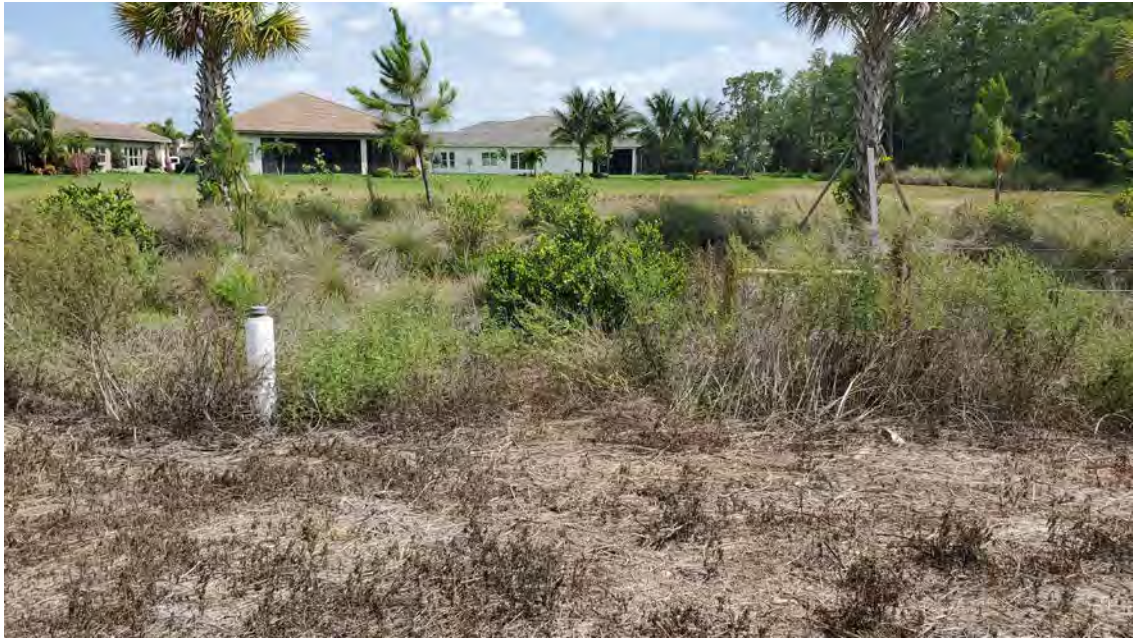
#18 - Valencia – Lake and Barbed Wire Fence (others)

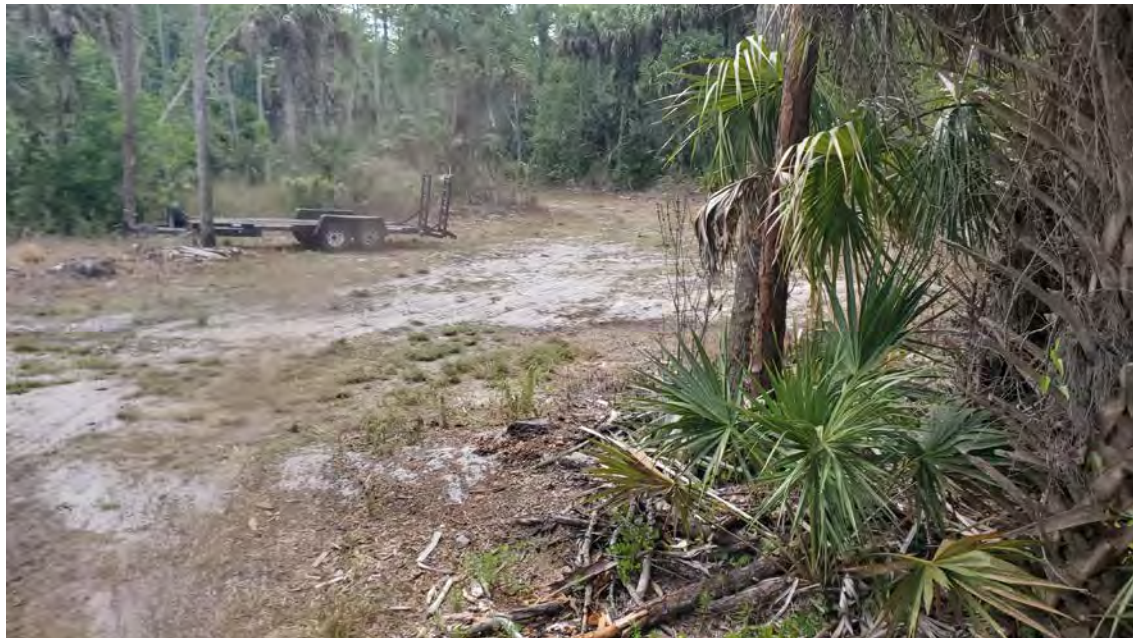
#26 - Abandoned Trailer

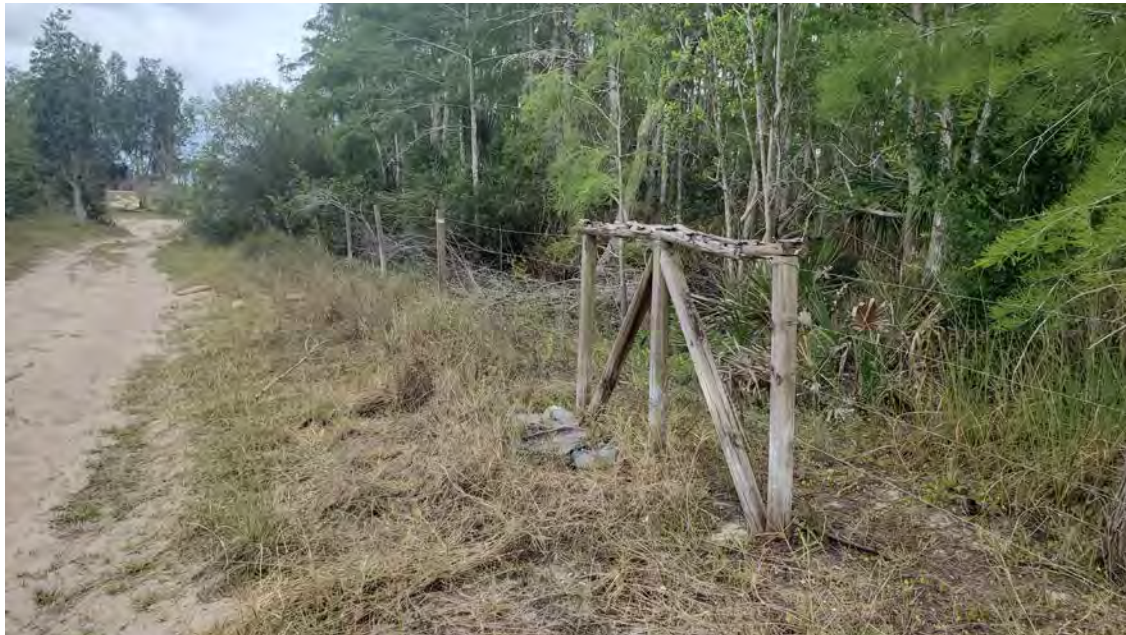
#73 - Collier ROW – Ex. Fence Good Condition

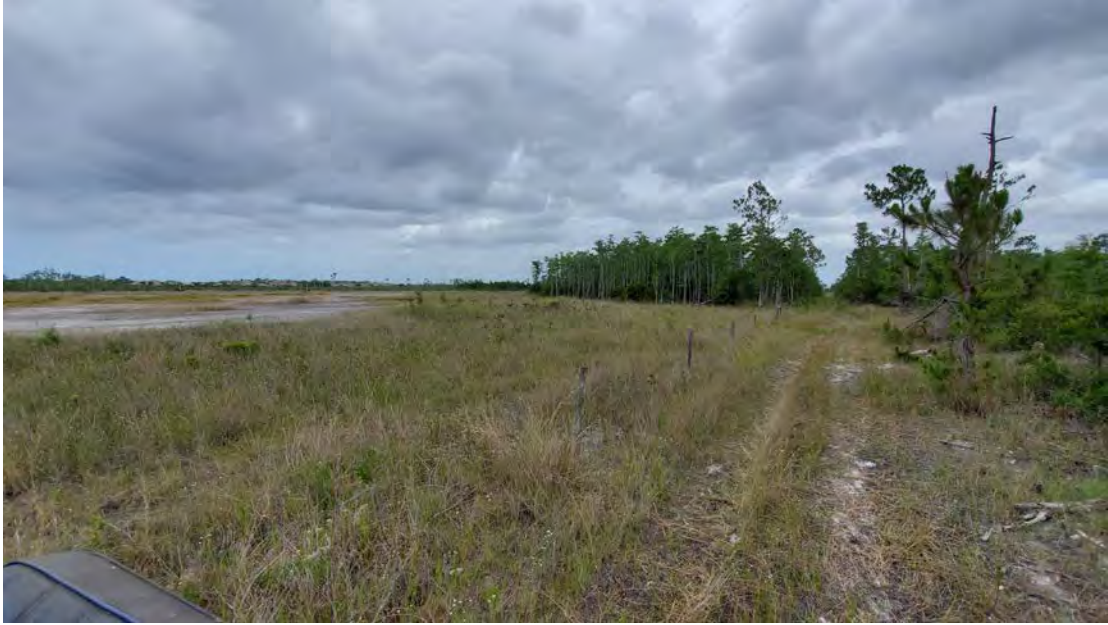
#58 - Terafina & Dirt Path

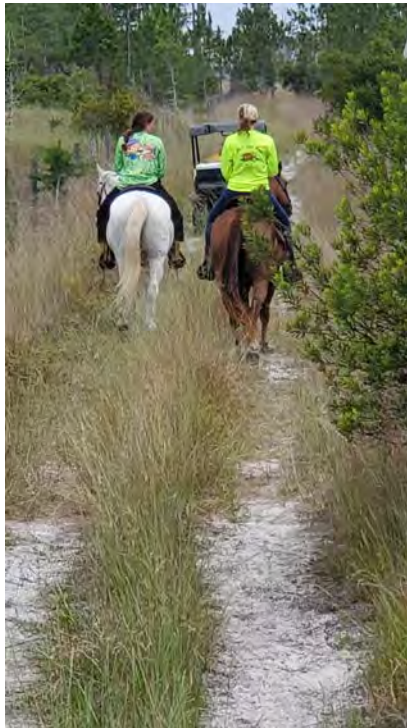
#56 - Horseback Riders

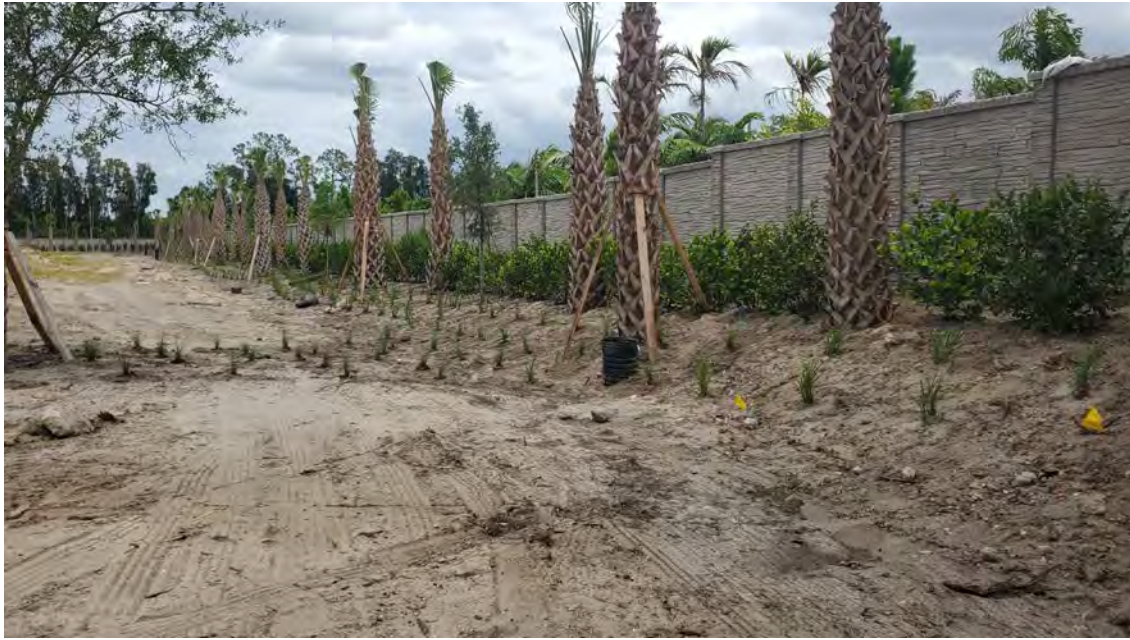
#77 - Outparcel Buffer Wall

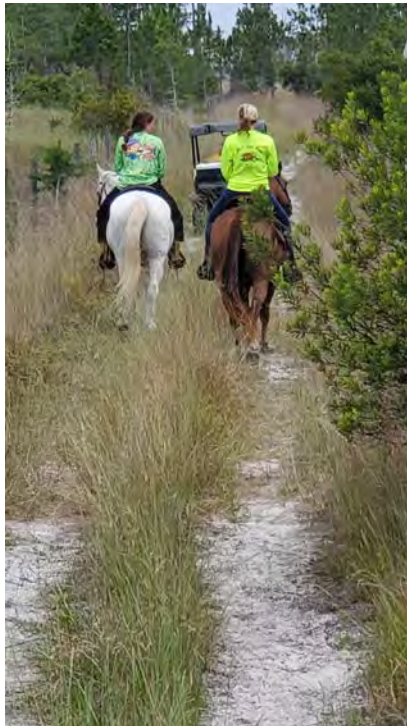
Horseback Riders

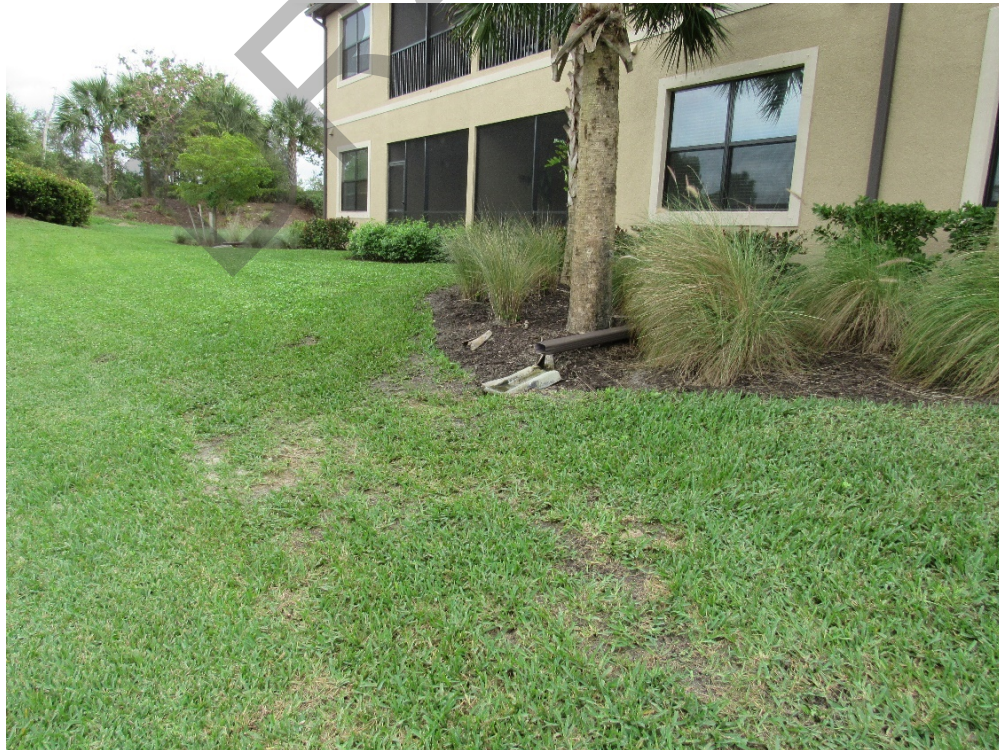
View of gutter downspout from a building - Lake 17/Benvenuto Court.

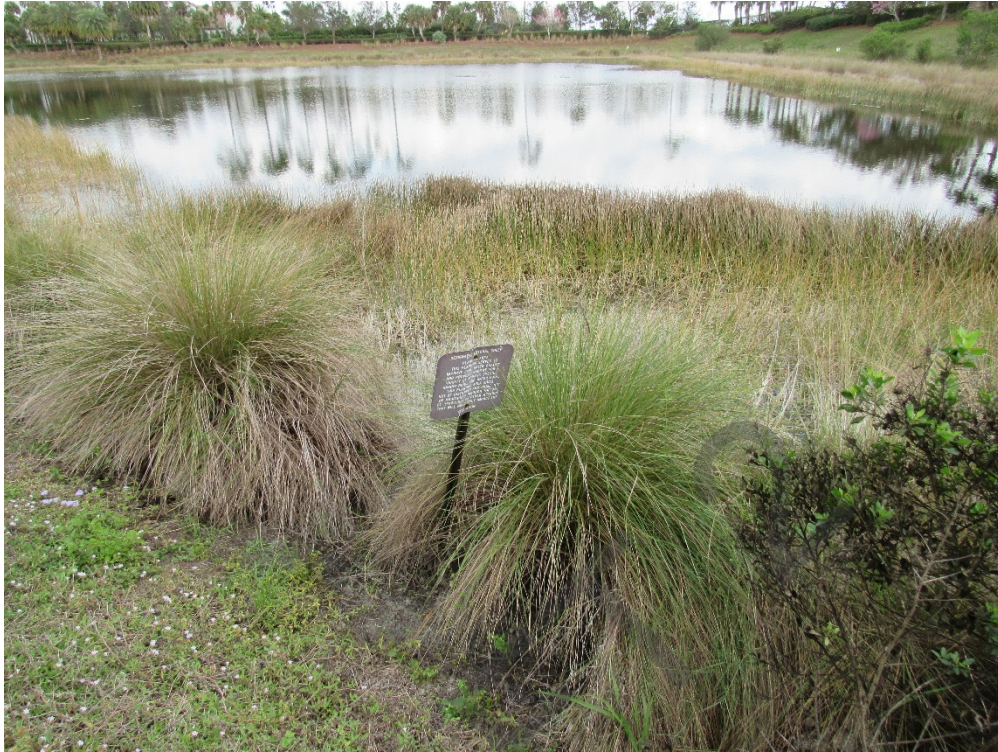
Typical view of Lake 1, note sign condition

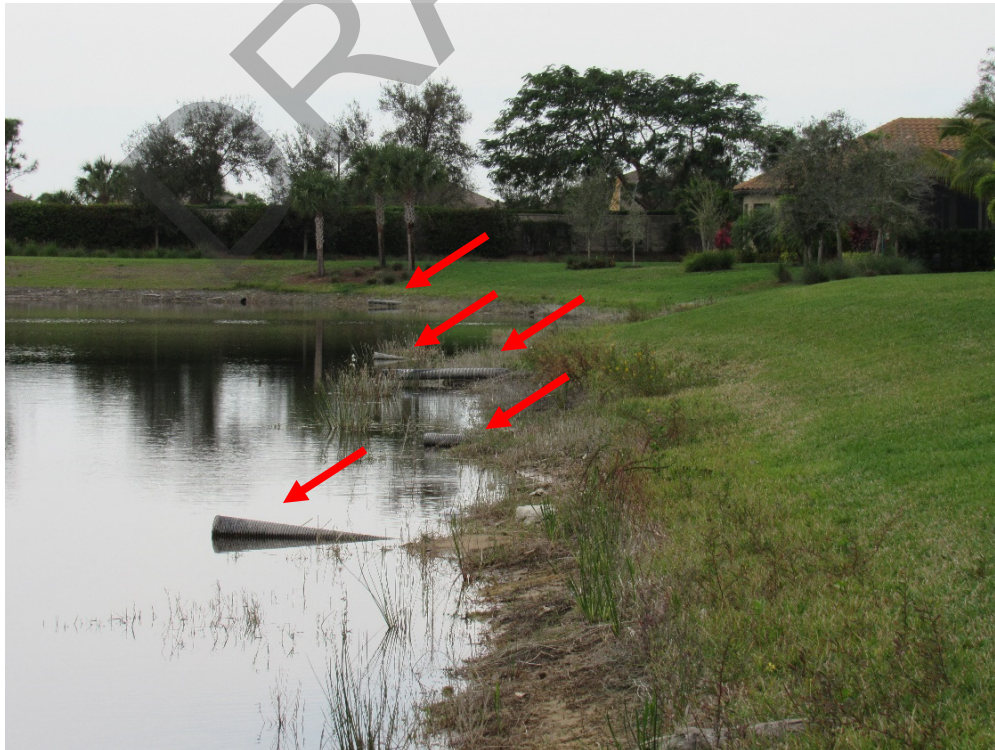
View of direct discharge lines - Lake 27.

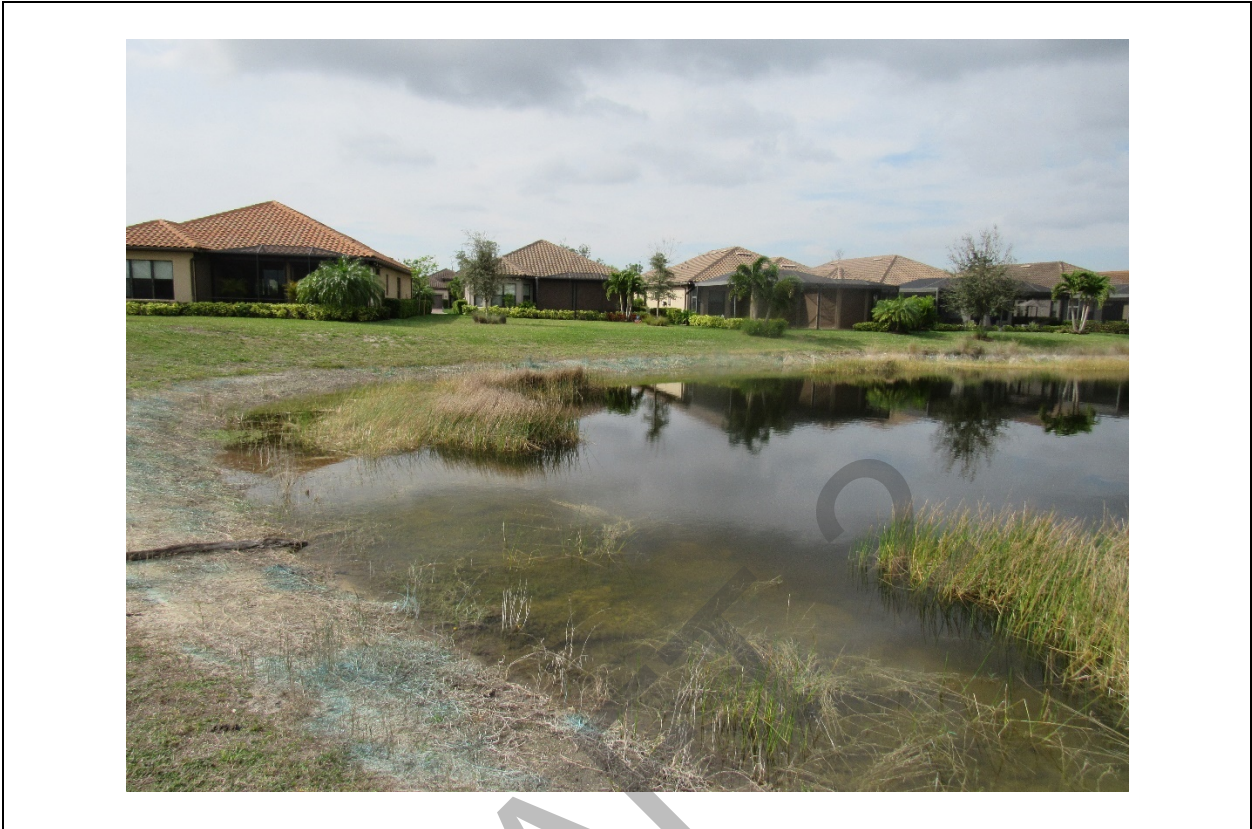
Typical view of littoral - Lake 9.

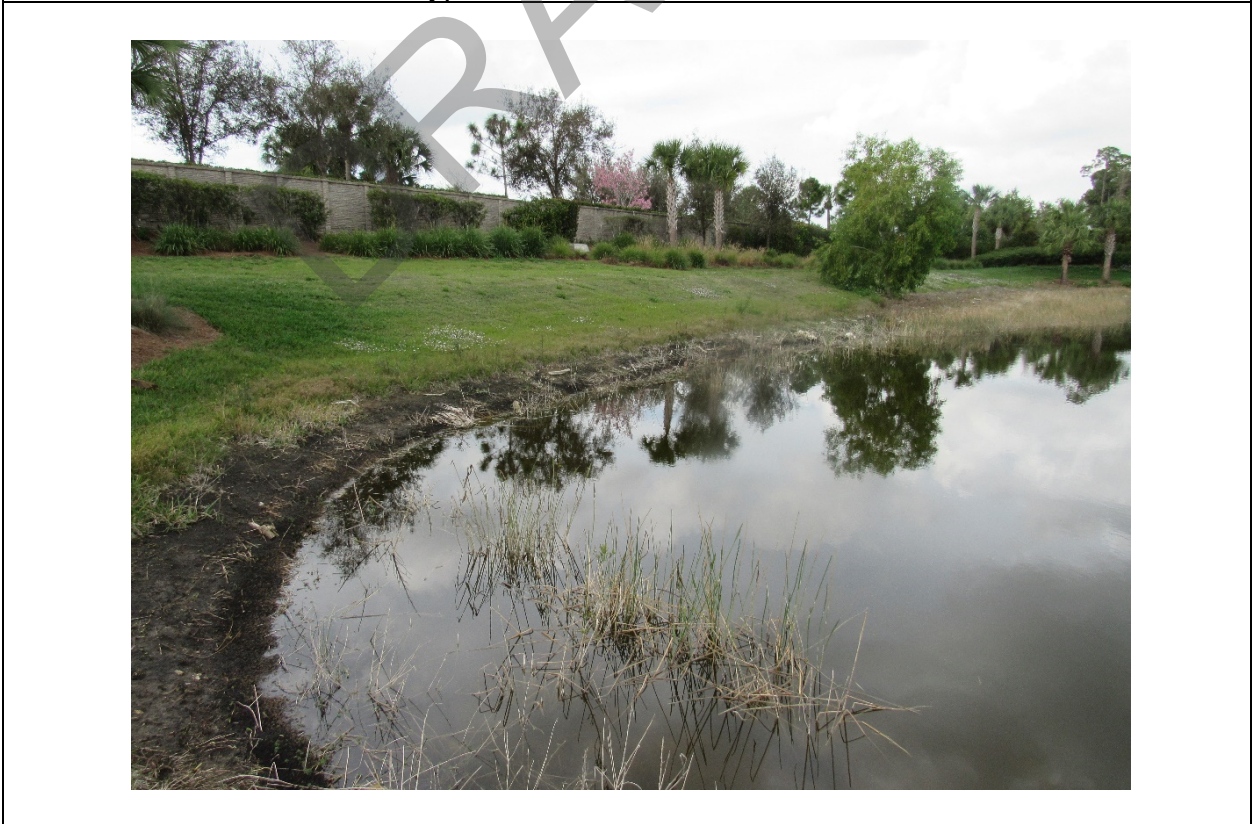
Typical view of littoral - Lake 26.

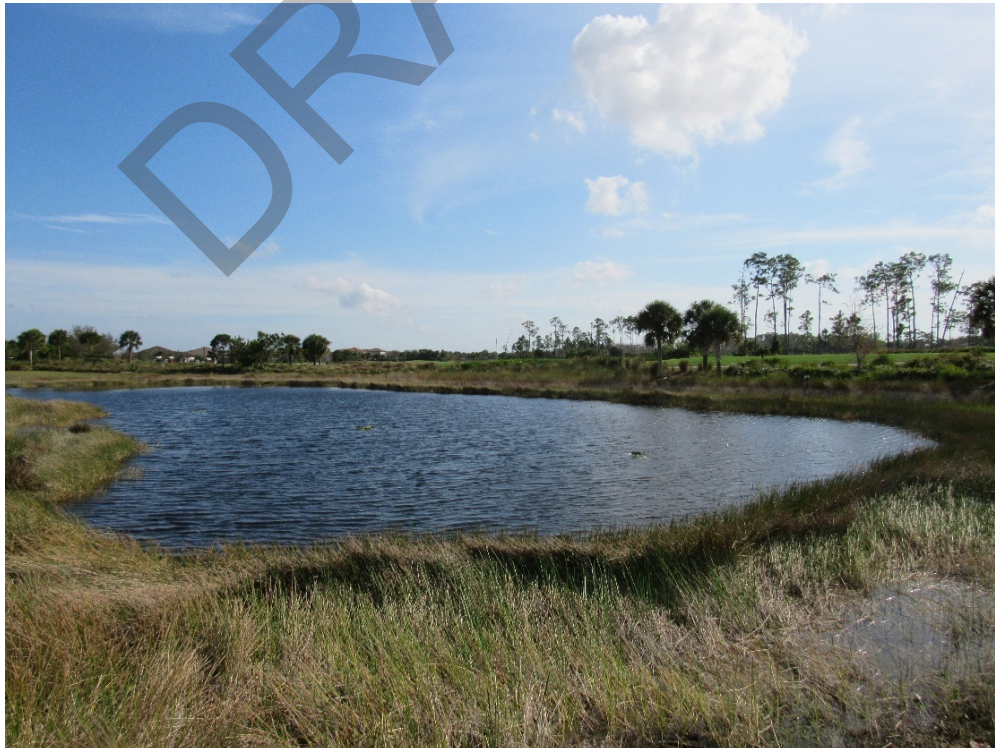
Typical view of Lake 6.

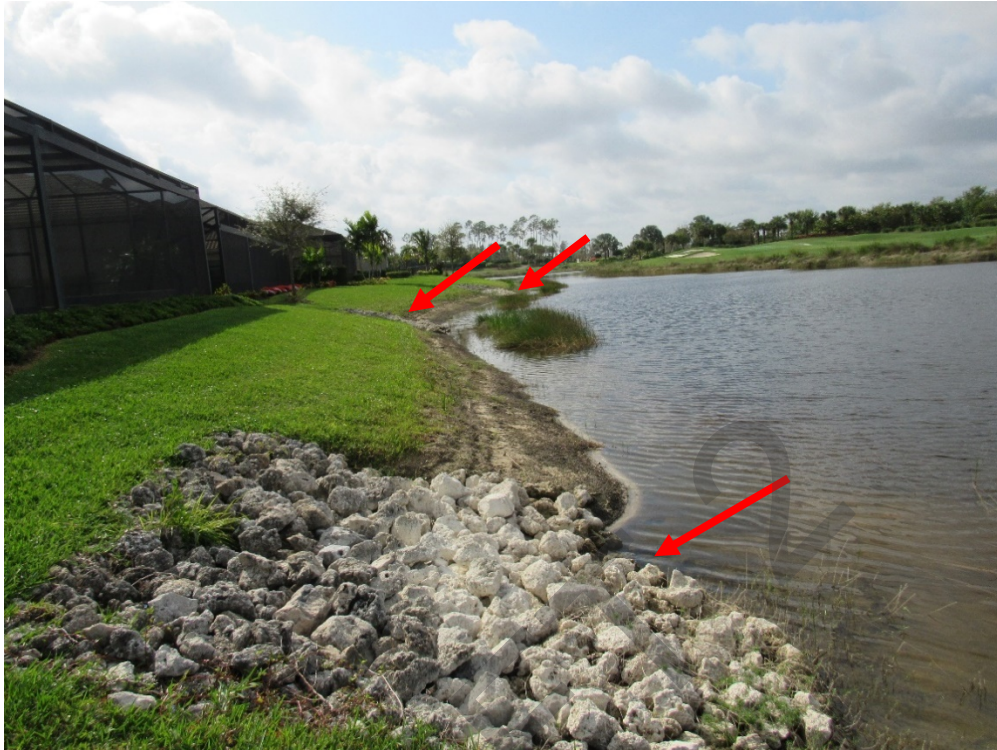
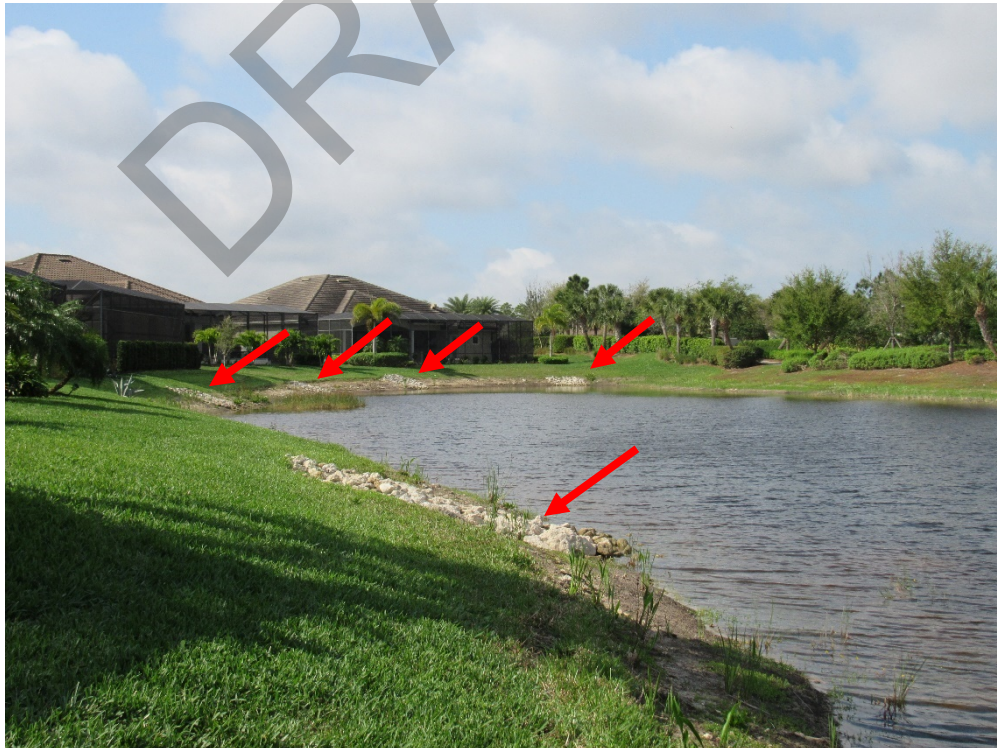
View of rip rap at areas of erosion - Lake 12.

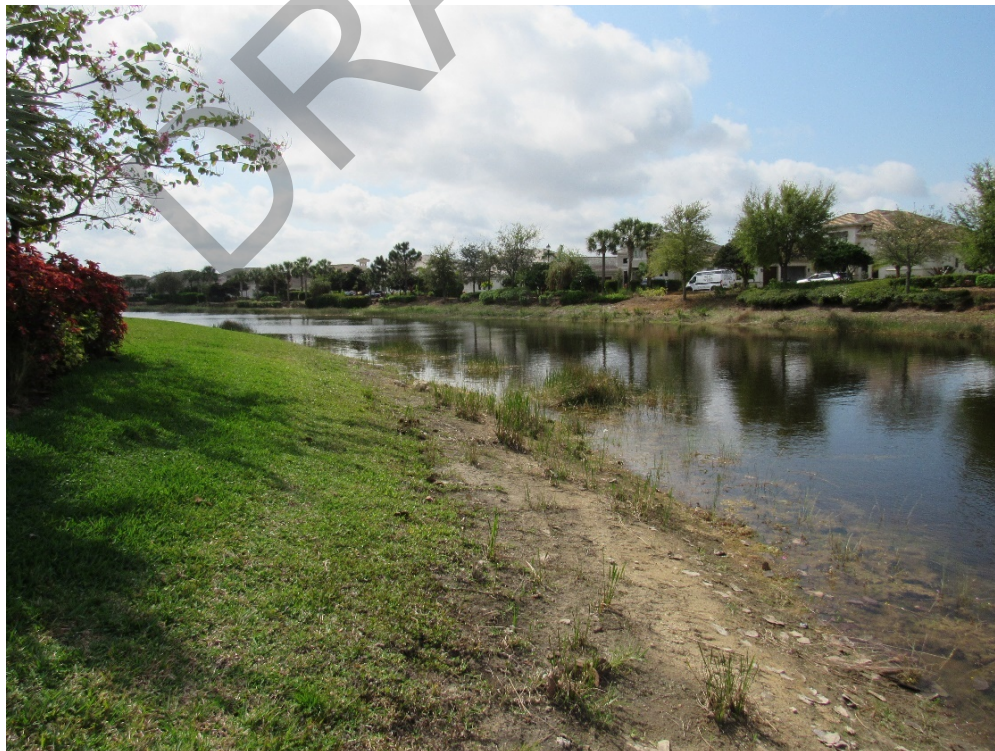
Typical view of Lake 14.

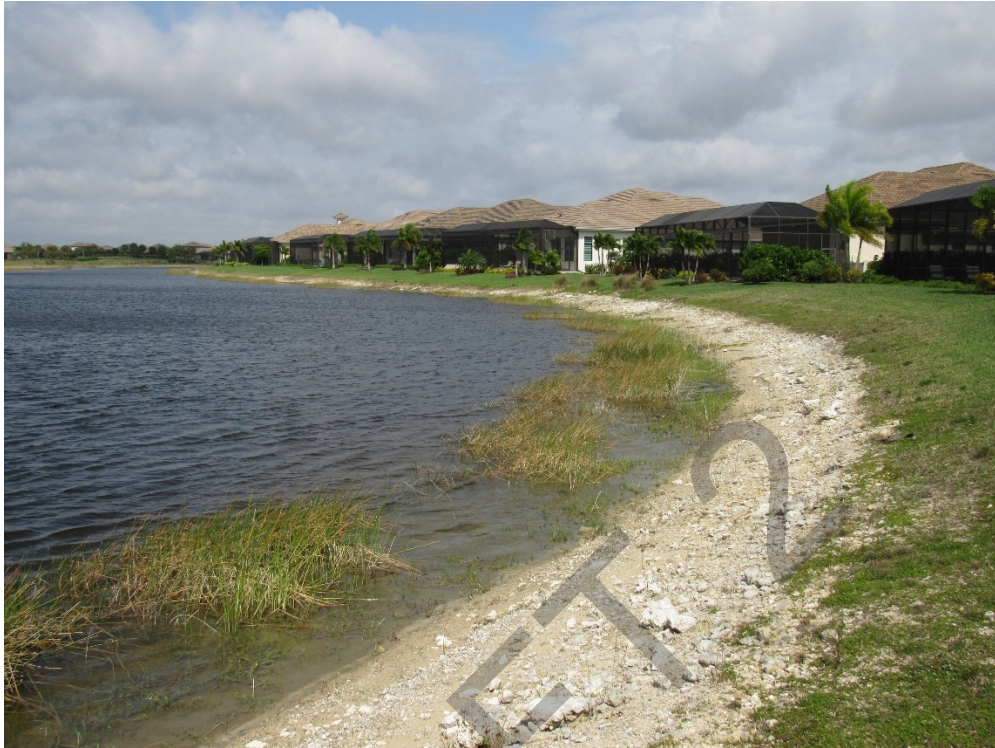
Typical view of Lake 13.

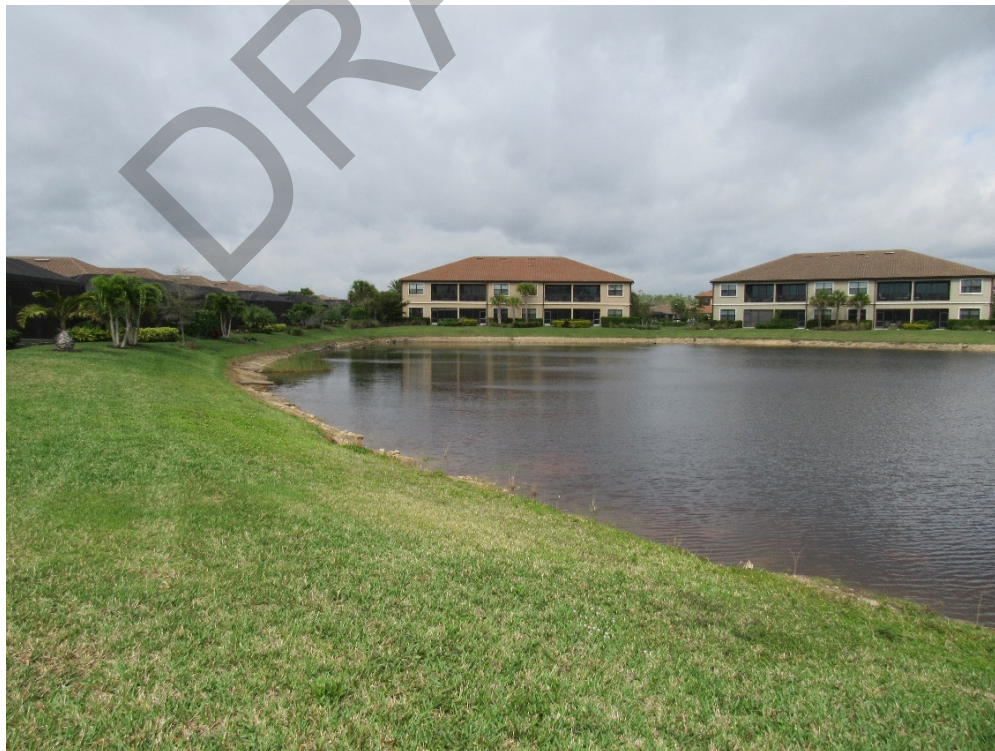
View of limited littoral plants - Lake 16.

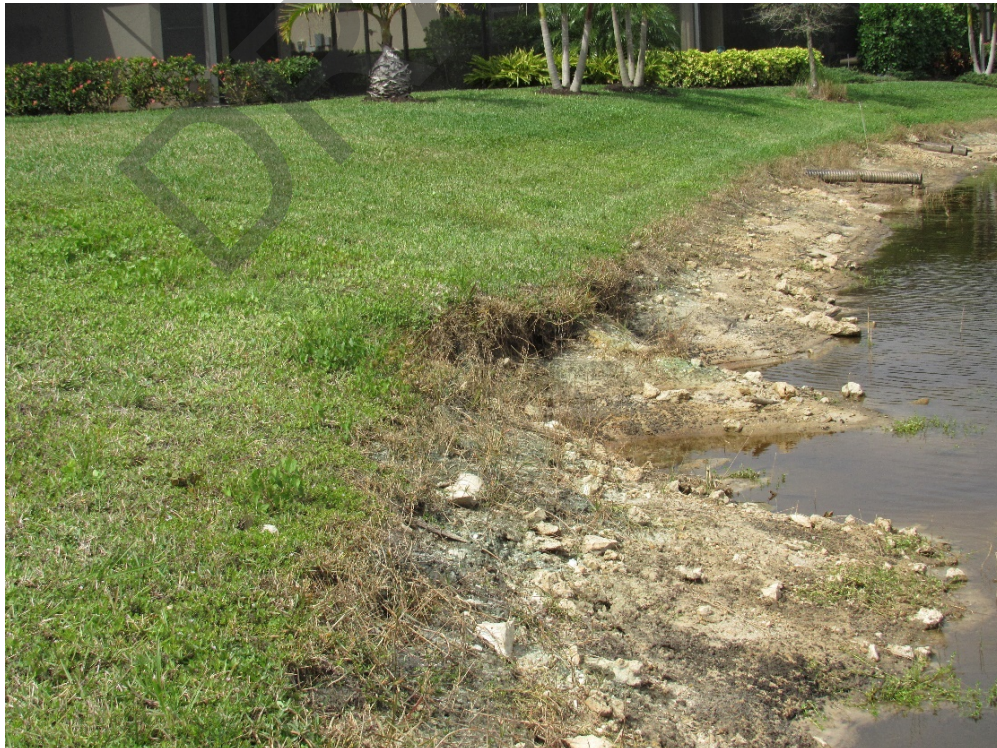
View of erosion at lake embankment and direct discharge lines - Lake 16

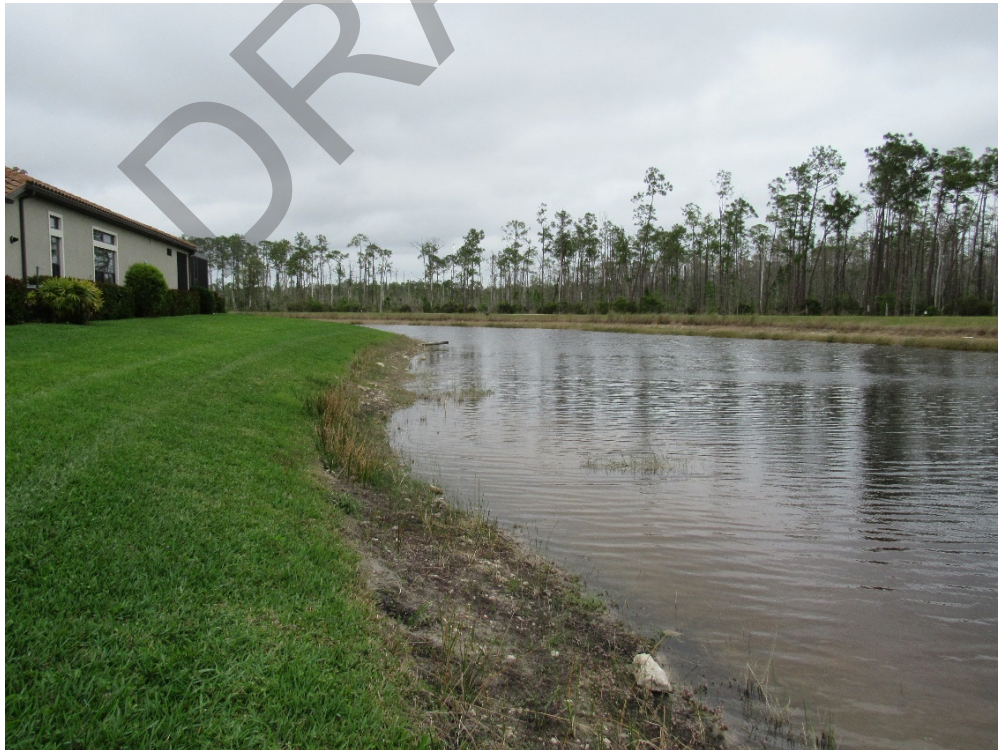
Typical view of limited littoral plants - Lake 18.

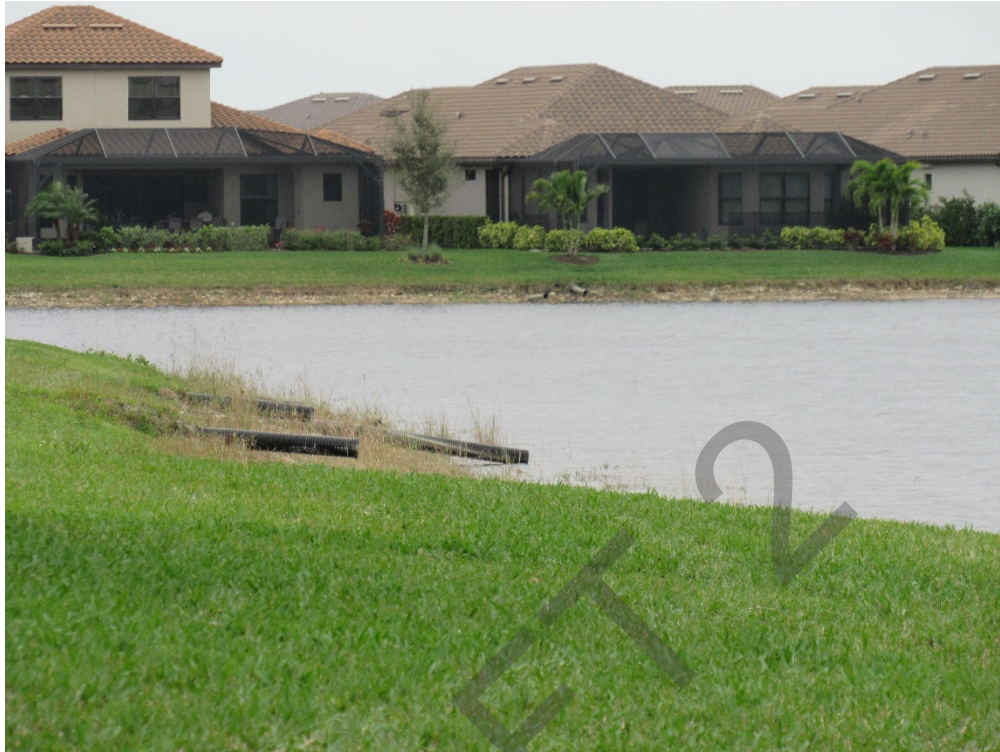
Typical view of limited littoral plants and direct discharge lines - Lake 18.

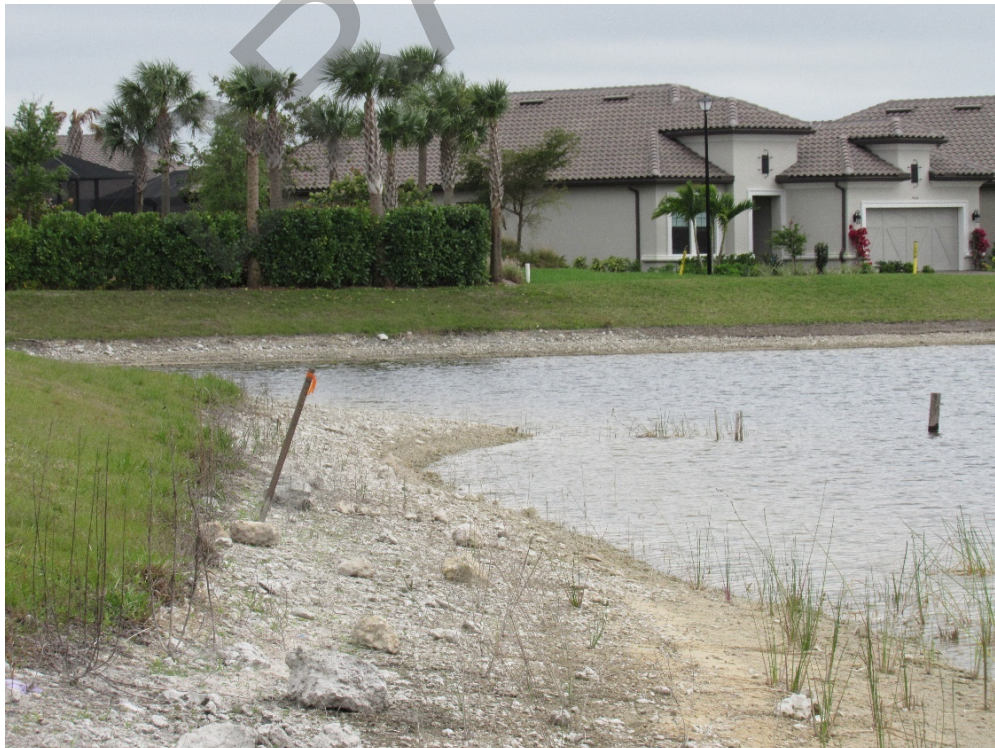
Typical view of limited littoral plants - Lake 25.

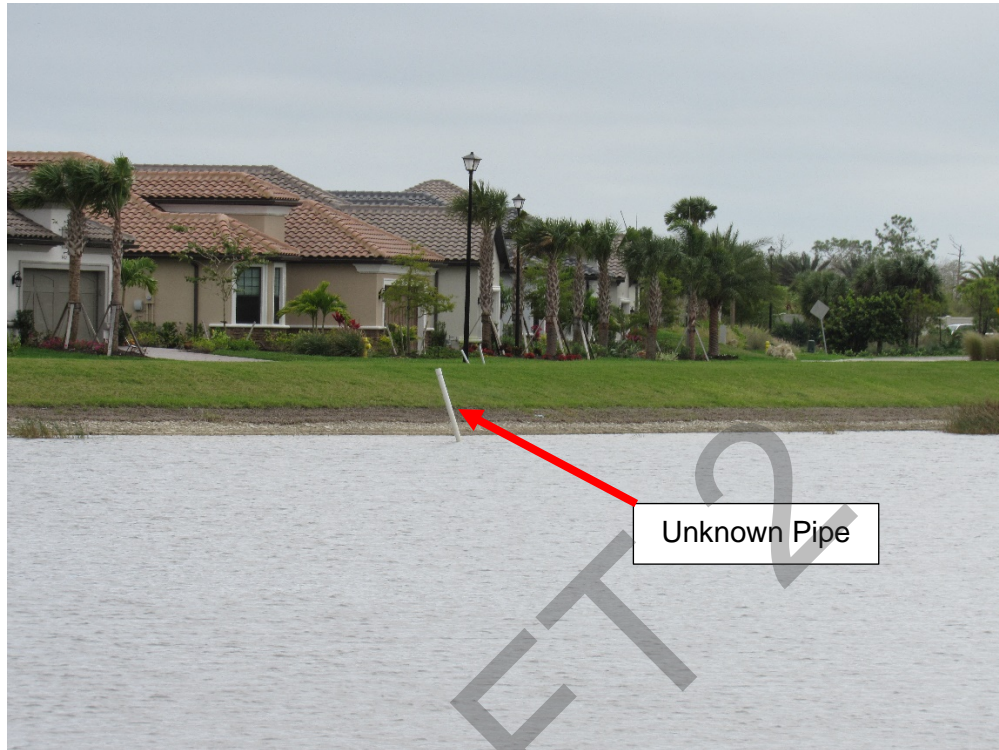
Typical view of limited littoral plants - Lake 25.

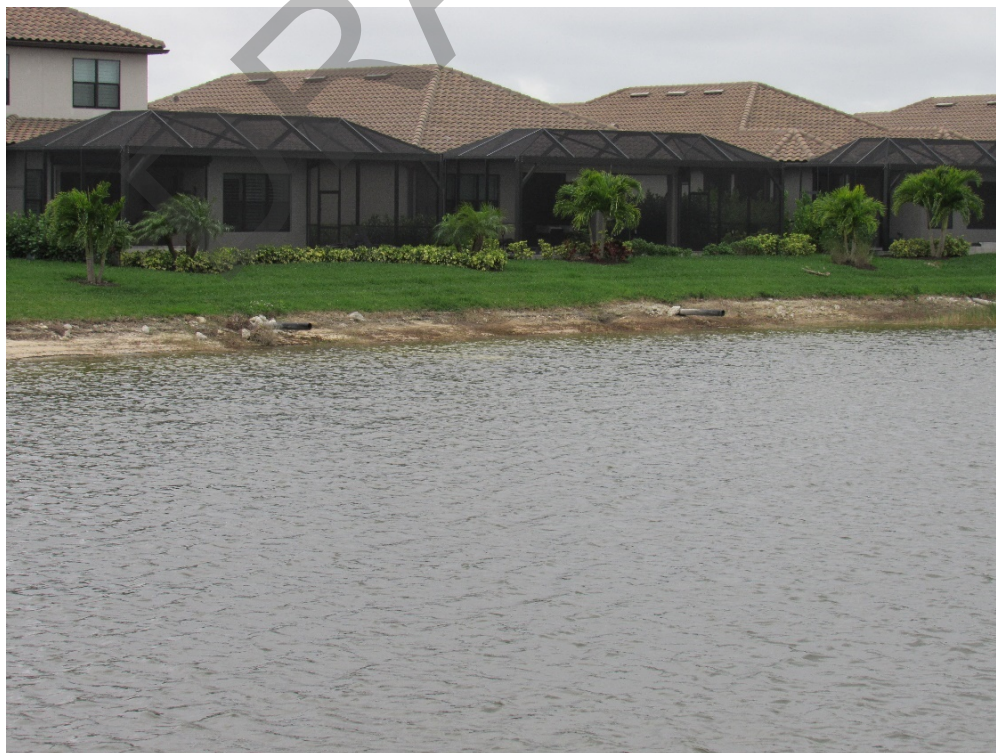
Typical view of limited littoral plants and direct discharge lines - Lake 20.

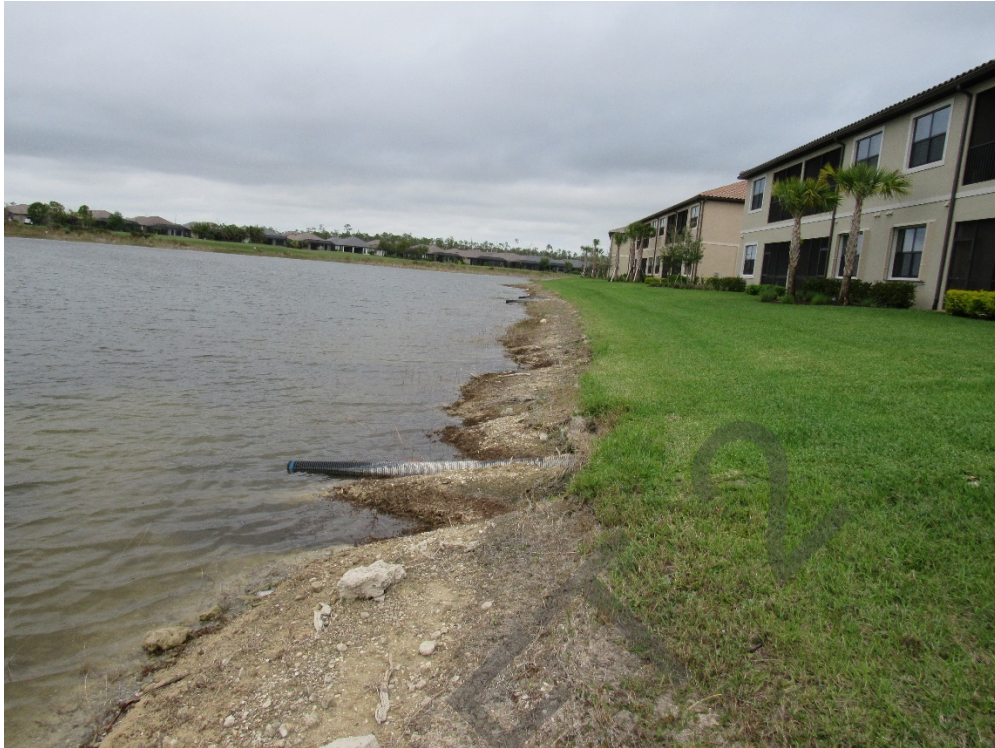
View of limited littoral plants and erosion at lake embankment - Lake 20.

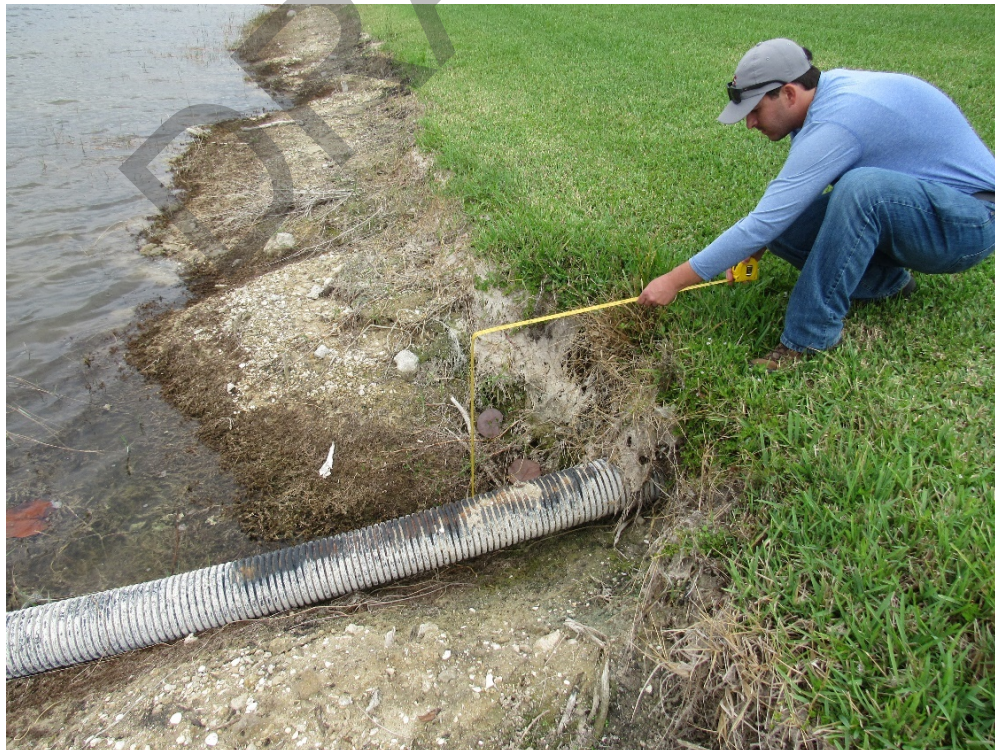
View of the depth of erosion at lake embankment - Lake 20.

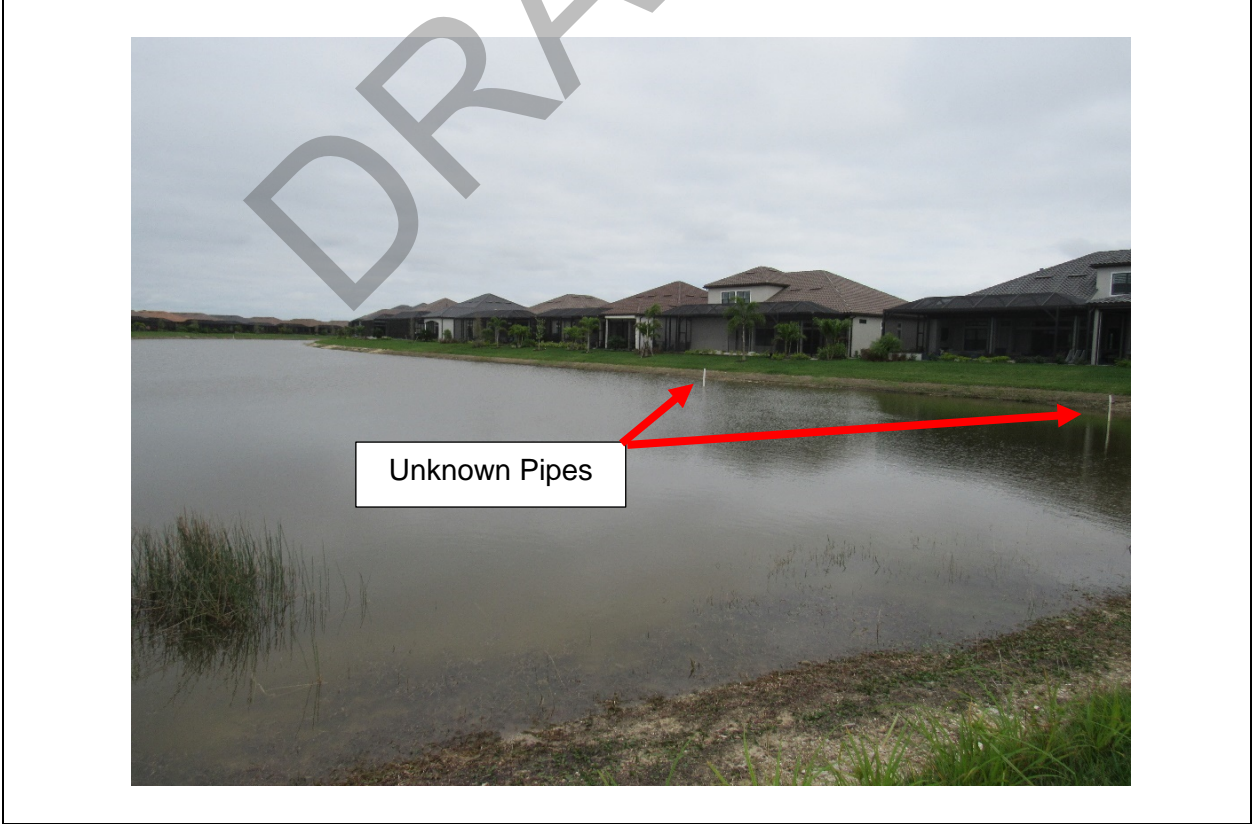
View of limited littoral plants - Lake 22.
