RE: *Flow Way CDD v. Taylor Morrison of Florida, Inc., et al.*
NOTICE OF CLAIM, PURSUANT TO FLA. STAT. § 558.004

Thus, pursuant to Chapter 558 of the Florida Statutes, **YOU ARE HEREBY NOTIFIED of the construction defects existing within the CDD Boundaries, each of which are set forth in more detail in the enclosed Forge Engineering Report, dated June 2, 2021, and the CGA Report.**

FLOW WAY CDD PERIMETER FENCING INVESTIGATION MAP

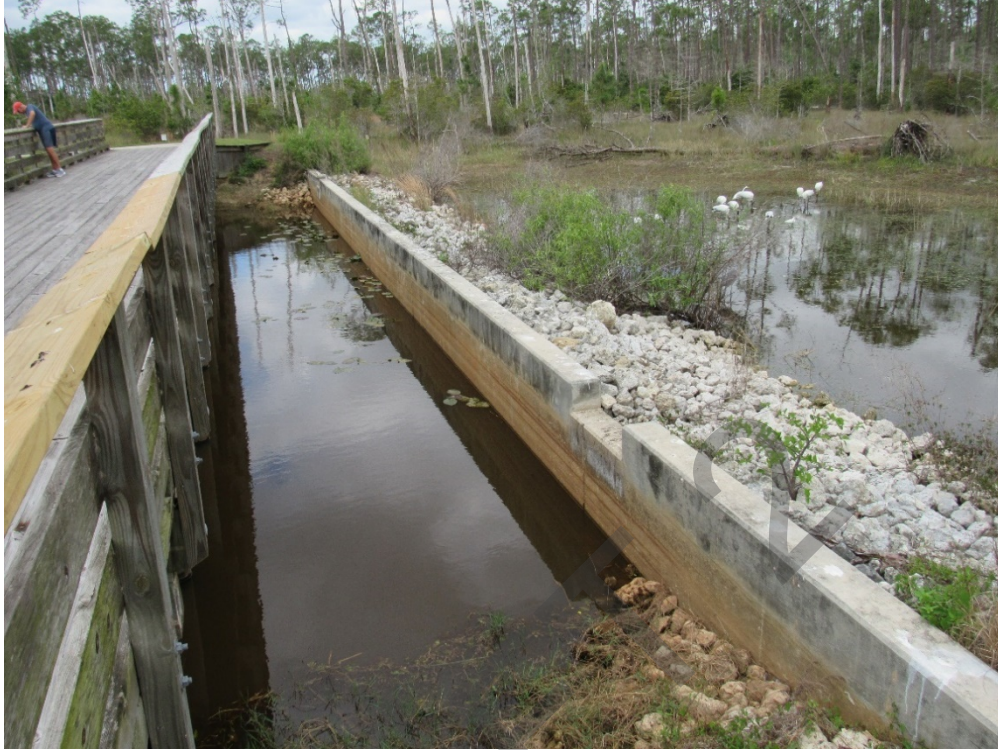
View of North Broad Crested Weir.

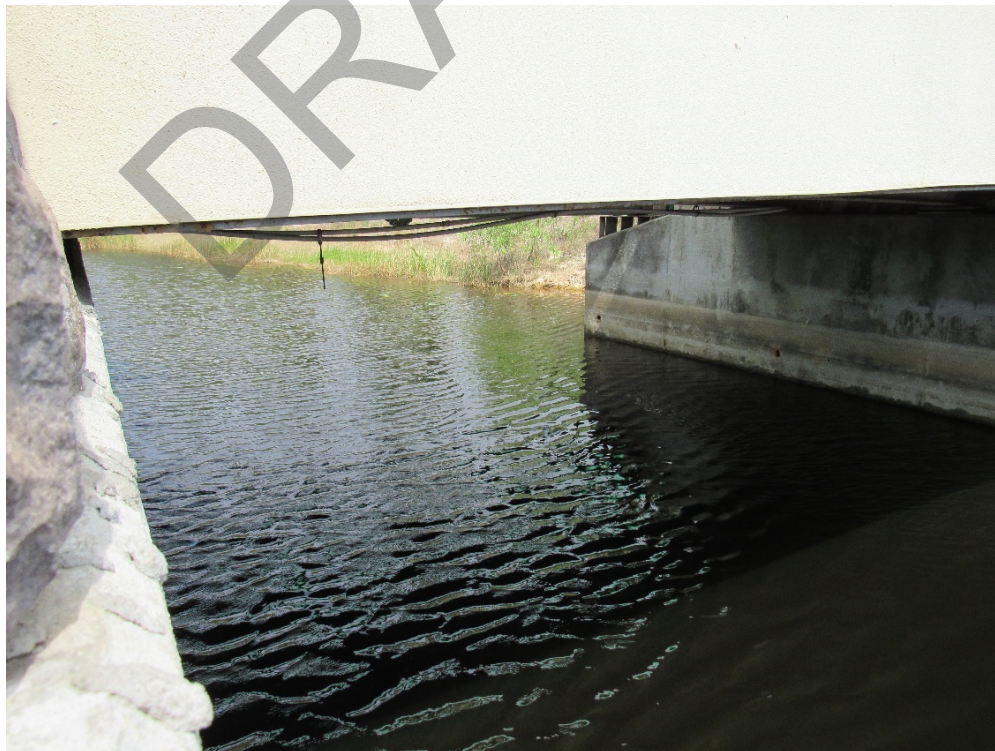
View of Flow Way at intersection with Immokalee Road Canal.

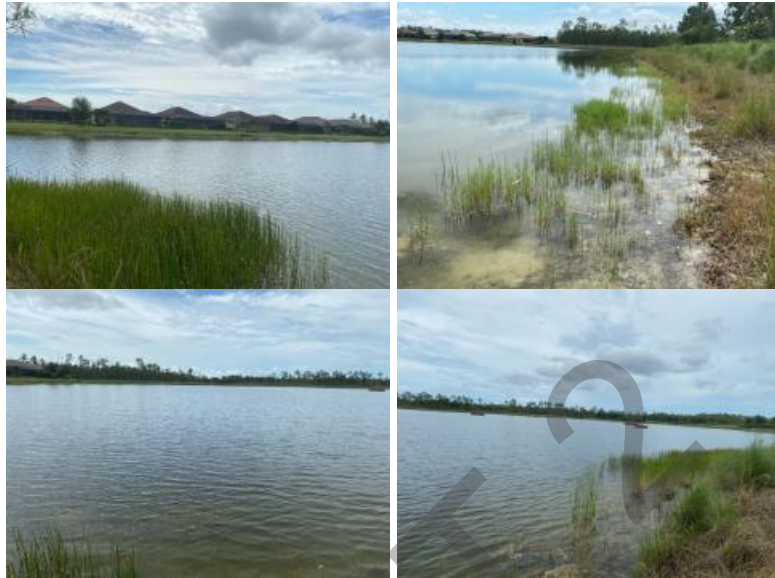
There is surface vegetation present. Spadderdock.

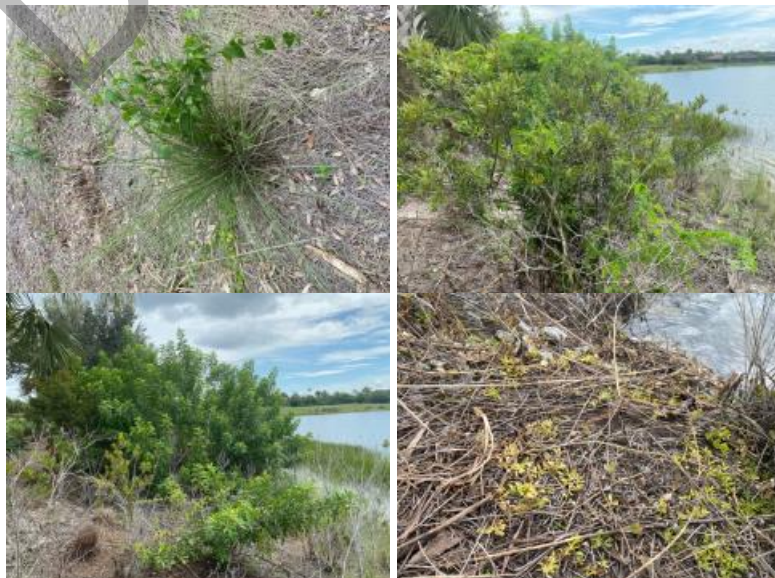
There is a littoral shelf present. Pickeralweed, Softstem Bulrush, Arrowhead, Fakahatchee Grass, Muhly Grass, Bacopa.

Littoral plants are not needed at this time.
There is no aeration present on the lake.
There is no fountain present.
Spadderdock topped out in lake. Cattails growing in spots along lake bank. Beneficials were sprayed during last terrestrial treatment. Some beneficials have vines overgrowing them. Huge Brazilian Pepper found on shoreline within littoral zone.

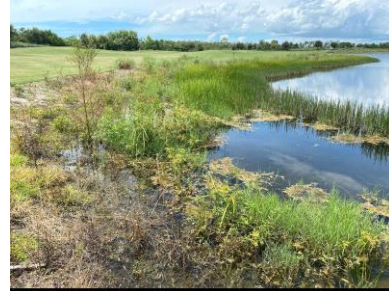
Primrose, Sedges, Tordeo Grass

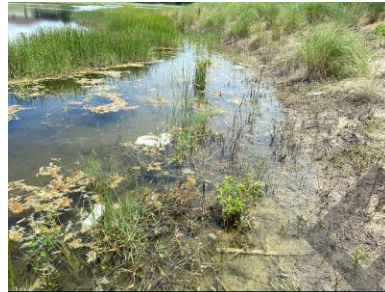
Trash along shoreline

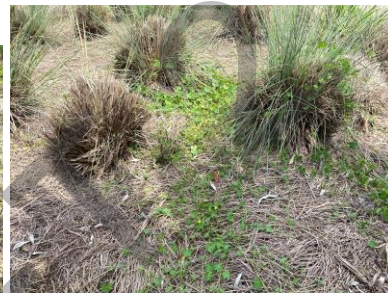
Vines growing over cordgrass and ground

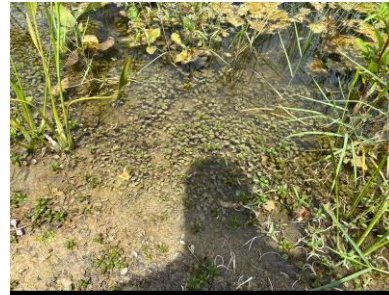
Red Ludwigia

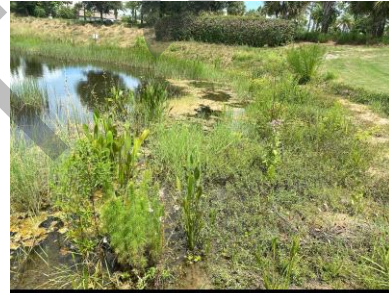
Established Torpedo grass and primrose

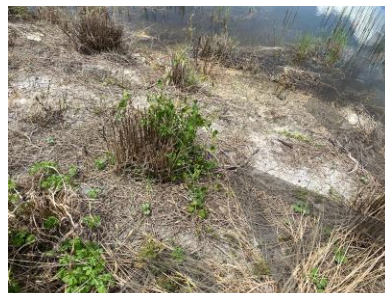
Vines overgrowing beneficials

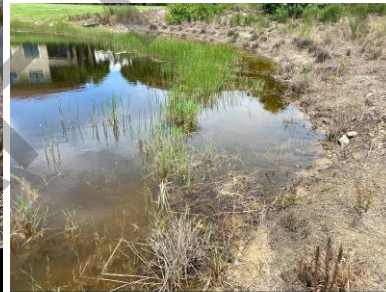
Torpedo Grass

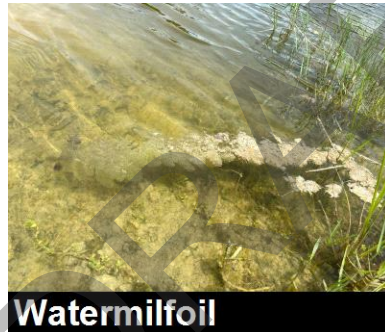
Watermilfoil

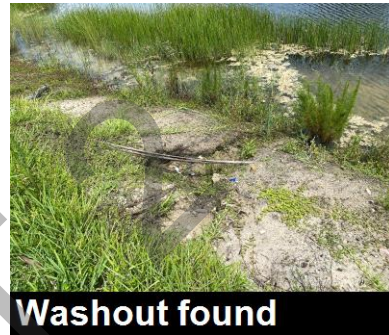
There is new erosion present at the time of inspection.

Spatterdock scattered throughout lake Taquito grass scattered around Shoreline dog fennel around edge trimmer is scattered Watermill for all scattered through our shoreline trash seen during inspection erosion found on corner behind homeowners house Melaleuca trees out in littorial zone scattered around Shoreline edge.

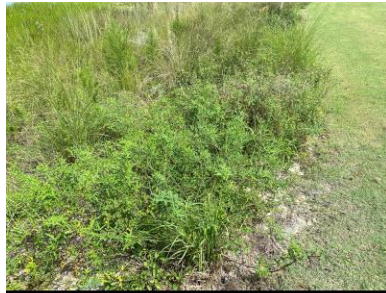
Vines overgrowing beneficials

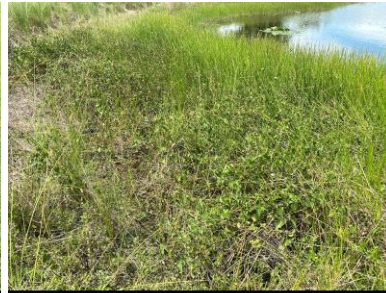
Vines overgrowing bullrush

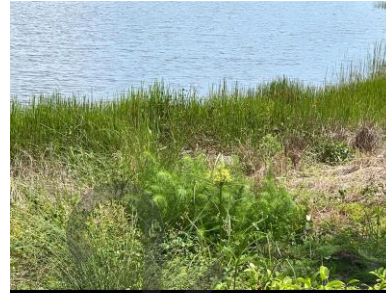
Dogfennel and sedges with littorial zone

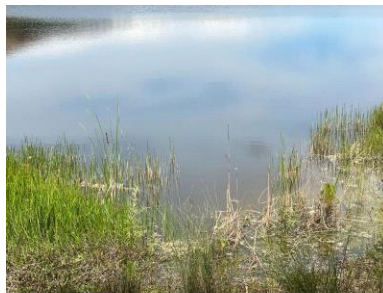
Cattail Clump

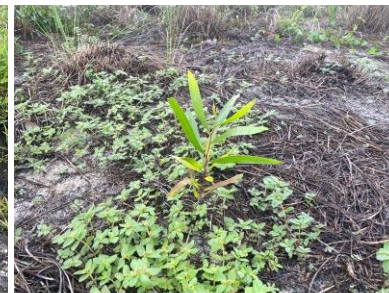
Sappling Earleaf within littorial zone

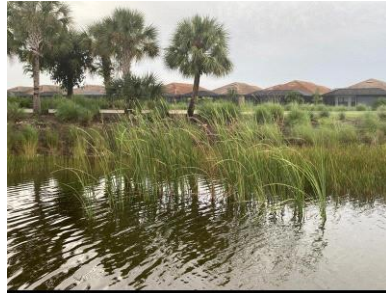
Large established clump of cattails

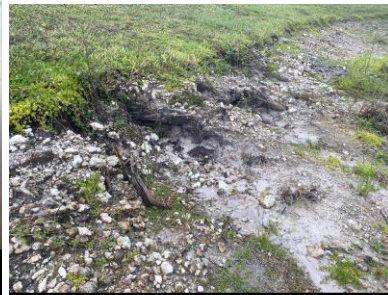
Washout

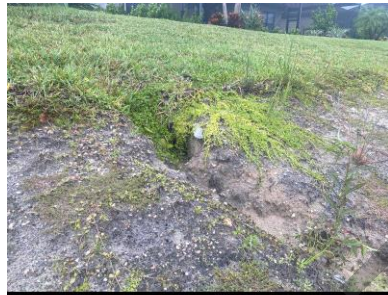
Washout starting

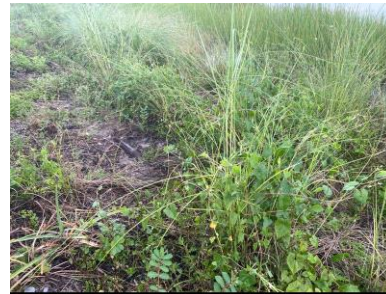
Vines overgrowing cordgrass

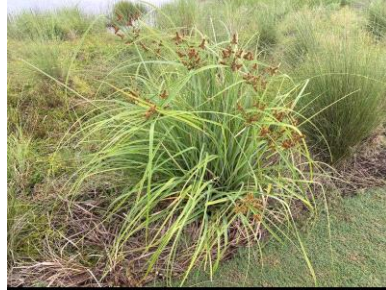
Large segdge growing within littorial zone

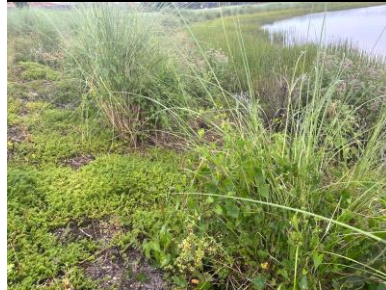
Another area overgrown with vines

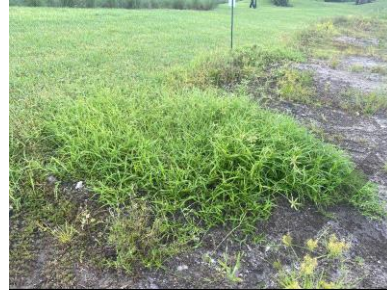
Large patch of crowsfoot on shoreline

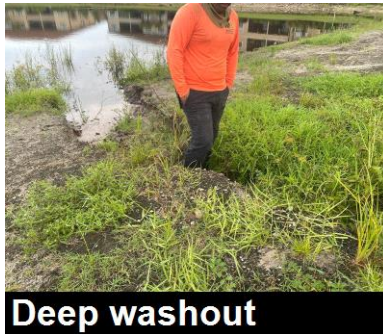
Deep washout

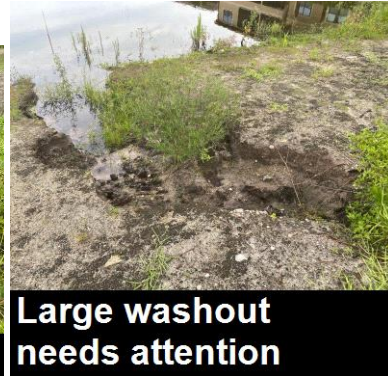
Large washout needs attention

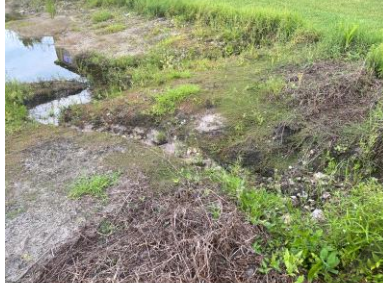
Large washout in corner of lake

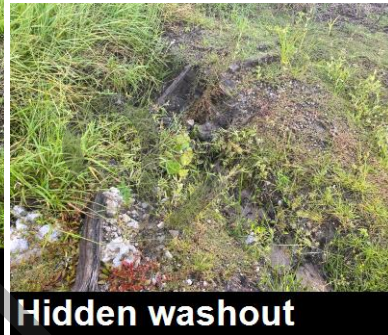
Hidden washout

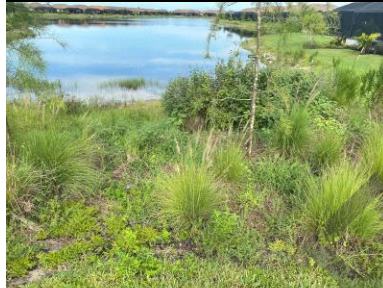
Ceaserweed and dogfennel

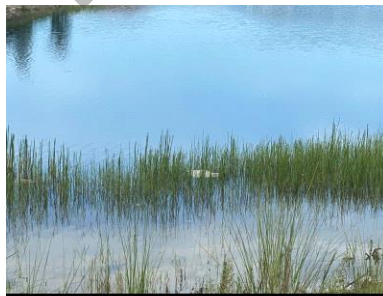
Trash in lake

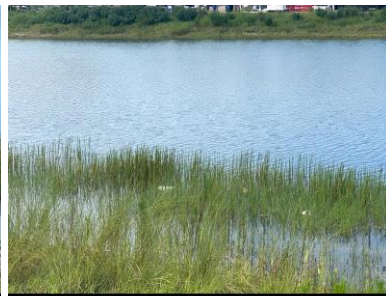
More trash in lake

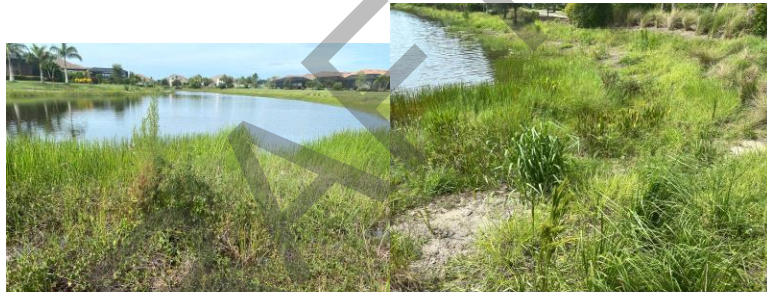
Vines overgrowing beneficials **Overgrown shoreline, torpedo grass in rush**

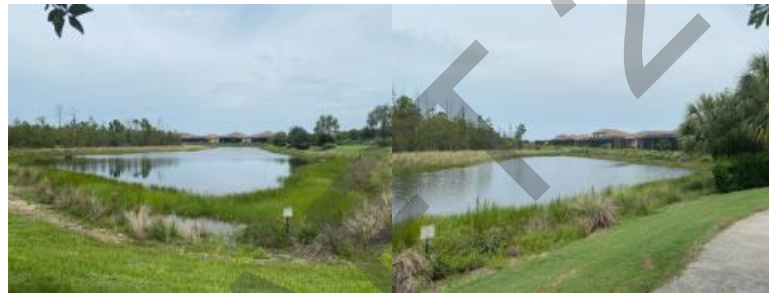
There is surface vegetation present. Spadderdock.
 The vegetation is not thriving.
 There is subsurface vegetation present. Watermilfol.
 There is emergent vegetation present. Torpedo Grass, Cattails, Primrose, Hemp Vine, Dog Fennel.
 The vegetation is thriving. Torpedo Grass, Hemp Vine.
 Water clarity is one to two feet.

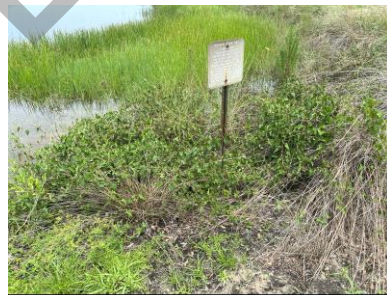
Vines taking over zone

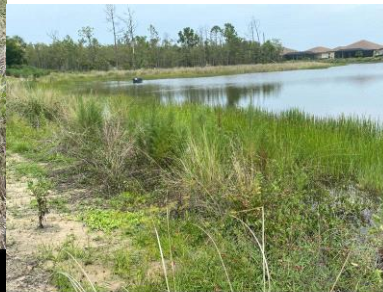
More vines

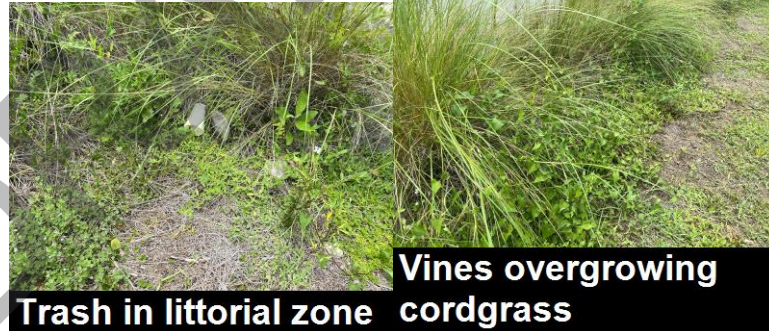
Trash in littoral zone

Vines overgrowing cordgrass

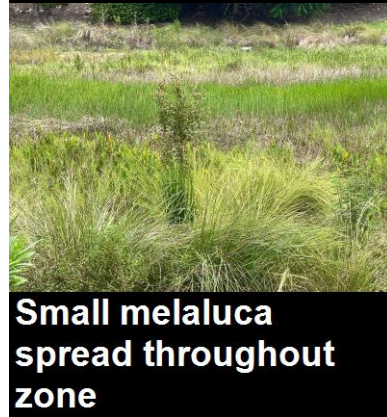
Small melaleuca spread throughout zone

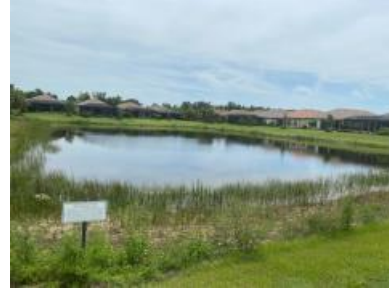
Large infestation of exotics including Cesar weed earleaf Acacia and Melaleuca limited Littorial in need of beneficalis.

Additional littoral plants are recommended at this time. Level of Urgency- Now.

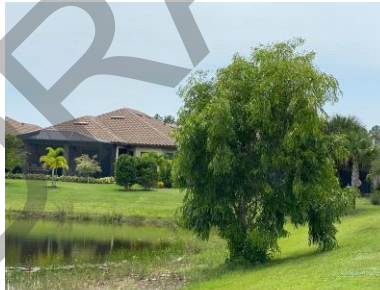
Large earleaf on shoreline

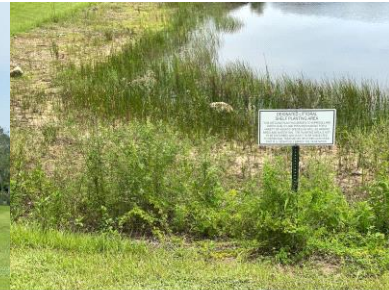
Vines and primrose taking over
