**Report of Water Management System Study**

**FLOW WAY  
COMMUNITY DEVELOPMENT DISTRICT  
(FLOW WAY CDD)**

**Forge Engineering Project Number 5911-001.01**

**June 2021**

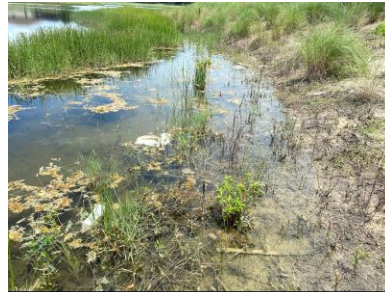
**Trash along shoreline**

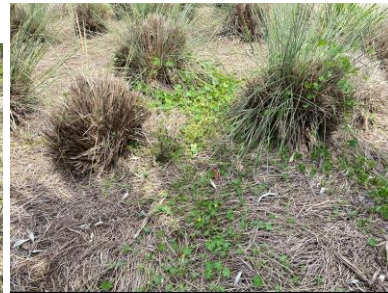
**Vines growing over cordgrass and ground**

Additional littoral plants are recommended at this time.

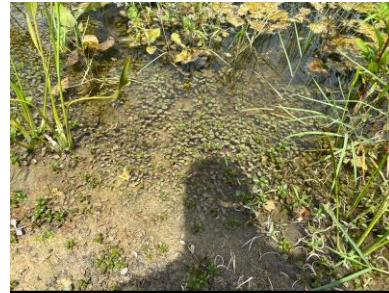
**Red Ludwigia**

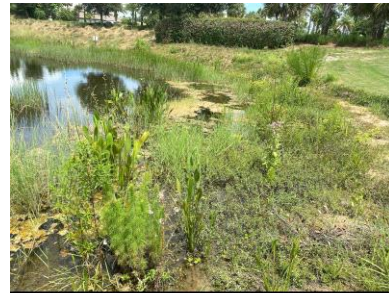
**Established Torpedo grass and primrose**

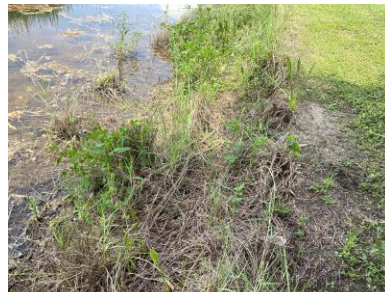
**Vines overgrowing beneficials**

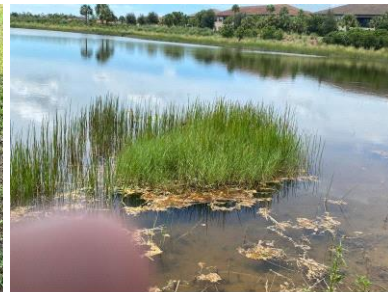
**Established Torpedo grass**

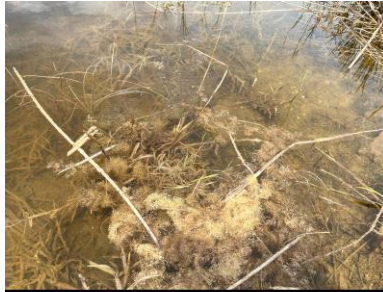
**Watermilfoil**

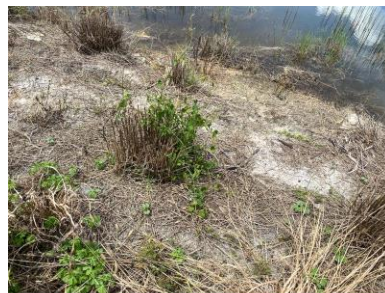
**Vines overgrowing  
beneficials**

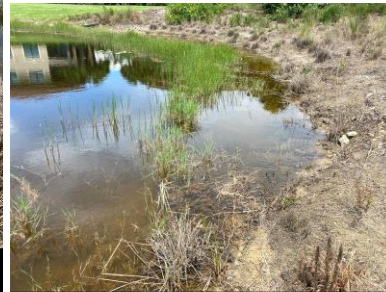
**Torpedo Grass**

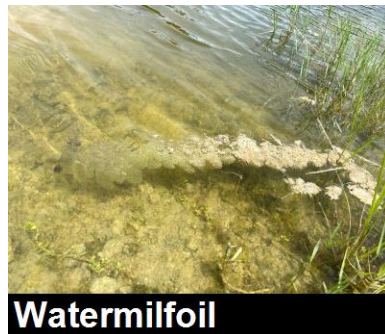
**Watermilfoil**

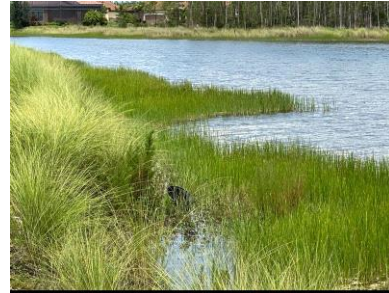
**Trash along shoreline**

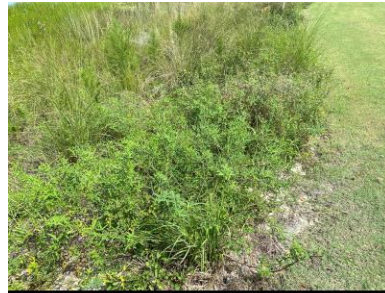
**Vines overgrowing beneficials**

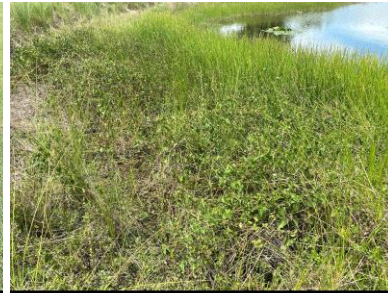
**Vines overgrowing bullrush**

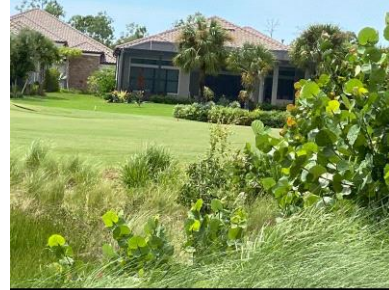
**Melaluca growing within littorial zone**

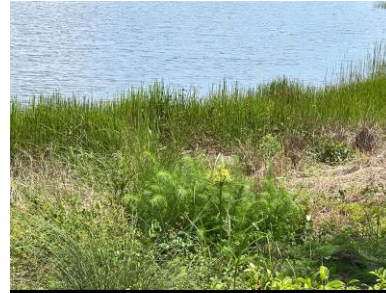
**Dogfennel and sedges with littoral zone**

*Aeration Present?* There is no aeration present on the lake.  
*Fountain present?* There is no fountain present.  
*Action Steps* Spotty Spatterdock throughout lake spotty torpedo grass heavy vines and beneficial zones sedges as well.

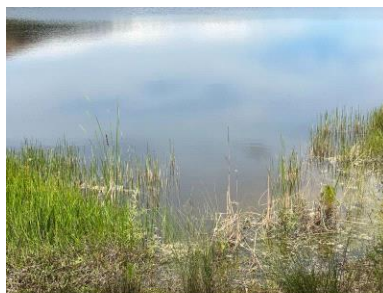
**Cattail Clump**

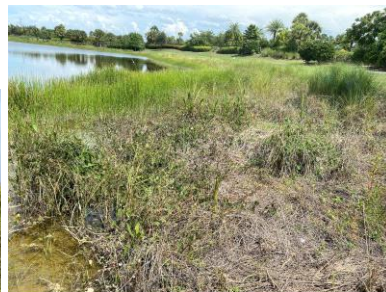
**Arrowhead overgrown with vines**

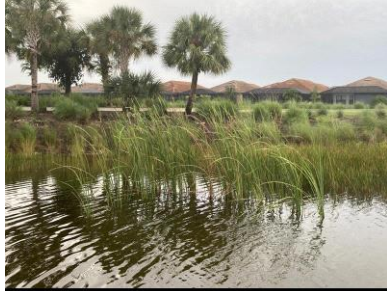
**Large established clump of cattails**

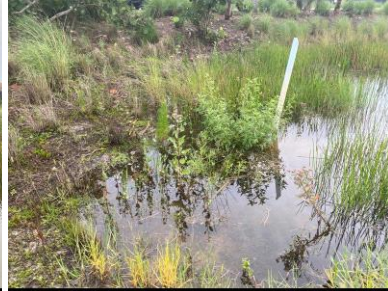
**Torpedo grass and Primrose**

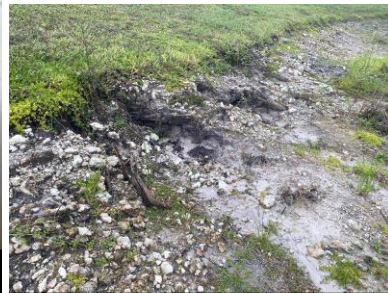
**Washout**

Repair should be considered at this time.  
There is no aeration present on the lake.  
There is no fountain present.

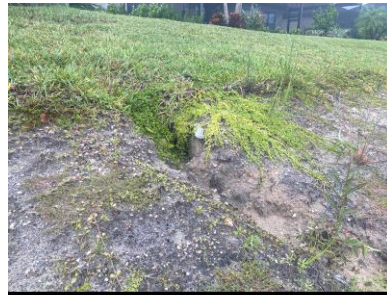
**Washout starting**

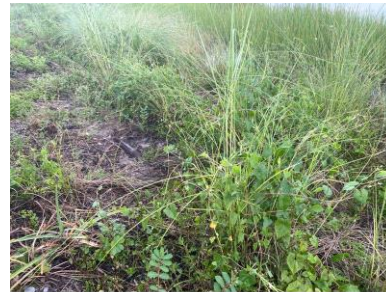
**Vines overgrowing cordgrass**

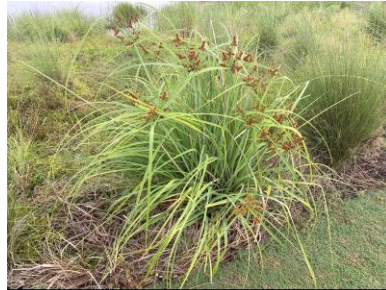
**Large segdge growing within littorial zone**

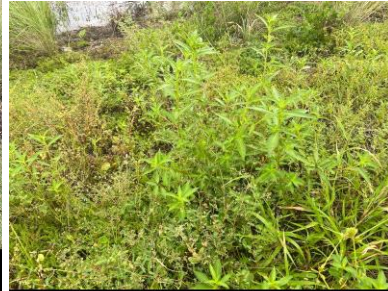
**Primrose scattered through zone**

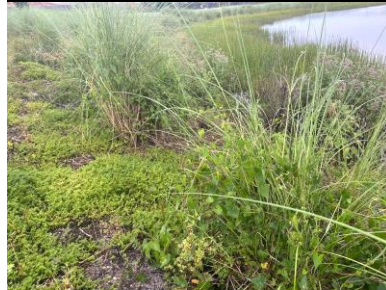
**Another area overgrown with vines**

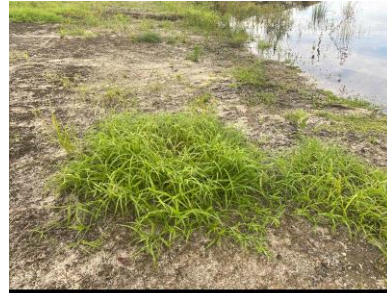
**Patch of crowsfoot on shoreline**

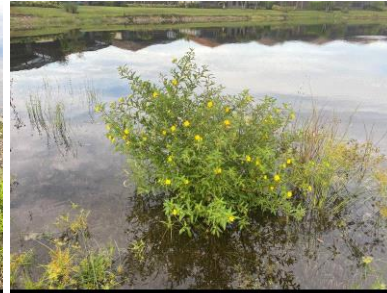
**Large primrose in lake**

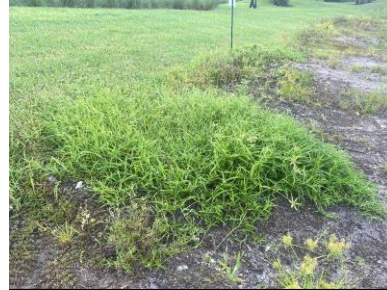
**Large patch of crowsfoot on shoreline**

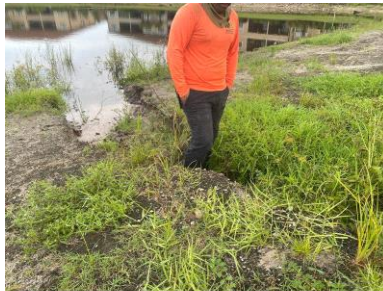
**Deep washout**

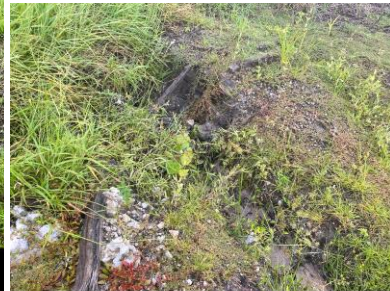
**Hidden washout**

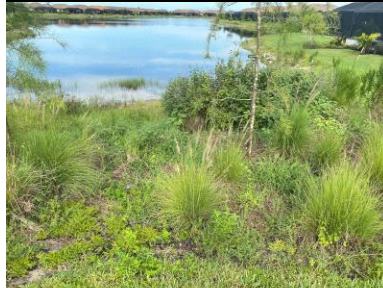
**Ceaserweed and dogfennel**

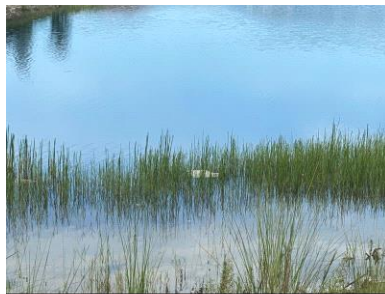
**Trash in lake**

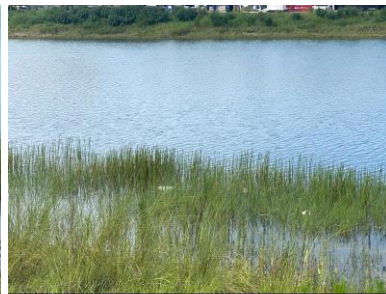
**More trash in lake**

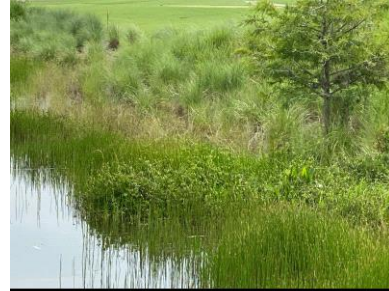
**Vines overgrowing**

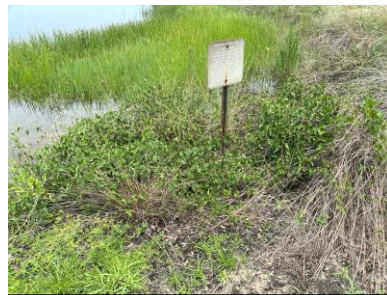
**Vines taking over zone**

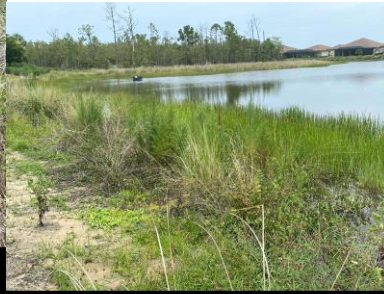
**More vines**

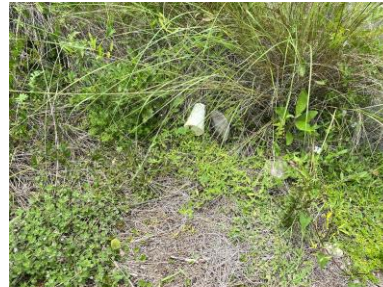
**Trash in littoral zone**

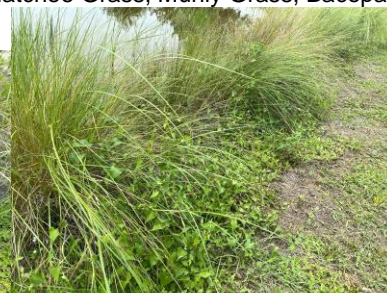
**Vines overgrowing cordgrass**

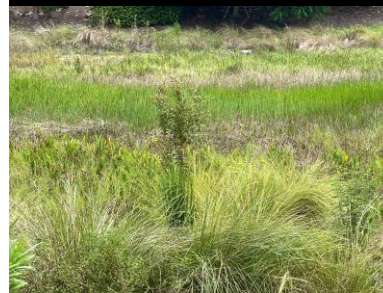
**Small melaleuca spread throughout zone**

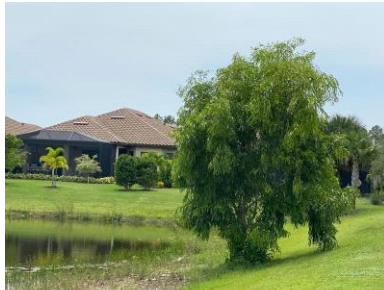
Large infestation of exotics including Cesar weed earleaf Acacia and Melaleuca limited Littorial in need of beneficials.

**Large earleaf on shoreline**

Additional littoral plants are recommended at this time. Level of Urgency- Now.

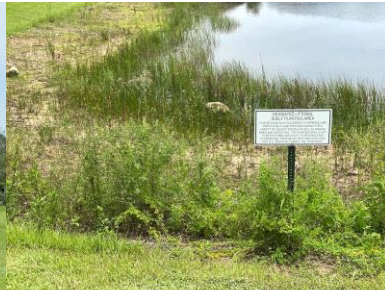
**Vines and primrose taking over**
