Wentworth Estates CDD at Treviso Bay Waterway Inspection Report

Reason for Inspection: Routine Scheduled

Inspection Date: 2026-01-27

Mason Maher, Field Operations Manager- Environmental Scientist

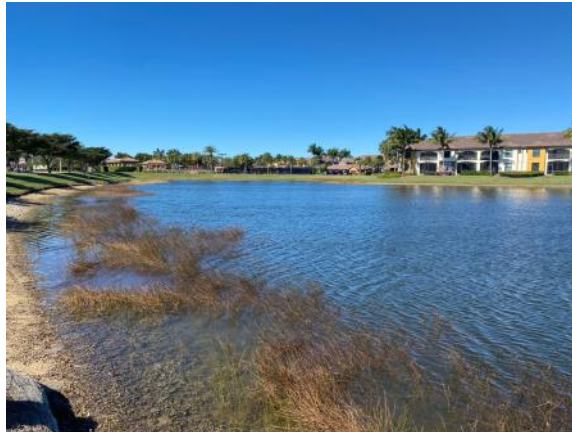
Normal growth observed

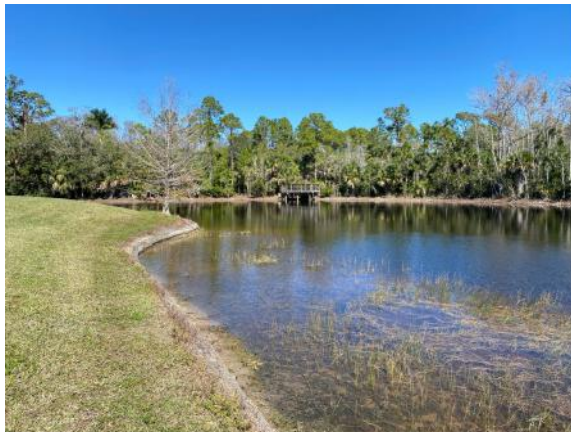
Normal growth observed

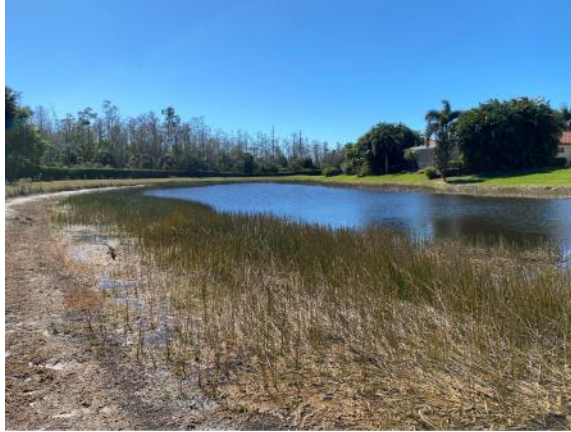
Site: 19

Shoreline is well maintained. Tall broom grass observed in landscape buffer zone. Minor algae present within littorals.

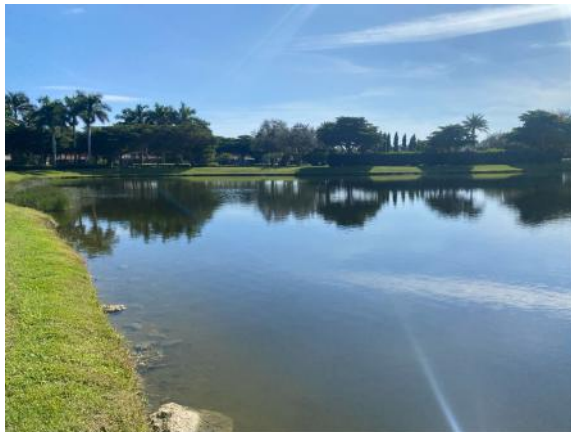
Site: 21

Normal growth observed

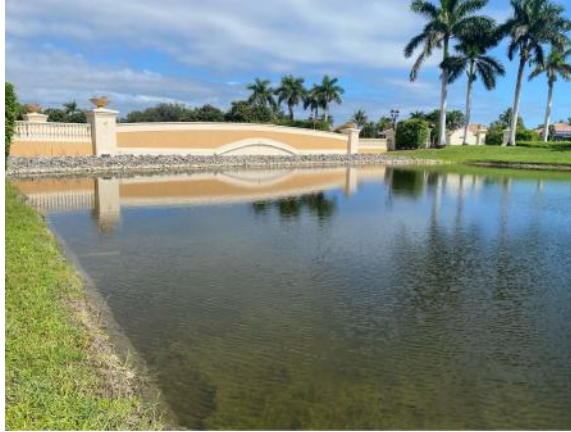
Site: 22

Normal growth observed

Shoreline is well maintained. Minor charra observed in lake has been treated.

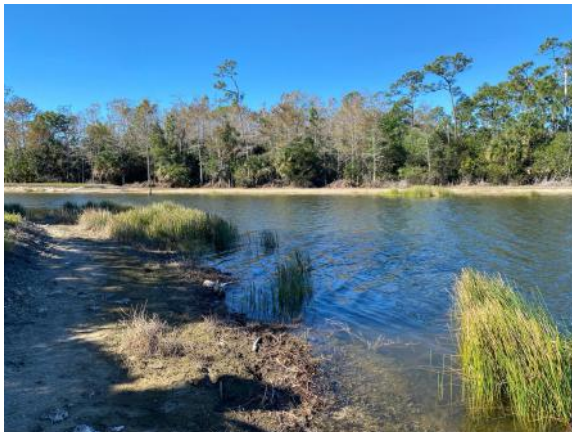
Site: 27

Normal growth observed

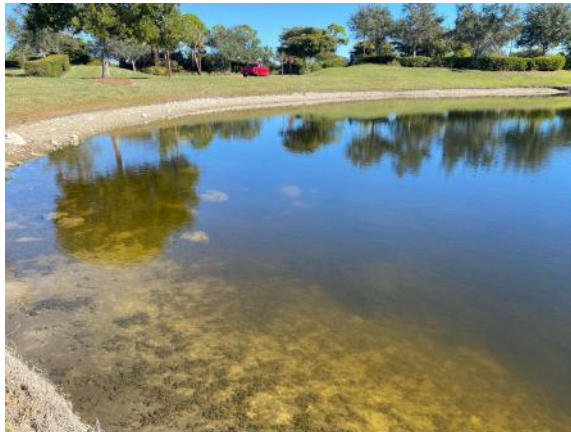
Treatment in progress

Shoreline is well maintained. Minor charra present in lake has been treated.

Re-inspect next visit

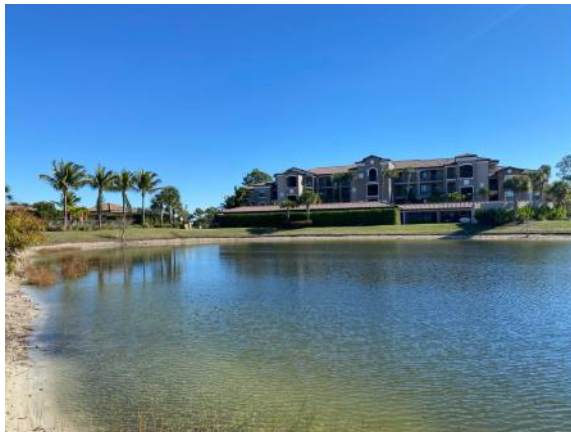
Site looks good

Shoreline is well maintained. Submersed vegetation and algae are at controlled levels.

Routine maintenance next visit

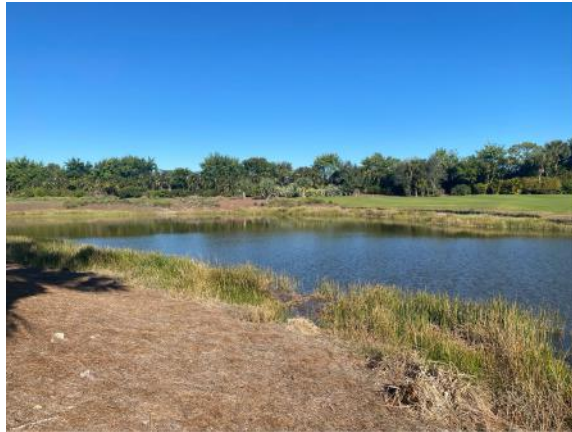
Site: 37

Site looks good
Shoreline is well maintained.
Algae and submerged vegetation are at controlled levels.

Routine maintenance next visit
